ROYAL AIR FORCE BOARD OF INQUIRY

INTO THE LOSS OF:

**HERCULES XV179
(IRAQ - 30 JAN 05)**

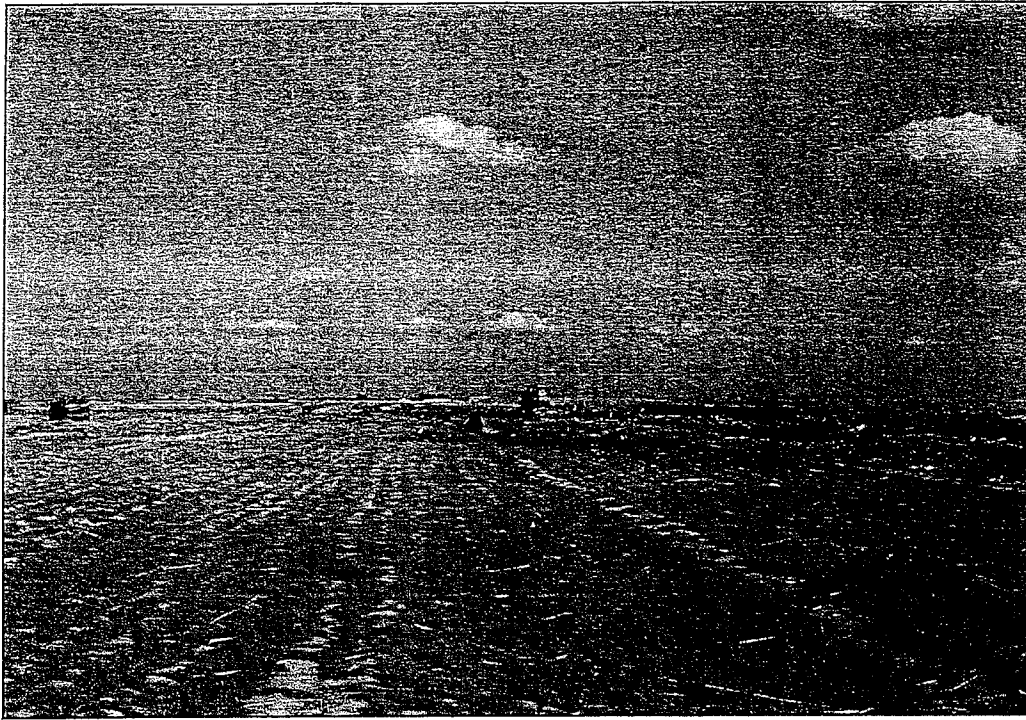
22. Incident Area Topography. The red arrow on Fig 2.1 shows the general area of the incident and the picture at Fig 2.2 gives a view of the topography at the main crash site. The area is completely flat agricultural land, criss-crossed with irrigation canals. There are small clumps of trees dotted across the landscape but none of significant height, nor any electricity pylons or wires within the immediate area. The region is sparsely populated and the local infrastructure is poor.

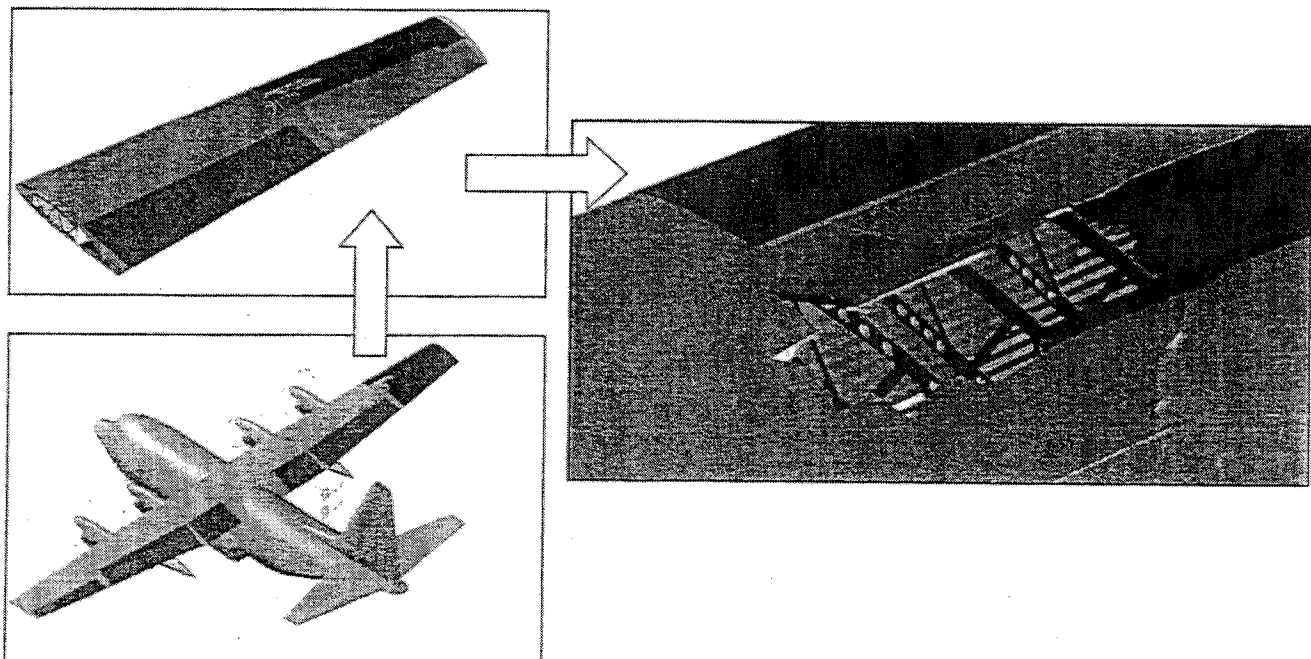
Fig 2.11

observed damage could have reduced the tank quantity thereby increasing the ullage volume, or a fire, caused by the damage, could have increased the ullage temperature. There is some evidence of airborne fire damage to the separated wing sections and the remaining section of right-hand wing at the main crash site. However, the AAIB conclude that there was no evidence consistent with a sustained airborne fire in the separated wing section and that the fire damage visible in this part of the wreckage occurred after separation, either as the sections fell or as a result of subsequent ground fire. There is evidence of sustained airborne fire on the remaining section of wing at the separation point, which is also likely to have occurred after separation, although evidence for this is less conclusive. This fire caused significant damage to the trailing edge of the wing, in the vicinity of OWS 300, and the observed damage is indicative of significant and sustained sideslip. After detailed inspection of the separation at OWS 317, the AAIB Senior Investigator concluded that there was some evidence of a large penetration consistent with impact. Two localised areas contrasted strongly with the more regular pattern of failure observed elsewhere on the separated wing section. The location of this suspect damage is shown in Fig 2.11. If such a penetration existed, it would allow rapid draining of the fuel tank, provide a possible source for sustained fire and locally reduce the wing's structural strength, which would account for this area becoming the separation point. The source of ignition for the explosive over pressure is discussed later in this report; however, the Board has concluded that the explosive separation of XV179's wing was caused by the ignition of the fuel/air mix in the number 4 fuel tank ullage. Furthermore, the Board concluded that the lack of a suppression system within the fuel tank, such as foam or inert gas, was a contributory factor. The Board also concluded that the violence associated with the separation and the resulting fire, caused significant damage to the remaining section of wing. Consequently, the aerodynamic effect on the ac would have been more significant than the loss of the outer wing section in isolation.
