# ***AAIB Bulletin***

***2/2018***

Boeing 767-36N	G-POWD	19-Mar-17	3
----------------	--------	-----------	---

<b>Aircraft Type and Registration:</b>	Boeing 767-36N, G-POWD	
<b>No &amp; Type of Engines:</b>	2 General Electric Co CF6-80C2B7F turbofan engines	
<b>Year of Manufacture:</b>	2003 (Serial no: 30847)	
<b>Date &amp; Time (UTC):</b>	19 March 2017 at 0900 hrs	
<b>Location:</b>	En route from London Stansted Airport to Rzeszow-Jasionka Airport, Poland	
<b>Type of Flight:</b>	Commercial Air Transport (Passenger)	
<b>Persons on Board:</b>	Crew - 9	Passengers - 262
<b>Injuries:</b>	Crew - None	Passengers - None
<b>Nature of Damage:</b>	None	
<b>Commander's Licence:</b>	Airline Transport Pilot's Licence	
<b>Commander's Age:</b>	52	
<b>Commander's Flying Experience:</b>	8,965 hours (of which 2,635 were on type) Last 90 days - 24 hours Last 28 days - 24 hours	
<b>Information Source:</b>	AAIB Field Investigation

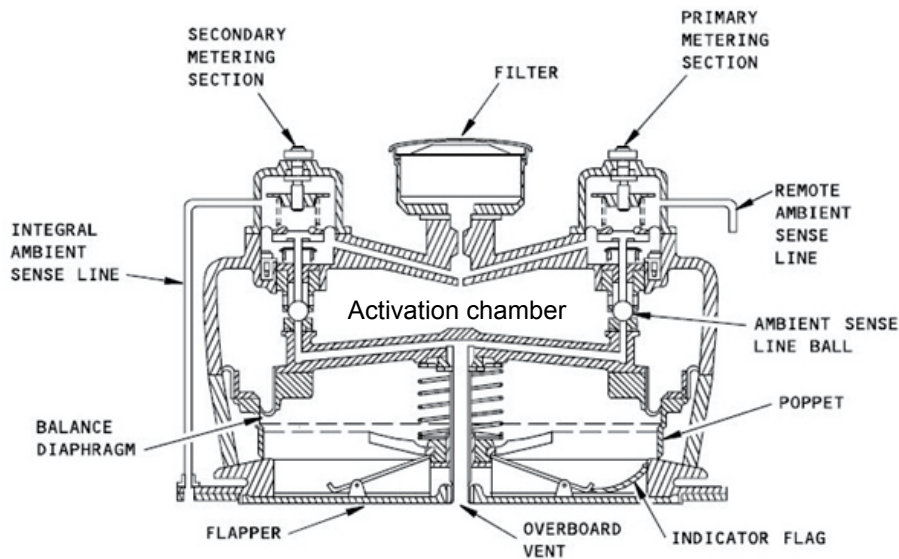
**Figure 2**

Schematic of the positive pressure relief valve

Whilst the reason for the PPRV's failure was not found, the manufacturer calculated that the valve would have opened at around 3.5 psi differential pressure if a piece of debris as small as 0.0033 inches in diameter had become trapped underneath the ball valve in either the primary or secondary metering section.

The investigation concluded that there was a fault in one PPRV that would result in gradual cabin air leakage. The reason for the fault was not identified, despite testing and careful strip examination. The valve manufacturer surmised that a small piece of debris could have become trapped in a metering unit ball valve, thus propping it open. However, it was not established how such debris could have entered the valve after it was tested as serviceable following overhaul.

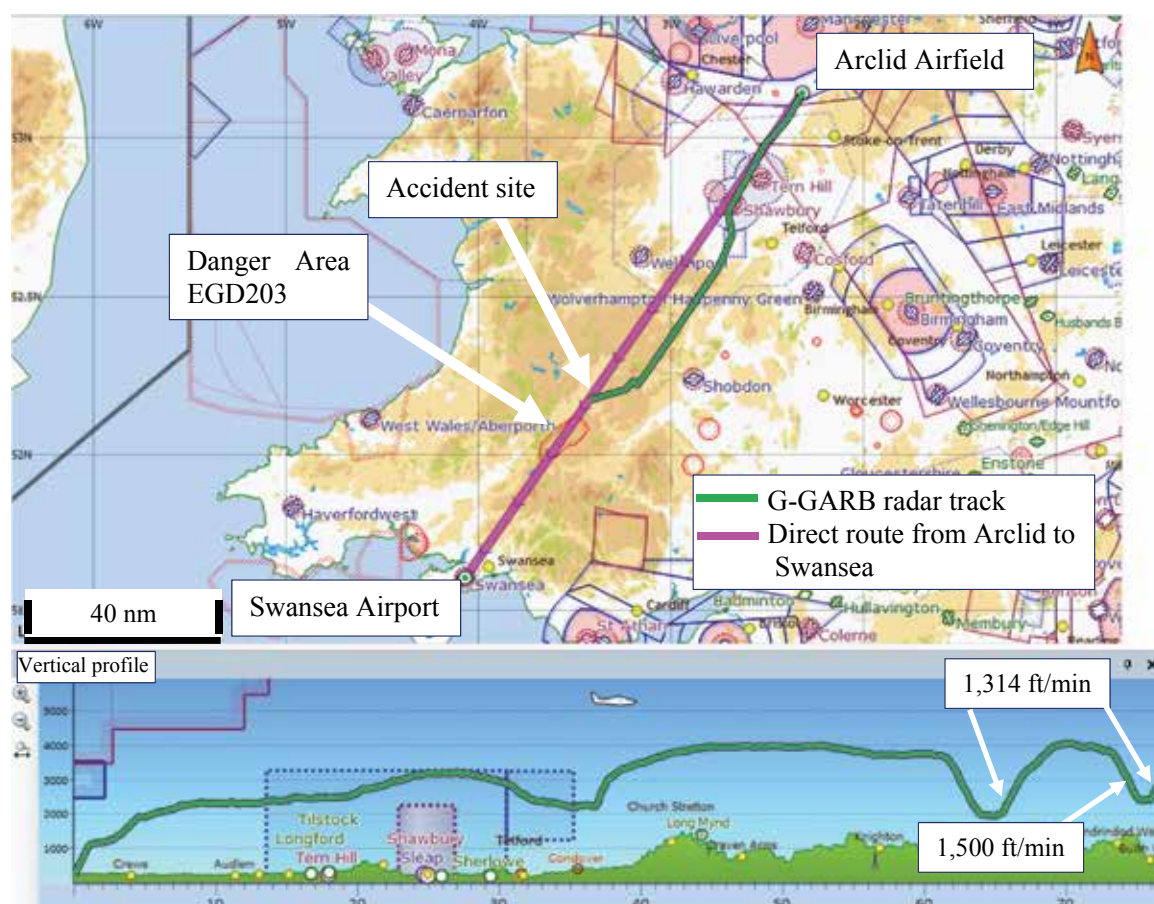
**Figure 1**

At about 0946 hrs G-GARB took off from Arclid Runway 20 and departed on a south-westerly course towards Swansea. Radar data later showed that the aircraft climbed gradually to an altitude of 3,300 ft amsl; the altitude during the flight varied but remained above 2,000 ft amsl up to the point of the accident. A plot of the vertical profile of the flight is shown in Figure 1.

G-GARB recorded radar track with derived vertical speeds  
(Chart produced by SkyDemon and used with permission)

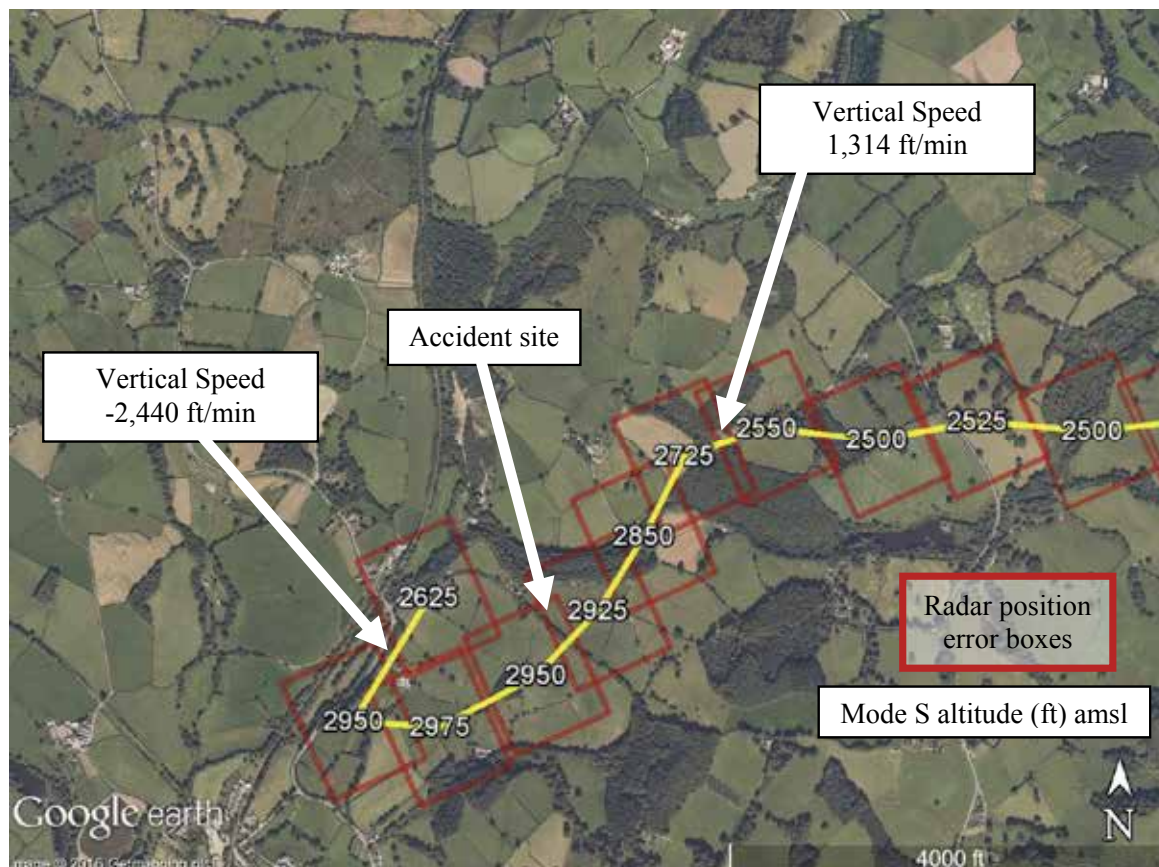
**Figure 4**

The final stage of the flight is illustrated in Figure 4, which includes 'error boxes', in red, denoting the limited accuracy of the radar position data. A minute and a half prior to the end of the radar recording, the aircraft started to fly at approximately level altitude and constant heading for 40 seconds. Calculated groundspeed for this period was 87 mph  $\pm$ 18 mph (depending on radar error). Considering the aircraft's approximate heading and a reported wind of 240°/ 10 kt, this equates to an airspeed of 97 mph  $\pm$ 18 mph. At 1055:27 hrs, the aircraft commenced a climb from 2,550 ft to 2,975 ft over 40 seconds. The maximum derived vertical speed during this climb was 1,314 ft/min with an average of 638 ft/min. Between the penultimate and final recorded radar returns, the aircraft descended 325 ft over 8 seconds; a descent rate of 2,440 ft/min. The final recorded radar return was at 1056:23 hrs with the aircraft at 2,625 ft (2,100 ft agl), almost overhead the accident site.

G-GARB recorded radar data showing altitude amsl and position error boxes in red

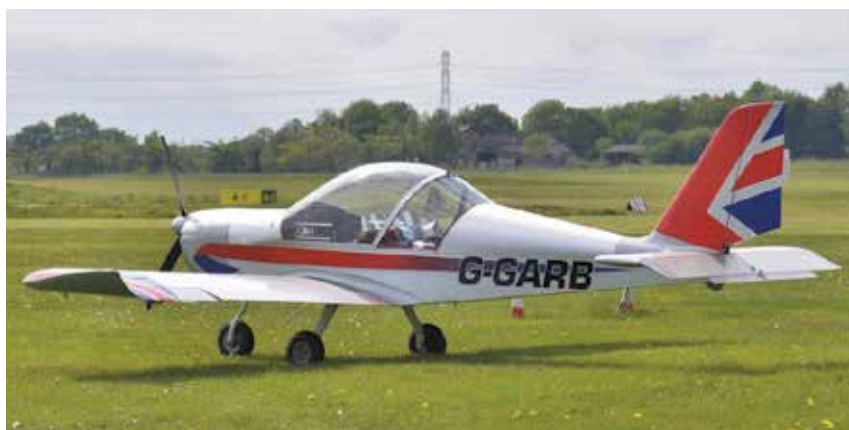
**Figure 5**

The accident aircraft, EV-97 Teameurostar UK, G-GARB  
(photo courtesy of and copyright Craig Duffy)

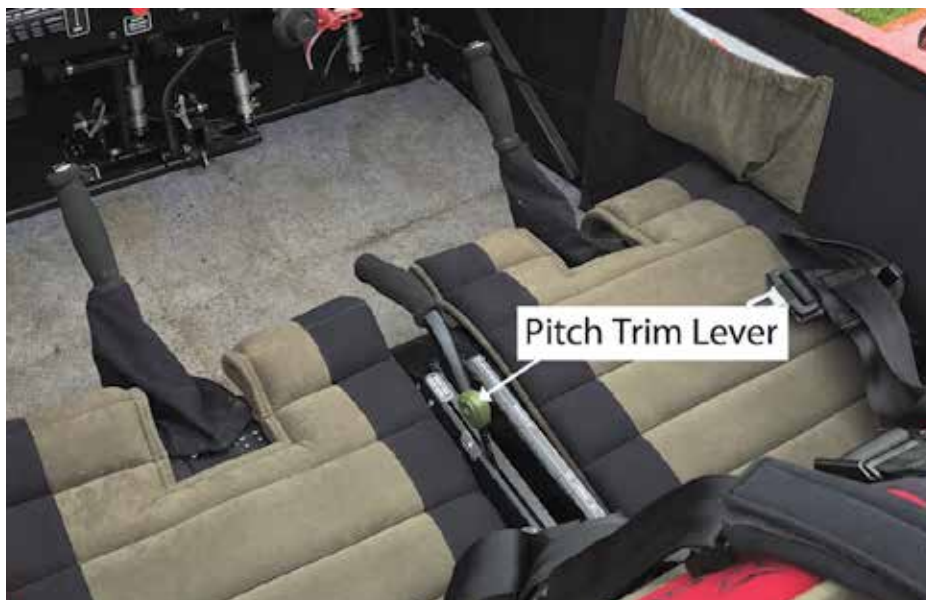
**Figure 6**

The elevator had a trim tab which was operated via a 'Bowden-type' cable and a lever mounted between the seats (Figure 6). This trim lever was pushed forward to generate nose-down trim and pulled aft to generate nose-up trim.

Pitch trim lever on another EV-97 aircraft

An EV-97 flight instructor informed the AAIB that he had experienced "a couple" of occasions when a student pilot or passenger had inadvertently pressed down on the trim lever causing a 'bunt type' manoeuvre. He said this could happen when someone was trying to shift their weight in the seat by pushing down with their left hand (Figure 6). The flight evaluation used an incremental approach to determine the effect of sudden changes in trim lever position from straight and level cruise flight. During trim changes the control stick was held loosely and allowed to move until recovery action was taken.

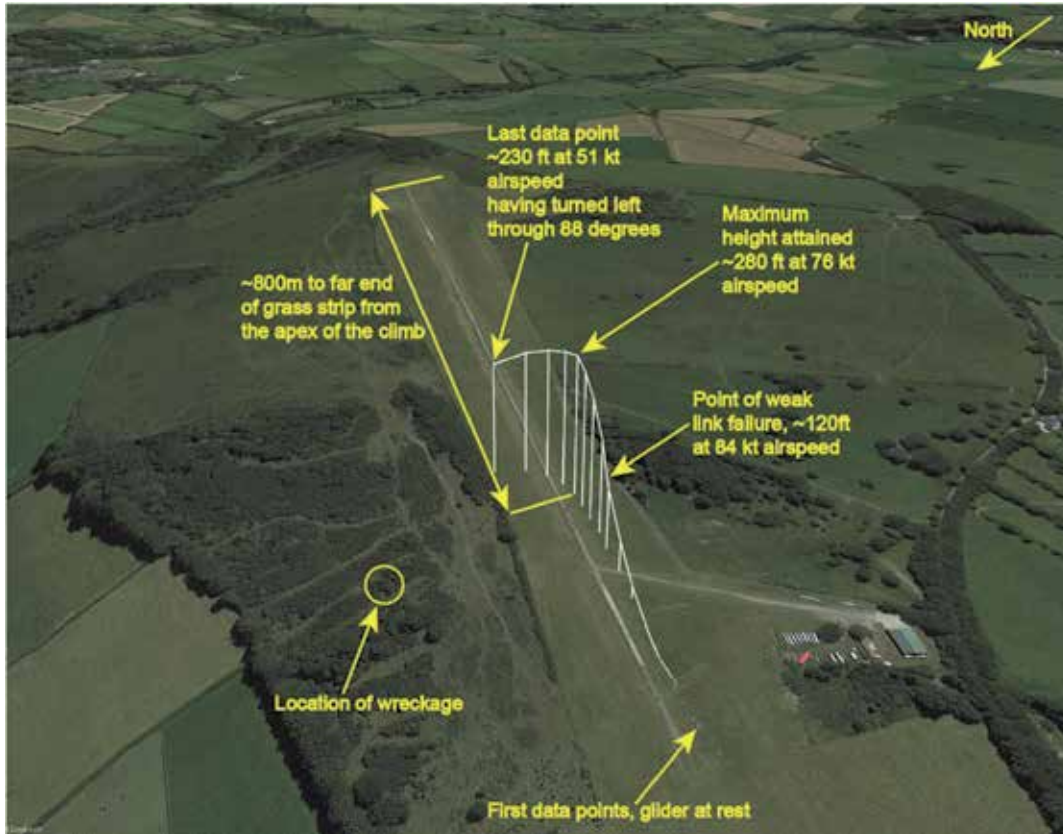
**Figure 1**

Vertical profile (ft aal<sup>7</sup>), ground track and true airspeed data for the accident flight

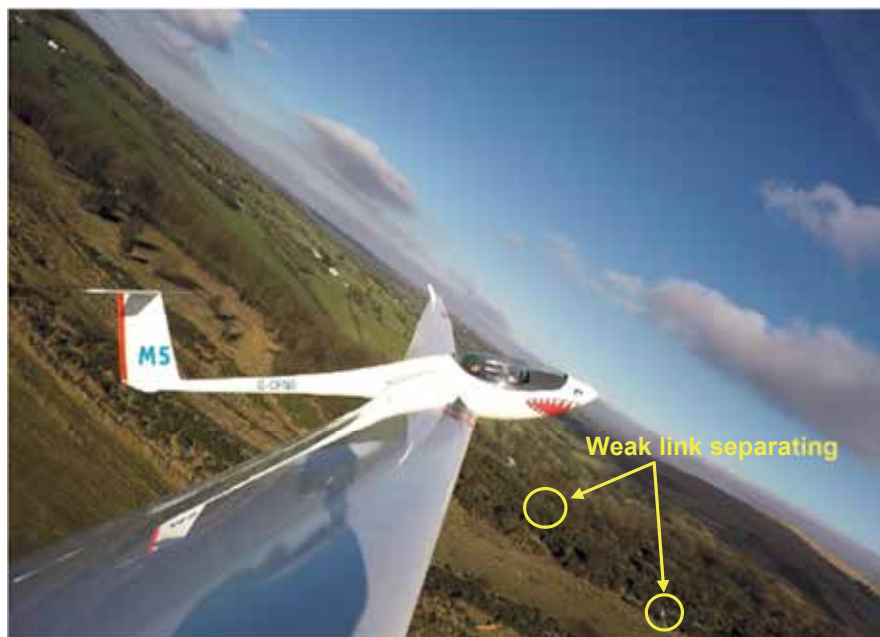
**Figure 2**

The initial launch appeared normal with the glider becoming airborne at about 53 KIAS, five seconds after the launch started. Three seconds after the glider became airborne it was at 78 KIAS, and about 100 ft aal, when the weak link parted (Figure 2). The pilot immediately looked left and looked left repeatedly from this point on. At no time did the pilot look to the right.

Glider at the moment of launch failure

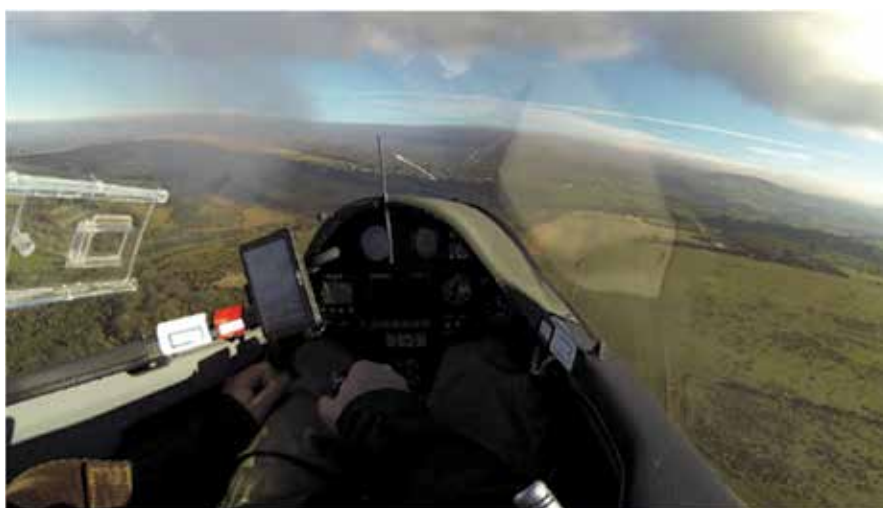
**Figure 3**

Over the next four seconds the glider pitched gently nose down, gaining height while slowing to 60 KIAS<sup>8</sup>. This pitch-down manoeuvre brought the nose of the glider to approximately level with the horizon. The pilot then made an approximately half-to-two-thirds left roll input on the control stick, while sustaining a neutral to slightly forward pitch input. The glider rolled left, the nose dropped below the horizon and began to turn to the north during which the speed reduced to 51 KIAS (Figure 3).

Cockpit view as left roll input is being made

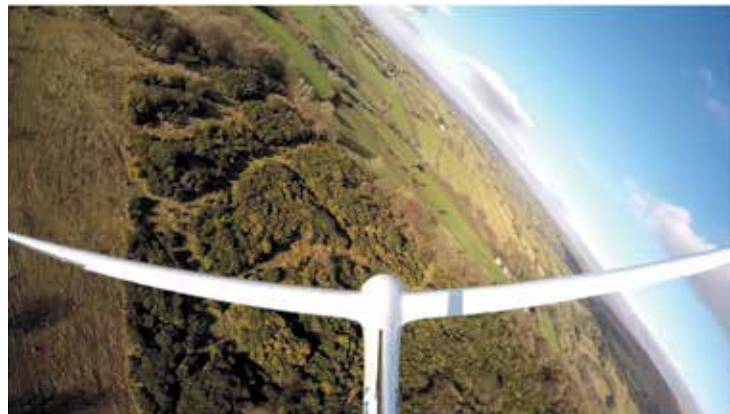
**Figure 4**

Eleven seconds after the launch failure, the glider was in a sustained 60° left turn at 51 KIAS (Figure 4) and had turned through approximately 90° from the launch heading. The nose of the glider then dropped well below the horizon and the airspeed and the descent rate increased, with the glider rolling rapidly left through 80°, with the airspeed reaching 70 KIAS before it hit the ground 14 seconds after the launch failure.

11 seconds after launch failure, with significant left aileron input

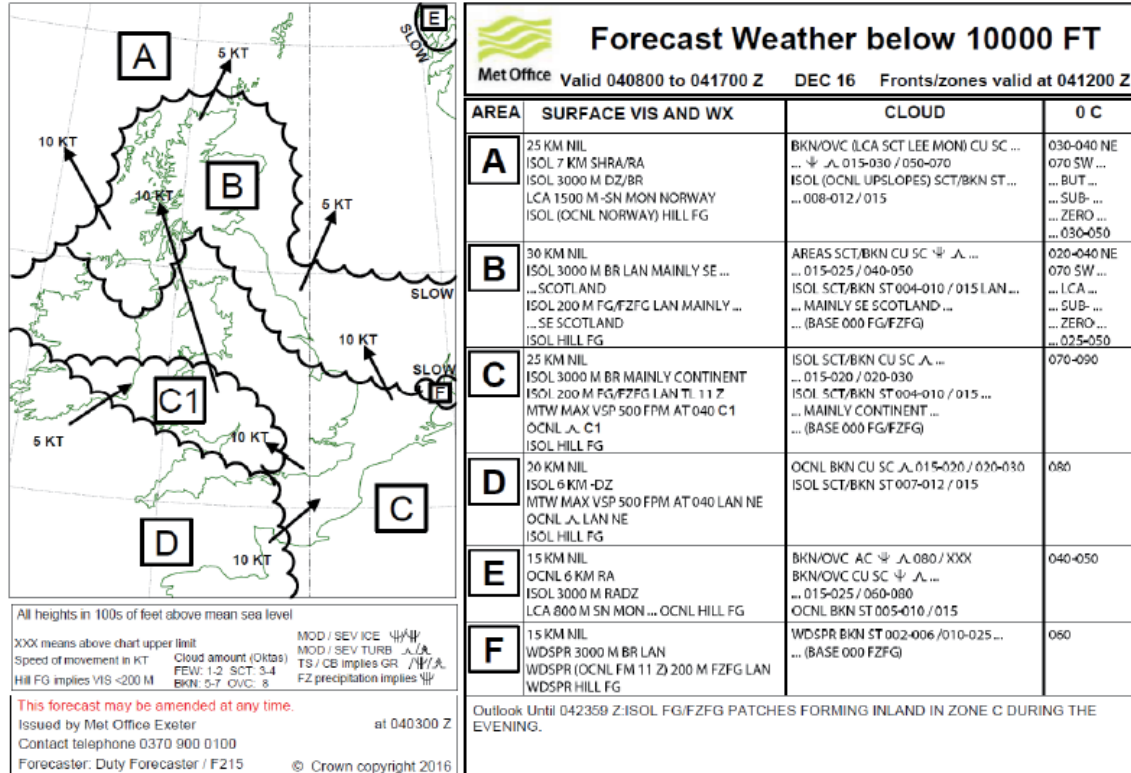
The forecast Metform 215 for the time of the accident (Figure 5) highlights at Area D the risk of mountain waves (MTW) and occasional moderate low-level turbulence near the accident site. In particular, it noted that mountain waves of 500 feet per minute were expected at around 4,000 ft.

**Figure 5**  
Forecast low-level weather, 4 December 2016

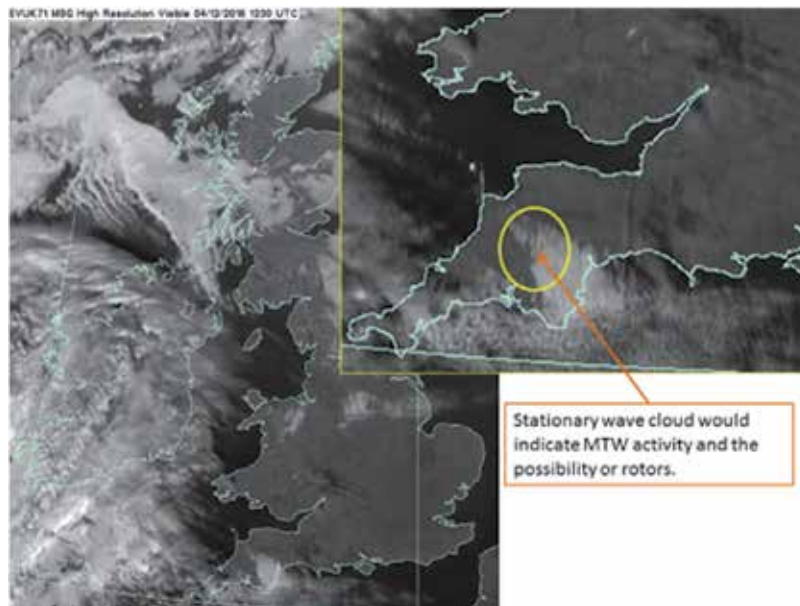
Satellite imagery of the area at the time of the incident confirms the presence of mountain wave activity in the Dartmoor area and therefore a high probability of significant turbulence at low levels (Figure 6).

**Figure 6**  
Satellite image

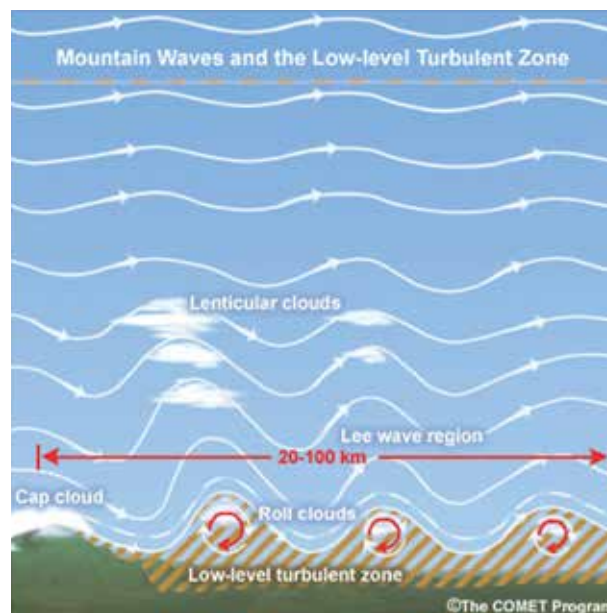
In areas of mountain wave activity a low-level turbulent zone can extend many kilometres downwind from the high ground inducing the phenomena. Brentor Airfield would have been within this zone on the day of the accident (Figure 7).

**Figure 7**  
'Mountain Wave' diagram

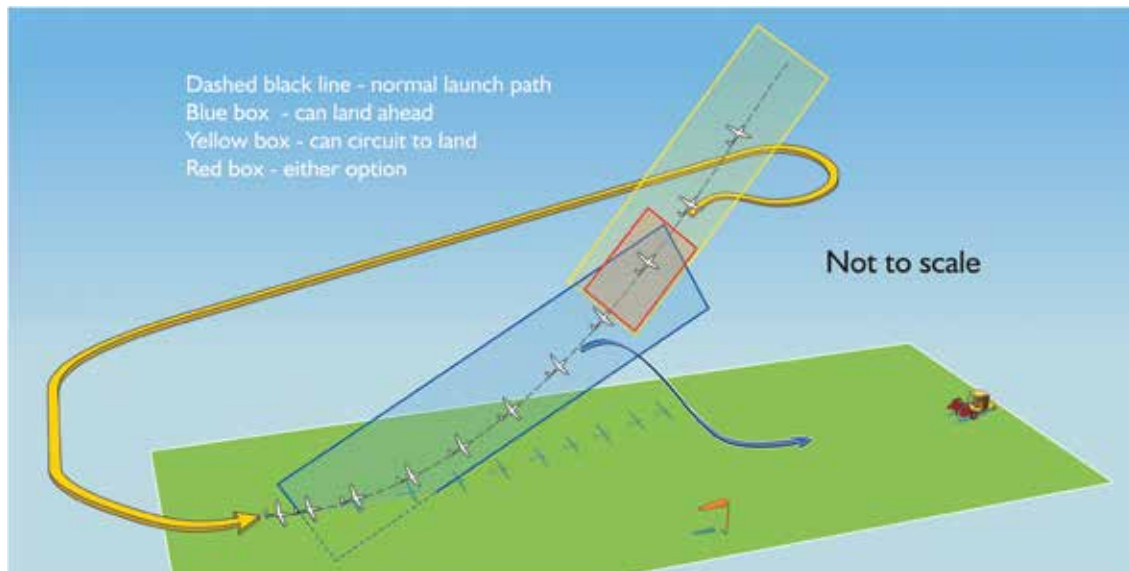
The failure handling can be broken down into phases depending on when it occurs. In the event of a failure during the initial stages of a winch launch the glider should be able to land ahead, on the gliding site (Figure 8). After a short period the glider will reach a height from which it is possible to return to the launch site via some form of abbreviated circuit. The glider site and conditions should be such that one option is always possible and to ensure this happens there will also be a period during which both options will be possible. This overlap is normally in the order of 200 to 300 ft deep and as the headwind or field length increases the depth of this overlap will also increase.

**Figure 8**  
 Launch options picture

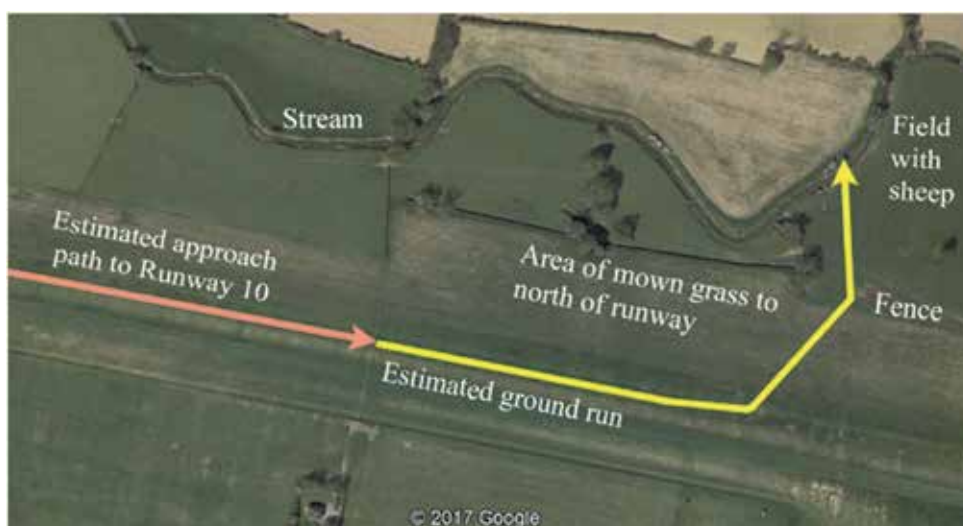
**Figure 1**

Aerial view of the eastern portion of Lashenden airfield with G-JODL's estimated track  
©2017Google, Image © DigitalGlobe
