**REPORT OF THE SERVICE INQUIRY INTO  
THE GROUNDING OF HMS ASTUTE ON 22 OCT 2010**

**NARRATIVE OF EVENTS**

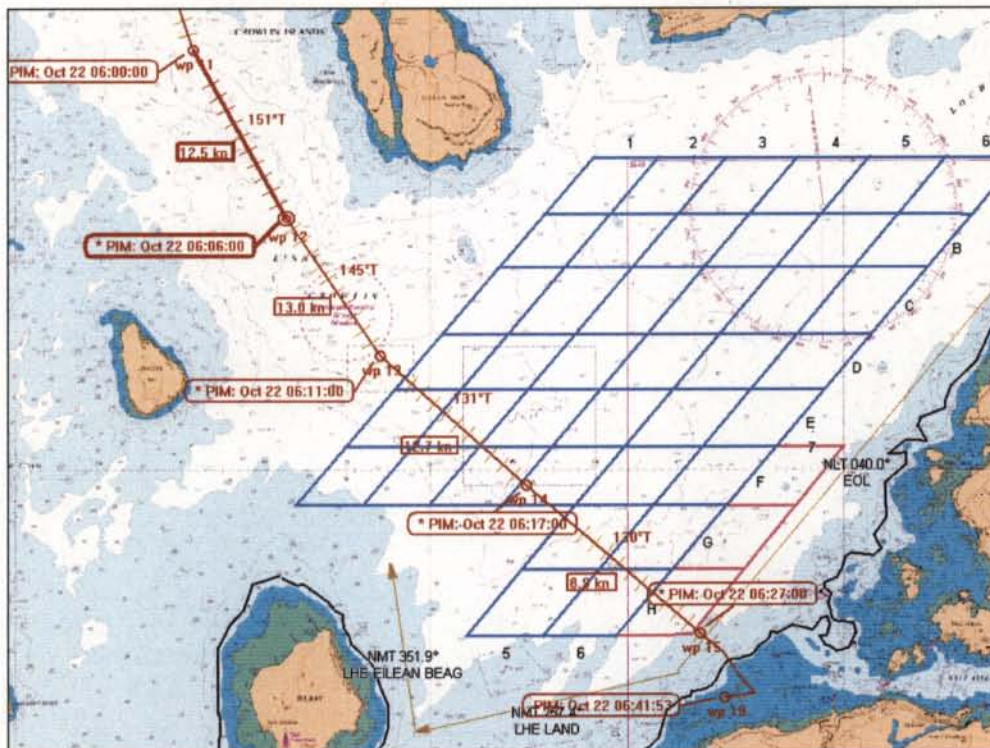
Figure 2 – Reconstruction of Navigational Track and Boat Transfer Grid

12. At sometime shortly before the 0611Z fix, ASTUTE had completed the shortcut to regain time and at the request of the plot, the OOW altered to a new course of 130, remaining at 13 kts. This course alteration is not recorded in the fixing log. ASTUTE entered the boat transfer grid (Figure 2) at 13 kts at 0612Z and continued to propel on a course of 130.

14. At 0619Z, the POOW (LS [REDACTED]) reported the next fix (recorded as 0618Z in the log and marked as 0617Z on the chart) and using the grid system on his chart (See Figure 2) reported the submarine position as box F3. The fix shown on the chart puts the submarine in box F4, at a speed of 13 kts. The POOW (LS [REDACTED]) requested that the OOW (Lt Cdr [REDACTED]) slowed to 4kts and turned to port to a new course of North<sup>18</sup>. The OOW (Lt Cdr [REDACTED]) acknowledged the report<sup>19</sup>. He had no chart and could not therefore reference the position, did not ask for clarification and chose not alter course due to the presence of MV OMAGH at R30, range 1.5-2kx, 40P<sup>20</sup>. The OOW (Lt Cdr [REDACTED]) had no handheld VHF radio to inform OMAGH that he wished to turn however, the submarine's VHF communications system was fully functional. There was no impediment to a retiring turn to Stbd. At 0621Z the submarine reduced speed to 4 kts, having advanced a further 1600 yards from the fix position and entered box G6. The POOW below became concerned when he noticed the submarine had not altered to North. He came and asked the Helmsman what course had been ordered and was told that the submarine had slowed to 16 revs and was still steering 130<sup>21</sup>.

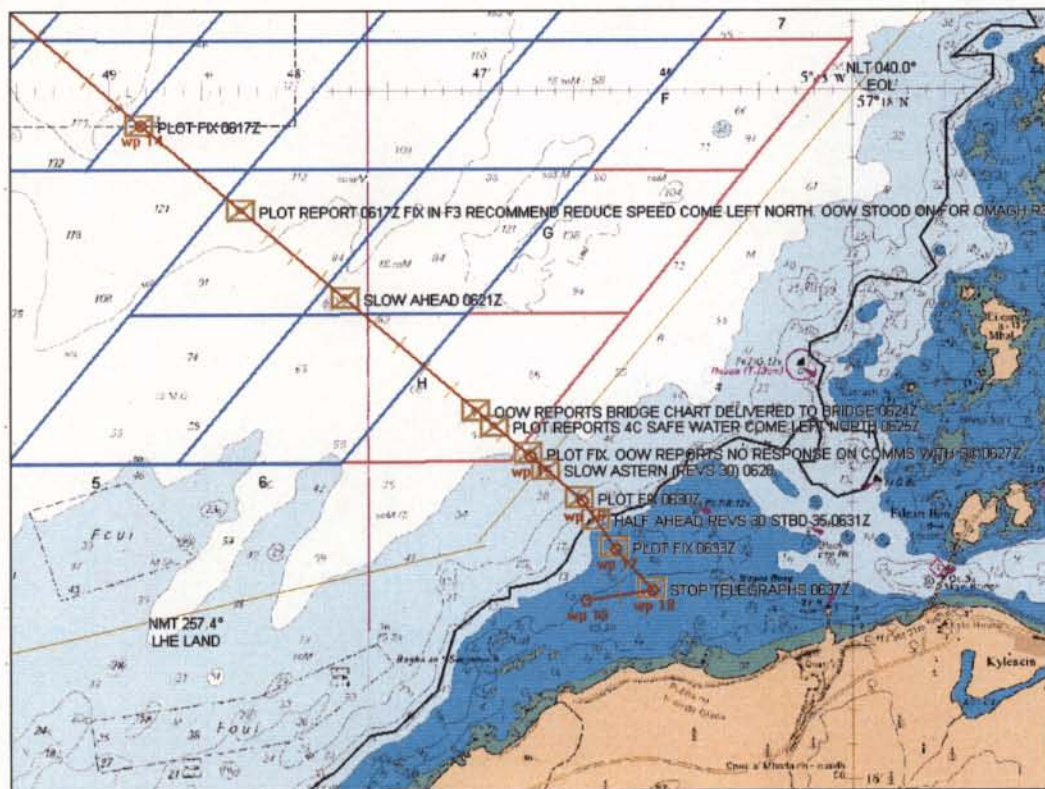
Figure 3 – Geo-referenced Narrative of Events Prior to Grounding

bridge chart<sup>33</sup>. Missing the 0624Z fix which was near to his interpretation of the boat transfer position by EP, the POOW (LS [REDACTED]) took the next fix at 0627Z. This fix put the submarine outside the inked grid by 1000 yds and now 1100 yds short of the grounding position. He reported the fix and for the second time requested the OOW (Lt Cdr [REDACTED]) turn to North<sup>34</sup>.

19. The OOW (Lt Cdr [REDACTED]) was now concerned about fishing floats 150-200 yds on the port bow and not wishing to snag the floats in the turn, he stood on<sup>35</sup>. Again, there was no impediment to a retiring turn to Stbd.

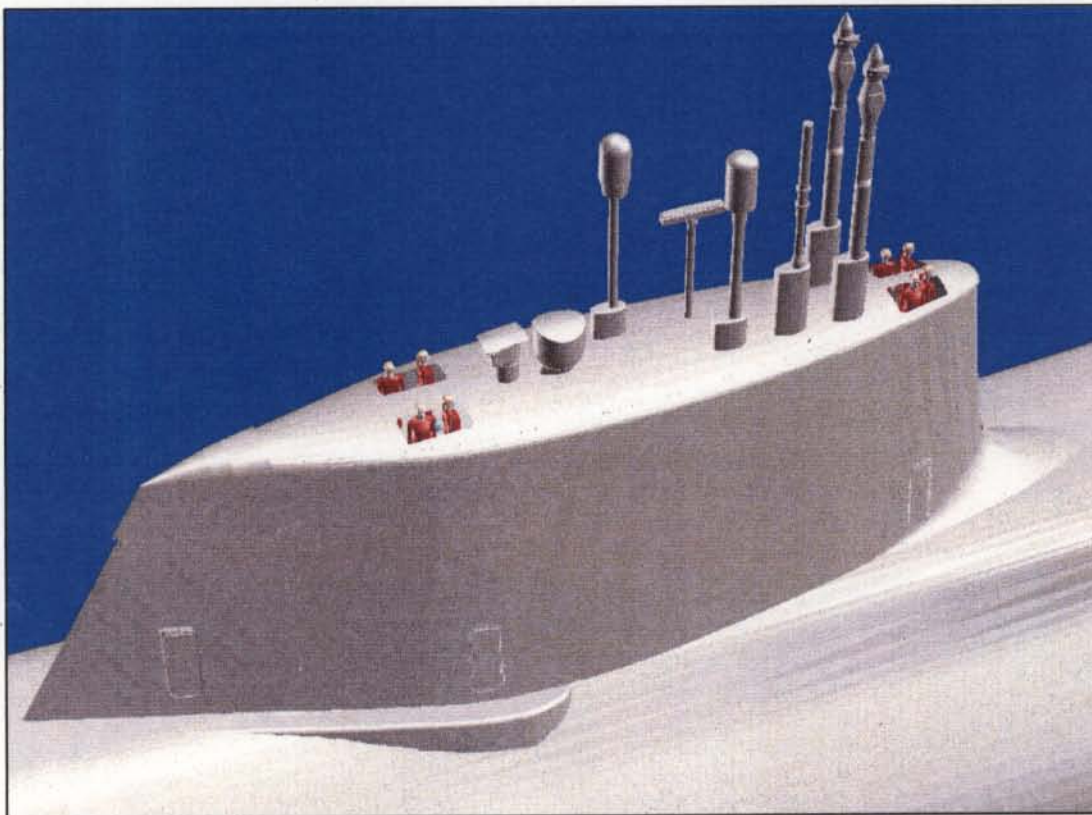
**Figure 6 – Layout of ASTUTE Class Fin**

34. **Planning.** There was no dedicated plan or specific briefing for the boat transfer scheduled for 0630Z on the morning of 22 Oct 2010. The submarine had conducted a number of transfers in this area on the previous 6 days, both afternoon and morning. Conduct of boat transfers was therefore reliant on personnel repeating the actions of earlier transfers. A general brief was conducted some days earlier to cover the conduct of noise ranging on the Rona Range and this included some instruction on boat transfers. Specifically the CO authorised that boat transfers would be conducted on the watch at Patrol Routine<sup>47</sup>. The watch would be supplemented by the XO going to the fin and directing the boat transfer from the SNP at the rear of the fin (approx 8 metres from the OOW position, Figure 6). The CO would be in the Control Room to meet and greet departing/arriving riders.
