H.M.S CONQUEROR GREEN PASSPORT

HMS CONQUEROR GREEN PASSPORT

ASBESTOS SURVEY REPORT - TYPE 3

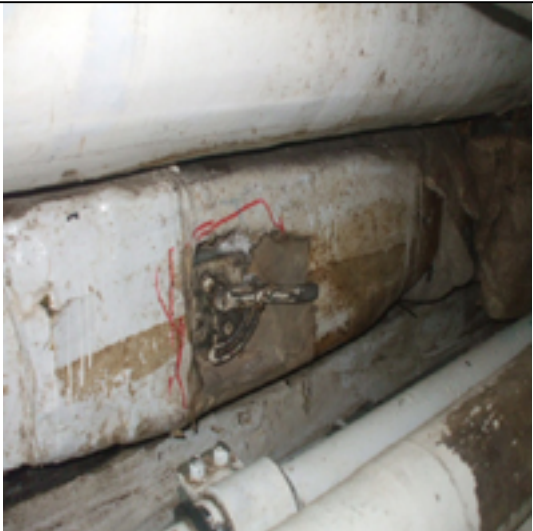
Risk Level Assessment	Vessel	Location	Item / Product Examined	Material Description	Sample No.	Initial Control Recommendation	Photograph
R1	HMS Conqueror	1/006 Sonar Room	insulation to duct behind stbd wall behind partition	Asbestos-containing insulation	21054747-058	remove

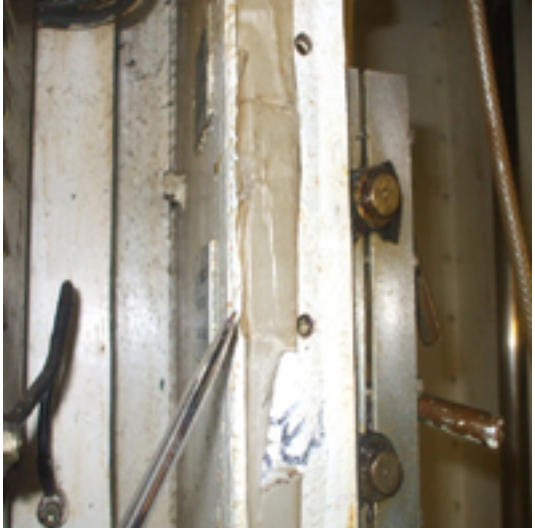
Risk Level Assessment	Vessel	Location	Item / Product Examined	Material Description	Sample No.	Initial Control Recommendation	Photograph
R2	HMS Conqueror	1/008 control room	putty sealant to previous periscope structure	Asbestos-containing mastic	21054747-073	remove

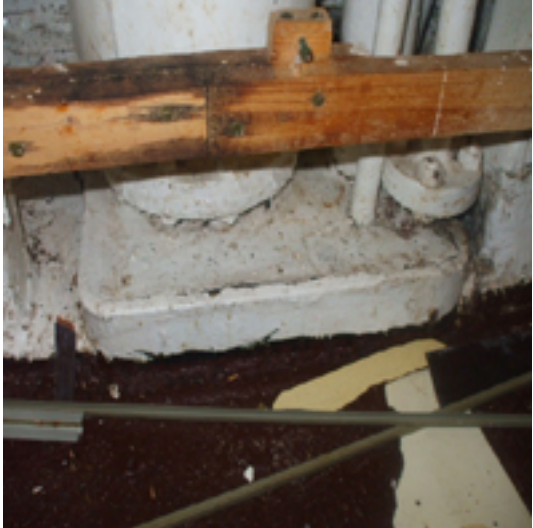
Risk Level Assessment	Vessel	Location	Item / Product Examined	Material Description	Sample No.	Initial Control Recommendation	Photograph
R2	HMS Conqueror	2/007 JR mess	insulation to cable penetration (frame 54)	Asbestos-containing insulation	21054747-023	remove

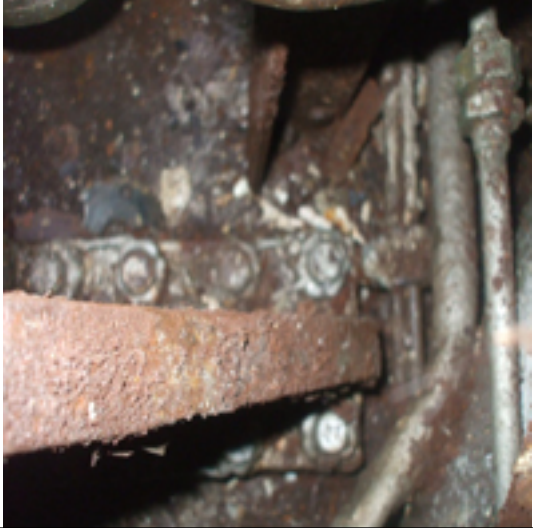
R2	HMS Conqueror	3/018 TG room	gasket debris to floor void	Asbestos-containing gasket	21054747-119	remove

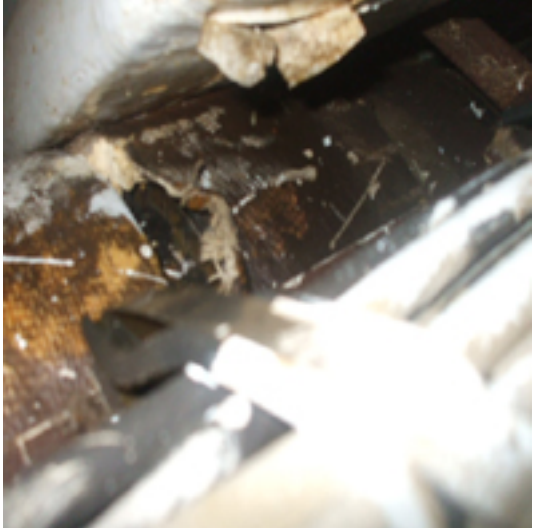
Risk Level Assessment	Vessel	Location	Item / Product Examined	Material Description	Sample No.	Initial Control Recommendation	Photograph
R3	HMS Conqueror	1/008 Control room	large pipe run behind water tank	Asbestos-containing woven product	21054747-066	remove

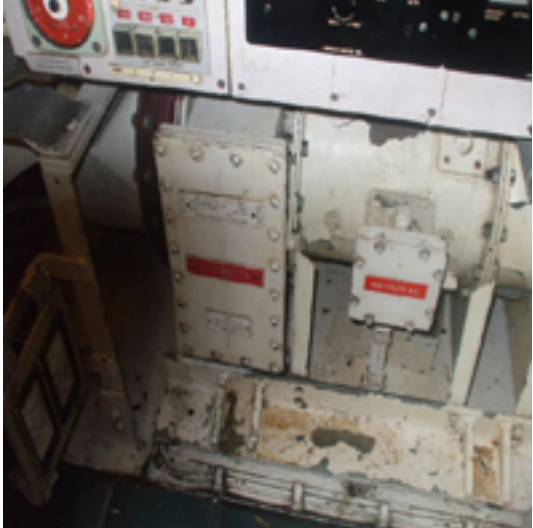
Risk Level Assessment	Vessel	Location	Item / Product Examined	Material Description	Sample No.	Initial Control Recommendation	Photograph
R3	HMS Conqueror	1/010 manoeuvring room	gasket to air heater duct plates	Asbestos-containing gasket	21054747-078	remove

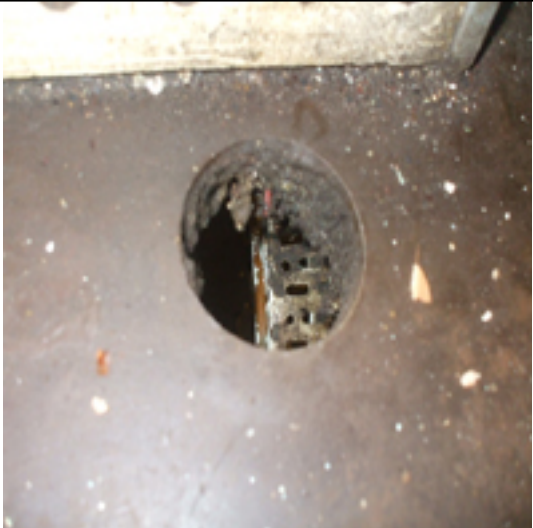
R3	HMS Conqueror	1/012 EMR	pipework	gasket	21054747-065	remove	
R3	HMS Conqueror	1/013 walkway	screed to underside of metal floor plates	Asbestos-containing composite	21054747-088	remove

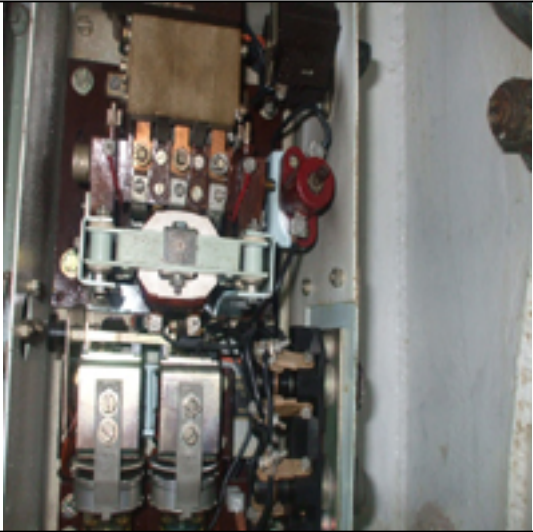
Risk Level Assessment	Vessel	Location	Item / Product Examined	Material Description	Sample No.	Initial Control Recommendation	Photograph
		area (stbd side)					
R3	HMS Conqueror	1/013 walkway - MMS access ladder area (port side)	fuseguards to electrical boxes	Asbestos-containing composite	21054747-084	remove

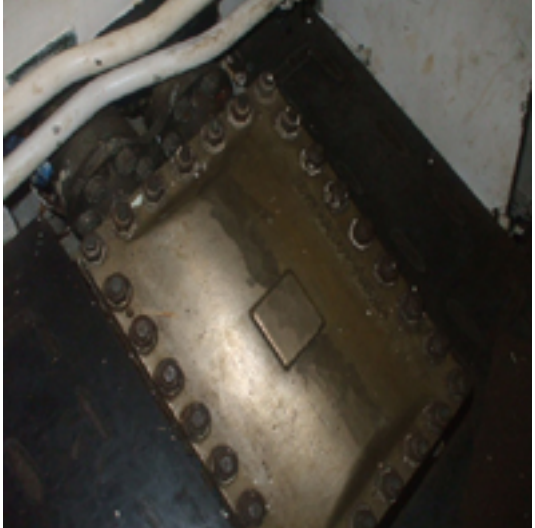
Risk Level Assessment	Vessel	Location	Item / Product Examined	Material Description	Sample No.	Initial Control Recommendation	Photograph
R3	HMS Conqueror	1/016 motor room	gasket to plates seals to tanks	Asbestos-containing gasket	21054747-095	remove

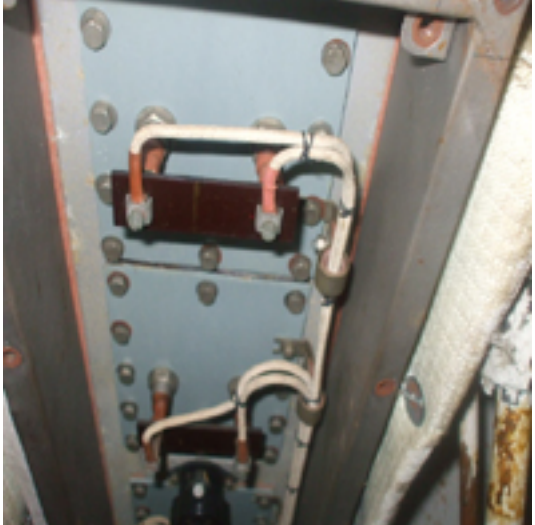
R3	HMS Conqueror	1/016 motor room	fuseguards to ATU fuse boxes	composite	21054747-084	remove	
R3	HMS Conqueror	1/016 motor room - lower level	pipework	gasket	21054747-092	remove	
R3	HMS Conqueror	2/001 upper torpedo compartment	covering to cables within vent duct heaters x2	Asbestos-containing woven product	21054747-003	remove

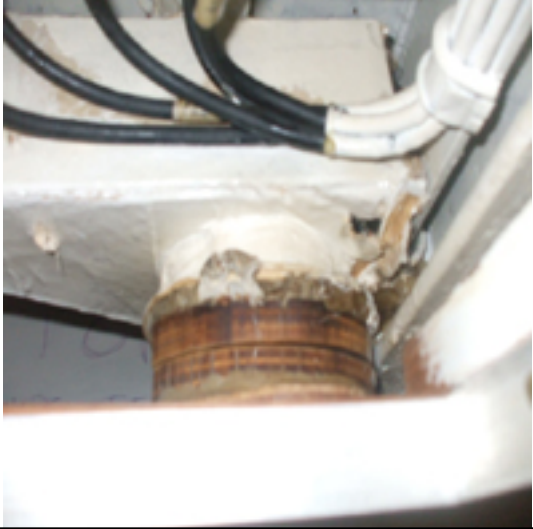
R3	HMS Conqueror	2/002 ships office	gasket putty to flange joints to air handling vents	Asbestos-containing composite	21054747-013	remove

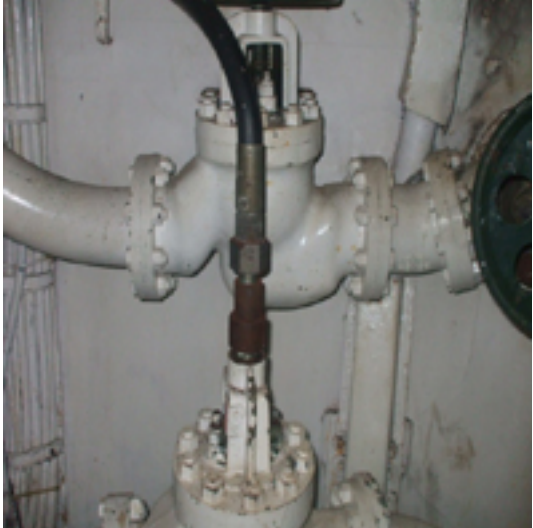
Risk Level Assessment	Vessel	Location	Item / Product Examined	Material Description	Sample No.	Initial Control Recommendation	Photograph
R3	HMS Conqueror	3/001 lower torpedo compartment	pipework	Asbestos-containing gasket	21054747-008	remove

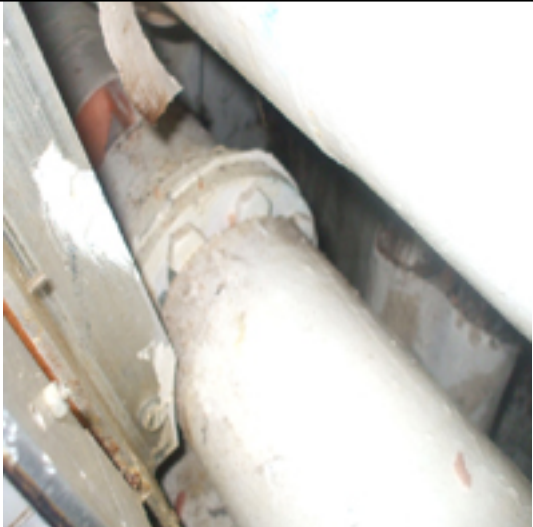
R3	HMS Conqueror	3/002 electrolyser space	pipework	gasket	21054747-008	remove	
R3	HMS Conqueror	3/005 JR bathroom	pipework	Asbestos-containing gasket	21054747-034	remove

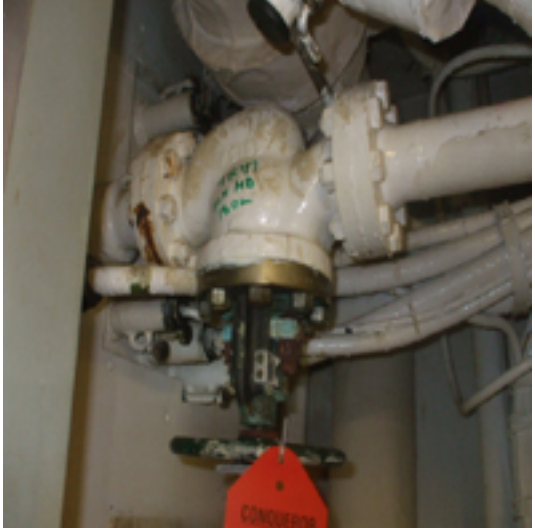
Risk Level Assessment	Vessel	Location	Item / Product Examined	Material Description	Sample No.	Initial Control Recommendation	Photograph
R3	HMS Conqueror	3/015 amp space	pipework	Asbestos-containing gasket	21054747-045	remove

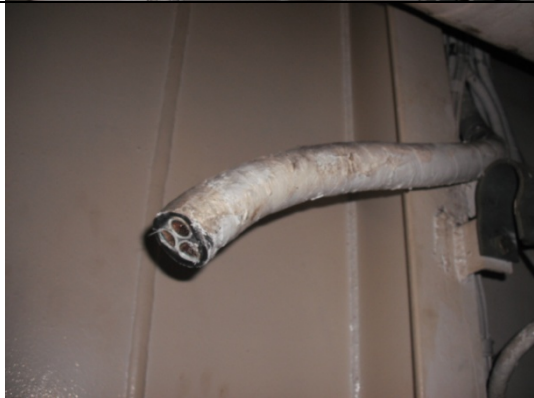
HMS Conqueror	2/011 Diesel Generator Room	AFT Deckhead triple core mains power cable - painted	PCB Containing cable	13	Dispose of accordingly during recycling

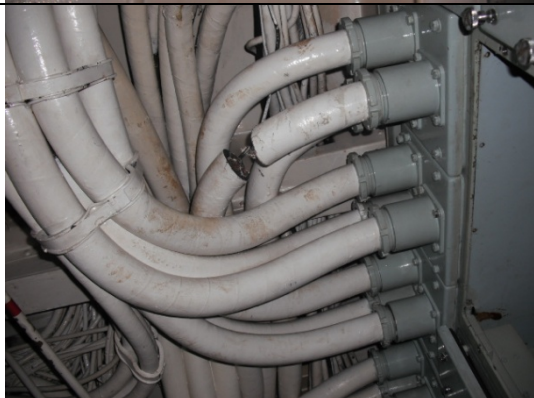
HMS Conqueror	2/011 Diesel Generator Room	Mains 440v input power to transformer unit	PCB Containing cable	14	Dispose of accordingly during recycling

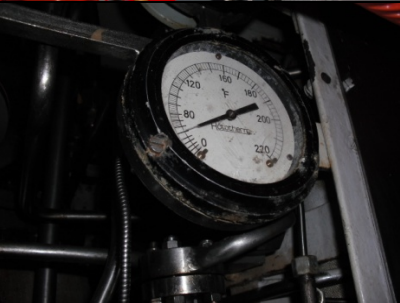
HMS Conqueror	LP Blower Room	Thermometers	Mercury Table B B-4	Visual	Small quantity

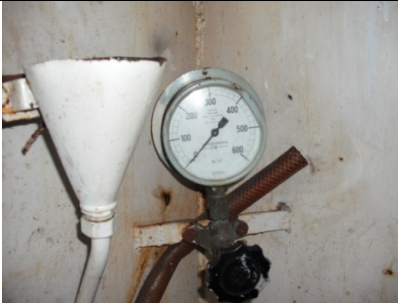
HMS Conqueror	1/008 Control Room	Pressure gauges	Beryllium Copper	Visual	Several units

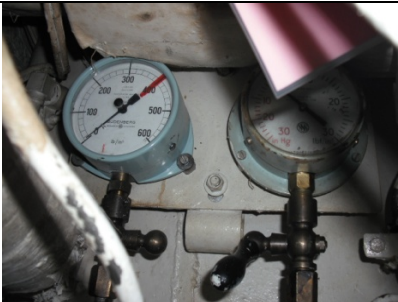
Vessel	Location	Item / Product Examined	Hazard Description and number from Appendix 1 of the Guidelines	Sampling Strategy	Extent	Remarks/Comments	Photograph
HMS Conqueror	1/010 Manoeuvring Room, to tank above DG access ladder	Pressure gauges	Beryllium Copper, Phosphor Bronze	Visual	2 Units

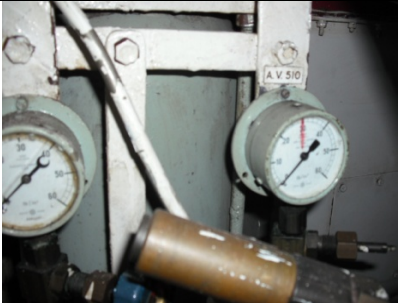
HMS Conqueror	1/010 Manoeuvring Room, port side radiation controlled area	Pressure gauges	Beryllium Copper, Phosphor Bronze	Visual	2 Units

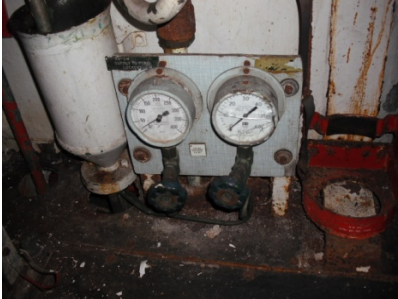
HMS Conqueror	1/016 Motor Room	Pressure gauges to Pyro Locker	Beryllium Copper, Phosphor Bronze	Visual	4+ Units

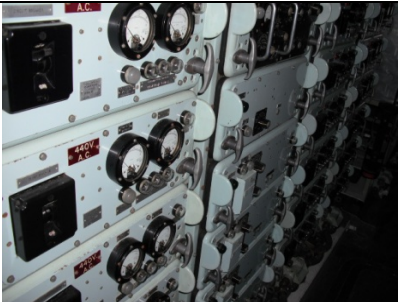
Vessel	Location	Item / Product Examined	Hazard Description and number from Appendix 1 of the Guidelines	Sampling Strategy	Extent	Remarks/Comments	Photograph
HMS Conqueror	3/003 Sonar Cab Space	Pressure gauges	Beryllium Copper, Phosphor Bronze	Visual	4+ Units

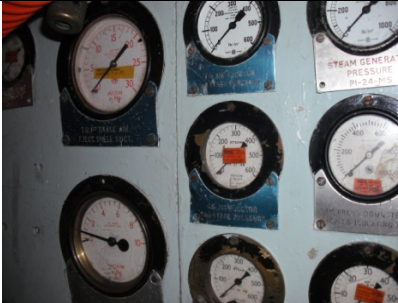
HMS Conqueror	3/017 Turbine Generator Room	Pressure gauges	Beryllium Copper, Phosphor Bronze	Visual	6+ Units

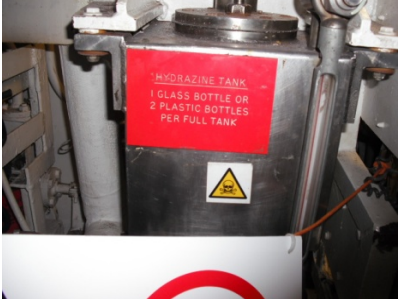
HMS Conqueror	2/011 Diesel Generator Room	Hydrazine store tank	Hydrazine (radioactive)	Visual	Residual	Left over active service, presumed emptied

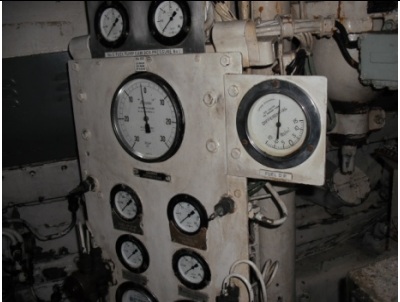
HMS Conqueror	2/011 Diesel Generator Room	Pressure gauges to Hydraulic control units	Beryllium Copper, Phosphor Bronze	Visual	2+ Units

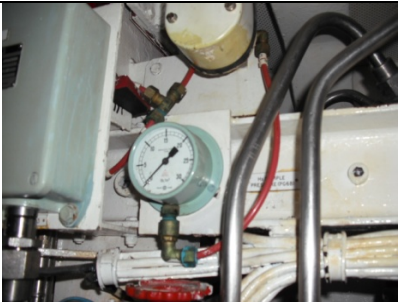
Vessel	Location	Item / Product Examined	Hazard Description and number from Appendix 1 of the Guidelines	Sampling Strategy	Extent	Remarks/Comments	Photograph
HMS Conqueror	3/002 Electrolyser Room	Pressure gauges to main indicator panel	Beryllium Copper and Phosphor Bronze held within indicator gauges	Visual	Several Units

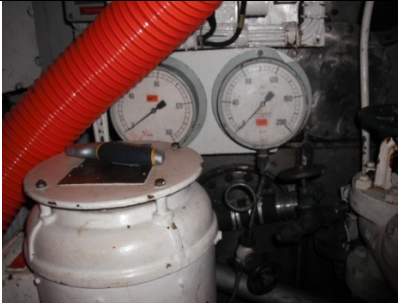
HMS Conqueror	4/002 Slop Tank Room	Pressure gauges to main indicator panel	Beryllium Copper and Phosphor Bronze held within indicator gauges	Visual	Several Units

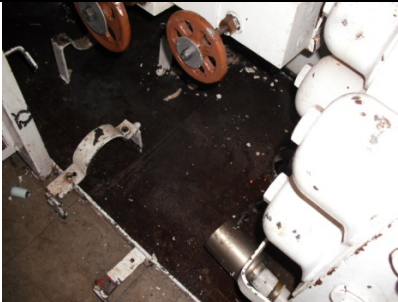
HMS Conqueror	Throughout vessel	Gauges and components to electrical switch gear	Cadmium to sensor equipment and electronic equipment	Visual	Small quantities expected within material structure		N/A
HMS Conqueror	2/001 Upper Torpedo Room	Lubrication oils to racking systems.	Lub oil C-3	Visual	Residual	Left over from active service	N/A
HMS Conqueror	2/001 Upper Torpedo Room, adjacent to hydraulic cylinder	Surface oil to floor.	Lub oil C-3	Visual	Residual	Left over from active service

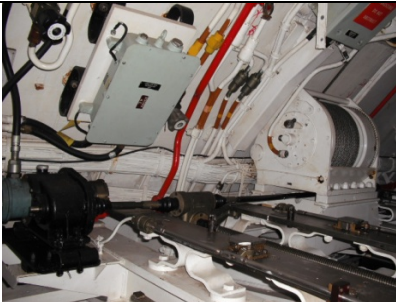
Vessel	Location	Item / Product Examined	Hazard Description and number from Appendix 1 of the Guidelines	Sampling Strategy	Extent	Remarks/Comments	Photograph
HMS Conqueror	2/001 Upper Torpedo Room	Lubrication oil to winch systems and associated machinery.	Lub C-3	Visual	Residual	Left over from active service

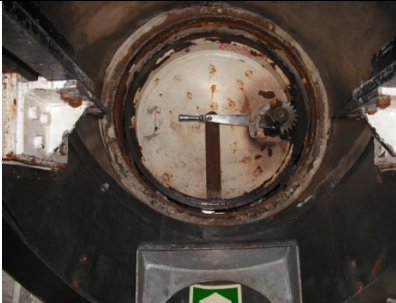
HMS Conqueror	2/001 Upper Torpedo Room	Grease to entrance hatch	Lub oil C-3, Hydraulic oil C-4	Visual	Residual	Left over from active service

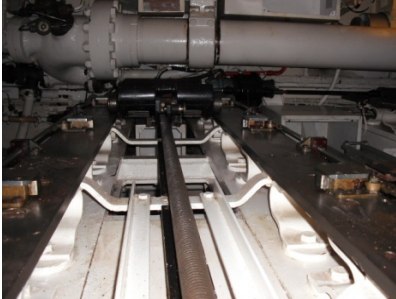
HMS Conqueror	3/001 Lower Torpedo Room	Lubrication oils to racking systems. Item	Lub oil C-3	Visual	Residual	Left over from active service

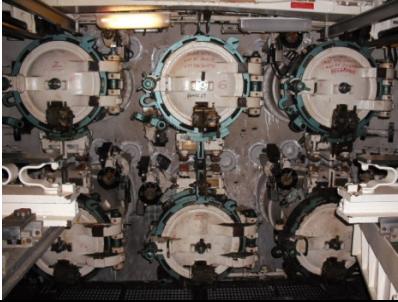
Vessel	Location	Item / Product Examined	Hazard Description and number from Appendix 1 of the Guidelines	Sampling Strategy	Extent	Remarks/Comments	Photograph
HMS Conqueror	3/001 Lower Torpedo Room	Lubrication greases to torpedo tube hatches	Lub oil C-3	Visual	Residual	Left over from active service

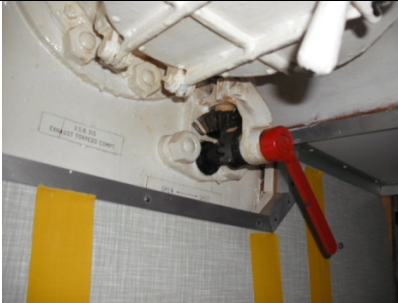
HMS Conqueror	2/002 Ships Office	Lubrication oil to Torpedo Exhaust Valves	Lub oil C-3	Visual	Residual	Left over from active service

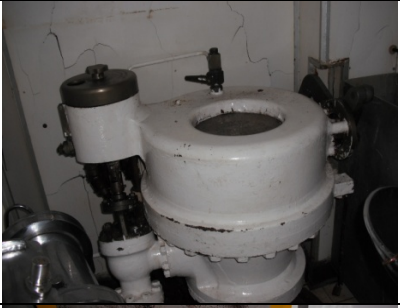
HMS Conqueror	2/005 Galley	Lubrication oil to GASH Ejector	Lub oil C-3	Visual	Residual	Left over from active service

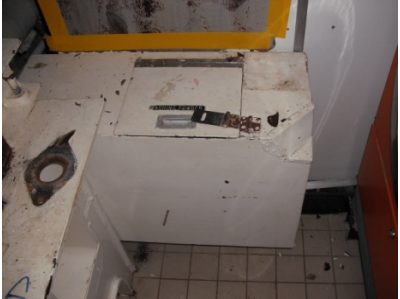
HMS Conqueror	3/006 Laundry Room	Detergent	C-49	Visual	<1kg	Left over from active service

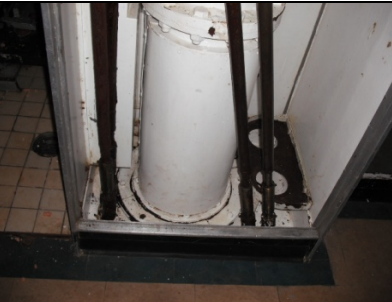
Vessel	Location	Item / Product Examined	Hazard Description and number from Appendix 1 of the Guidelines	Sampling Strategy	Extent	Remarks/Comments	Photograph
HMS Conqueror	3/012 Lobby	Lubrication oil to rotary systems	Lub oil C-3	Visual	Residual	Left over from active service

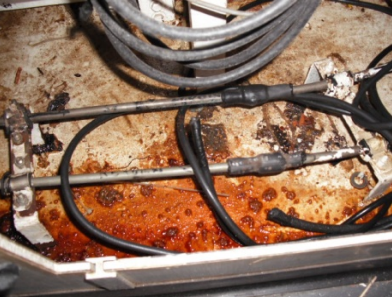
HMS Conqueror	1/008 Control room. Port side deck behind wall panels	Surface oils	Lub oil C-3	Visual	Residual	Left over from active service

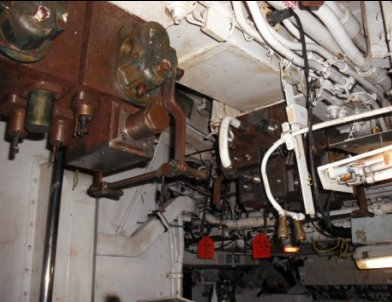
HMS Conqueror	1/008 Control room, overhead moving plant	Surface oils	Lub oil C-3, Hydraulic oil C-4	Visual	Residual	Left over from active service

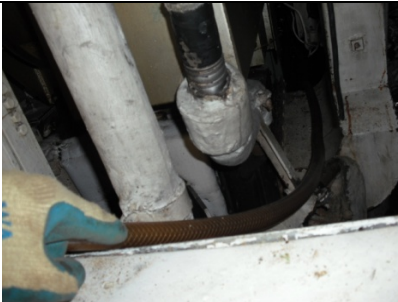
Vessel	Location	Item / Product Examined	Hazard Description and number from Appendix 1 of the Guidelines	Sampling Strategy	Extent	Remarks/Comments	Photograph
HMS Conqueror	1/008 Control Room	Oils and lubs to hoses and valves	Lub oil C-3	Visual	Residual	Left over from active service

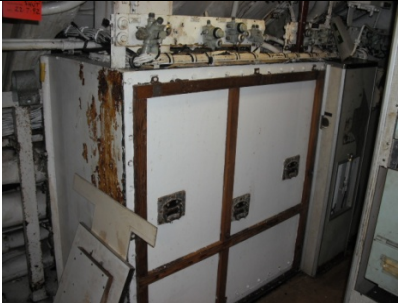
HMS Conqueror	1/008 Control Room	Water associated within Septic Tank	C-34	Visual	Residual	Left over from active service, presumed drained and presumed untreated.

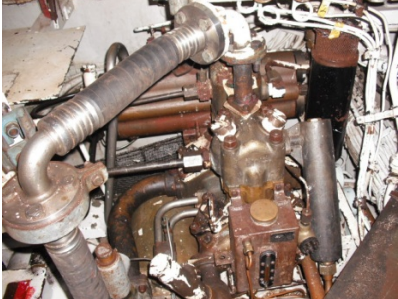
HMS Conqueror	1/016 Motor Room	Lubrication grease to machinery parts and surfaces	Lub oil C-3	Visual	Residual	Left over from active service

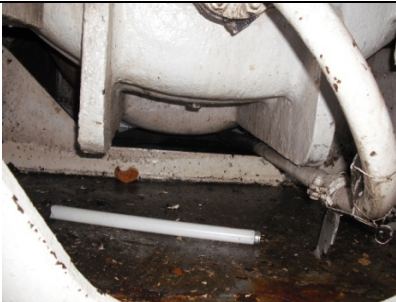
Vessel	Location	Item / Product Examined	Hazard Description and number from Appendix 1 of the Guidelines	Sampling Strategy	Extent	Remarks/Comments	Photograph
HMS Conqueror	1/016 Motor Room	Surface oils, below prop shaft motor	Lub oil C-3	Visual	1 litre estimate	Left over from active service

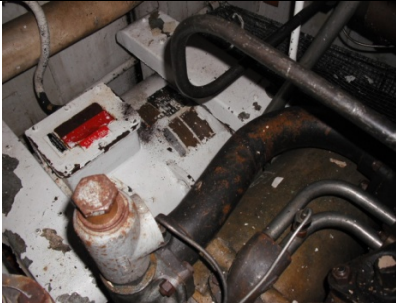
HMS Conqueror	2/013 Motor Room	Surface fluids to port side and starboard side motors	C-4, C-3	Visual	5 litres estimate	Left over from active service

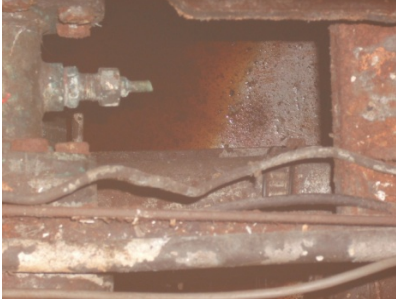
HMS Conqueror	3/017 Turbine Generator Room	Surface fluids to bilge wells, presumed	C-4, C-3	Visual	50 litres estimate	Left over from active service. Spill is 3inches deep at base of bilge

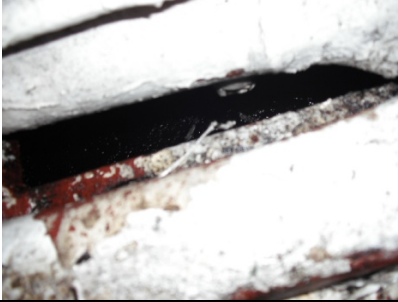
Vessel	Location	Item / Product Examined	Hazard Description and number from Appendix 1 of the Guidelines	Sampling Strategy	Extent	Remarks/Comments	Photograph
HMS Conqueror	2/011 Diesel Generator Room	Surface fluid oil under Diesel Generators	C-4, C-3	Visual	10+ Litres estimate	Left over from active service

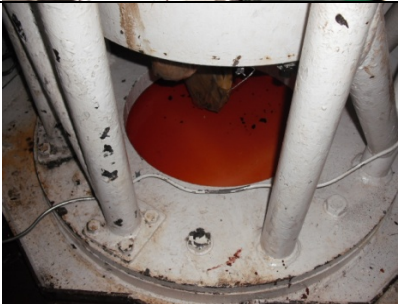
HMS Conqueror	2/011 Diesel Generator Room	Surface hydraulic fluid under hydraulic tank 2	C-4, C-3	Visual	3 litres estimate	Left over from active surface, potential leak from hydraulic tank 2

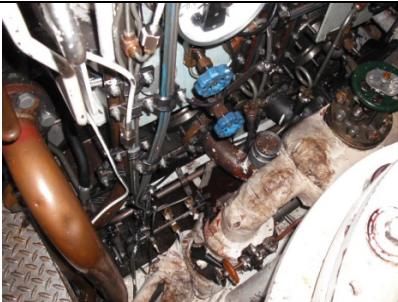
Vessel	Location	Item / Product Examined	Hazard Description and number from Appendix 1 of the Guidelines	Sampling Strategy	Extent	Remarks/Comments	Photograph
HMS Conqueror	2/011 Diesel Generator Room	Surface oils under hydraulic control unit	C-4, C-3	Visual	3 litres estimate	Left over from active service

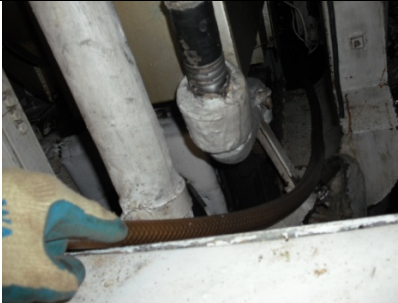
HMS Conqueror	2/001 Upper Torpedo Room	Oils within hoses.	C-4, C-3	Visual	Residual	Left over from active service

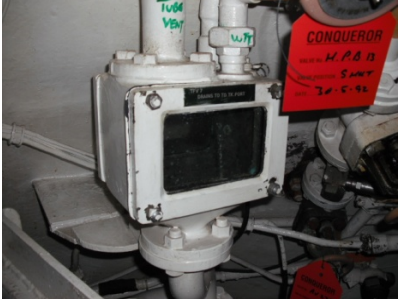
HMS Conqueror	2/001 Upper Torpedo Room, Port and Starboard side	Oils to tank in indicator	C-4, C-3	Visual	Residual	Left over from active service

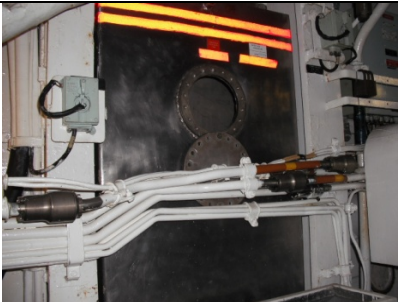
Vessel	Location	Item / Product Examined	Hazard Description and number from Appendix 1 of the Guidelines	Sampling Strategy	Extent	Remarks/Comments	Photograph
HMS Conqueror	2/001 Upper Torpedo Room	Possible water contaminants (not in Appendix)		Visual	Residual	Left over from active service, presumed drained

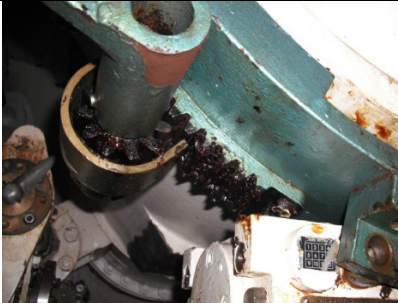
HMS Conqueror	3/001 Lower Torpedo Room	Lubrications oils	C-3	Visual	Residual	Left over from active service

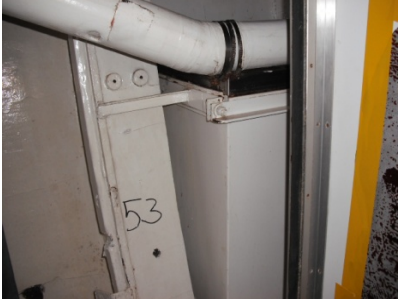
HMS Conqueror	3/005 Bathroom	Fluids within cistern tanks, presumed water based		Visual	Residual	Left over from active service, presumed drained

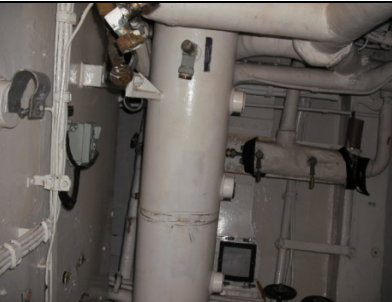
Vessel	Location	Item / Product Examined	Hazard Description and number from Appendix 1 of the Guidelines	Sampling Strategy	Extent	Remarks/Comments	Photograph
HMS Conqueror	3/010 Refrigeration Space	Liquids within liquid receivers	C-15	Visual	Residual	Left over from active service, presumed drained

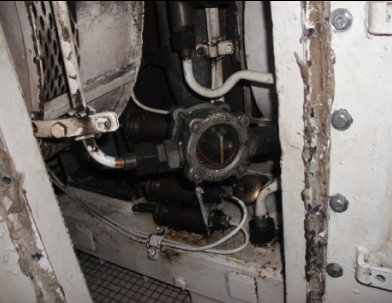
HMS Conqueror	3/012 Lobby	Lubrication oil	C-4, C-3	Visual	0.6m3	Tank is approximate 1m3. Indicator gauge reads 2/3 full

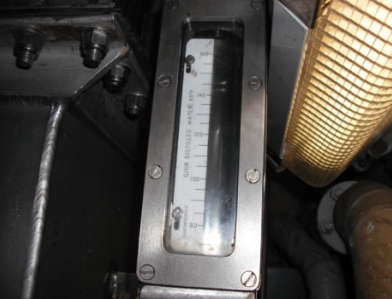
HMS Conqueror	LP Blower Room	Water associated		Visual	Residual	Left over from active service, presumed drained

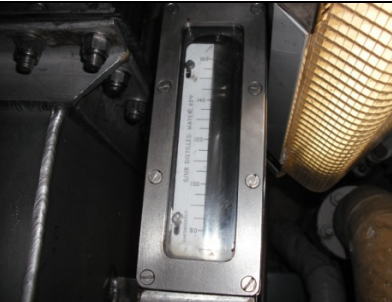
Vessel	Location	Item / Product Examined	Hazard Description and number from Appendix 1 of the Guidelines	Sampling Strategy	Extent	Remarks/Comments	Photograph
HMS Conqueror	LP Blower Room	Distilled water		Visual	Residual	Left over from active service, presumed drained

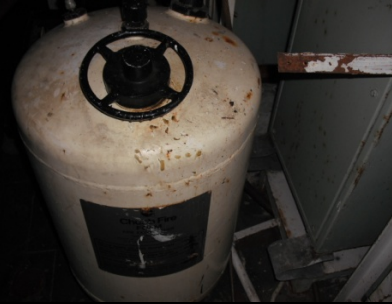
HMS Conqueror	1/010 Manoeuvring Room	Water based foam		Visual	Residual	Left over from active service, presumed drained

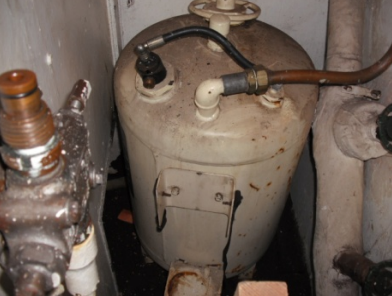
HMS Conqueror	1/013 Walkway, starboard side	Water based foam		Visual	Residual	Left over from active service, presumed drained

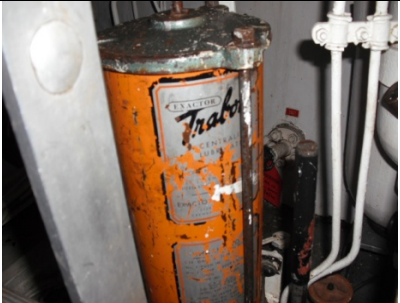
HMS Conqueror	2/013 Motor Room	Extractor fluid	C-4, C-3	Visual	Residual	Left over from active service

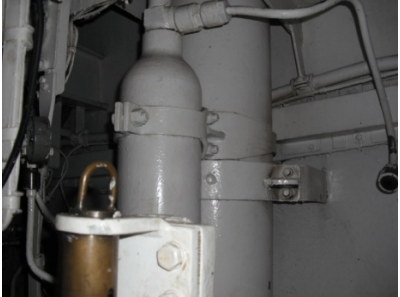
HMS Conqueror	2/013 Motor Room	Fluid feed tanks, presumed hydraulic and fuel.	C-4, C-3	Visual	Residual	Left over from active service, presumed drained

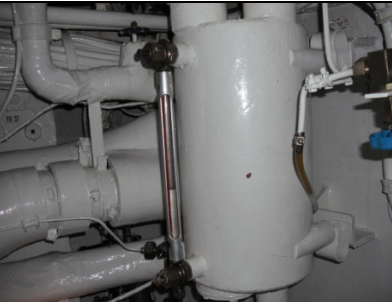
Vessel	Location	Item / Product Examined	Hazard Description and number from Appendix 1 of the Guidelines	Sampling Strategy	Extent	Remarks/Comments	Photograph
HMS Conqueror	3/003 Sonar cab space	Coolant additives	C-7	Visual	5 litres	Left over from active surface, approx 10litre tank, indicator gauge reads half full

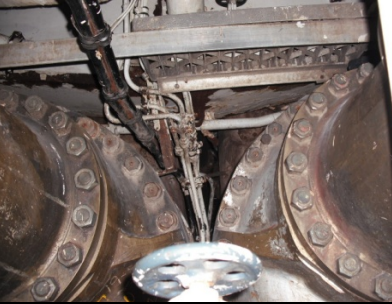
HMS Conqueror	3/017 Turbine Generator Room	Lubricating fluids and oils within Turbine units, x 2.	C-4, C-3	Visual	Residual	Left over from active service

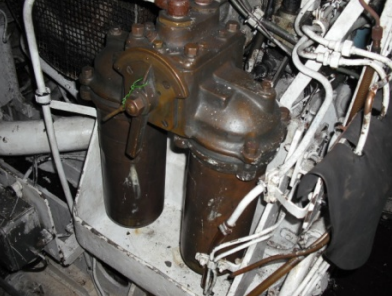
HMS Conqueror	2/011 Diesel Generator room	Fuel remnants to fuel filters		Visual	Residual	Left over from active service, presumed drained

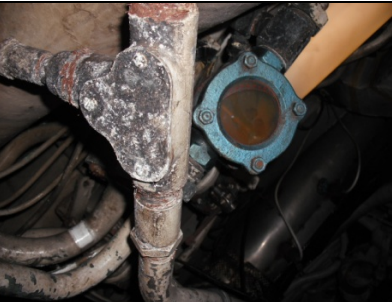
Vessel	Location	Item / Product Examined	Hazard Description and number from Appendix 1 of the Guidelines	Sampling Strategy	Extent	Remarks/Comments	Photograph
HMS Conqueror	2/011 Diesel Generator room	Hydraulic fluid	C-4	Visual	Indicator reads 2/3 full, tank size not quantifiable	Left over from active service, presumed drained

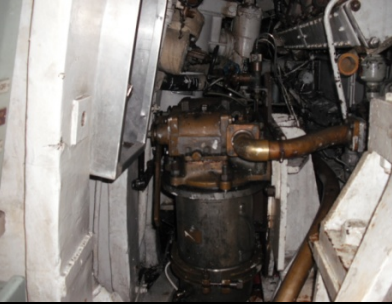
HMS Conqueror	2/011 Diesel Generator room	Fluid tanks behind diesel generators, unknown origin		Visual	Residual	Left over from active service, presumed drained

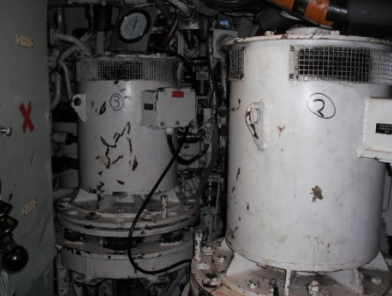
HMS Conqueror	2/011 Diesel Generator room	Hydraulic fluid	C-4, C-3	Visual	Residual per tank 3 no.	Left over from active service, presumed drained

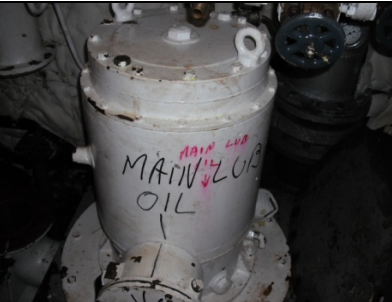
Vessel	Location	Item / Product Examined	Hazard Description and number from Appendix 1 of the Guidelines	Sampling Strategy	Extent	Remarks/Comments	Photograph
HMS Conqueror	4/011 Main Machinery Space	Lubricating oil	C-4, C-3	Visual	Residual	Left over from active service, presumed drained

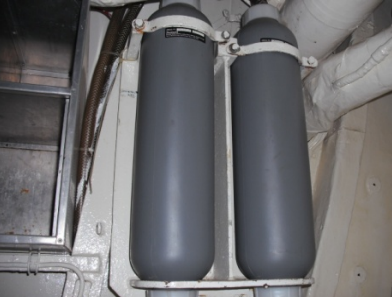
HMS Conqueror	3/002 Electrolyser Room	Demineraliser (unknown type)		Visual	Unknown	Left over from active service, presumed emptied

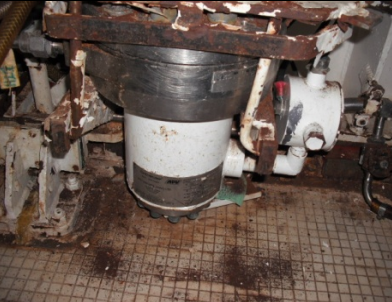
HMS Conqueror	3/002 Electrolyser Room	Various Chemicals, unknown origin		Visual	Residual	Left over from active service, presumed drained

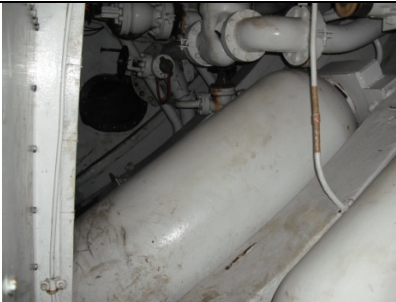
Vessel	Location	Item / Product Examined	Hazard Description and number from Appendix 1 of the Guidelines	Sampling Strategy	Extent	Remarks/Comments	Photograph
HMS Conqueror	4/002 Slop Tank Room	Fluids to Port side tank		Visual	Residual	Left over from active service

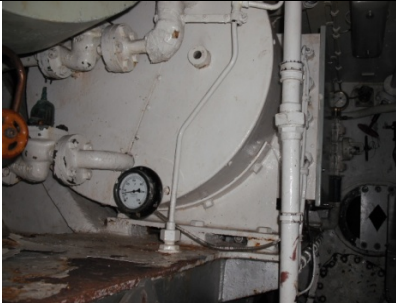
HMS Conqueror	4/002 Slop Tank Room	Water components		Visual	Residual	Left over from active service, presumed drained

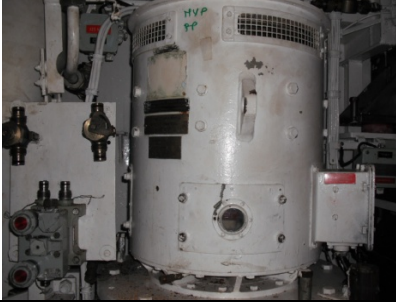
HMS Conqueror	4/002 Slop Tank Room	Hydraulic fluid	C-4, C-3	Visual	Residual to tanks (2 no.)	Left over from active service, presumed drained

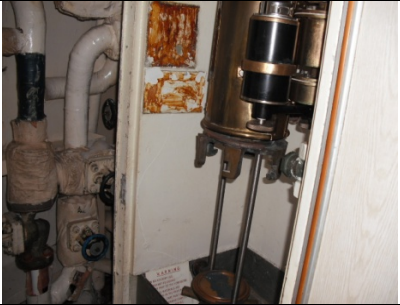
Vessel	Location	Item / Product Examined	Hazard Description and number from Appendix 1 of the Guidelines	Sampling Strategy	Extent	Remarks/Comments	Photograph
HMS Conqueror	Where moving machinery and motors and found	Anti freeze compounds	C-8	Visual	Presumed small quantity and plant/machinery is in active and presumed drained	Left over from active service	N/A
HMS Conqueror	Diesel Generator Room	Battery Electrolyte	C-16	Visual	2 litres estimate	Left over from active service	N/A
HMS Conqueror	Throughout vessel	Water treatment test re-agents	C-9	Visual	Residual per unit	Left over from active service, presumed drained	N/A
HMS Conqueror	2/003 Oxygen Generator Room	Oxygen Generator	Oxygen C-21	Visual	Residual	Left over from active service

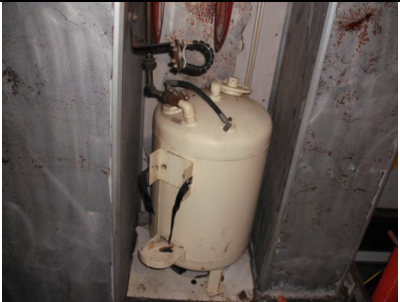
HMS Conqueror	2/010 Corridor	Fire Extinguisher	Carbon Dioxide C-47	Visual	Residual	Left over from active service, presumed drained

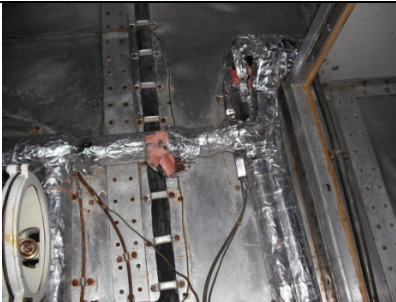
Vessel	Location	Item / Product Examined	Hazard Description and number from Appendix 1 of the Guidelines	Sampling Strategy	Extent	Remarks/Comments	Photograph
HMS Conqueror	3/011 Cold Room	Refrigerator	Refrigeration Gases Suspected R12	Visual	Residual	Left over from active service, presumed drained

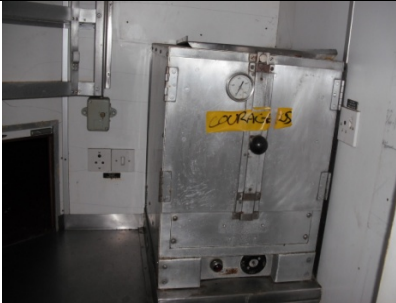
HMS Conqueror	1/005 Pantry	Tabletop Refrigerator	Refrigeration Gases (Unknown type). Likely to be ammonia or R134	Visual	Residual	Left over from active service, presumed drained

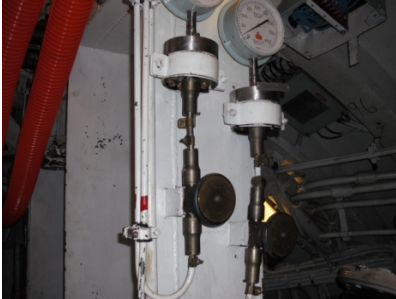
HMS Conqueror	1/013 Walkway	Hydrogen reduction valves/pipes	Hydrogen	Visual	Residual	Tanks been removed, associated feed pipes and valves still in situ

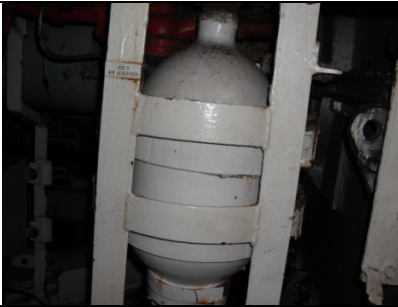
Vessel	Location	Item / Product Examined	Hazard Description and number from Appendix 1 of the Guidelines	Sampling Strategy	Extent	Remarks/Comments	Photograph
HMS Conqueror	2/013 Motor Room	Base 3 Air reservoir	Air components	Visual	Residual	Left over from active service, presumed drained

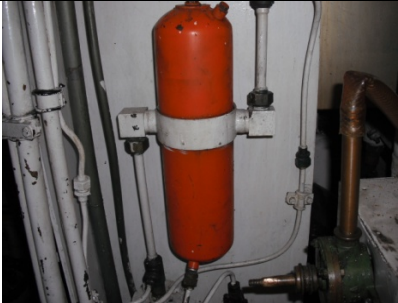
HMS Conqueror	2/011 Diesel Generator room	Gas tanks adjacent to radiation exclusion zone	Gas within gas containers, unknown origin	Visual	Residual	Left over from active service, presumed emptied

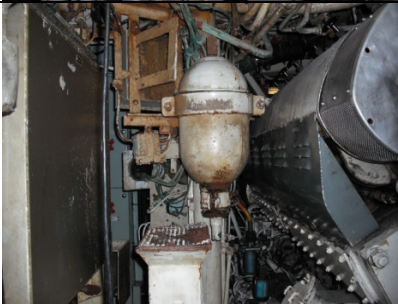
HMS Conqueror	2/011 Diesel Generator room	Base 3 Air reservoir	Air components	Visual	Residual	Left over from active service, presumed drained

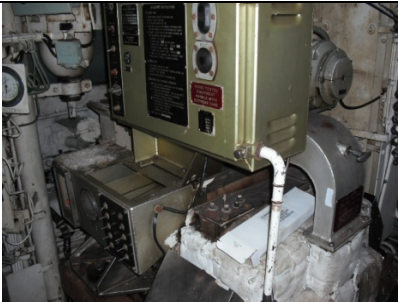
Vessel	Location	Item / Product Examined	Hazard Description and number from Appendix 1 of the Guidelines	Sampling Strategy	Extent	Remarks/Comments	Photograph
HMS Conqueror	2/011 Diesel Generator Room	Hydrogen tank adjacent Diesel Generator 1.	Hydrogen	Visual	Residual	Left over from active service, presumed emptied

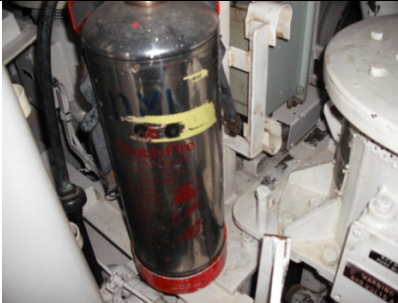
HMS Conqueror	2/011 Diesel Generator Room	Within FWD Port side fire extinguisher	Carbon Dioxide C-47	Visual	Residual	Left over from active service, presumed drained

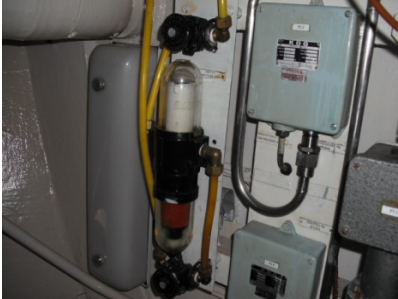
HMS Conqueror	3/002 Electrolyser Room	Within air filtration units Port Side	Air components	Visual	Residual	Left over from active service, presumed emptied

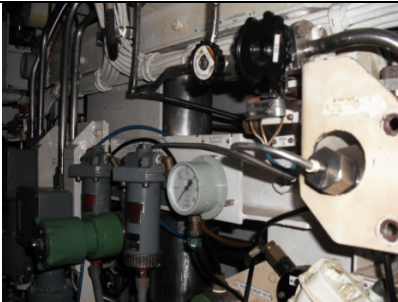
Vessel	Location	Item / Product Examined	Hazard Description and number from Appendix 1 of the Guidelines	Sampling Strategy	Extent	Remarks/Comments	Photograph
HMS Conqueror	3/002 Electrolyser Room	Within electrolyser unit	Oxygen and hydrogen C-21	Visual	Residual	Left over from active service, presumed drained

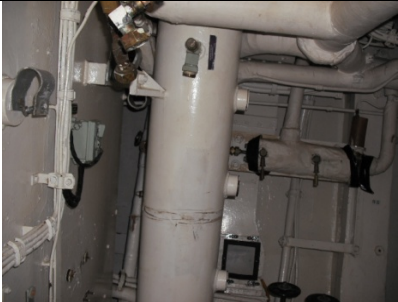
HMS Conqueror	3/011 Cold Room	Within Number 1 and 2 system condensers.	R12 Refrigerant gas A-2	Visual	Presumed emptied, plaque evidence to say up to 6kg in both condensers	Left over from active service
