Learning from experience

Post-incident reporting for UK dams
2009 annual report

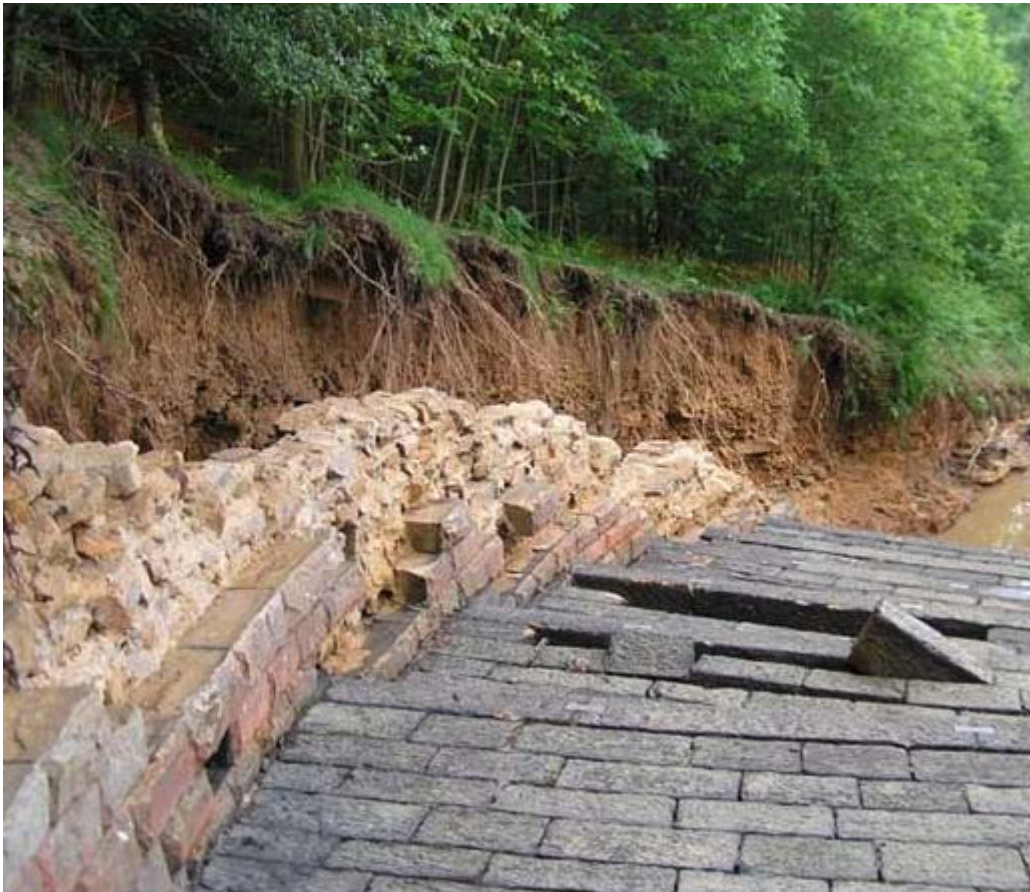
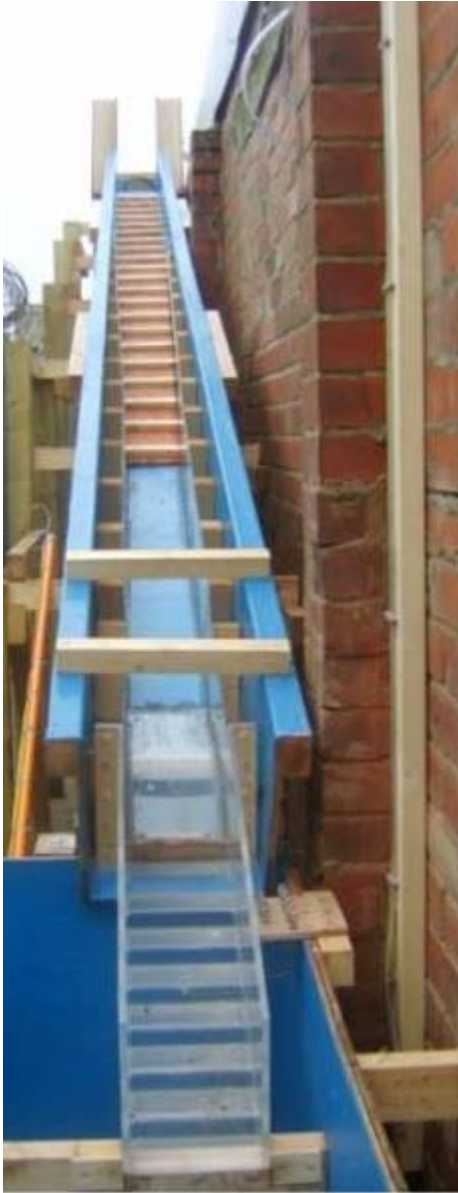
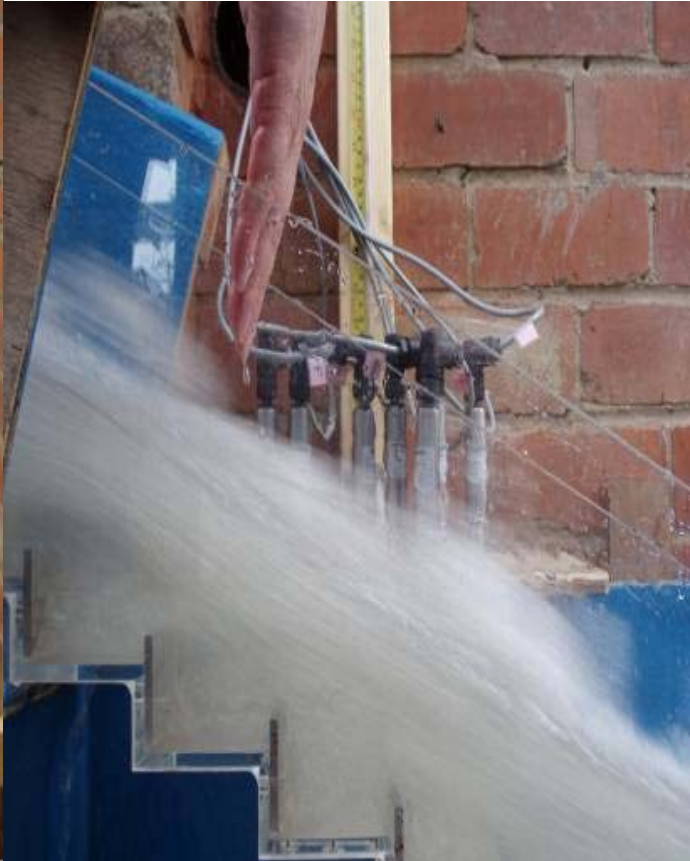
The report on the research highlights the need for regular inspection and includes advice on how to identify distress in spillways and appropriate means of repairing any damage. It encourages the use of photographs in inspection reports and investigating voids behind masonry walls. It also notes that regular inspection of the spillway is important to ensure the integrity of the mortar pointing.

The following images show the stages of the work.
