KIT!

A quarterly guide to equipment care

Issue 79 | 2012

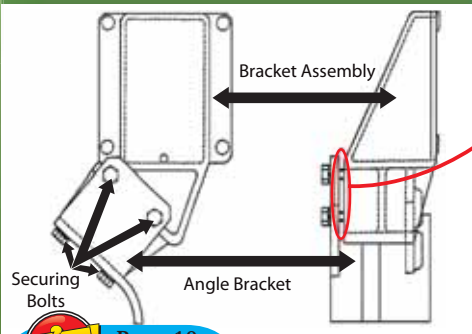
The MVR mounting bracket complete, consists of the bracket assembly and the angle bracket. There should be a gap of approx 5mm present between the bracket assembly and the angle bracket once secured in place. Previously some securing bolts have been tightened to remove this gap resulting in the failure of the bracket. To reduce unnecessary and costly MVR bracket replacements a spacer will be fitted to ensure that the required gap is retained.

These changes are detailed within AESP 1015-K-100-822 Gen Instruction 51. Units are requested to action this instruction accordingly.

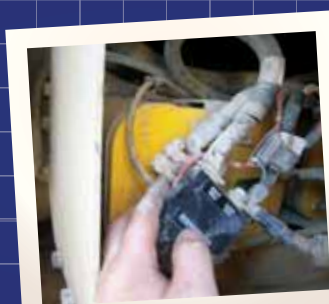
Fig 3

If when turning the battery disconnect switch to the 12 o'clock (NORMAL) position the dials don't sweep and no power is available first check the master switch is in 6 o'clock position, if no power then check the vehicle battery terminals. Located under the right hand side of the vehicle, in front of the right hand rear wheel. (An access plate must be removed Fig 3).

The terminals must be free from dirt and should be tightly connected, loose connections will cause all kinds of electrical faults often resulting in damage to other electrical components.
