A quarterly guide to equipment care

Issue 82 | 2012

Welcome to KiT! 82 Winter 2012

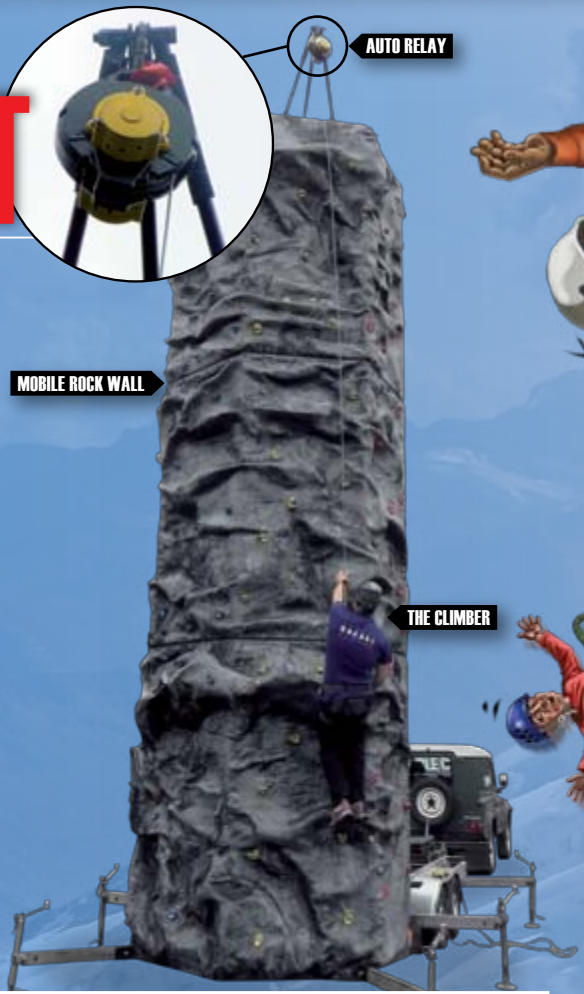
Automatic Climbing Wall Descent Controller (Auto Belay) is used to enable the safe ascent and descent of a mobile climbing wall while eliminating the need to have a person belaying. During a display the equipment failed to operate as designed, **leading to the cable becoming slack and entangled around the climber's neck.**

INCORRECTLY FITTED

The descent controller had been incorrectly fitted to the climbing wall.

During operation the cable became mis-layered on one side of the cable drum, it became snagged on the drum and failed to retract leading to the slack cable. This was a direct result of the device being fitted 90° out of correct alignment.

It was noted that the casing of the equipment suffered gouges indicating that the equipment had been incorrectly fitted for an extended period of time.

All holding units should carry out an immediate review, to ensure that the equipment is Fitted and Operated in accordance with the Manufacturer's Manual and subject to before use inspections.

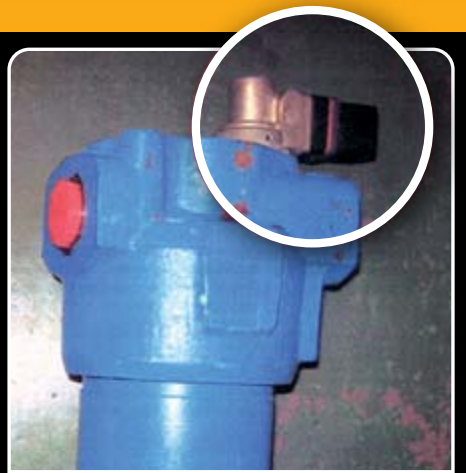
A failure of the microswitch, either in the closed position so that the warning lights are always on, or in the open position so that the warning lights never illuminate should be repaired by replacement of the microswitch (and not the complete assembly)

NSN: Switch 5930-99-774-5294

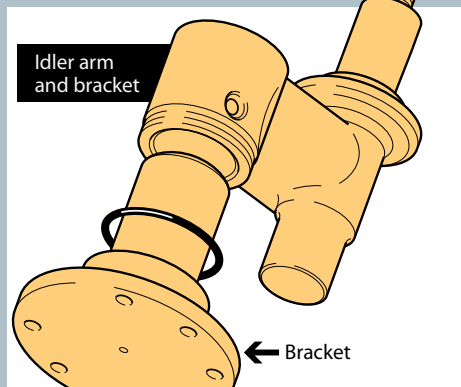
The misalignment was due to a bent idler arm bracket, the force required to bend this substantial component can only have been generated by an impact with an immovable object, which should have been noticed by the crew. The impact may have cracked the hull around the bracket mounting threads.

This damage would have caused the vehicle to track to one side, which would have required a constant steering input from the driver. The track would have worn unevenly and at a greater rate than is normal.

Users are reminded:

Vehicle maintenance must be carried out correctly and in accordance with the AESPs.

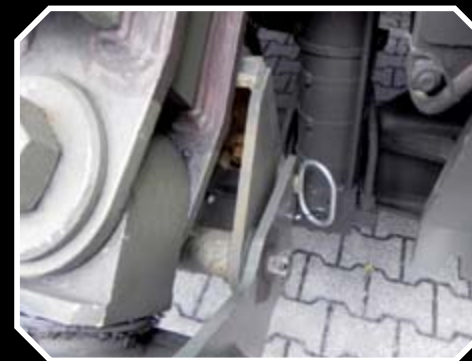
A recent SEFIT investigation into the loss of hydraulic function on a MAN SV(Recovery) recovery device, identified that damage to the recovery device hydraulic system can be caused.

Retraction of the recovery device with the tilt ram extended may result in contact between the tow pintle and the hydraulic pipes on the recovery device lift rams.

Also ensure that the tow pintle is in either the deployed for use or fully stowed position before stowing the recovery device.

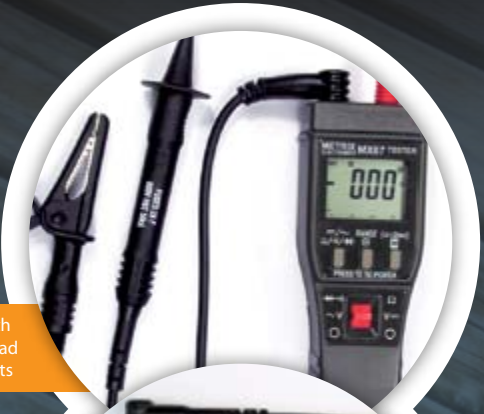
MX67-MOD with the old Black lead and attachments

They are to be replaced by a Test Lead Kit,
NSN Z4/6625-99-152-7134
