KIT!

Welcome to KiT! 83 Spring 2013

KIT 83 | 2013

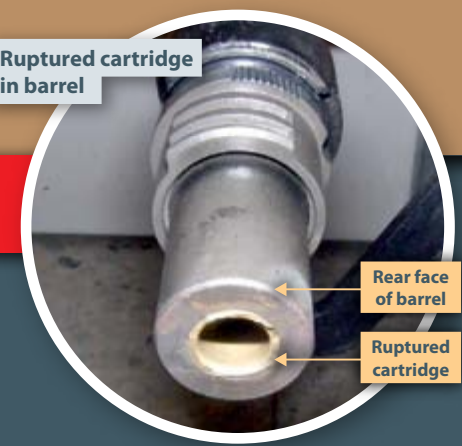
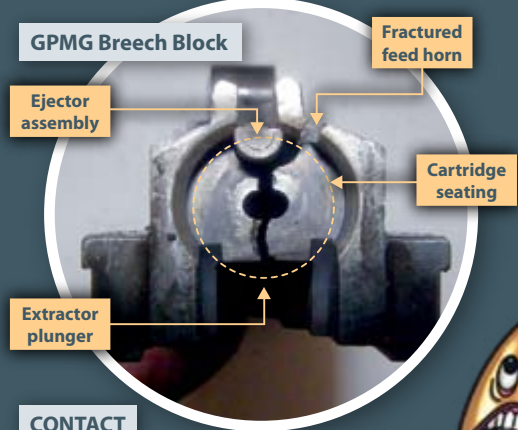
The Importance of Correct Cartridge Head Space (CHS)

Ruptured cartridge in barrel

A reminder to all maintainers and users:
There has been a recent increase in reported GPMG breech explosions. Subsequent SEFIT inspection reports have identified a trend of fitted incorrectly matched barrels.

Correct CHS is critical to the safe functioning of the GPMG weapon system and preventing possible injury to the user or catastrophic equipment failure.
