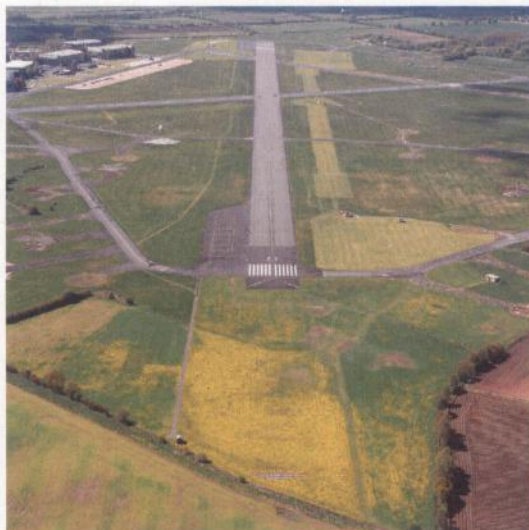
Fig 17 – Illustrative Cockpit View on Selection of ESDL to Off/Feather.

1.4.58. Suspecting an engine failure, the HP selected the ESDL to Off/Feather 9 secs after the re-selection of EEC Normal and committed to a forced landing on Rwy 21. This occurred at a height of 828 ft and 152 kts at 0.55 nm from the threshold (see Fig 16). Operation of the ESDL closes the mechanical fuel shut-off valve, disables the NTS system, initiates the fuel purge system and operates the feathering valve to allow the propeller to feather, thus reducing drag. Flaps were still available as they are electrically operated but the landing gear could now only be lowered using the standby system. Fig 17 shows a cockpit view of the aircraft's position in relation to Rwy 21 when the ESDL was operated.

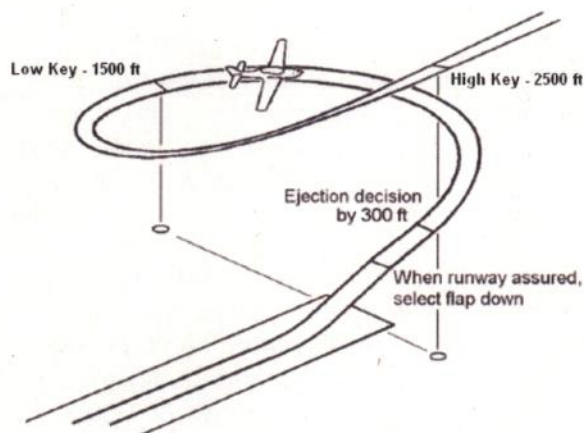
Fig 18 - The PFL Pattern.

c. **Visual Forced Landing Procedures.** The rate of descent in a glide at 115 kts with the engine shut down and the propeller feathered, flaps and landing gear up and the airbrake in, is approximately 900 ft/min. Both high key and low key occur abeam the threshold at a height of 2500 ft and 1500 ft respectively. Emergency pre-landing checks are completed between high and low key where the speed is reduced to 110 kts. Flaps are selected down when certain of reaching the desired touchdown point (approximately a third of the way down the runway) and 110 kts is maintained until the flare is started; threshold speed of approximately 100 kts (fuel weight dependent) should be achieved during the flare. Fig 18 shows a typical PFL pattern.

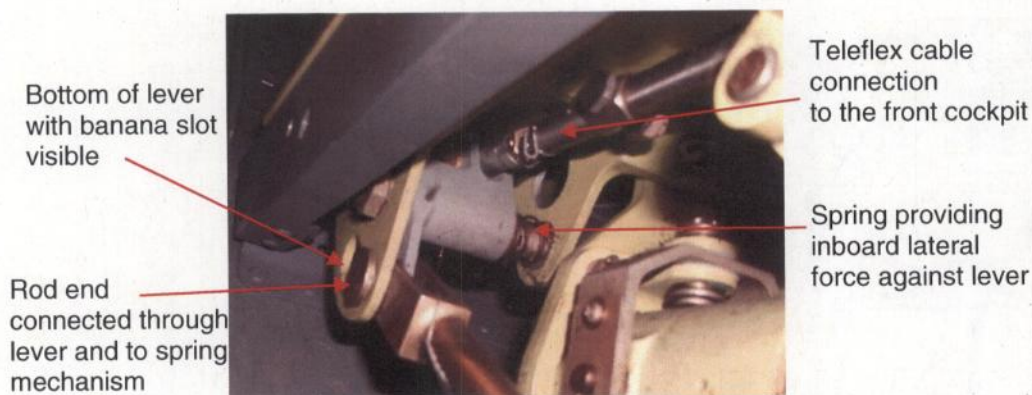
Fig 21 - Longitudinal View of the Rear Cockpit SSL Mechanism.

1.4.65. **Technical Description.** The standby lowering system is operated by levers, linked mechanically by a teleflex cable, below the pilots' left console. There is a spring attached to the rod assembly in the front cockpit that opposes longitudinal travel of the SSL and a second spring attached to the rod assembly in the rear cockpit that applies a lateral force which pushes the SSL inboard into a 'L' shaped gated position. Once gated, the SSL remains aft by spring force without the requirement to be held. The rod assembly is connected via 2 banana slots (shown at Figs 21 and 22) which, when the SSL is selected to down, mechanically opens the emergency shut-off valve and allows emergency hydraulic accumulator pressure to operate the gear and the door actuators. The landing gear then falls under gravity before being forced into the locks hydraulically. With the engine shut down, the hydraulic pump is no longer being driven; therefore, the landing gear must be lowered using the standby lowering system using the emergency accumulator. The speed limit for lowering the landing gear is 120 kts using the standby system because of the structural limitations when the main doors remain open. A micro-switch, fitted 2.5mm forward of the gated position on the front cockpit SSL, overrides the indication sequence so that locking the 3 legs causes the green indication, otherwise a red indication would remain because the doors have not retracted. When lowering the undercarriage using the SSL, anomalous indications of initial nose leg green and/or red and green lights on together may be seen briefly. The only confirmation that the landing gear is down and locked is 3 greens. The accumulator is pressurised by the main hydraulic pump, and is depressurised either through operation of the SSL or by manually turning a pressure release valve situated on the side of the aircraft, which opens a return to the hydraulic reservoir. Fig 23 shows the external valves for the emergency accumulator.

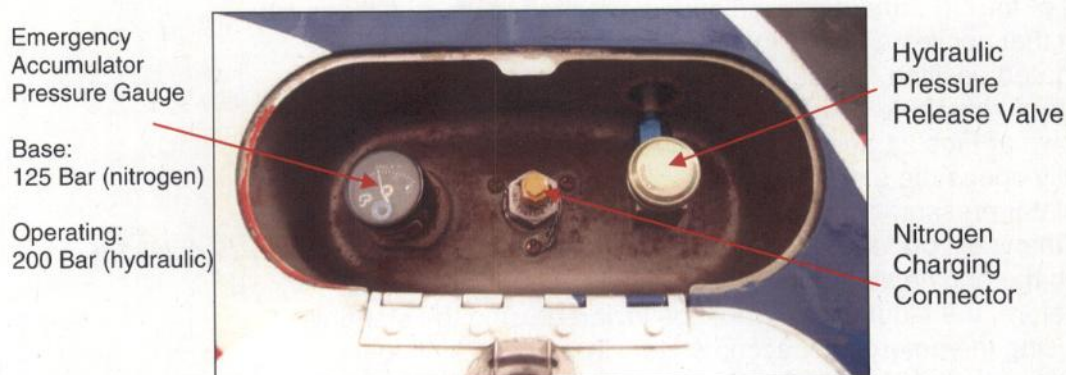
Fig 23 - Emergency Accumulator Panel.

a. **Discharged Emergency Accumulator.** The ADR does not record the Emergency Hydraulic caption²⁷ or the emergency accumulator pressure. Neither of the crew reported seeing the 'EMER HYD' caption which could indicate a leak across the emergency system. The accumulator pressure was not checked for 24 hrs after the accident but there was no damage found to the accumulator during initial assessment. However, the spring-loaded hydraulic pressure release valve used during before and after flight servicing can fail to reseat correctly²⁸; this would leave the return

valve to the hydraulic reservoir slightly open and allow a low level of return from the emergency system. As the hydraulic pump is designed to respond to demand, in flight it would simply supply more fluid into the accumulator, continually working to maintain the normal operating pressure. Once ESDL was selected to Off/Feather the hydraulic pump no longer operates and this pressure could no longer be maintained. This would have allowed a dissipation of pressure over time as fluid returned to the reservoir and could account for a slow discharge of the accumulator post accident without the EMER HYD caption being triggered during flight. As the closed position of the valve is not marked, it is not possible to establish if the valve was incorrectly seated in this instance (See Fig 23), although nothing was noted during the before flight servicing. The Panel could not positively determine when the accumulator discharged but considered it most likely to have been due to the hydraulic pressure relief valve failing to return to its seated position. This would cause hydraulic fluid to return into the main reservoir thereby reducing the available emergency pressure.
