Land Equipment Programmes

Welcome to KiT! 84 Summer 2013

KiT! CONTENTS
KiT 84 | 2013

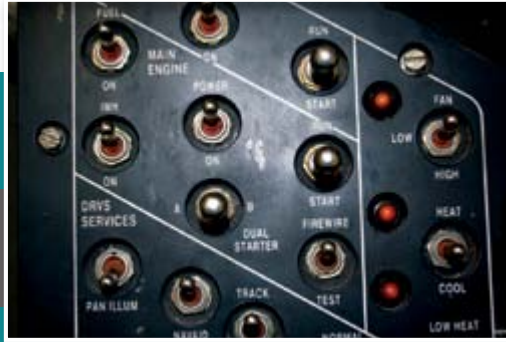
Failure of either starter motor will not be apparent to the driver as the engine will turn over on the functioning starter with the dual start switch in the central position. Starting the engine with one starter motor should only be attempted in an emergency. It is essential that correct operation of the starter motors is checked IAW AESP 2350-P-102-601 Table 5 Serial 6.5 which states:

Check operation of A and B bank starter motors individually at normal working temperature.

Failure of either starter motor should be reported immediately so as to not overload the serviceable starter.

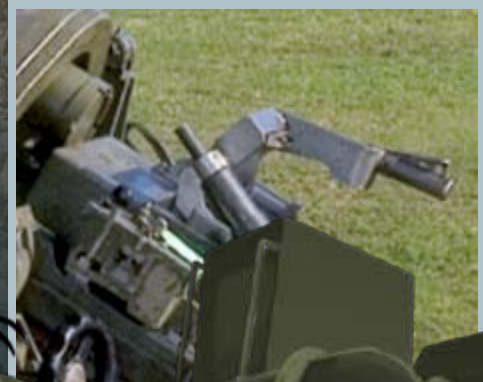
Recuperator Dowty Washer Issues

The following Recuperator Dowty washer NSNs have been superseded:

- (1) 5330-99-942-8452 (Stuffing Box)
Changed to: 5330-99-789-6756
- (2) 5330-99-942-8453 (Recuperator filling Plug)
Changed to: 5330-99-753-0393

AESP References;
1015-K-100-711
(Chap 2-1-4, Pages 6/7, Items 18/20)

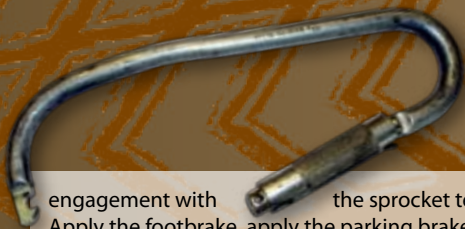
Track Rope Karabiner Failure

Further investigations into track rope karabiner failure, (highlighted in KIT 79), have identified that the most likely failure mode occurs if the karabiner is not disconnected from the track once the leading links have engaged with the sprocket teeth. The karabiner is then pulled into contact with the sprocket carrier where it will twist so that lies flat against the surface of the carrier.

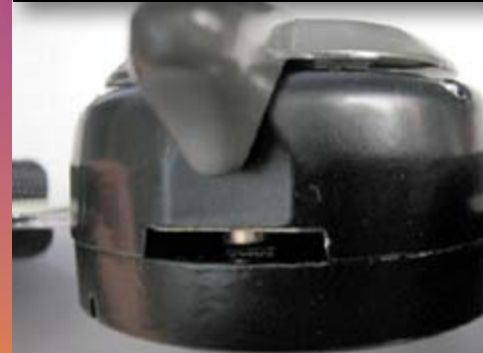
5th hole - Crutch Strap Connection

Following this change a number of unserviceable harnesses were found where a tongue was **forced** into this aperture, resulting in the harness and buckle being jammed and needing replacement.

SECURON have now introduced a blanking plug, permanently fitted with the 'dropped' pin to eliminate this risk.
