KIT!

A quarterly guide to equipment care

Issue 80 | 2012

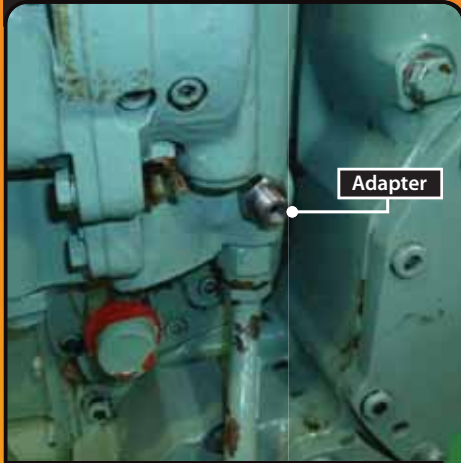
Adapter

The adaptor listed in AESP 2350-T-220-522, Chap 4, Table 1, Serial 17 part No AS37967 for pressure testing the TN15 transmission is now available through stores system - 9CVT/4730-99-958-5904. The AESP will be amended in due course.

Pressure testing the transmission allows full failure diagnosis to be carried out - information that should be included with the EFR to inform the Level 4 overhaul process.

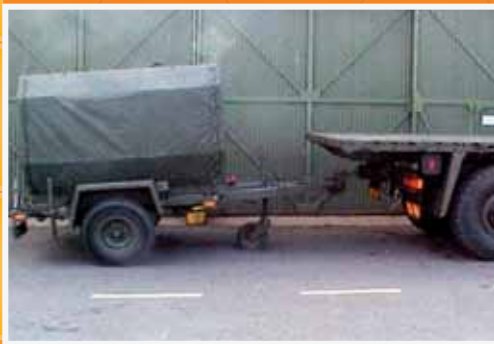
FEPS - Towing Ban

Support Vehicle users are reminded that there is still an ongoing ban on FEPS being towed behind all variants of SV.

Further trials are taking place and it's hoped that a solution will be available to the user soon.

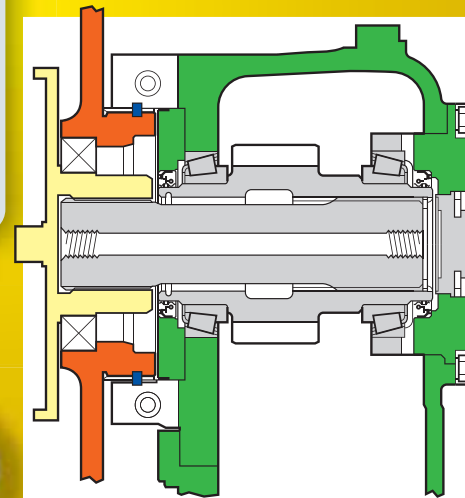
A recent Warrior serious failure resulted in a loss of steering. The LH drive coupling was found lying on the floor - the transmission output flange was correctly located in the transmission and the final drive input flange was in the disengaged position.

The damage to the rotating part of the end plug is more difficult to understand, also why the coupling came apart rather than the drive shaft disengaging from the transmission.

It is unlikely that the train of events that preceded the failure will ever be fully understood, which is why a fleet wide check was instigated to see if there is any evidence of a similar failure in the early stages.

There has been no evidence of any further failures at the time of writing (19 Mar 2012) and **CTG consider this failure to be a one off event.**

The end plug in the LH final drive is fitted correctly.

The driver is aware that he/she must report any unusual noises or vibrations.

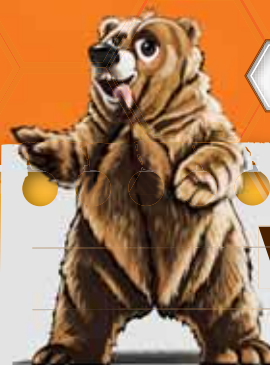
Yamaha Grizzly Quad Bike

Throttle Jammed

On examination it was immediately obvious that the throttle cables had been incorrectly routed. It was also found that there was no O Ring in the Throttle Wheel Housing - This acts as a dirt seal, without it the throttle wheel and housing was dirty and had corroded.

After this incident other Quads were examined, the standard of throttle and other cable routing was found to be poor in many cases, also the incorrect use of fittings and most alarming one instance where the fuel line appeared to have been touching the engine. Quads are petrol driven. Petrol has a flashpoint of 43 °C (109 °F). Clearly it should not be touching the engine.

All defects are to be reported to DE&S through the chain of command by EFR. Point of contact within SLV PT is [REDACTED]

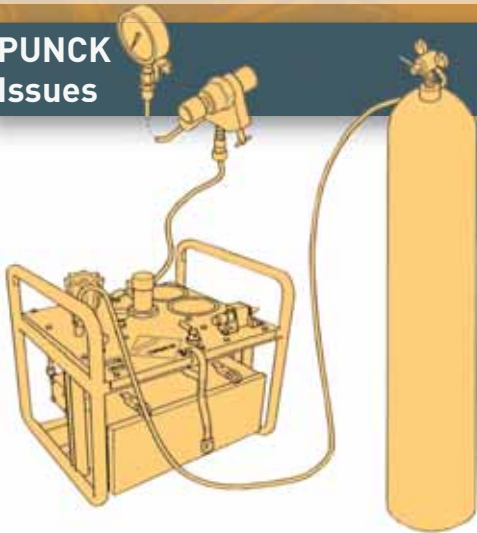
PUNCK Issues

Safety notice 388 has been issued to all units that hold PUNCKs or SLUCKs, instructing them to contact Combat Track Group with the serial numbers and Issue No. of any equipment held on charge.

Please contact Combat Track Group on 9679 71270 if you have not already done so.

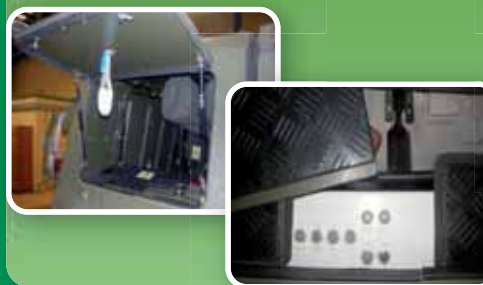
Fire suppression bottle extension

Units are reminded that the service life of the fire suppression bottles has been extended from 5 years to 10 years.
