Aircraft Type and Registration:	Boeing 777-236, G-VIIO	
No & Type of Engines:	2 General Electric GE90-85B turbofan engines	
Year of Manufacture:	1999	
Date & Time (UTC):	16 August 2004 at 2317 hrs	
Location:	Off the coast of the USA during climb	
Type of Flight:	Public Transport (Passenger)	
Persons on Board:	Crew - 15	Passengers - 334
Injuries:	Crew - 5 (Minor)	Passengers - 1 (Serious)
Nature of Damage:	None	
Commander's Licence:	Airline Transport Pilot's Licence	
Commander's Age:	52 years	
Commander's Flying Experience:	16,796 hours (of which 3,755 were on type) Last 90 days - 186 hours Last 28 days - 83 hours	
Information Source:	Aircraft Accident Report Form submitted by the pilot

INCIDENT

Aircraft Type and Registration:	Boeing 777-21H, A6-EMF	
No & Type of Engines:	2 Rolls-Royce Trent 877 turbofan engines	
Year of Manufacture:	1996	
Date & Time (UTC):	19 February 2005 at 1415 hrs	
Location:	Birmingham Airport, West Midlands	
Type of Flight:	Public Transport (Passenger)	
Persons on Board:	Crew - 14	Passengers - 294
Injuries:	Crew - None	Passengers - None
Nature of Damage:	Right-hand engine pylon panel 427AL delaminated	
Commander's Licence:	Airline Transport Pilot's Licence

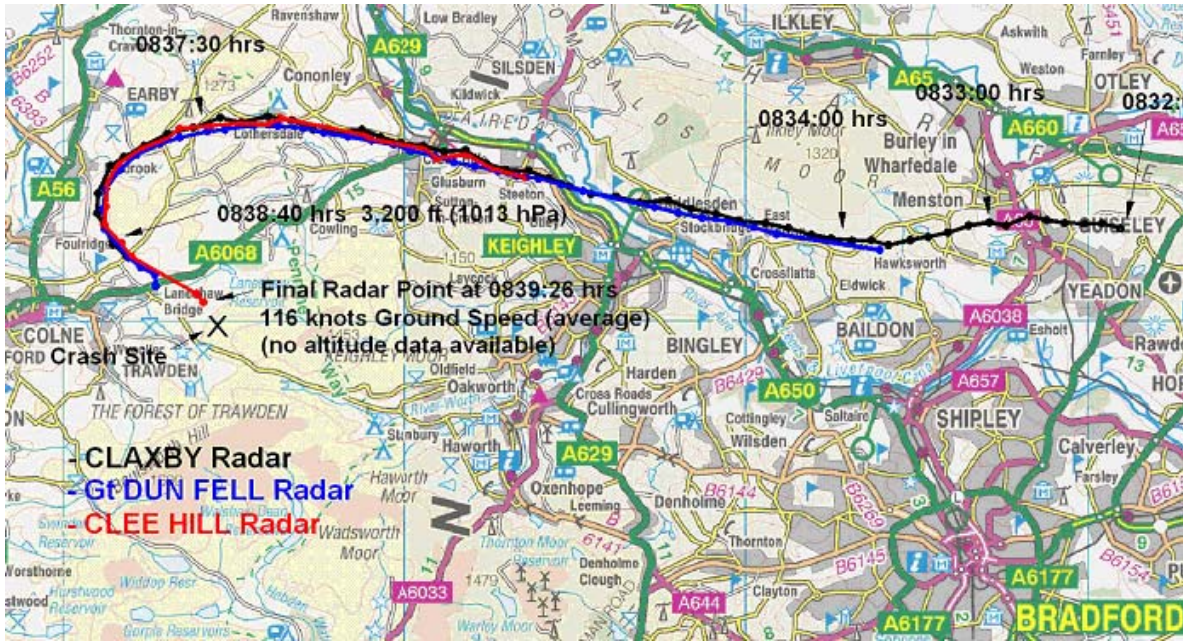
Figure 2 - Radar traces of flight by N6834L

The last radar contact placed the aircraft in the vicinity of Wycoller Country Park, 15 nm west of Leeds Bradford Airport. A driver in a car park on the eastern edge of the country park, whose broken down car was being repaired at that time, heard what sounded like the noise of an aircraft or 'an old tractor engine' coming from the direction of a hill half a mile to his east. The noise reminded him of a car engine running on dirty petrol. He looked up and saw very low in the sky a slow moving, white coloured, light aircraft, heading in a north-westerly direction as if it was taking photographs or just "messaging about". "It appeared to be flying level and did not seem to be in trouble". After glancing at the aircraft the driver turned away and continued talking to the mechanic repairing his car. He then heard a noise "like farm machinery tumbling down a gully". Both he and the mechanic looked up and the mechanic remembered seeing the nose of an aircraft digging into the ground with its tail somersaulting over the top. The driver's recollection was of a large amount of dust and debris travelling down the hillside in a westerly direction. Just before the crash the mechanic recalled hearing the noise of an engine which was "spluttering or failing, as if it was running out of fuel". He said that this sound had lasted for two to three seconds.

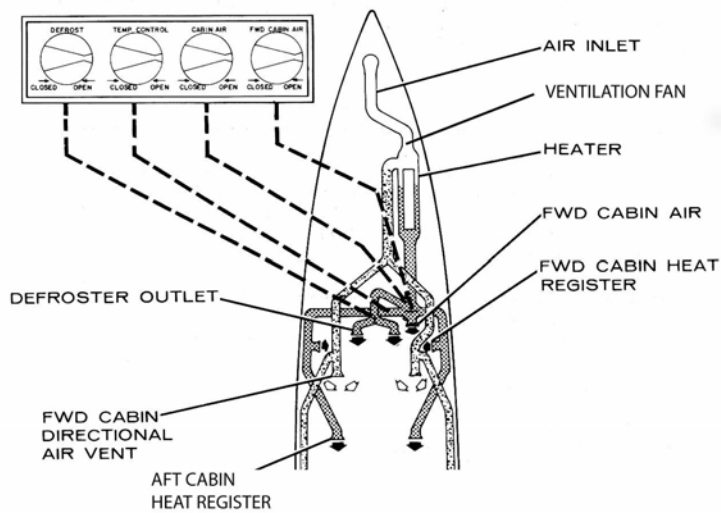
Figure 4 - Heater and ventilation system - T310R

The layout and functioning of the cabin heating and ventilation system can be seen at Figures 4, 5 and 6. Figure 4 shows the position of the combustion heater in the nose of the aircraft and the routing of the heating and ventilation air flows into the cabin. Figure 5 shows the principal components of the system (combustion heater, ventilation fan, centrifugal fan and fuel pump), as configured for a bench test. Figure 6 illustrates the internal functioning of the combustion heater.

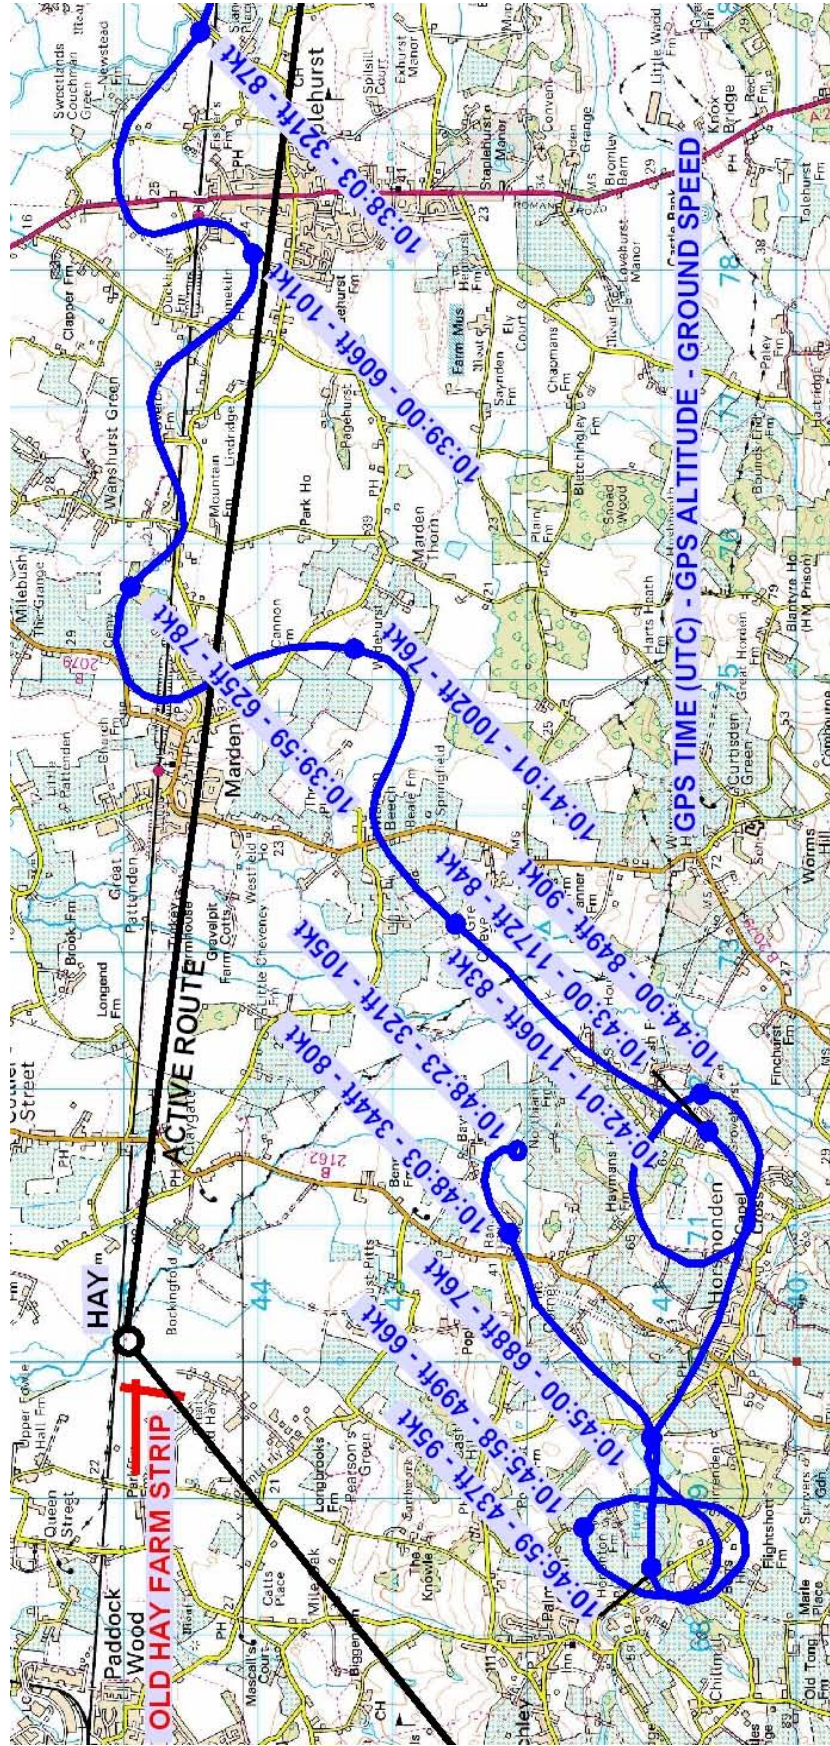
Figure 1
G-BHIL - GPS Aircraft track and height
for the last 10minutes of flight

The pilot had undertaken a long international flight to an undeclared destination in an area of weather conditions well below VFR minima. His apparent desperate need to land at Old Hay contributed to poor decision making processes in the later stages of this flight. In attempting to maintain or regain visual contact with the surface, possibly whilst distracted by activity in the cockpit related to navigation, loss of engine power due to carburettor icing, loss of situational awareness due to inadvertent entry into fog or due to a medical distraction or incapacitation, the aircraft descended into the ground. No technical causal factors for the accident were identified.

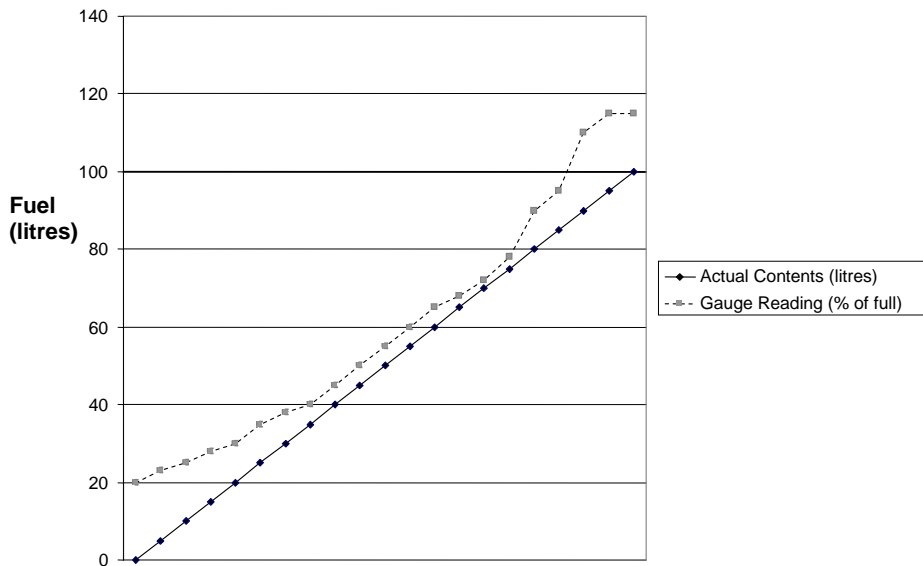
Fuel flowed readily from the tank and no cavitation of the electric fuel pump was apparent. The helicopter's tail was then weighted down, to simulate a nose-high attitude, as might be encountered when transitioning into the hover. In this attitude, the pump was again selected on, and fuel began to flow. Very soon, the flow became less steady and the pump was heard cavitating. Some 700 mls of fuel were collected before flow ceased. The helicopter was again returned to the level attitude and the test re-commenced, with a further one litre being collected before flow stopped. The tank was then drained into a measured container. The total fuel taken from the tank was determined to be 4.8 litres, or 1.3 USG.

The fuel tank was gradually re-filled with measured quantities of Avgas, the gauge readings being taken at various fuel states. The chart above compares fuel in the tank with fuel contents indicated on the gauge.

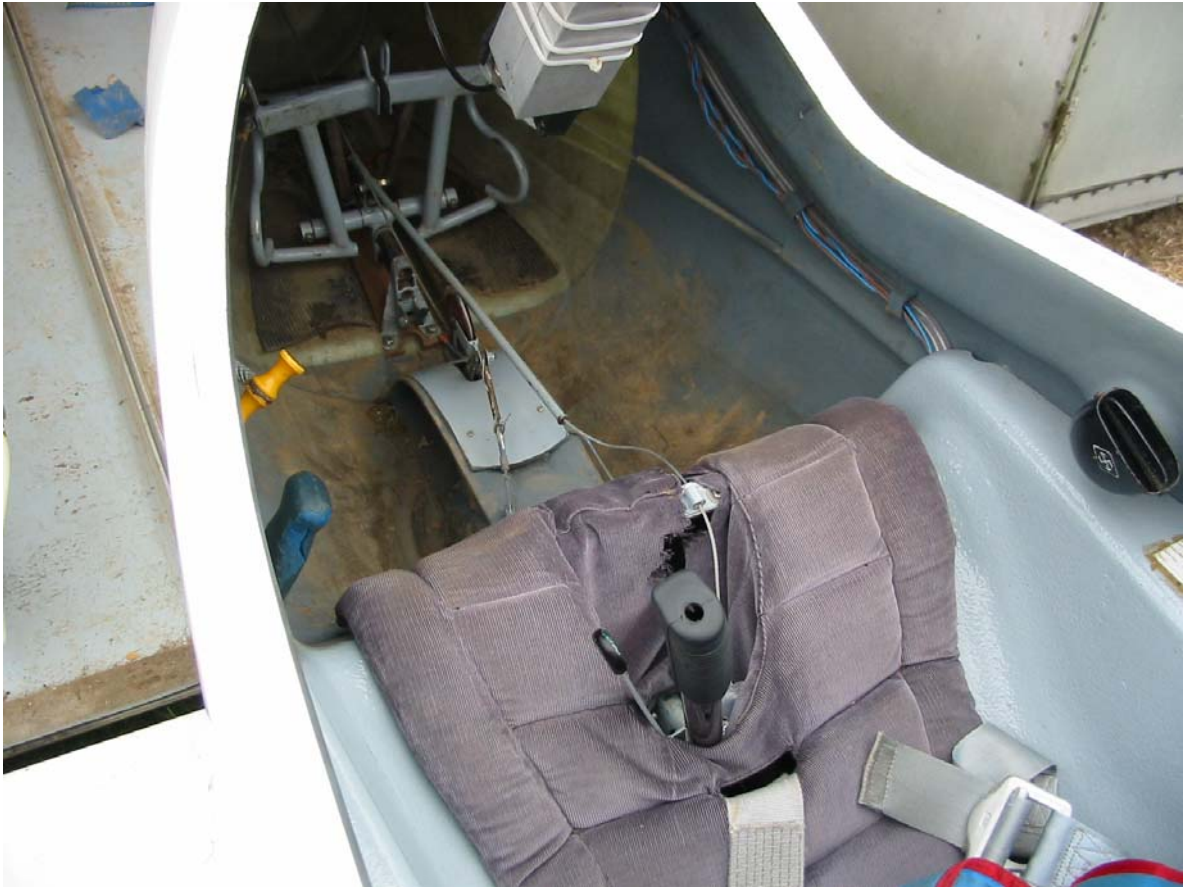
Figure 1

An examination of the glider revealed that, in the accident, the student's camera had been damaged. Initial indications suggested that the camera might have become lodged in the aperture for the front seat control column, between the column and its forward control stop; this is located at the aft end of the cockpit floor. This was possible because the space behind the floor around the control column, which allowed the control to be moved through its full range, was unguarded (see example in Figure 2). Further examination revealed that there was a small piece of black material in the edge of the floor in front of the control column, which looked similar to the material on the camera case (see Figure 3). Also the dents in the camera and witness marks on the camera case appeared to be consistent with the camera being jammed between the floor edge and control column at this point. Consequently, the material that was wedged in the edge of the floor and the camera case were sent for analysis.

It is recommended that the British Gliding Association reinforce the message that there must be no loose articles in aircraft when they are being flown.
