CONTENTS

(ALL TIMES IN THIS BULLETIN ARE UTC)

INCIDENT

Aircraft Type and Registration:	Airbus A320-214, G-BXKD
No & Type of Engines:	2 CFM56-5B4/P turbofan engines
Category:	1.1
Year of Manufacture:	1997
Date & Time (UTC):	15 January 2005 at 1635 hrs
Location:	London Gatwick Airport, West Sussex
Type of Flight:	Public Transport (Passenger)
Persons on Board:	Crew - 7 Passengers - 177
Injuries:	Crew - None Passengers - None
Nature of Damage:	Left nose wheel detached from aircraft
Commander's Licence:	Airline Transport Pilot's Licence
Commander's Age:	40 years
Commander's Flying Experience:	6,200 hours (of which 4,400 were on type) Last 90 days - 113 hours Last 28 days - 55 hours
First Officer's Flying Experience	4,392 hours (of which 2,566 were on type) Last 90 days - 82 hours Last 28 days - 36 hours
Information Source:	AAIB Field Investigation

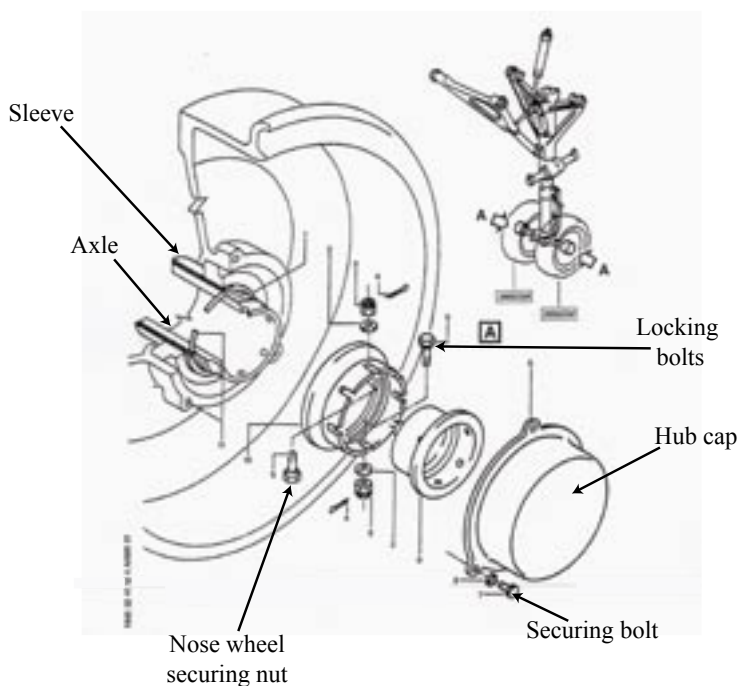
Figure 3

The nose wheel assembly consists of two wheels each running on an inner and outer bearing that sits on a sleeve fitted over the axle (Figure 3). A circlip secures the bearing in the wheel hub during transportation. Grease seals are fitted on the outside face of both bearings and the wheel is secured to the axle by the nose wheel securing nut, which has a right hand thread. Secondary locking of the nose wheel securing nut is achieved by two locking bolts fitted with castellated nuts and split pins. The hub cap is secured by three securing bolts.

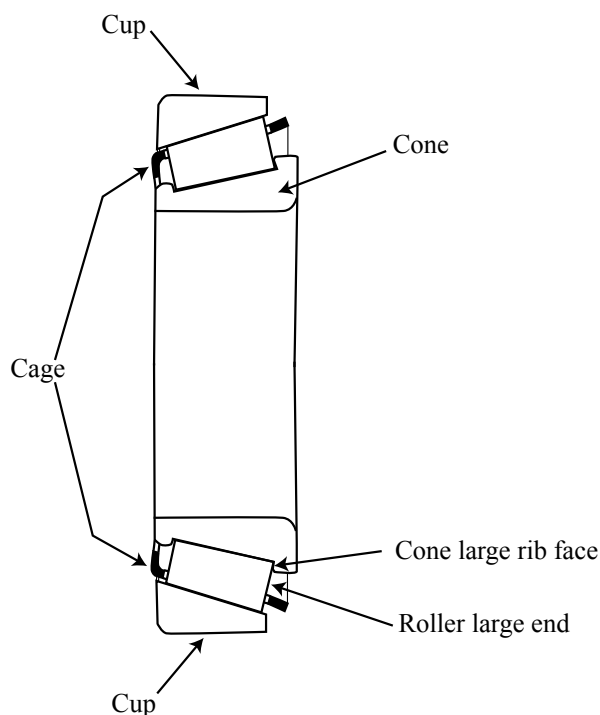
Figure 4

The nose wheel bearing consists of a cone, taper roller, cup and cage (Figure 4). The cup is fixed to the hub and is not normally replaced at wheel overhaul unless there is any evidence of physical damage. The tapered rollers are spaced and retained on the cone by the cage. The radial and side forces on tapered roller bearings are reacted primarily by the tapered races and roller bodies, and also by the roller large end and cone large rib faces.

Roller end scoring results from metal to metal contact between the roller large end and cone rib face. In normal operation the roller body rolls along the face of the cone, whilst the roller large end moves with a sliding and rolling motion across the cone large rib face. However, if the load between the roller large end and rib face is too high, or there is insufficient lubrication,

then metal to metal contact between the roller large end and rib face could occur. This contact may result in the micro-welding and tearing of metal causing excessive heat to be generated. The increase in friction at the roller large end would cause the rollers to start to skew and slide along the cone face, causing the softer cage pockets to be distorted. A further increase in temperature might be sufficient to cause the rollers to weld to the cone and ‘bearing lock up’ to occur.

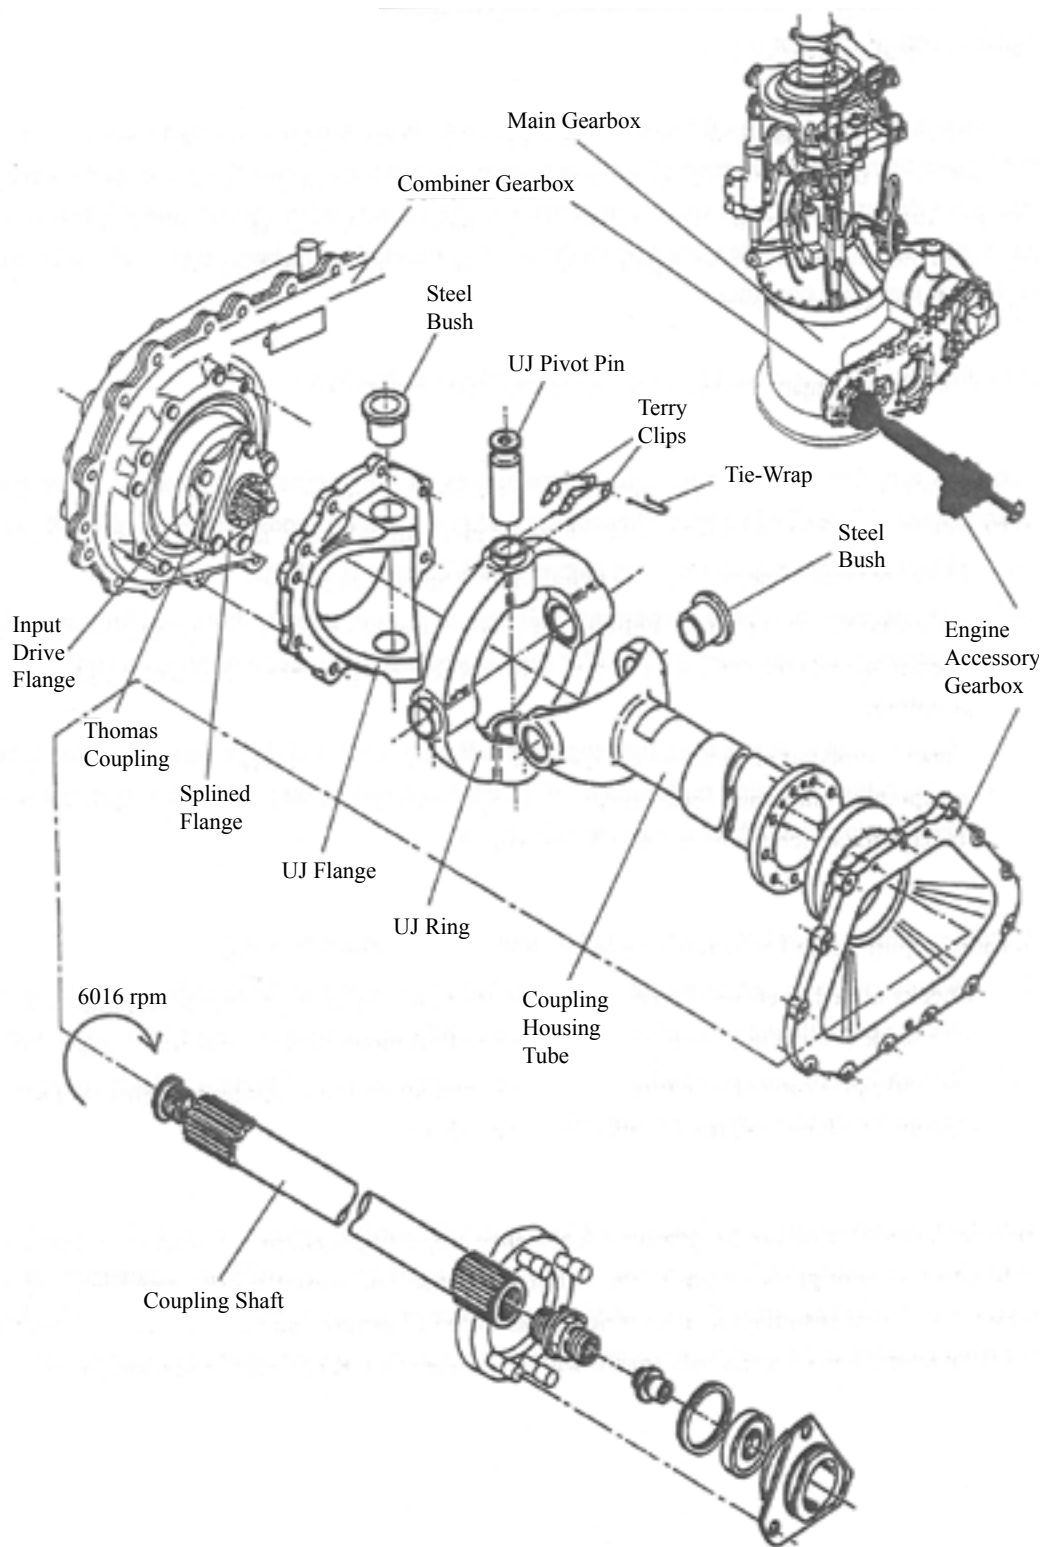
Figure 1

On 8 December 1992, another AS355F1 helicopter, registration G-OHMS, suffered a similar failure of the Thomas coupling of the No 2 engine. An uneventful single-engine landing was also achieved without damage to the helicopter. The AAIB report on this incident (AAIB Bulletin 1/94), noted that there had been four previous cases of coupling failure known to the manufacturer, one of which had been the subject of an earlier AAIB field investigation (AAIB Bulletin 12/91, registration G-WMPA). The other three were, according to the manufacturer, considered to be due to deterioration of the MRGB elastomeric mounts.

No significant deterioration of the MRGB mounts was found on G-WMPA but, in the case of G-OHMS, a number of the elastomeric laminated pads were found to have deteriorated to the extent that, in the manufacturer's opinion, MRGB location could have been compromised. It was concluded that this was probably responsible for the Thomas coupling failure.

No evidence was found that either item No 1 or item No 3 above were responsible for the failure of the Thomas coupling of G-FFRI. It is regrettable that any evidence regarding the condition of the coupling flange bolts seems lost, particularly in the light of a discovery made by the same maintenance company in January 2005 and brought to the attention of the AAIB. During routine maintenance on an AS355F2 helicopter (not G-FFRI), it was necessary to dismantle the engine drive Thomas couplings. Four of the six nuts and bolts seemed quite normal but two showed signs of severe fretting of both the nut and the bolt, apparently caused by a loose-fitting split pin (Figure 2). The pins themselves were intact but, as can be seen from Figure 2, the loss of material from the nut is considerable. Informal contact with another maintenance company suggested that they, too, had experience of this phenomenon as did an AAIB consultant metallurgist who had observed it in applications other than helicopters. The helicopter had flown a total of 5,597 hours since new and the combining gearbox had a total of 1,072 hours since overhaul (overhauled gearboxes are supplied with new Thomas couplings and hence bolts).

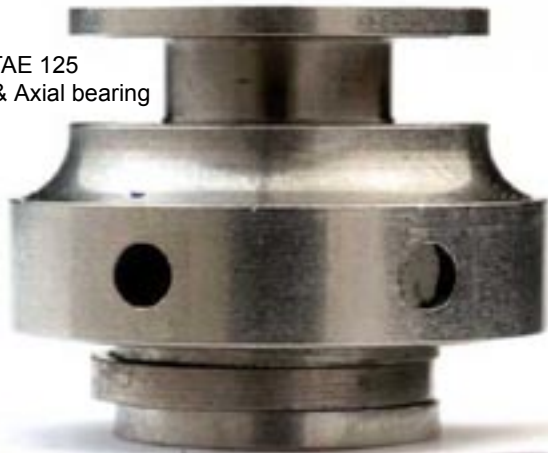
TAE 125
Radial & Axial bearing

The engine was stripped and examined by the aircraft manufacturer but it was also inspected by an air accident investigator from the German BFU (Federal Bureau of Aircraft Accidents Investigation). An examination of the combustion chamber revealed severe overheating damage as a result of loss of lubrication. The oil scavenge pump was found seized and its driveshaft had sheared. Disassembly of the scavenge pump revealed a piece of metal debris wedged between the gears (see Figure 4). The metal debris was identified as a part from the turbocharger radial and axial bearing.

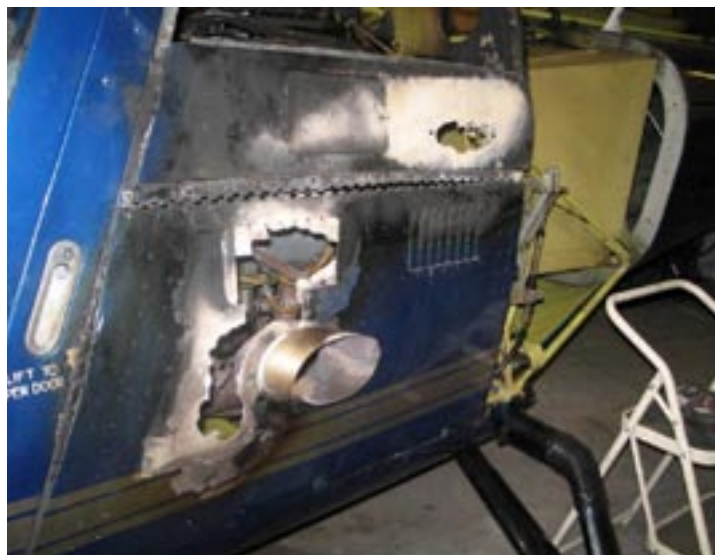
Figure 2

Fire damage to cowling and exhaust pipe outlet

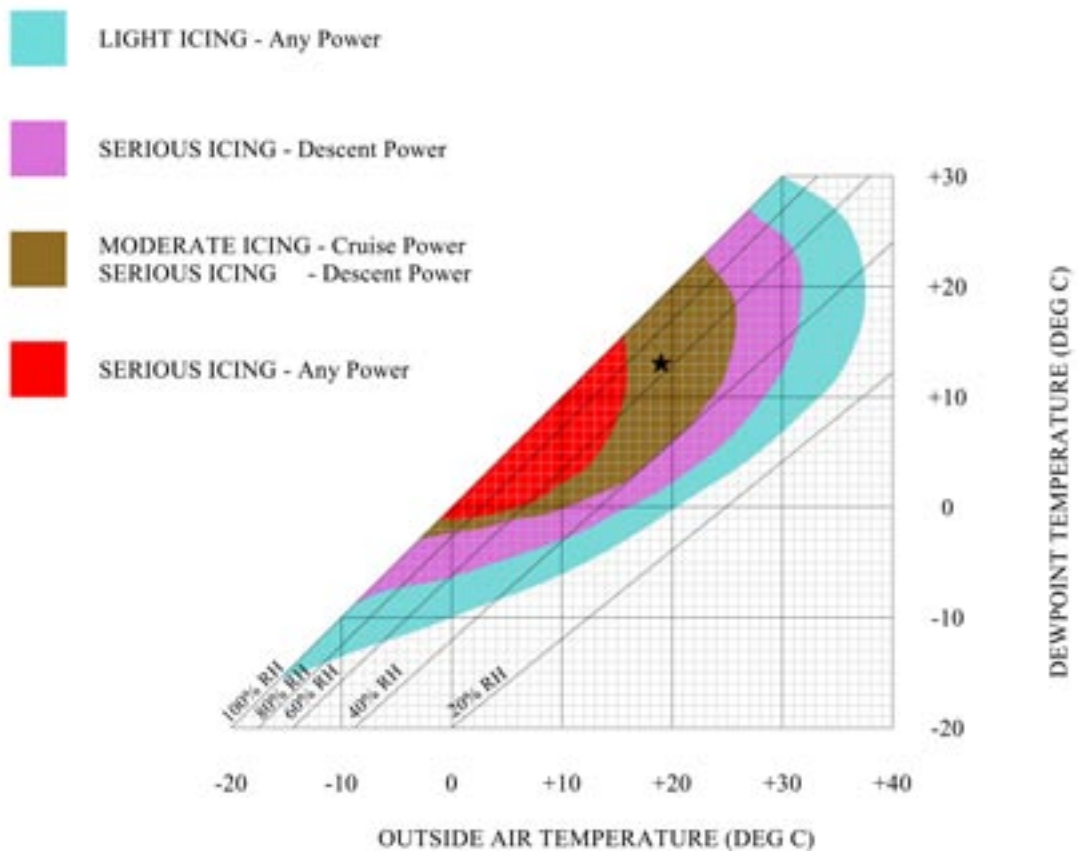
CARB ICING PREDICTION CHART

The weather at the time of the accident was observed as being a wind of 5 kt from 135° with good visibility. The temperature was 19°C with a dew point of 13°C, and this placed the engine in the '*moderate icing at cruise power and serious icing at descent power*' area of the carburettor icing prediction chart.
