CONTENTS

SPECIAL BULLETINS

COMMERCIAL AIR TRANSPORT

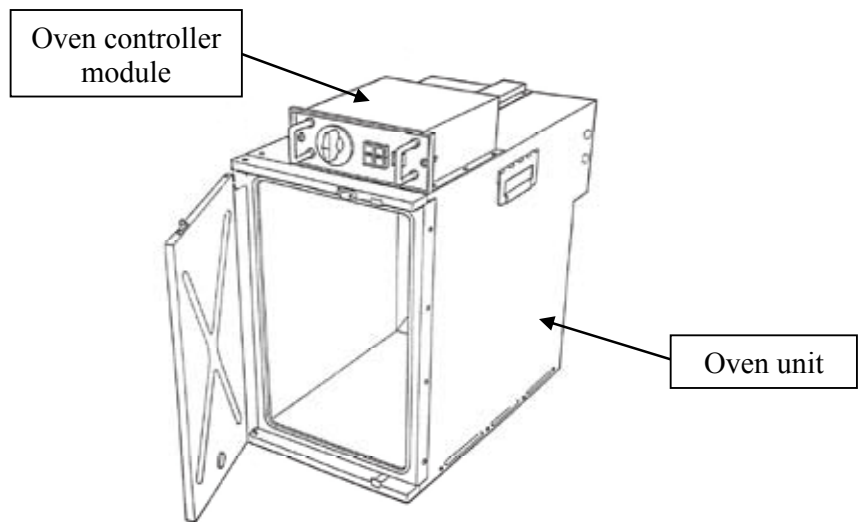
Figure 1
Oven assembly

unit, as shown in Figure 1. The two ovens in the forward galley are supplied with 115 volt AC electrical power and are protected by a circuit breaker, rated at 15 amps, that is accessible to the cabin crew. Each oven controller module is additionally equipped with a circuit breaker rated at 5 amps, installed on the rear of the controller. This circuit breaker is not accessible without removal of the oven from the galley.

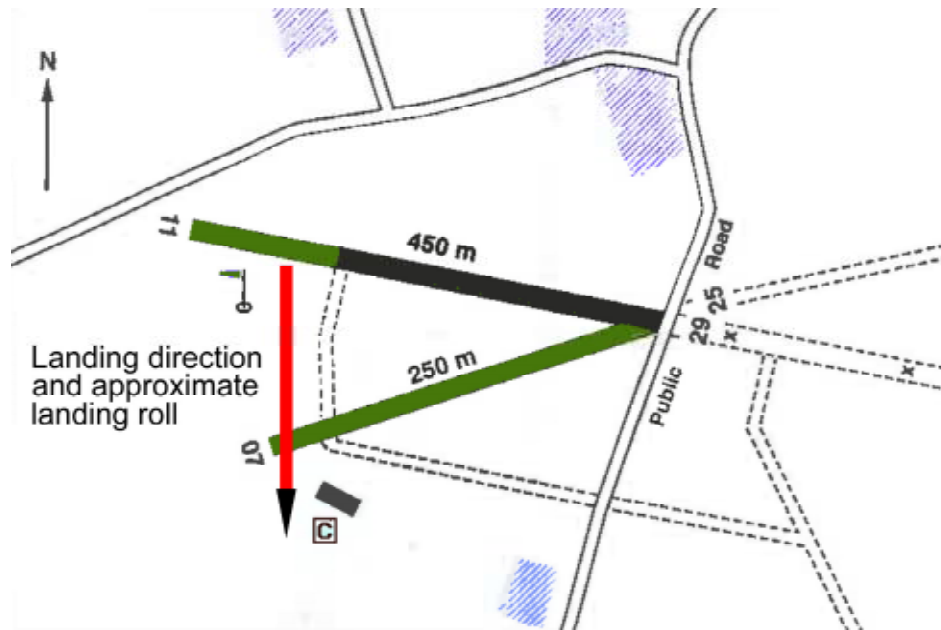
Figure 1

The pilot had flown from Plockton Airfield to East Fortune Airfield (see Figure 1). East Fortune Airfield has two unlicensed runways. Runway 07/25 is a grass runway of 250 m in length and Runway 11/29 is 450 m in length, with the first 350 m of Runway 29 being

G-CFPA Landing direction and approximate landing roll

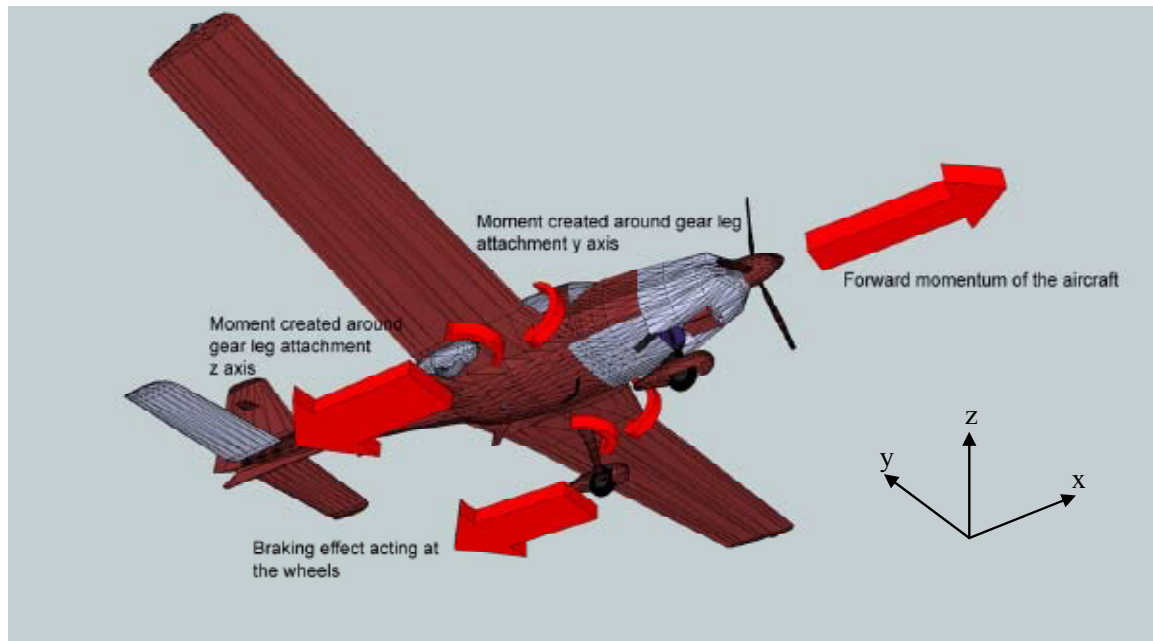
Figure 4

When the brakes were applied during the avoiding action, both the wheels locked causing the aircraft to skid. The momentum of the aircraft effectively acting through the aircraft's centre of gravity and the effect of the locked brakes at the level of the wheels/tyres, produced moments around the gear leg attachment points in both the vertical and horizontal planes (Figure 4). These were transmitted into shear loads on the adhesive bonds locating the gear ribs. The adhesive bonds failed and the ribs separated from the spar and wing skins around a section of their circumference, with the ribs flexing outwards and downwards. This caused the rib and web to crack at the point where it kinks to meet the root rib. It also caused associated flexing and cracking of the lower wing skin, as it became a secondary path for the loads. Loss of the rigid location of the landing gear meant the deceleration loads could no longer be transferred to the primary aircraft structure, compromising stopping distance and the ability of the pilot to control the aircraft.

Illustration of loads acting on the aircraft
