SS Richard Montgomery

Survey Report

2010

Maritime & Coastguard Agency
May 2012

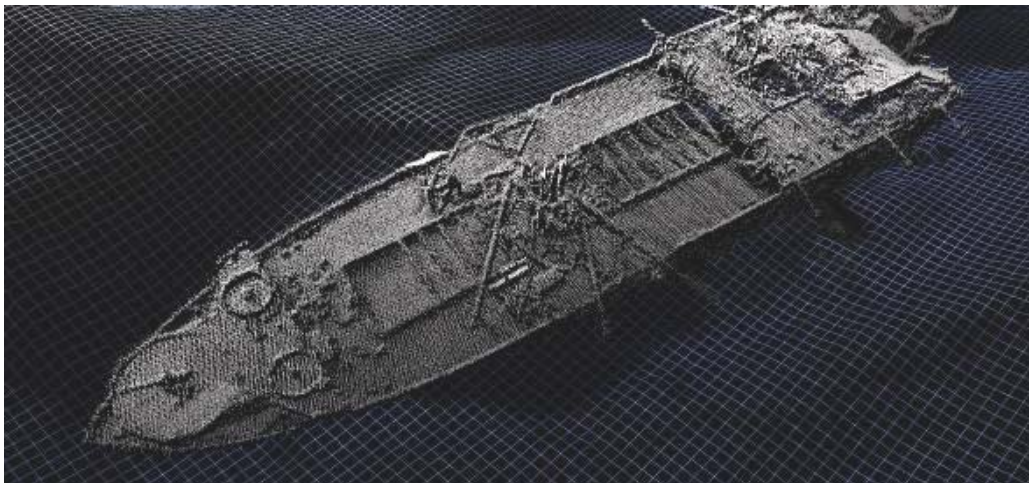
Fig. 4 SS Richard Montgomery stern section

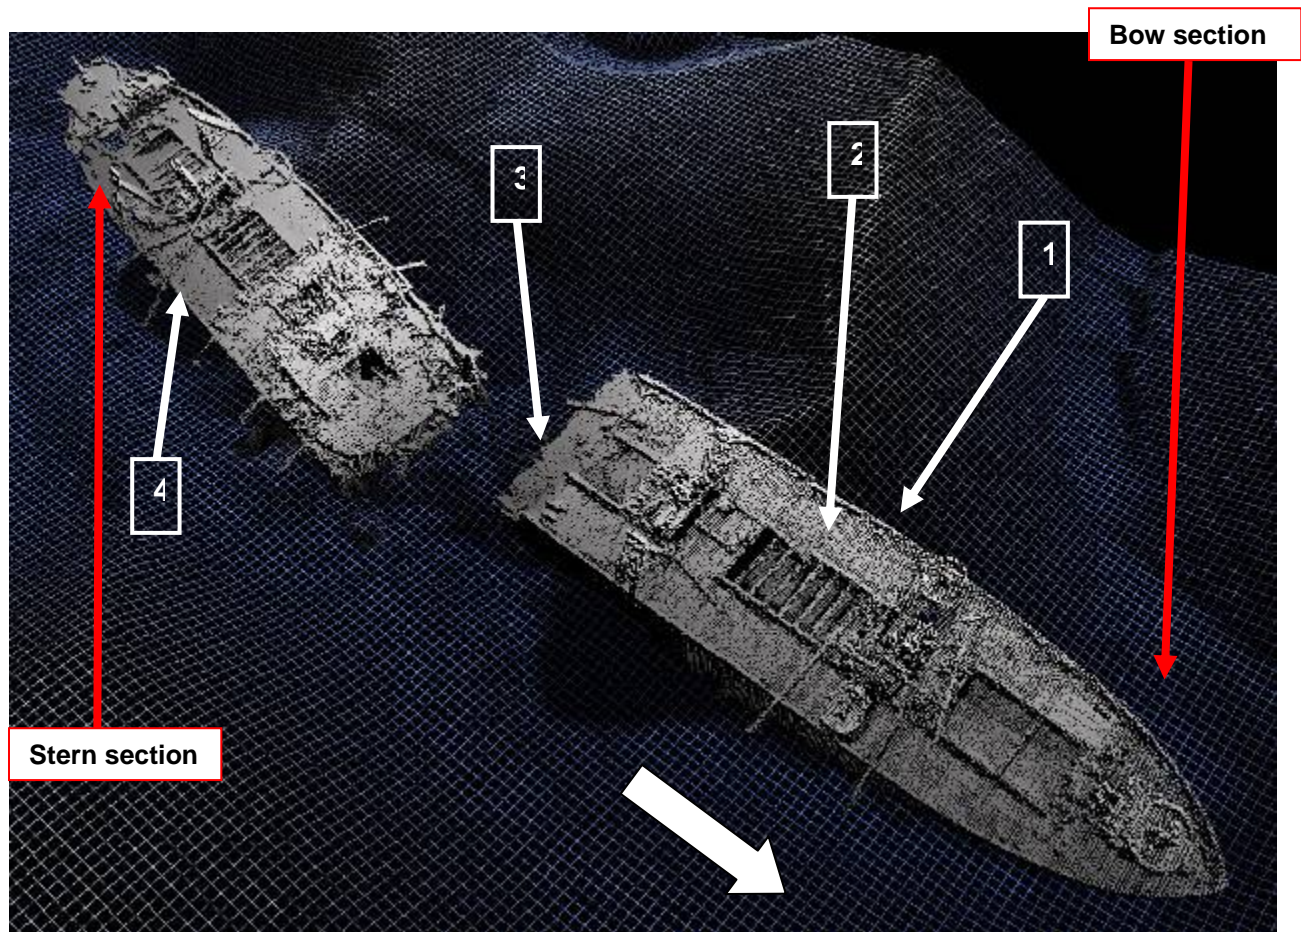
1. the crack in the hull at hold 2
2. the drop in deck plating above hold 2
3. holes in the bulkhead aft of hold 3
4. crack in the hull plating on the starboard side of hold 4

Fig. 5 - SS Richard Montgomery Overview with locations of key areas numbered.
