CONTENTS

SPECIAL BULLETINS

(ALL TIMES IN THIS BULLETIN ARE UTC)

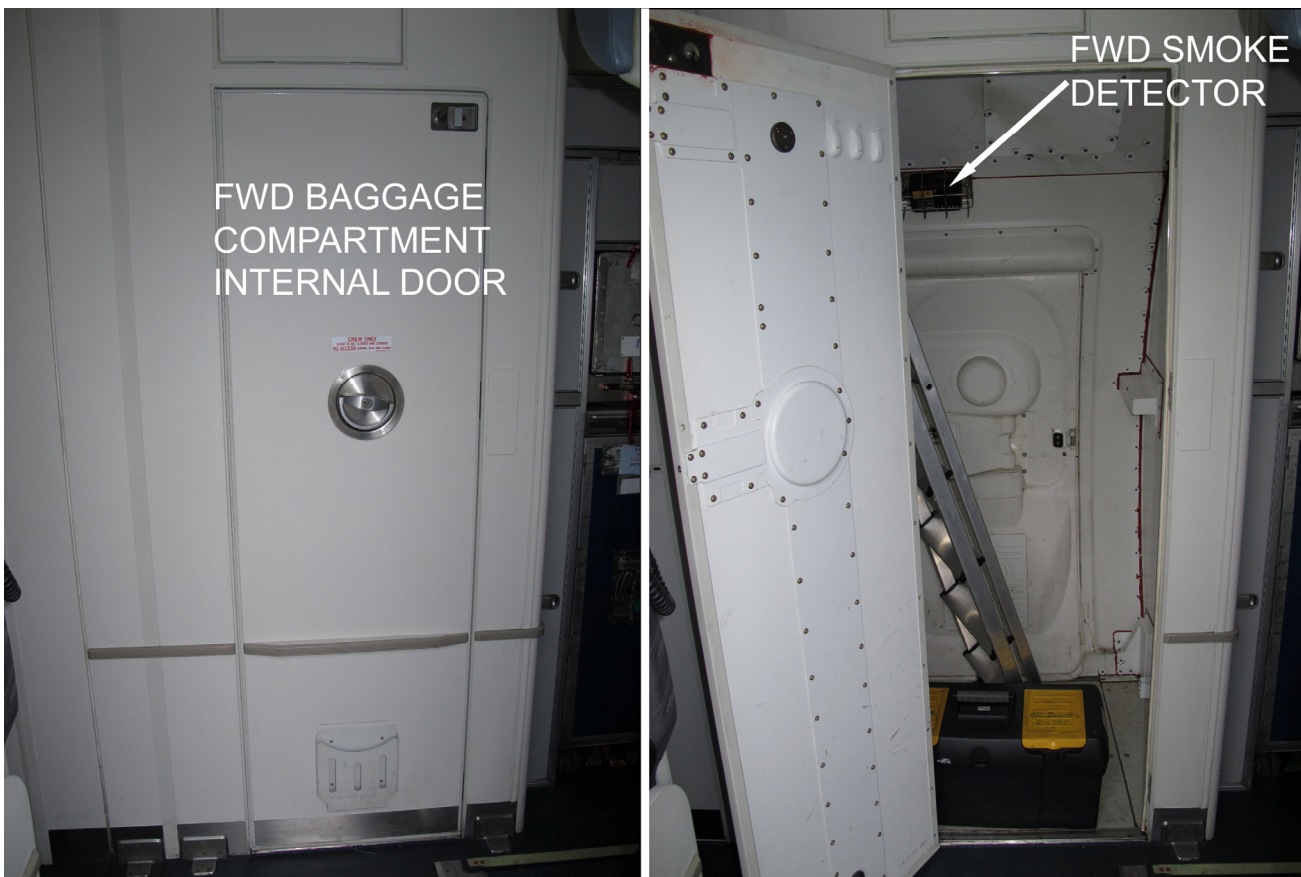
Figure 2

Forward baggage compartment with its internal door closed (left) and door open (right)

The forward baggage compartment smoke detector is mounted above the external door and is protected by a wire cage (Figures 2 and 4). The smoke detector contains a photo-electric sensor which detects a change in light beam intensity when smoke passes through it.

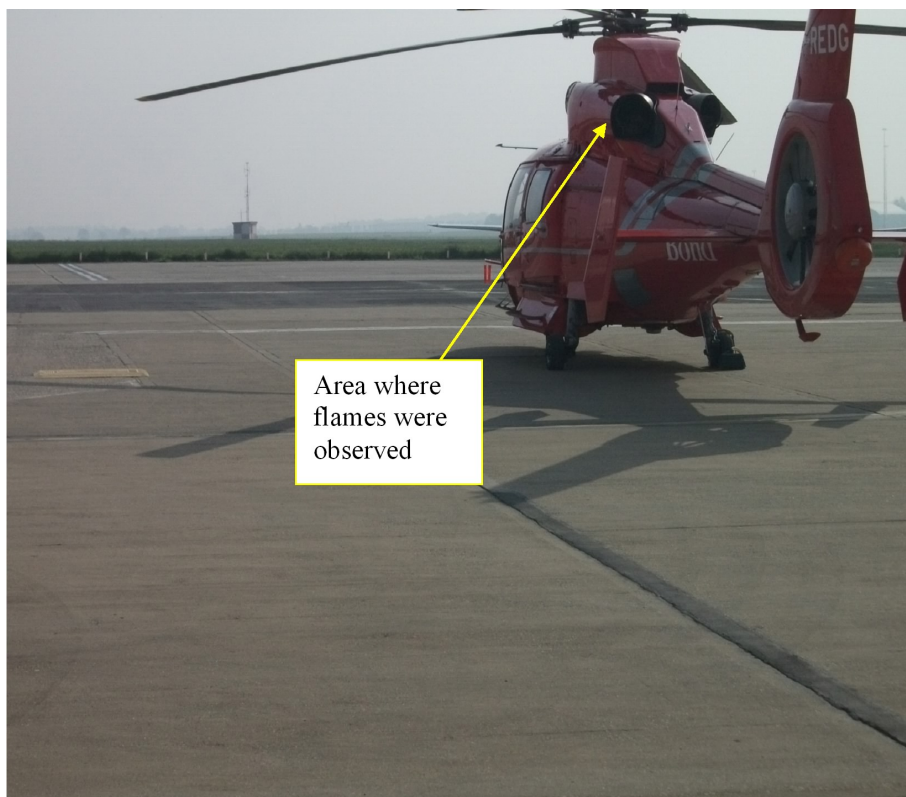
Figure 2

The engineer reported that as the helicopter taxied away, he observed flames coming from the 7 to 11 o'clock position on the No 1 (left) engine, between the engine and the engine cowling (Figure 2). He did not recollect seeing any smoke at this time. The engineer informed the operator's base manager, who was also in the operations room, to contact the flight crew by radio and tell them to shut the engines down. The base manager attempted to contact the crew but was unsuccessful.

View of the helicopter from the operations room (helicopter pointing east)

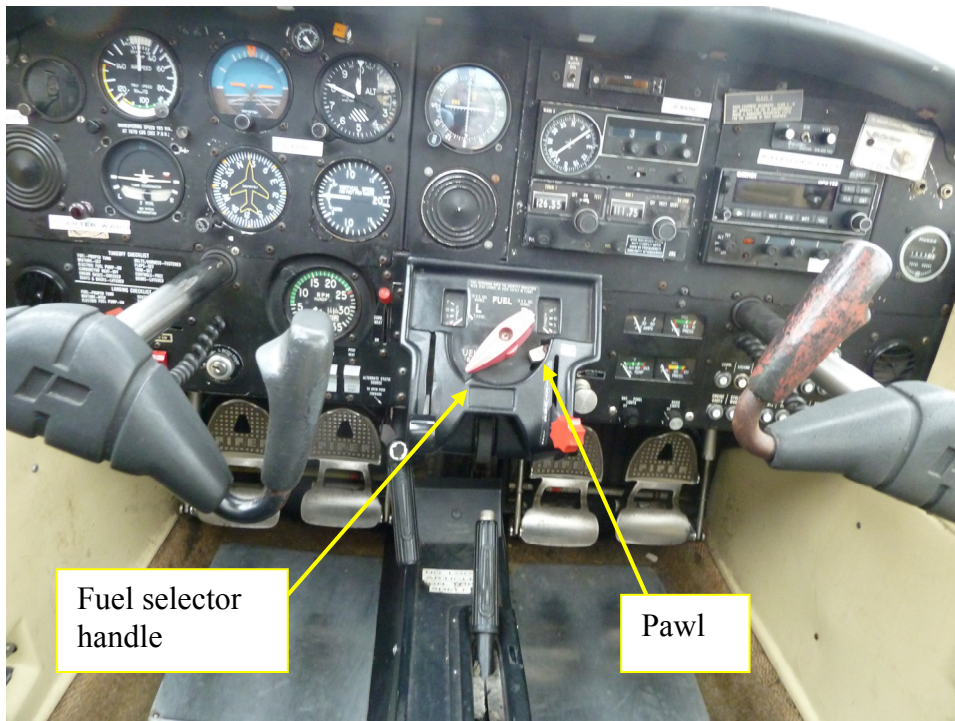
Figure 1
Fuel selector handle in the OFF position

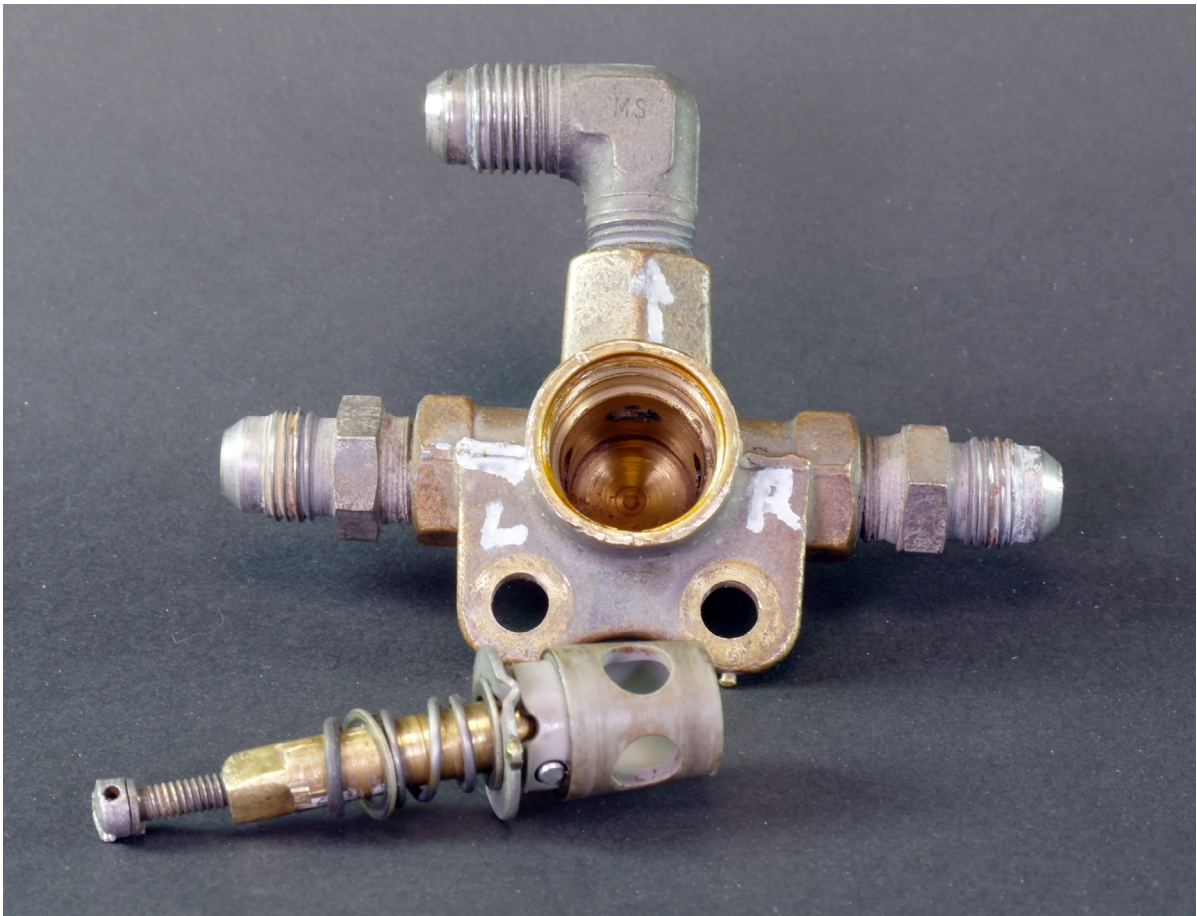
Figure 2

tank and one which passes through the firewall to deliver fuel to the engine. The stem of the valve is attached to a plastic plug with two holes in it, which rotates within the body of the valve. When the valve is in the OFF position the plug blanks off the engine delivery pipe. When the plug is rotated to select the left tank, the holes line up with the pipe from the left tank and the engine delivery pipe to allow the fuel to flow. Similarly when rotated again to select the right tank, the holes line up with the engine delivery pipe and the pipe from the right fuel tank. The top of the plug has four recesses aligned in a cross shape. Above this is a spring-loaded, non-rotating washer with a ridge across its diameter. In each of the defined positions of the valve, the ridge in the washer slots into the recesses on the plug, providing a positive detent to give tactile feedback that the holes in the plug are correctly orientated with the feed and exit pipes (see Figure 2).

Fuel selector valve (valve cap removed)
