CONTENTS

AAIB FIELD INVESTIGATIONS

Bolkow 208C Junior	D-EGFU	02-Sep-11	3
Cessna T210N	XB-LLD	14-Nov-11	13
YAK-52	RA-3585K	28-Apr-11	21

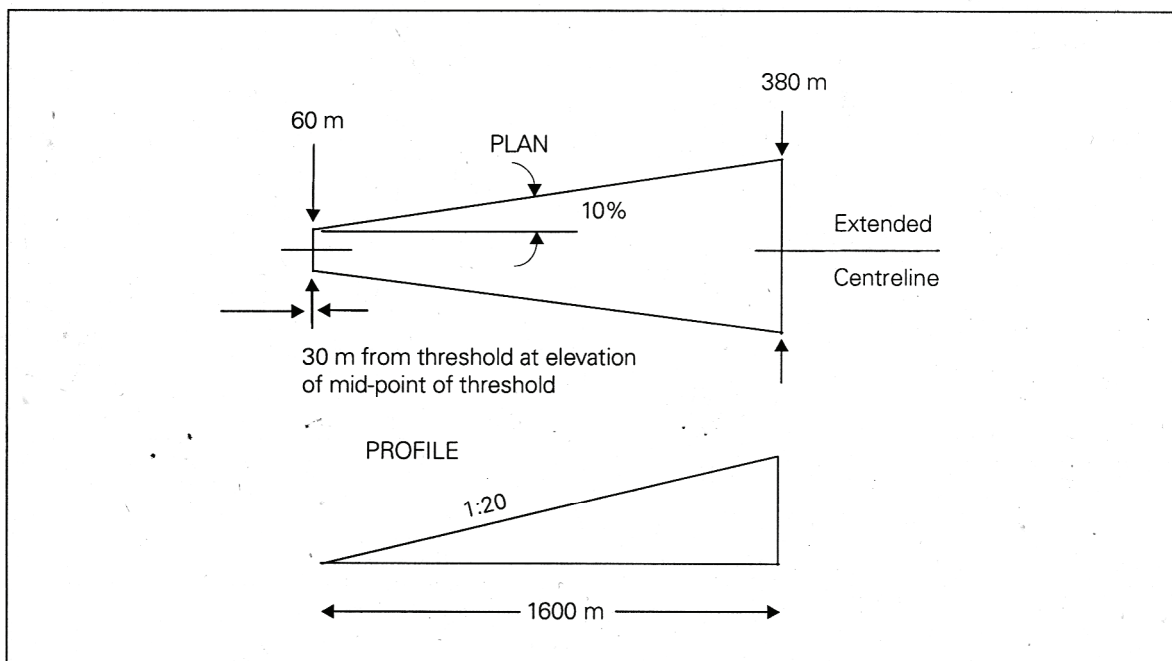
Figure 4 illustrates the obstacle limitation surface as defined in CAP 168 for the category of runway appropriate to Runway 24 at Sibson.

Figure 4.10 Approach surface associated with a non-instrument runway where the code number is 1
