CONTENTS

COMMERCIAL AIR TRANSPORT

List of recent aircraft accident reports issued by the AAIB 112
(ALL TIMES IN THIS BULLETIN ARE UTC)

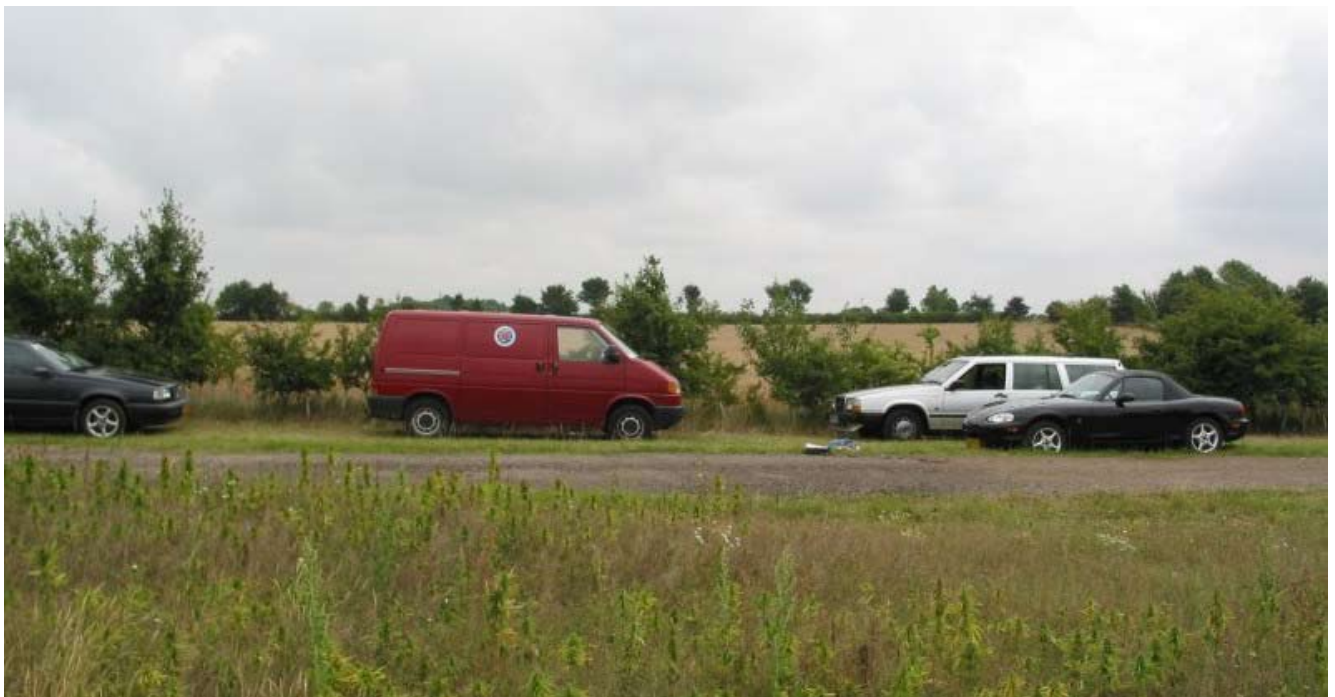
Figure 2

View looking east of vehicles parked in the lane

The vehicles parked in the lane where the accident occurred were largely hidden by the trees of the hedgerow from the view of the low-flying glider pilots crossing the field leading up to the lane (as shown in Figure 2). However, the spectators standing on the vehicles should have been visible to the glider pilots although they would not necessarily have been particularly conspicuous. On the other hand, as some video recordings showed, the spectators standing on their vehicles could be seen clearly by people on the airfield standing close to the finishing line. The white clothing of one spectator made that person very conspicuous. The lane was a place where, at the time of the accident, the race organisers attempted no control or influence over the presence of people. It would seem that those in authority were either unaware of these people or were content to tolerate their presence. Nevertheless, during subsequent race days at Husbands Bosworth, the competition officials wisely positioned a member of staff at the entrance to the lane to discourage people from standing there.

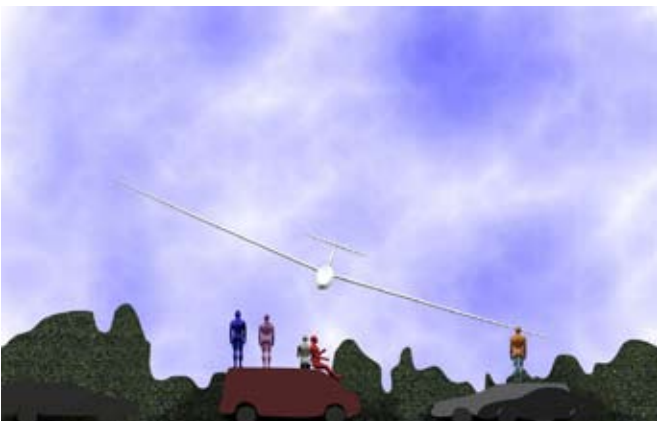
From examination of the accident site and the glider, it was apparent that the photographer had been struck by the leading edge of the left wing. The damage to the glider's left wing indicated that the strike occurred about 3 ft inboard of the left wing tip. Using this evidence, together with video recordings (described in detail below), it was found that the manoeuvring glider was banked at least 20° to the left when it struck the photographer. The height of the glider fuselage at this point was estimated to be about 15 ft agl (see Figure 4a). Had the glider been in a wings-level attitude at a height of 15 ft agl, it would have cleared all of the obstacles and the spectators (see Figure 4b).

Figure 4a
Impact banked

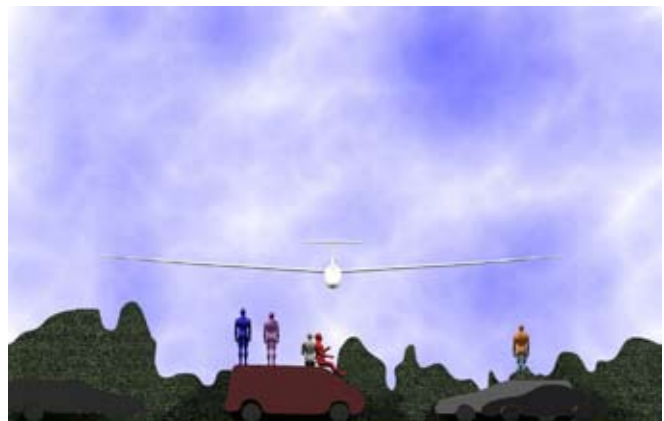
Figure 4b
Glider wings-level at 15 ft agl

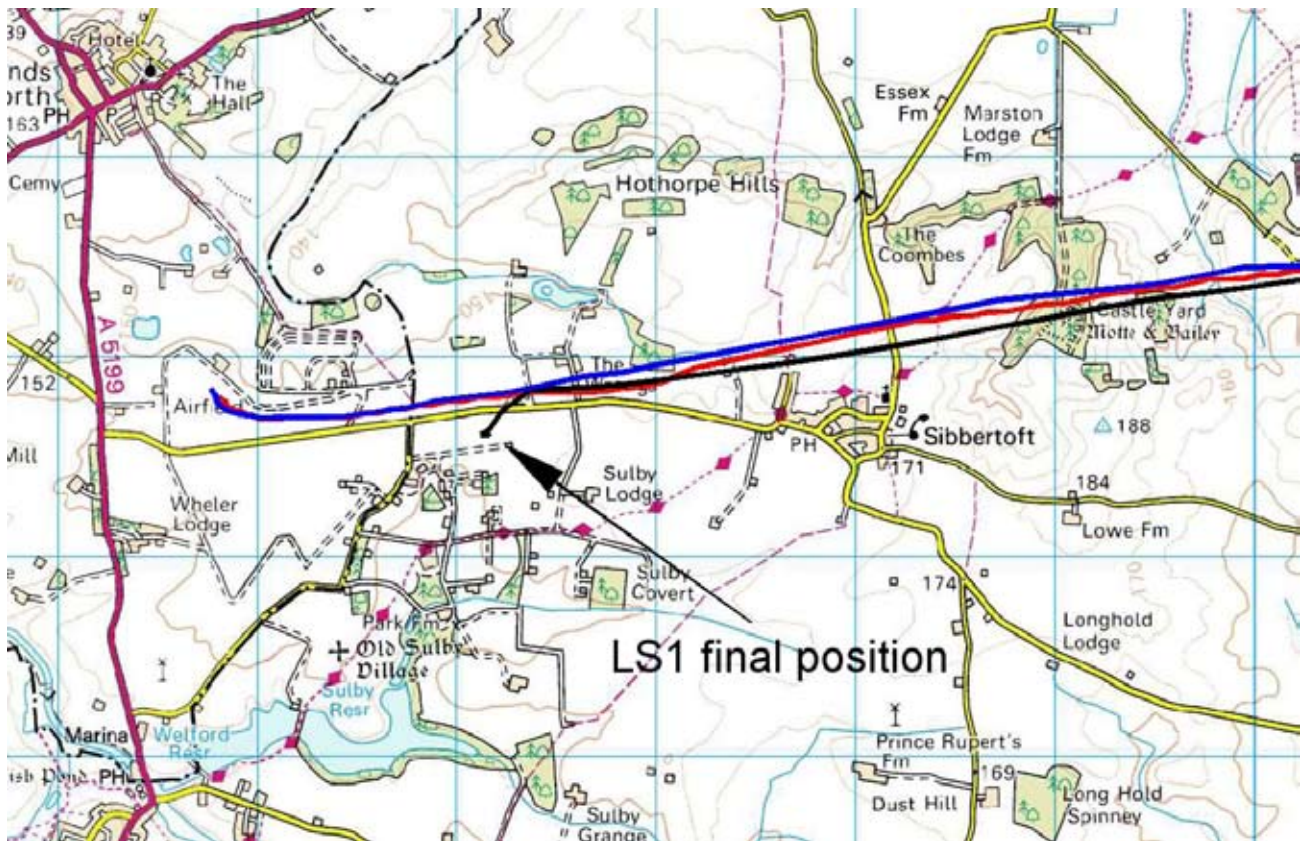
Figure 5

Using the recorded data, a plot was created of the accident glider's track and that of the two preceding gliders as they approached the airfield (Figure 5).

Ground tracks of gliders approaching the airfield

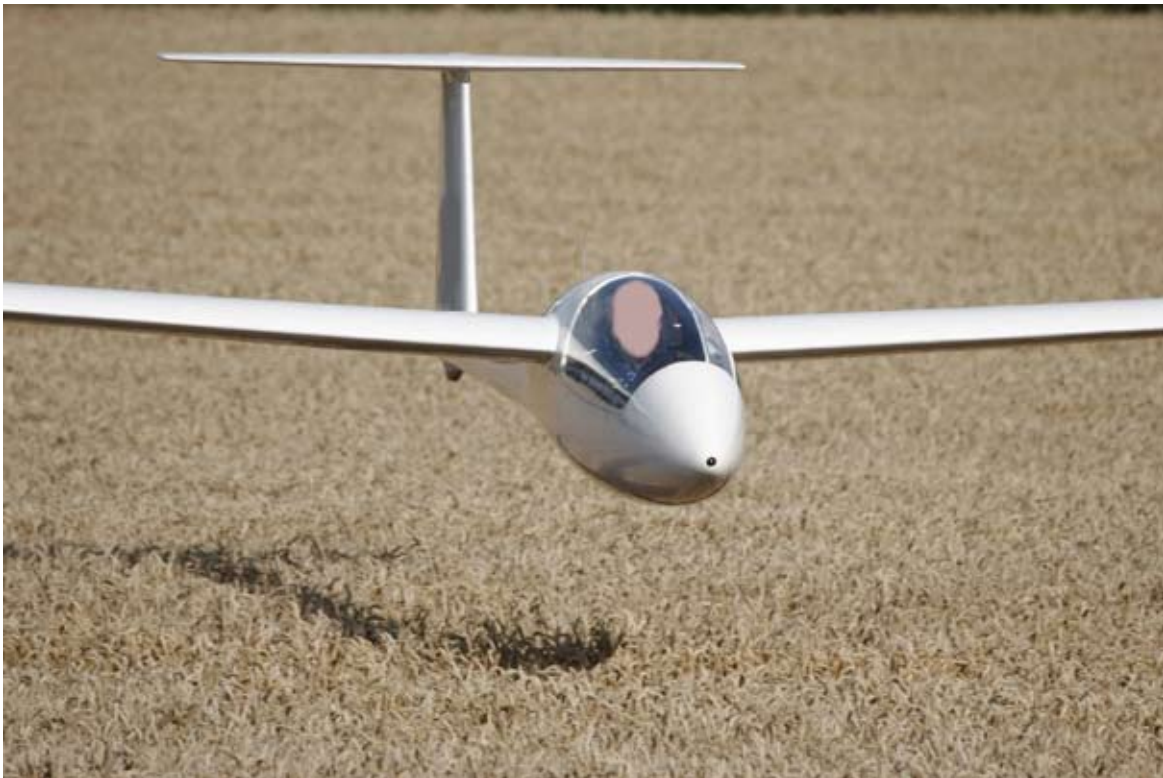
Figure 6

The last two photographs on the photographer's camera are of the glider that struck him. These, together with other video imagery, showed that he had the camera up to

Photograph of an approaching glider

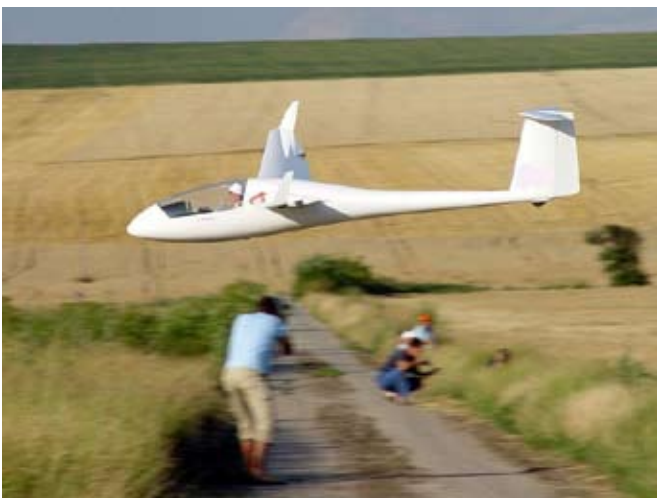
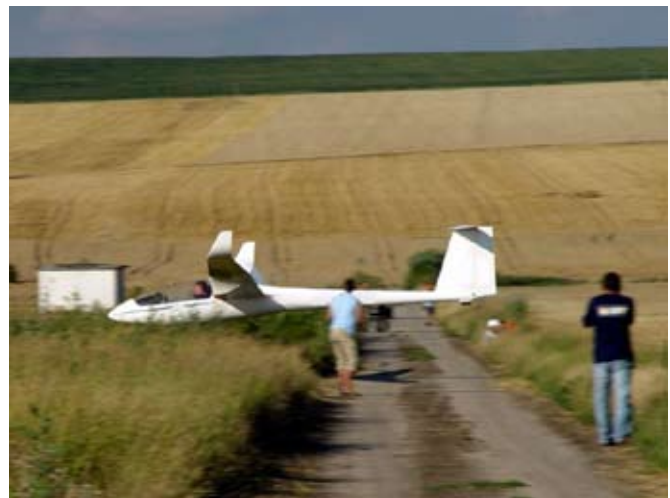
On the day of the accident, no attempt was made to control or influence the presence of spectators beneath the final approach path. Moreover, evidence was found of low flying in close proximity to people during the final approach phase of other international competitions. For instance, photographs published on the Internet of the 2005 FAI European Championships held overseas show spectators close to gliders in the late stages of the final glide to the finishing line. Two examples are shown in Figures 8 and 9 below; the gliders and their pilots in these examples have been deliberately disidentified.

Glider and spectators

This accident and the photographs at Figures 8 and 9 demonstrate that there is a tendency for spectators to position themselves deliberately outside the confines of the airfield, where the competition organisers may have no effective authority to exclude them. These people may accept or underestimate the personal risks they take. However, there is also a risk to other people who might not be spectators or not involved in gliding and who happen to pass beneath the final approach path, even though they may be hundreds of metres from the finishing line. To ensure a safe margin of clearance between gliders and people during a competition finish, there appear to be only two options: exclude people from the area beneath the final glide or ensure that gliders do not fly so low that they risk colliding with a person.

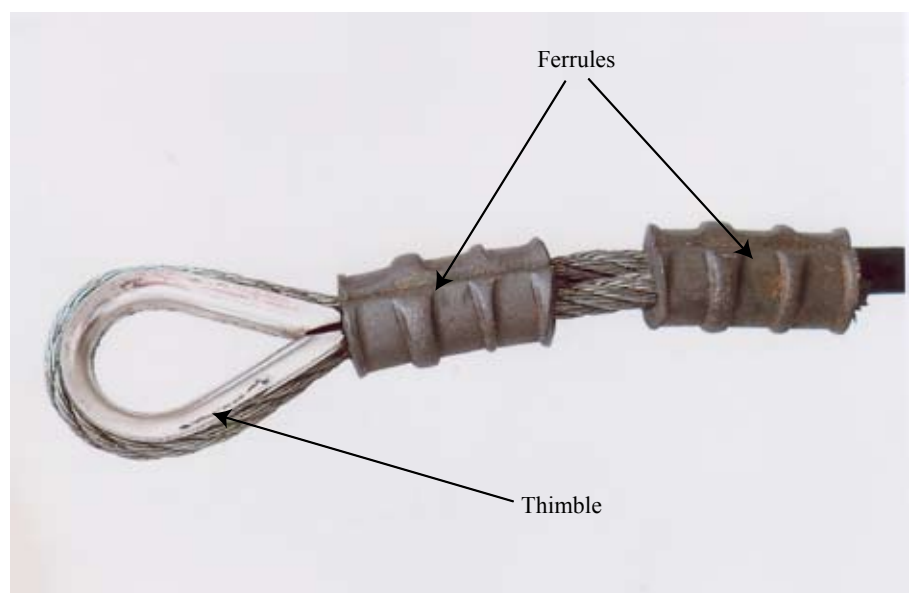
Figure 2

appropriate ferrule, it will fit into the gauge and should guarantee that the copper fitting has flowed closely up against the cable strands and gripped them tightly. A correctly formed joint should be stronger than the cable itself and thus a tensile overload force applied to the cable typically causes failure of the cable adjacent to the joint and not at the joint itself.

Intact swaged joint

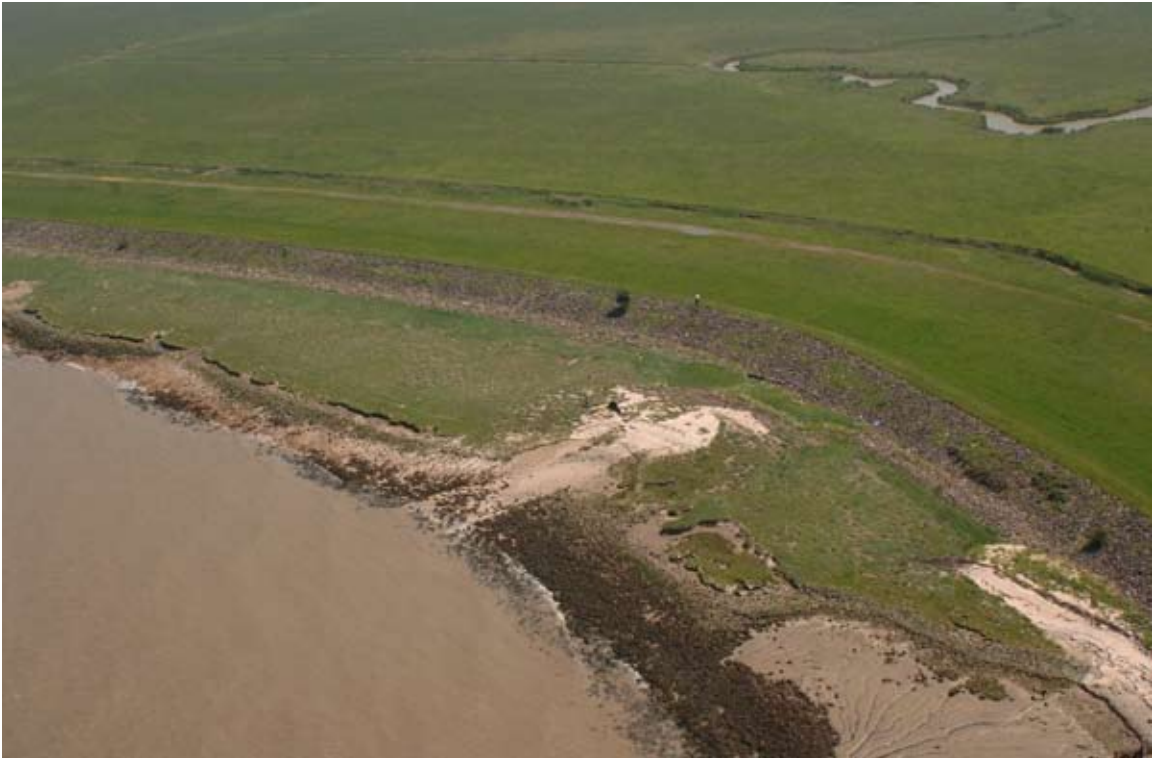
Figure 5

It transpired that the microlight school's chief instructor had almost certainly flown over the accident site during his initial search but the black and yellow upper wing surface and pilot's dark green flying suit made the site relatively inconspicuous from the air (see Figure 5). Manufacturers now use white as the default colour for the upper wing surface but bright clothing and reflective strips would also improve visual conspicuity. Some microlight flying schools advocate the carrying of a switched-on mobile telephone in order to provide a signal for rescue services to use should incapacitation prevent a call being made. This accident demonstrated that a mobile telephone signal alone cannot be relied

upon to guide rescue services directly to the accident site. An alternative and more accurate method would be to use a personal locator beacon. However, their use does depend on positive initiation of the beacon which may not be possible if the occupant is incapacitated.
