CONTENTS

SPECIAL BULLETINS

COMMERCIAL AIR TRANSPORT

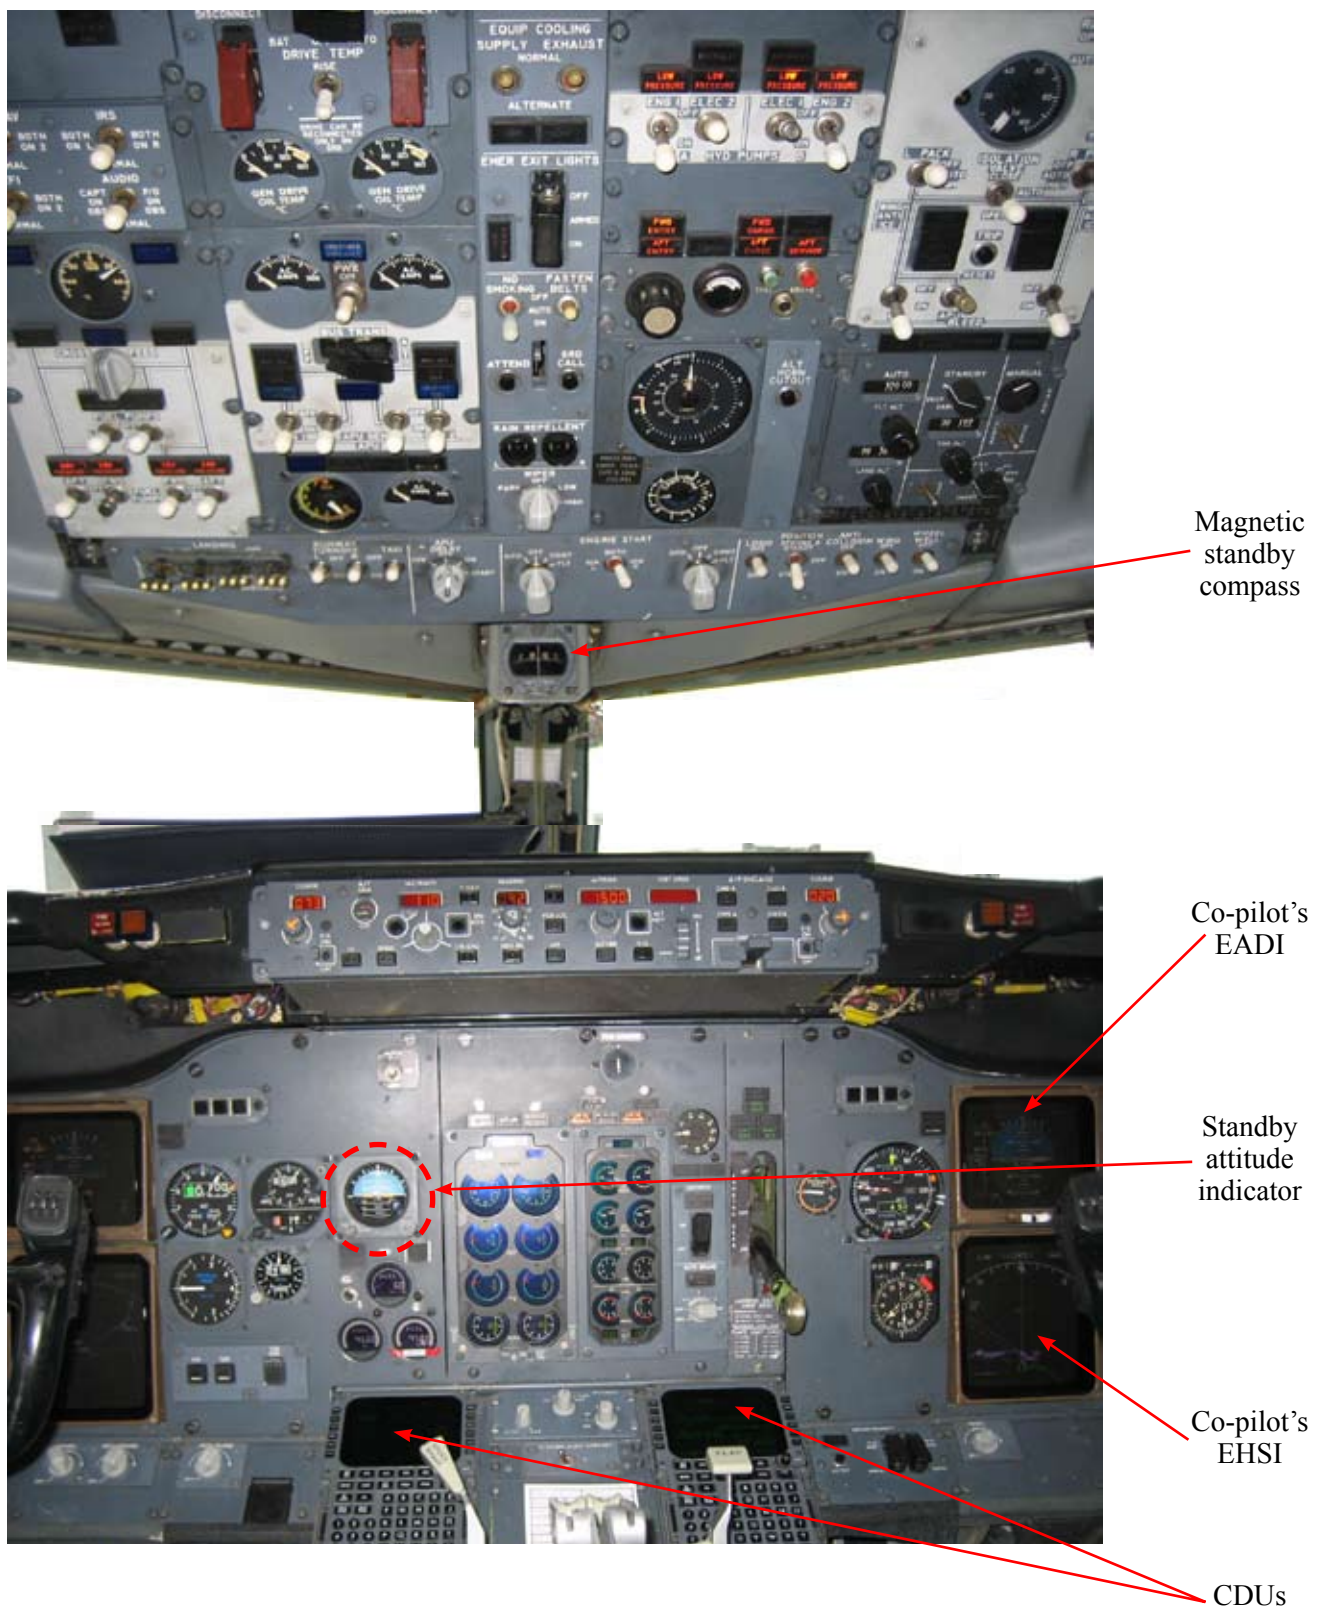
Figure 1
Representation of 'blank' EADI

When the IRSs are in ALIGN mode (IRSs data being NCD), the EFIS displays will show very limited information, Figure 1. For approximately two minutes before LOT 282 took off, the pilots' displays were probably in this condition. As the pilots were busy watching for other traffic and lining the aircraft up on the runway, it is possible neither one looked at the displays during this period. As the aircraft accelerated along the runway, it is likely that the commander's attention would have been focussed on his ASI. It was probably only when the aircraft rotated on takeoff that the co-pilot would have looked down or seen that no attitude or navigational information was available.

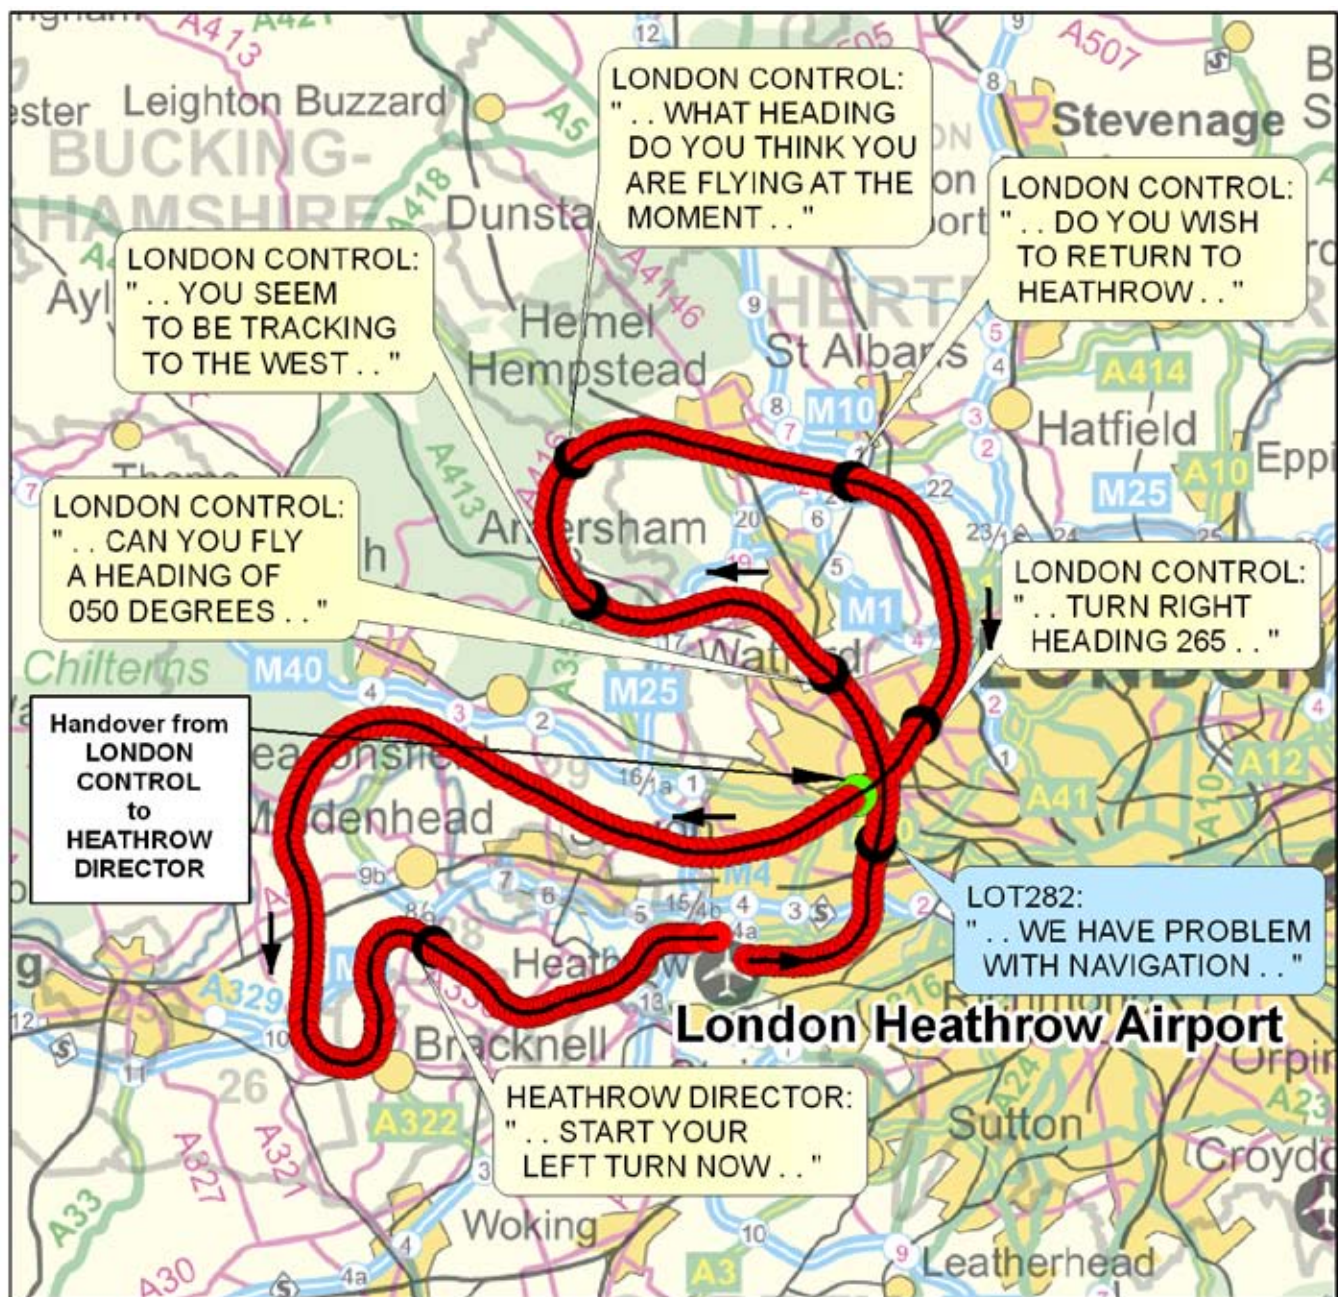
Figure 3

vector the aircraft to the west on a heading of 260°, to allow for an extended final approach track, but the aircraft maintained a heading of south and cut across the localiser course for Runway 09L at 90°. The commander then reported that he had "GLIDESLOPE ONLY, NO DIRECTION". The controller asked the crew to turn left on to a northerly heading, which was achieved, and then on to a heading of 060°, to intercept the localiser. However, the aircraft continued to fly north and again passed through the localiser at 90°; the commander again reported that he had "NO DIRECTION ONLY GLIDESLOPE".

The controller now advised Lot 282 that he would give radar vectors until visual contact with the runway was established. He issued 'start and stop' turn instructions and a further descent clearance. At 1032 hrs, the commander reported "RUNWAY IS THE GROUND IN SIGHT" and was cleared for a visual approach to Runway, 09L. However, the controller noticed that the aircraft continued to track to the south of the airfield and asked the commander to confirm that they were approaching Runway 09L. The commander replied it was not in sight and, a moment later, that he was now visual for Runway 09L. At 1034 hrs, the controller issued a landing clearance for Runway 09L. In

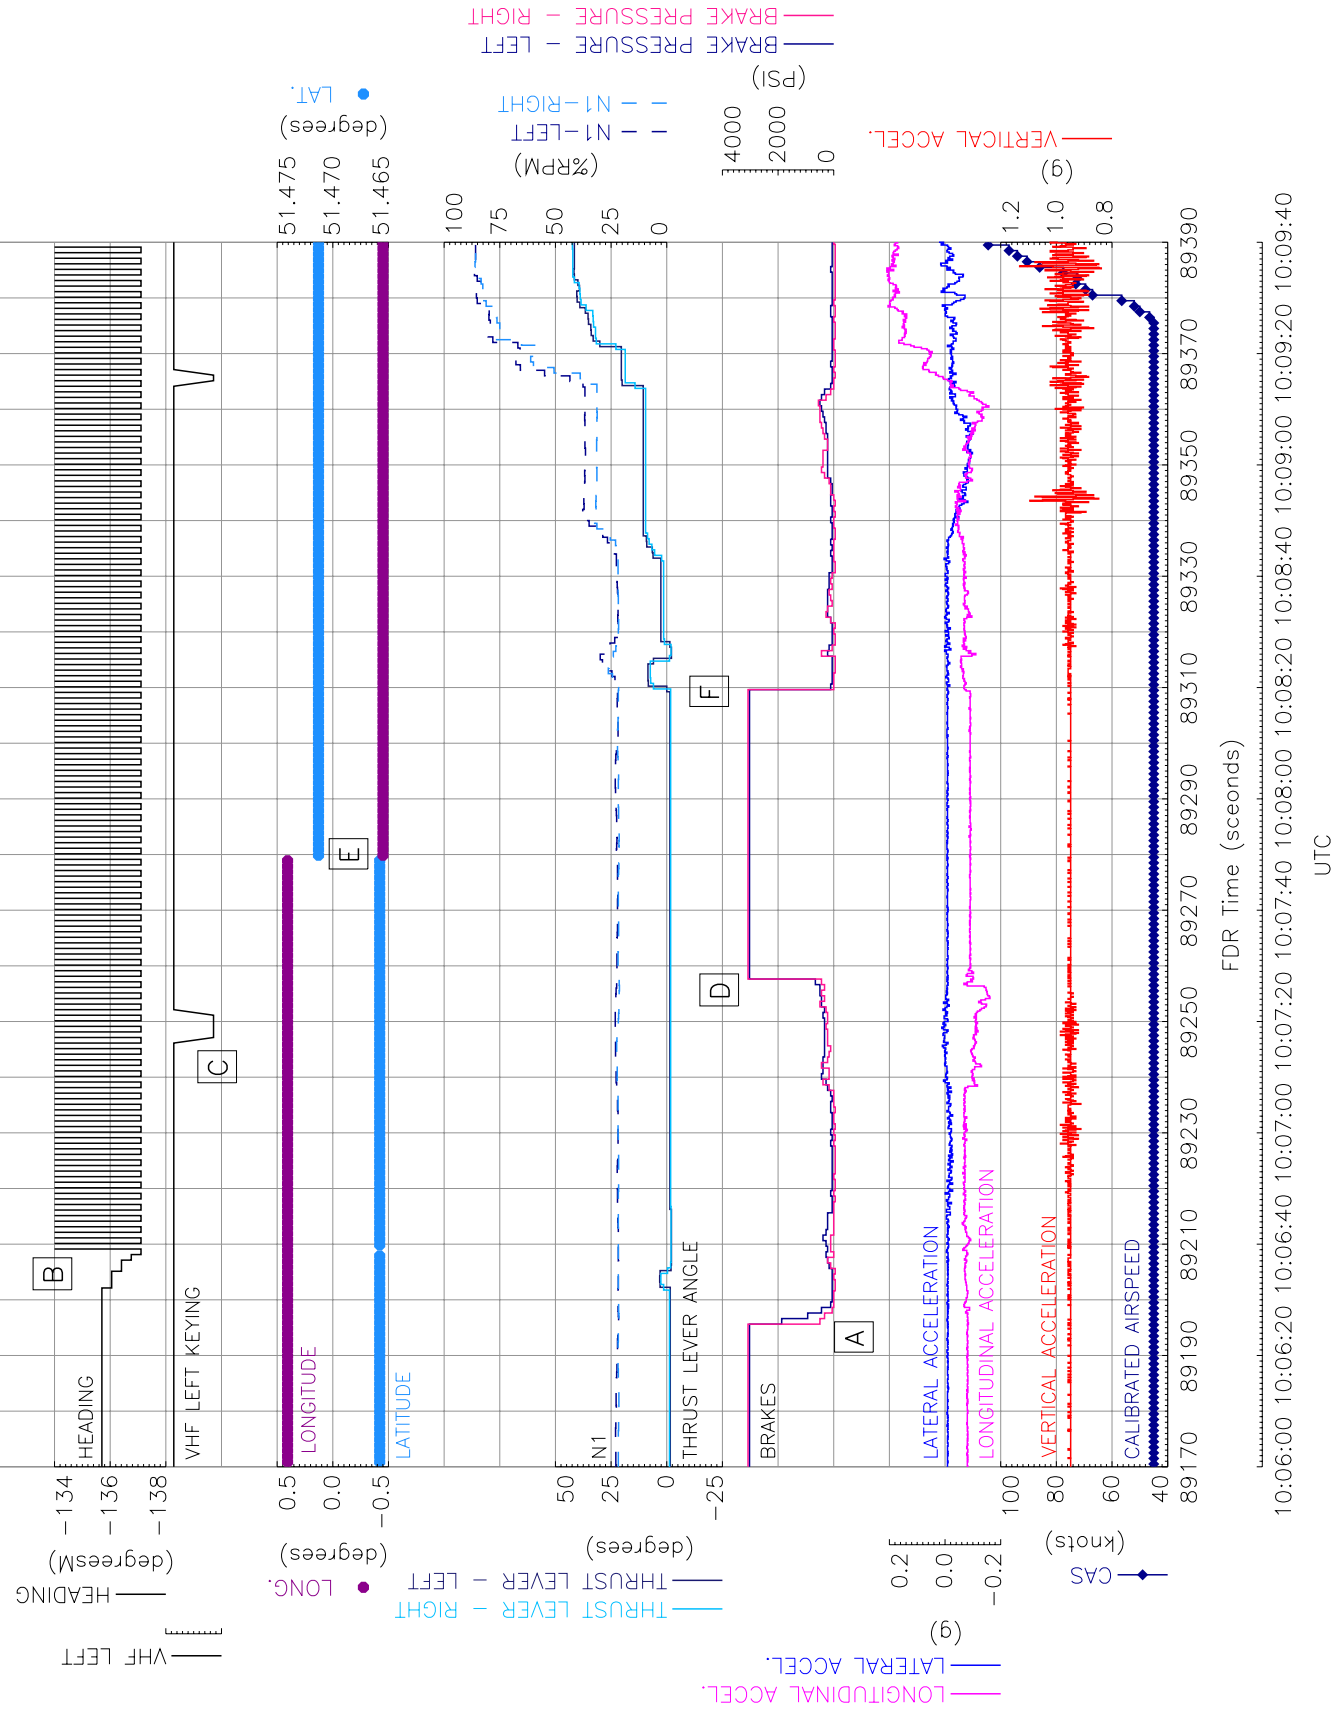
Figure 8
Selected FDR parameters

Figure 8 shows some FDR parameters in detail, starting with the aircraft at the hold. At 10:06:25 hrs **[A]**, the brakes were released and the aircraft moved slowly forward, turning to the left though 224°M before the heading and other IRU sourced parameters became NCD **[B]**. At 10:07:20 hrs, the commander **[C]** transmits a reply to ATC just before reapplying the brakes and stopping at hold NB11 **[D]**. While waiting at this point, the aircraft's position is updated in the FMS **[E]**. This position remains fixed as the brakes are released 30 seconds later **[F]** and the aircraft lines up and takes off from Runway 09R.

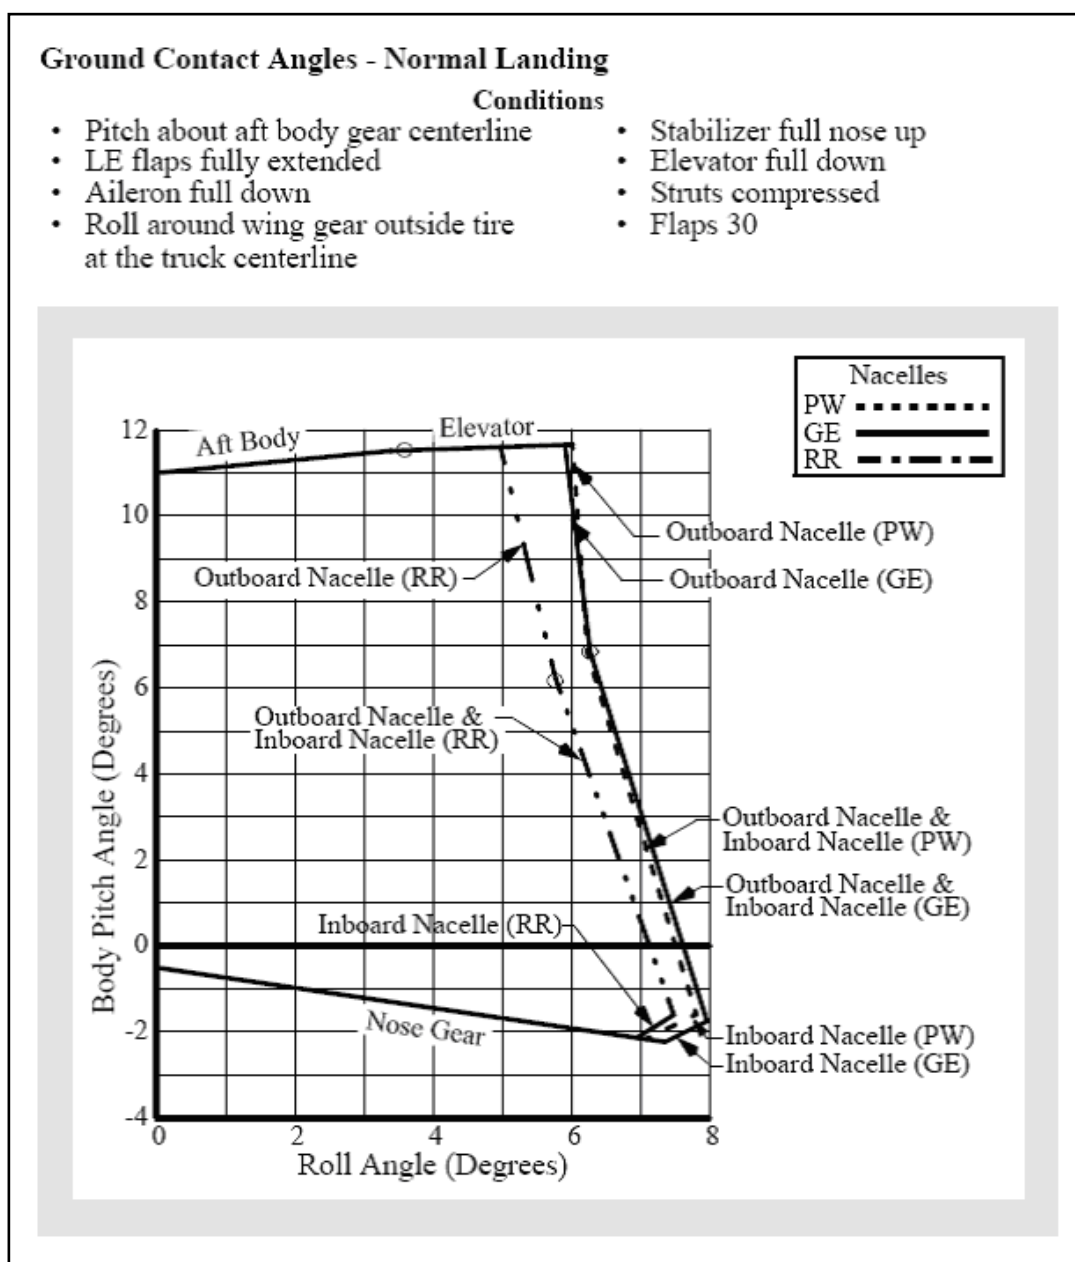
Figure 1

The aircraft attitude required for contact between the engine nacelles and the ground surface during a landing, as advised in the B747-400 FCTM, is shown in Figure 1. The diagram caters for the different makes of engine fitted to the aircraft type ie General Electric (GE), Pratt & Whitney (PW) and Rolls Royce (RR) and is based on a rigid wing, as opposed to one that flexes.

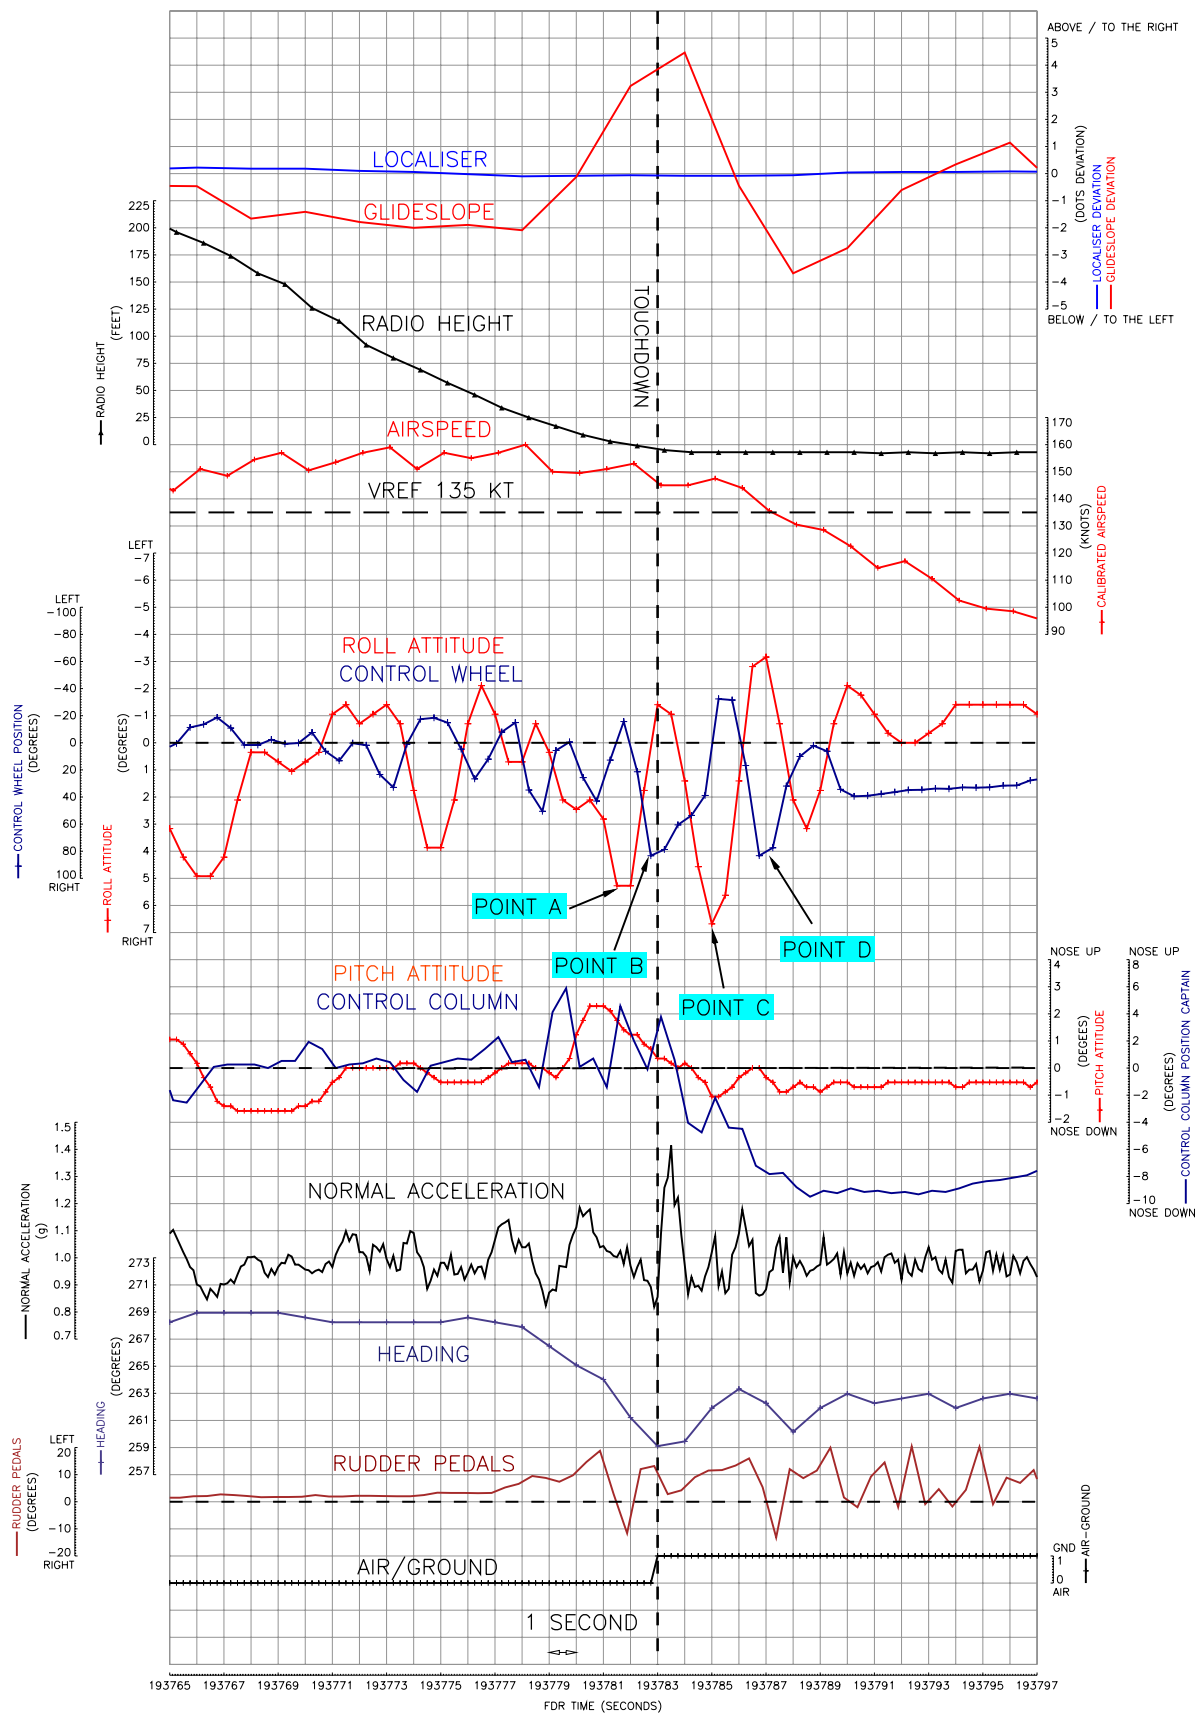
Figure 2
Salient FDR Parameters

The aircraft touched down with a small amount of left bank (1.5°) and at an almost nose level pitch attitude; airspeed was 145 KCAS and the normal acceleration at touchdown was at 1.43 g. The aircraft started to roll quickly to the right and about two seconds after touchdown the bank angle reached 6.7° right wing down (see Figure 2, point C). The pitch attitude was 1° nose down. A left roll was commanded and the aircraft rolled to the left quickly, before another almost full travel deflection of the control wheel to the right (see Figure 2, point D) was made. The aircraft continued in a rocking motion for a few more seconds before the roll attitude stabilised at about 2° left wing down, with right (into wind) control wheel applied.

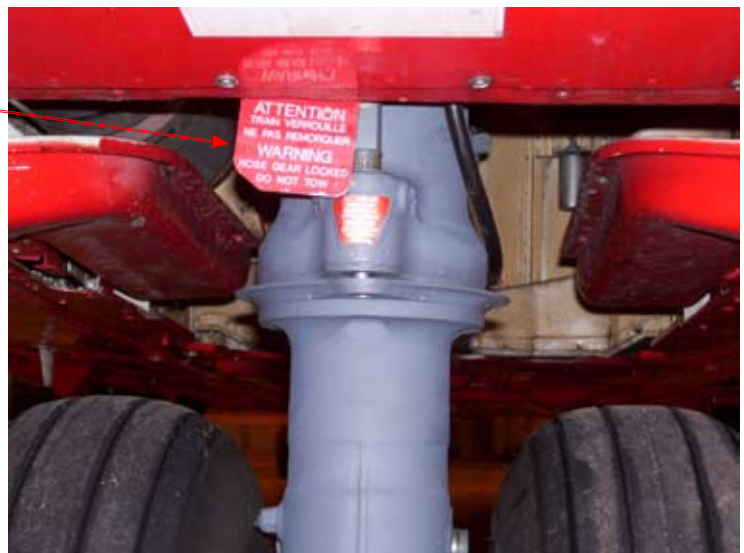
Figure 4 (right)

The nosewheel locking pin is engaged by raising the lever and rotating it to the right (Figure 3), the pin then dropping under spring pressure and entering into a fixed hole on the nosewheel leg when the nosewheel is centred. This also causes a flag (see Figure 4) to drop below the body of the aircraft in front of the wheel indicating the pin has been applied. The flag will drop as soon as the lever is rotated, even if the pin has not engaged into the fixed hole in the nosewheel leg.

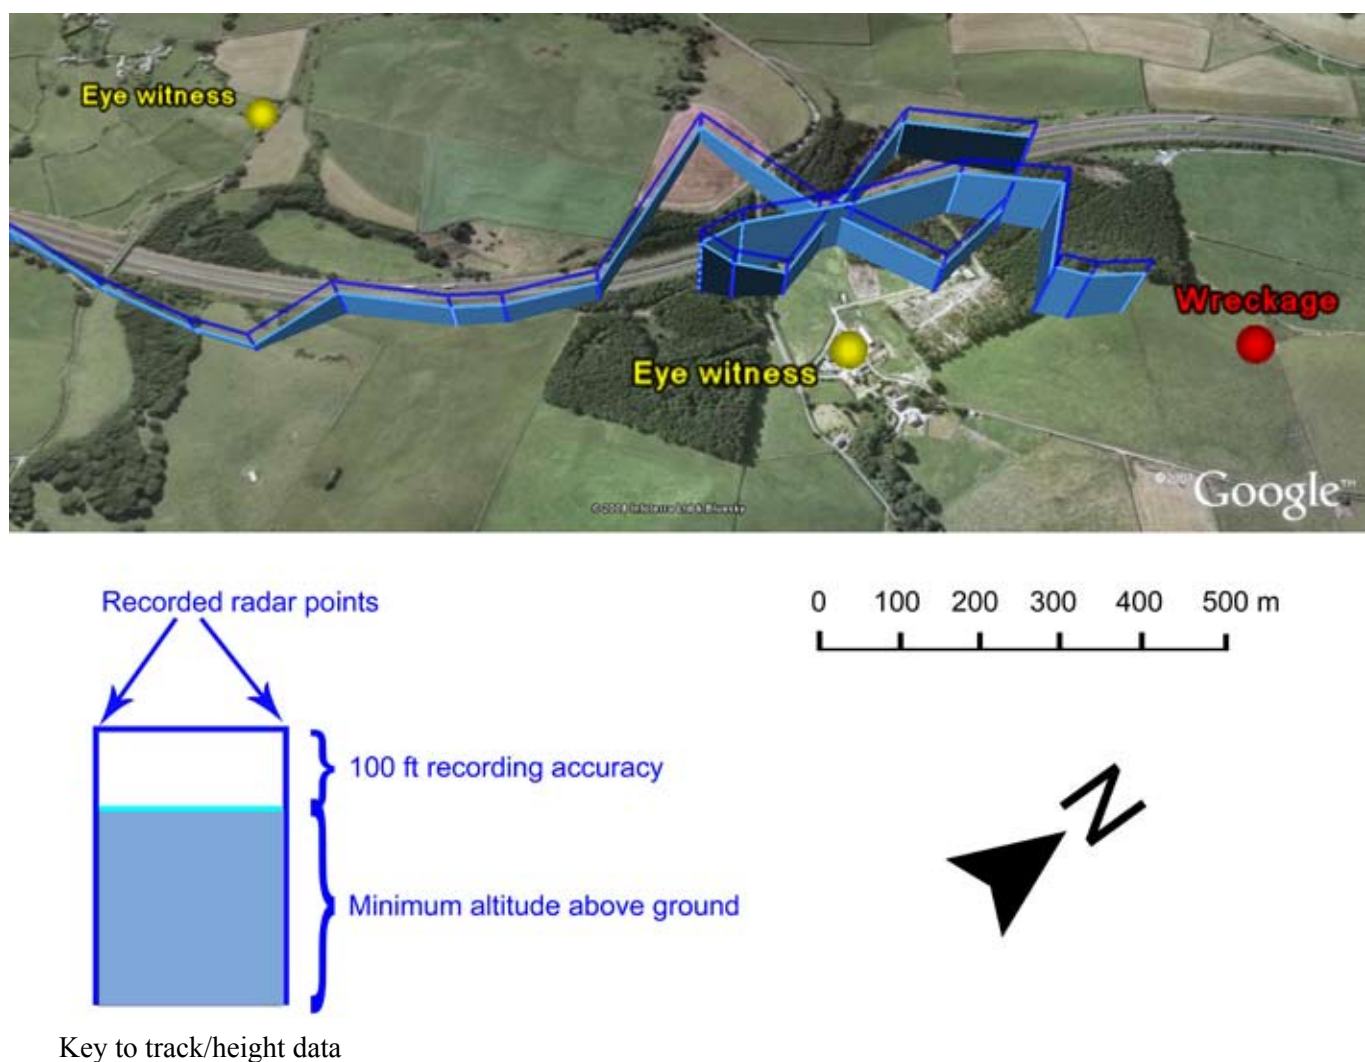
Figure 1

G-OSSI - Track/height plot prior to the accident (Radar Data)
