Aircraft Type and Registration:	Boeing 737-78J, YR-BGF	
No & Type of Engines:	2 CFM 56 - 7B22 turbofan engines	
Year of Manufacture:	2001	
Date & Time (UTC):	4 March 2004 at 1230 hrs	
Location:	Stand 214, London Heathrow Airport	
Type of Flight:	Public Transport (Passenger)	
Persons on Board:	Crew - 8	Passengers - 61
Injuries:	Crew - None	Passengers - None
Nature of Damage:	Damage to top of No 1 engine cowling	
Commander's Licence:	Airline Transport Pilot's Licence	
Commander's Age:	51 years	
Commander's Flying Experience:	17,000 hours (of which 1,900 were on type) Last 90 days - 200 hours Last 28 days - 60 hours	
	Note: the hours provided by the commander are approximate	
Information Source:	AAIB Field Investigation

Aircraft Type and Registration:	Boeing 747-436, G-BNLG	
No & Type of Engines:	4 Rolls-Royce RB211-524G2-19 turbofan engines	
Year of Manufacture:	1989	
Date & Time (UTC):	21 April 2004 at 1002 hrs	
Location:	Stand 127L, London Heathrow Airport	
Type of Flight:	Public Transport (Passenger)	
Persons on Board:	Crew - 18	Passengers - 326
Injuries:	Crew - None	Passengers - None
Nature of Damage:	Puncture to leading edge of port wing above No 2 Engine. No 2 engine damaged b

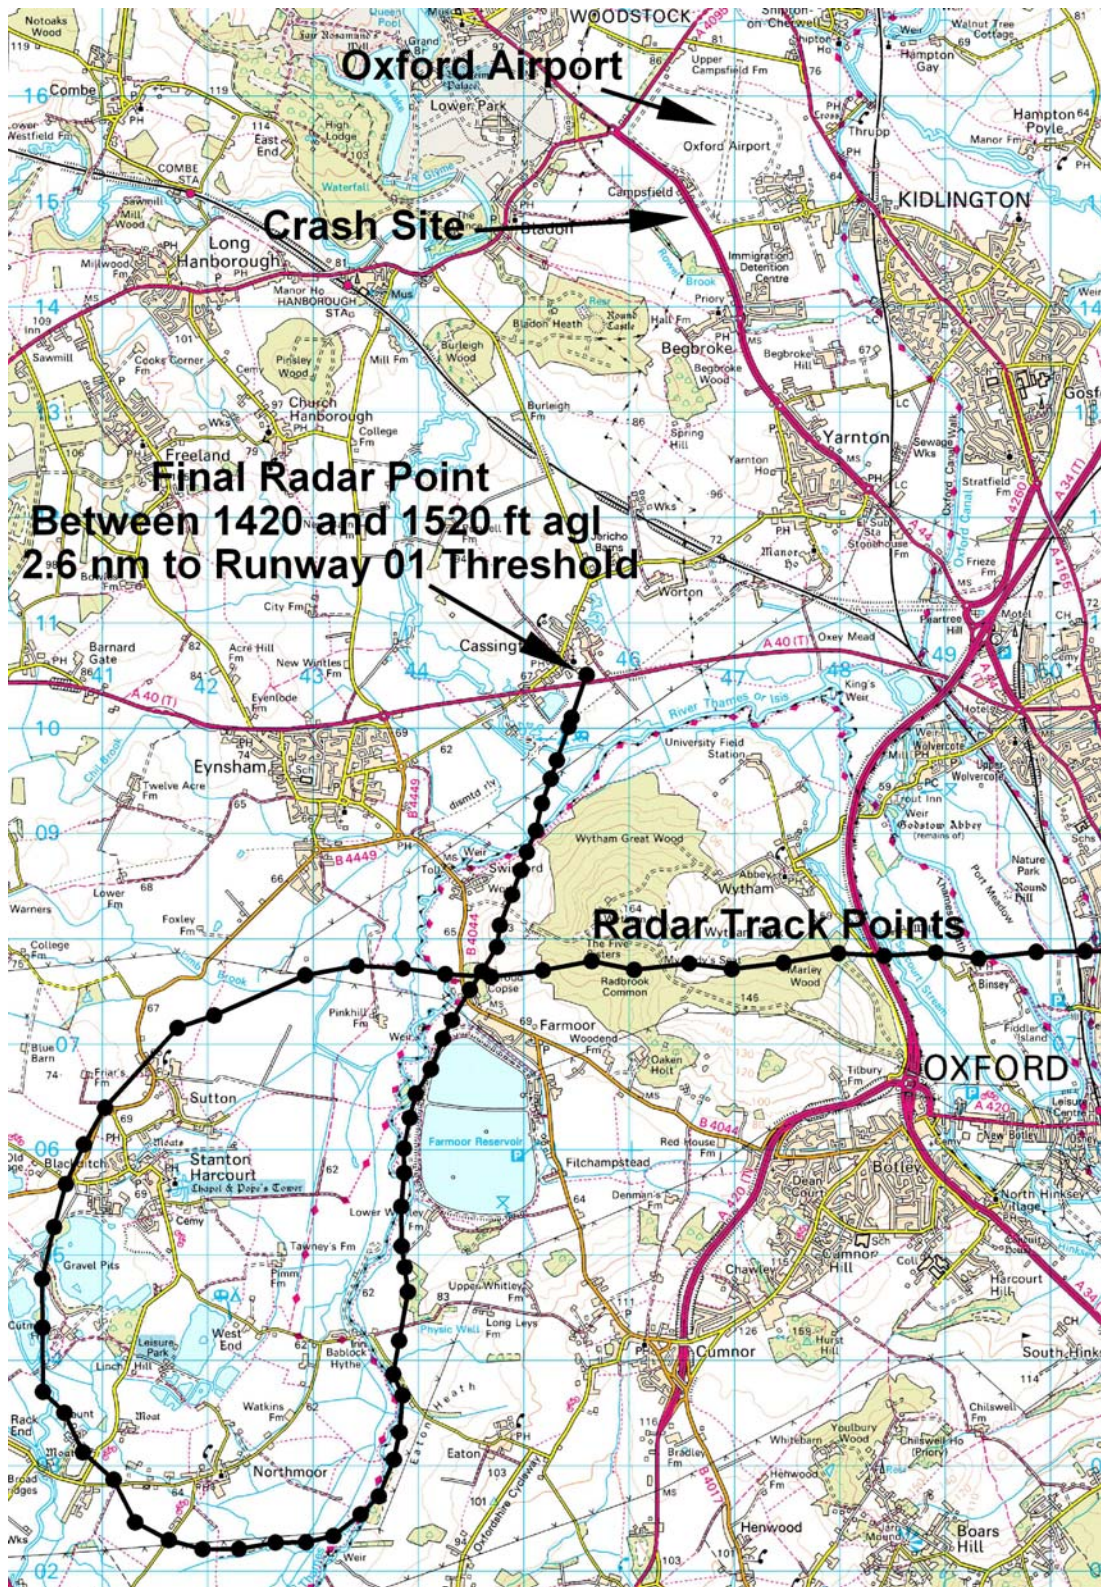
Figure 2

Final radar track of N30LT

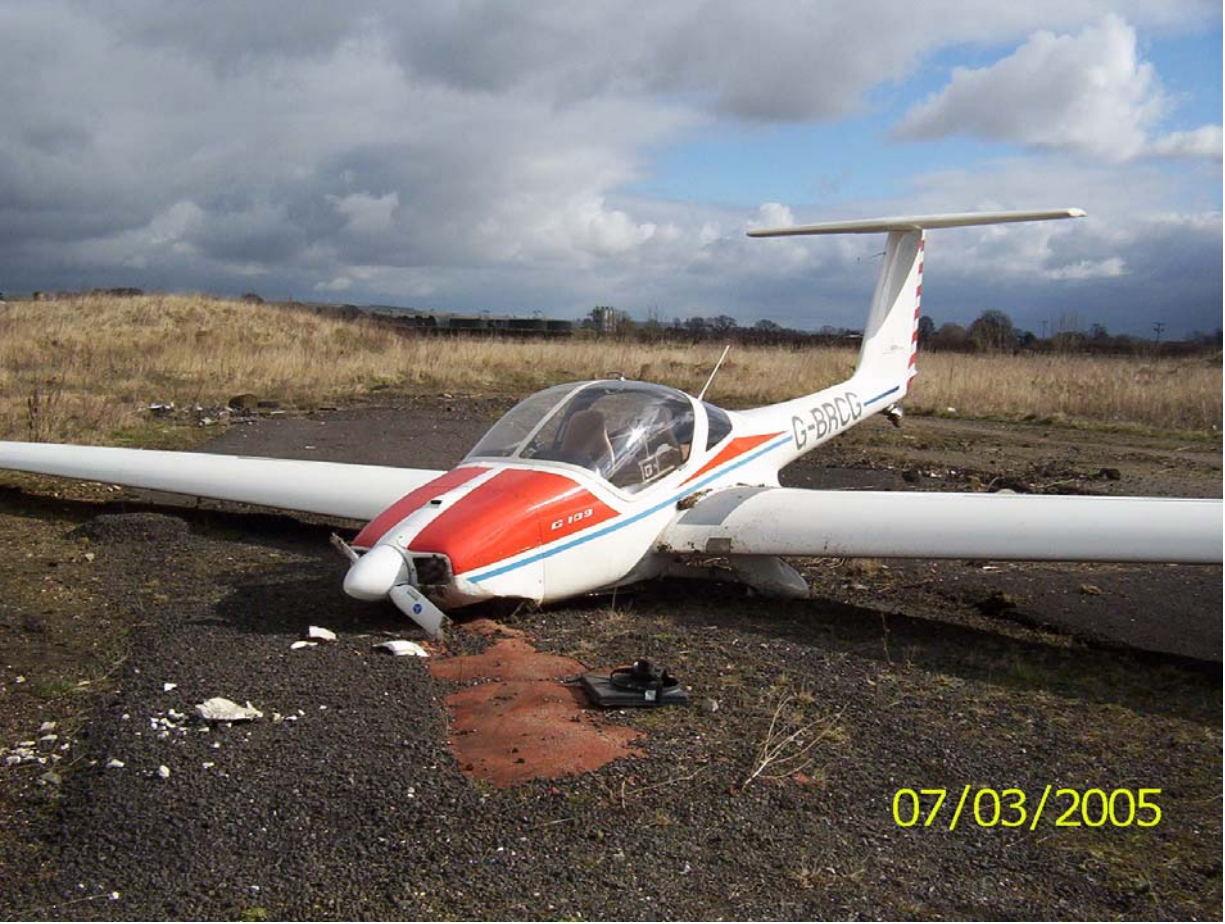
Figure 1

The pilot reported that, in the prevailing wind conditions, a three metre high earth bank, located 20 metres short of the runway threshold, may have created an area of sink. Exposure to this sink was exacerbated by the increased time at low level brought about by the shallower than normal approach angle. The aircraft's high aspect ratio wings are particularly susceptible to loss of lift and subsequent sink can occur very rapidly.

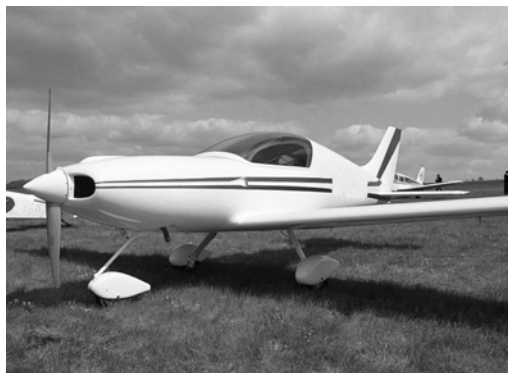
The Pulsar, pictured at right, is a low-wing composite single-seat kitplane operated under a Permit to Fly. The aircraft was on a cross-country flight from Perth to Oban. Ten miles away from Oban the pilot called Oban Radio and requested the airfield information. He did not receive a reply but he heard the wind direction and speed being passed to another aircraft. While at 4,000 feet on the Oban QFE the pilot detected a slight burning smell. He advanced the throttle but the engine did not respond.

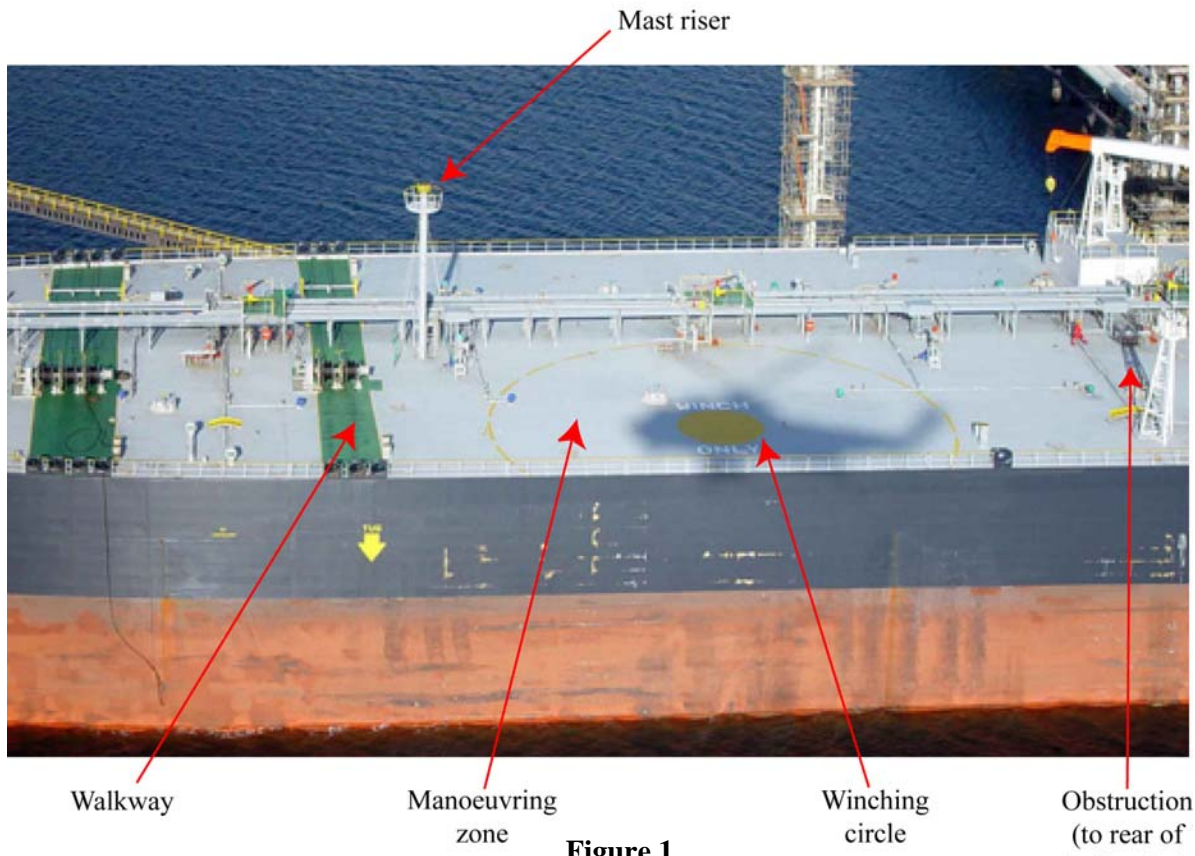
Walkway

Manoeuvring zone

The International Chamber of Shipping should review the deck markings on ships involved in winching operations with the aim of including a requirement to clearly display the dimensions of the 'manoeuvring zone', such that it can be clearly seen by the helicopter crew.

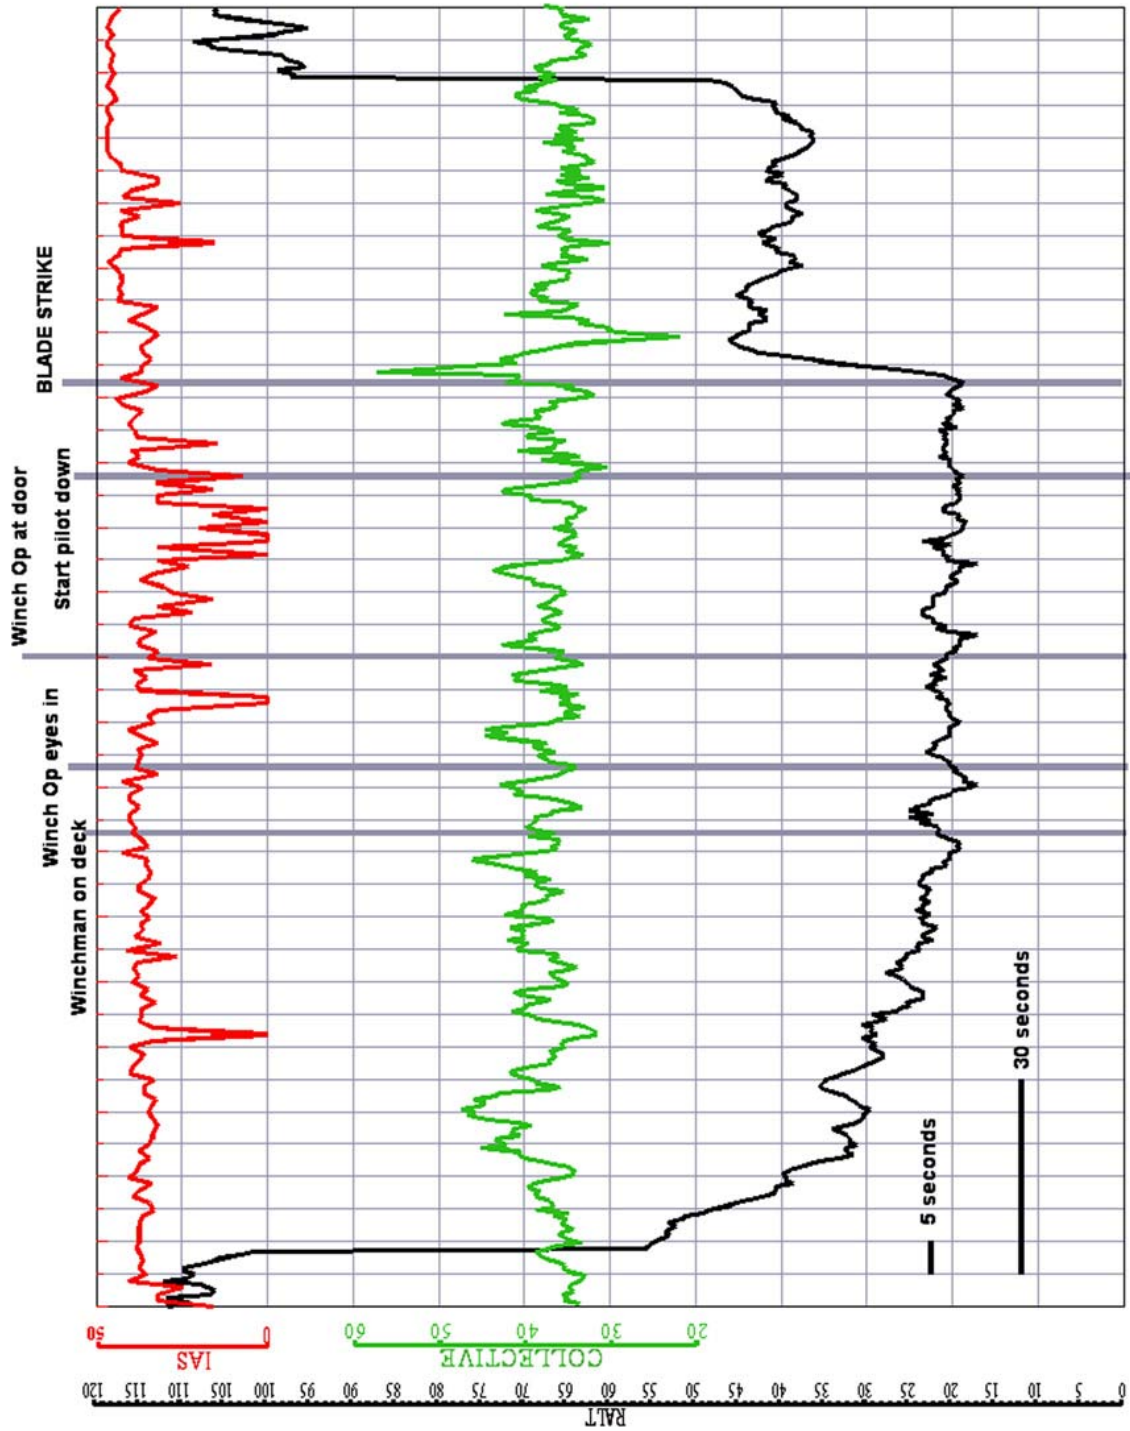
Figure 3
 Relevant FDR parameters and related crew activities

Figure 3 shows relevant FDR parameters together with related crew activities. Given a lack of data pertaining to the ship's movements, the FDR data could not be used to reconstruct the motion of the helicopter relative to the ship except that the radio altitude shows when the helicopter was over the deck of the ship. The radio altitude also indicated that the peak-to-peak wave effect at the time was about five feet. The radio altitude above the deck started at 55 feet and settled to approximately 20 feet after about a minute, holding steady at 20 feet plus/minus wave action for a further minute and a quarter before the blade strike. After the blade strike, the helicopter altitude increased to approximately 45 feet above the deck. Over the next 40 seconds, the helicopter remained over the deck with a slow reduction of mean radio altitude of about five feet. Some 45 seconds after the blade strike, the helicopter was over water.

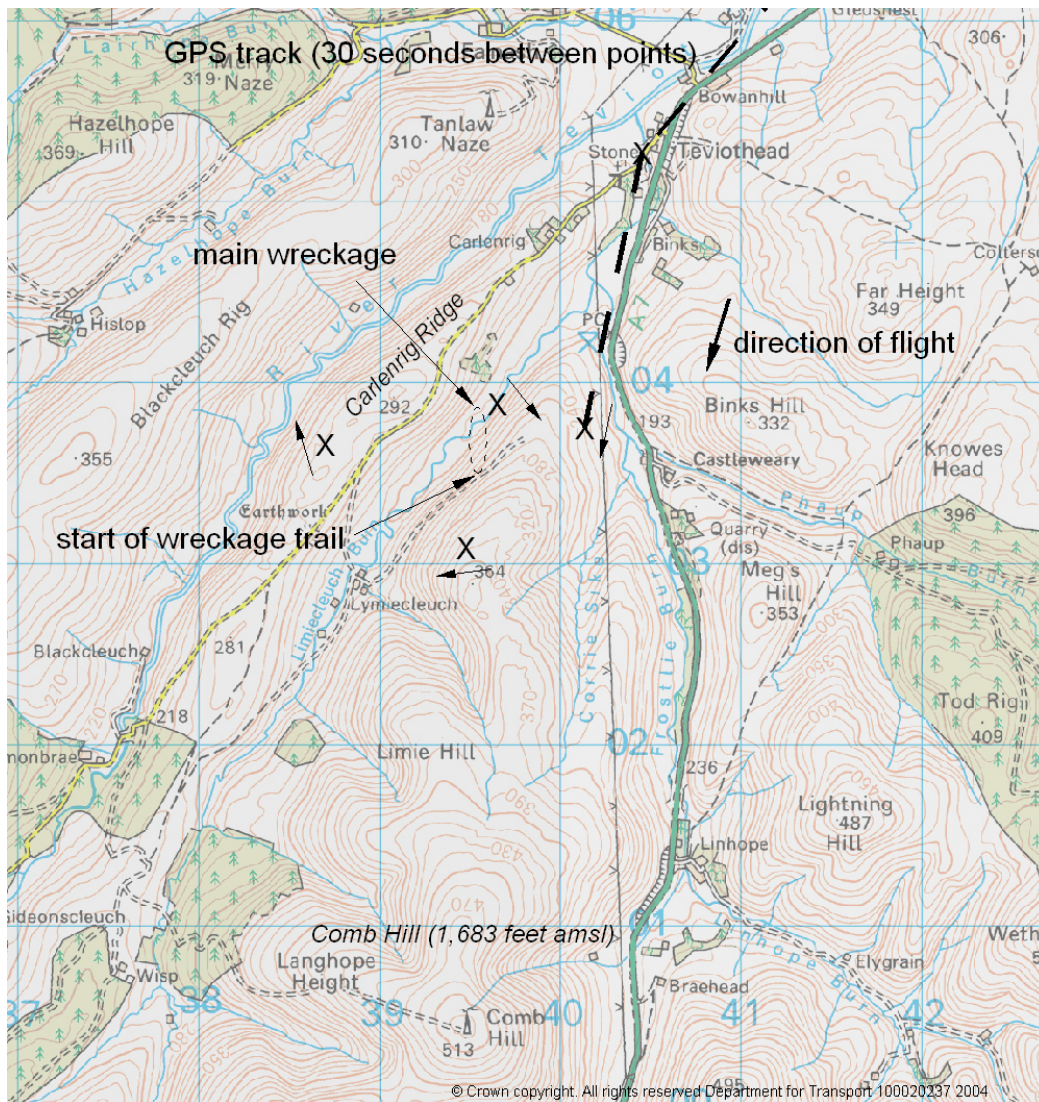
Figure 1

Final GPS track of G-OUEL and wreckage site location

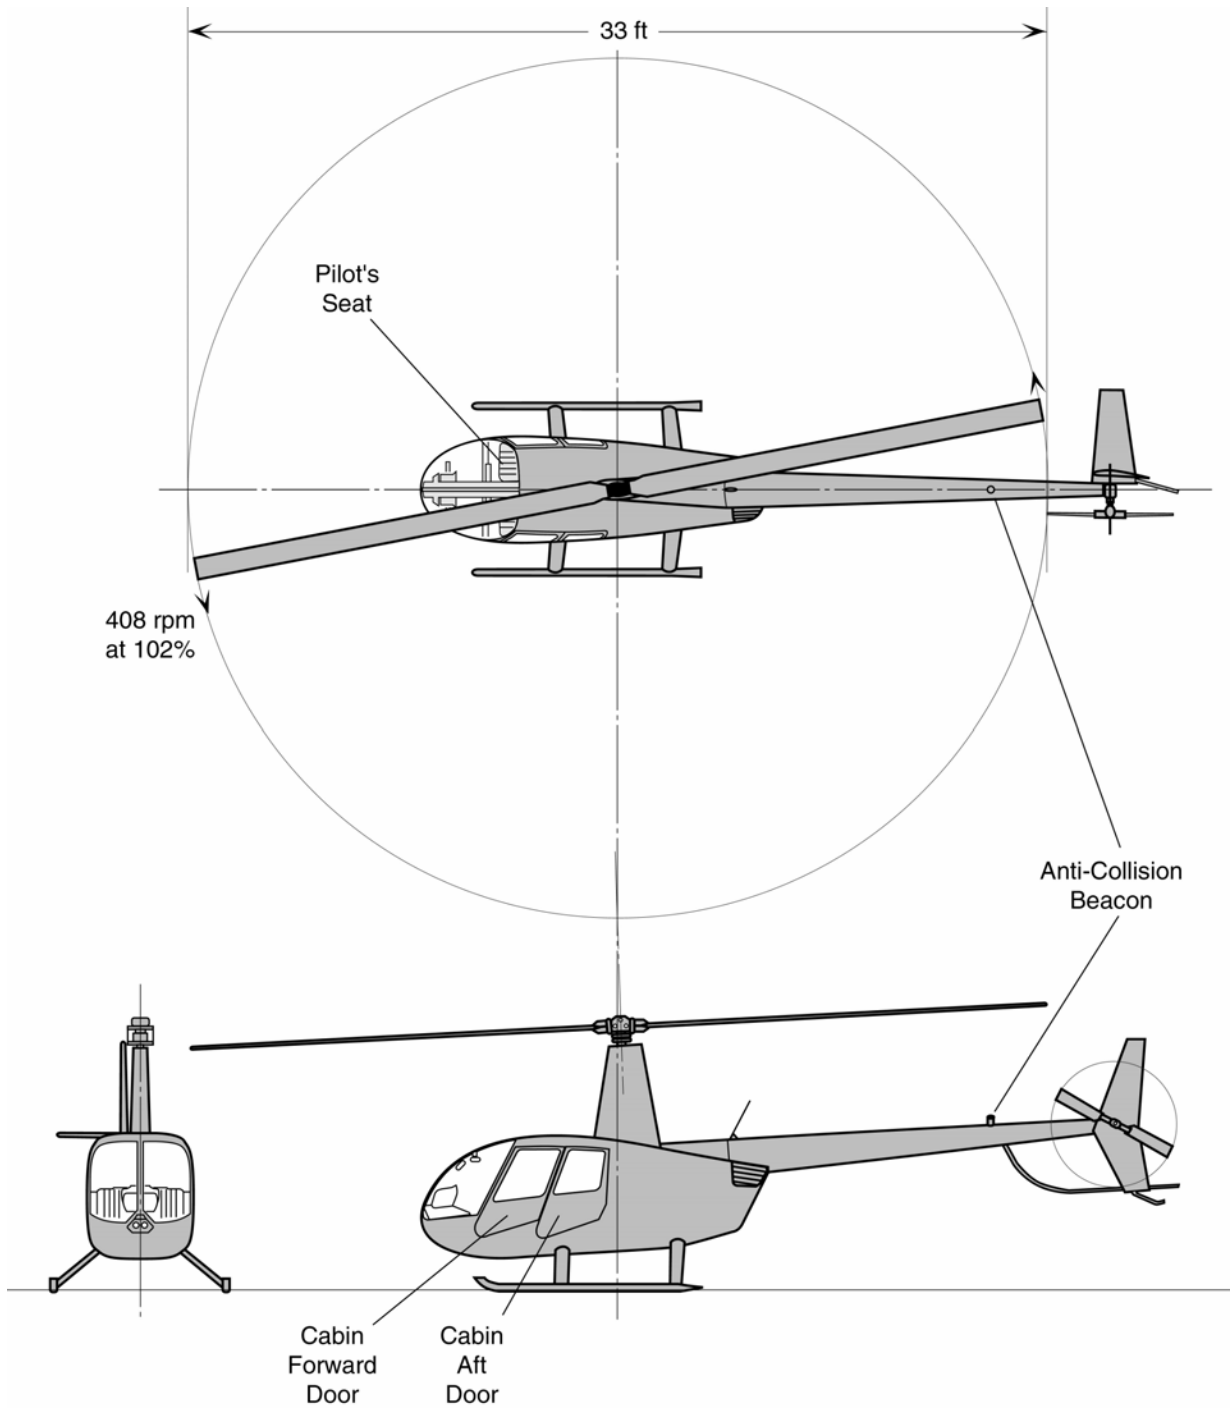
Figure 2

The Robinson R44, manufactured in the USA, is a single-engined helicopter of conventional layout (Figure 2) with a maximum gross weight of 2,400 lb. At the time of the accident the manufacturer had constructed approximately 1,500 R44s, in three versions, over a 10 year period. The primary fuselage structure is constructed of welded steel tubing covered with a riveted aluminium skin and is fitted with a skid landing gear. The tailcone is a monocoque aluminium structure. There are two front and two rear seats; the pilot normally occupies the front right seat. The GPS receiver fitted to G-OUEL incorporated a moving map display; it was mounted on the central frame of the forward transparency. V_{NE} (the never exceed indicated airspeed) at G-OUEL's weight and altitude at the time of the accident was 130 kt (100 kt when operating at power above Maximum Continuous.)

Robinson R44 - General arrangement

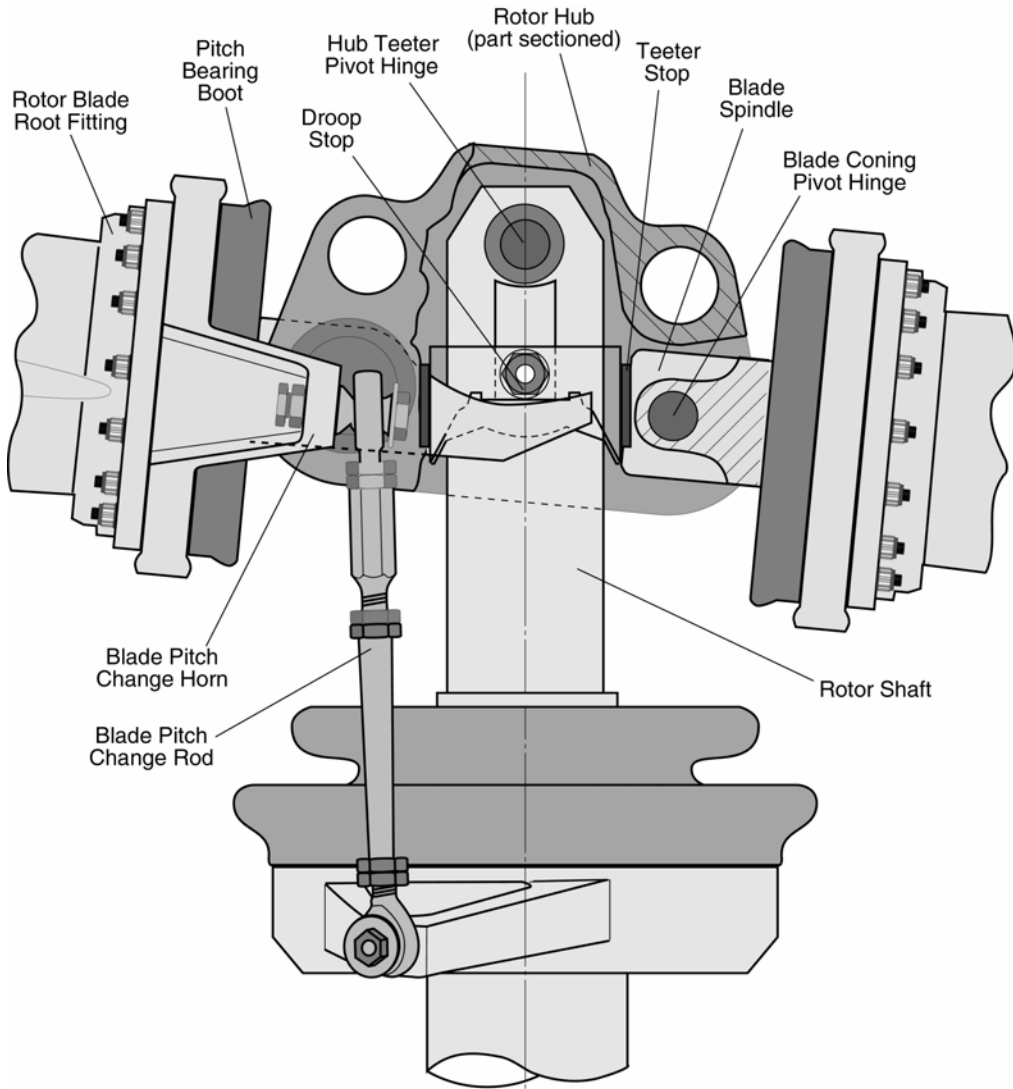
Figure 3

The main rotor has two all-metal blades, each of which is attached to a MR hub by a coning pivot hinge (Figure 3). The hub is mounted to the top of the MR shaft by a horizontal teeter pivot hinge located above the coning hinges. The design places the main rotor centre of mass close to the teeter hinge point under normal operating conditions to minimise vibration and improve rotor stability. The provision of coning hinges permits a lighter blade design by reducing flapping bending moments near the blade roots. Teetering travel is limited by contact of the blade spindles with elastomeric stops on the rotor shaft. Pitch-change bearings for each blade operate in an oil bath contained in a blade root housing that is sealed by a neoprene boot; nominal blade pitch angles are 2-3° with the collective fully down and 14.5-16.5° with the collective fully raised. No blade drag hinges are provided.

Robinson R44 Main Rotor Head

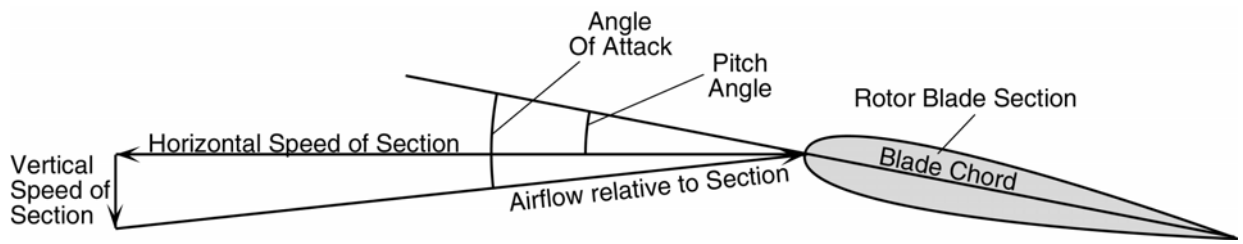
Figure 4

The lift and drag forces generated by airflow over each section of the MR blades are a function of the relative speed of the airflow over the section and its angle of attack (AOA), the angle between the blade chord and the airflow (Figure 4). Increased lift and drag forces are generated by increasing AOA, up to a critical aerodynamic stall angle (around 15° for the R44), beyond which the airflow separates from the upper surface of the section. This results in a sudden reduction in lift and large increase in drag on the section.

Rotor Blade Angles

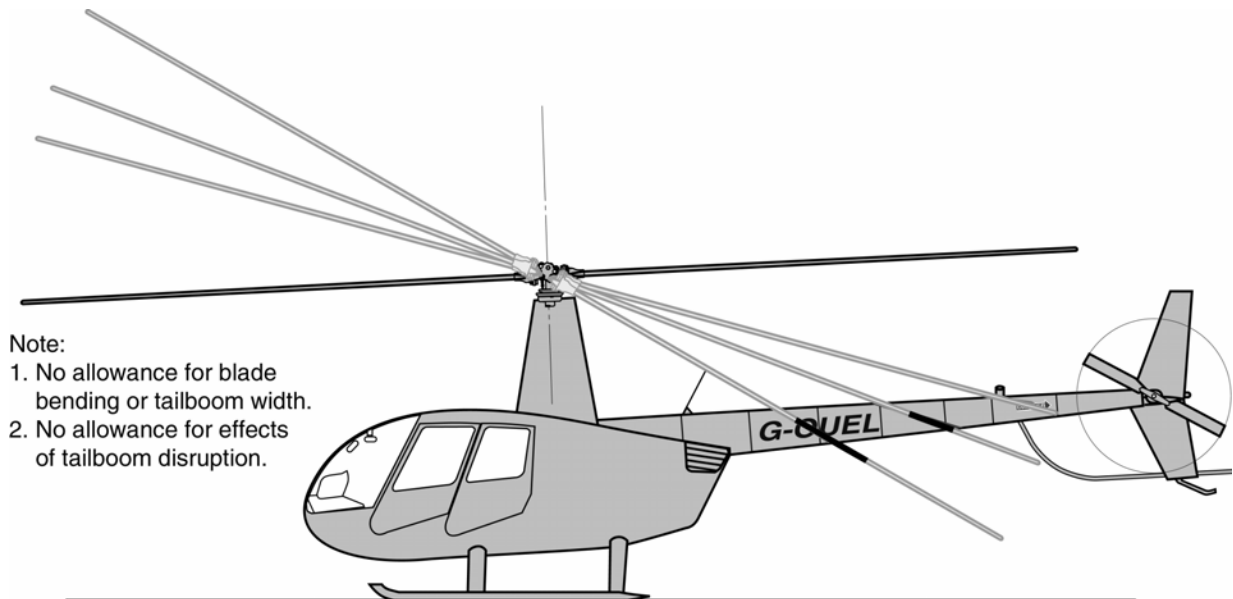
Figure 5

Both MR blades had suffered surface gouging, consistent with contact with the tailboom, in a region between around 2.3-4.3 feet from the tip for Blade A and 4.9-7.4 feet from the tip for Blade B (Figure 4). Neither blade had sustained appreciable leading edge damage from the ground impact. The inner portion of Blade A had buckled, consistent with its end-on ground impact. The fracture of the blade, 3.5 feet from its tip, was at the inboard end of the tip weight fitted within the blade spar. The blade had a pronounced, smooth forward bend in the plane of the blade outboard of the fracture and this, together with the spar fracture surface characteristics, indicated that the fracture had resulted from in-plane bending overload. The evidence, in conjunction with that from the markings on the blade and on the tailboom and from the distribution of the detached parts, was fully consistent with the fracture having resulted from overload caused by inertial effects when the blade struck the tailboom. Blade B was intact; it exhibited marked upward bending deformation along its length.

G-OUEL - Main rotor blade and tailboom marks

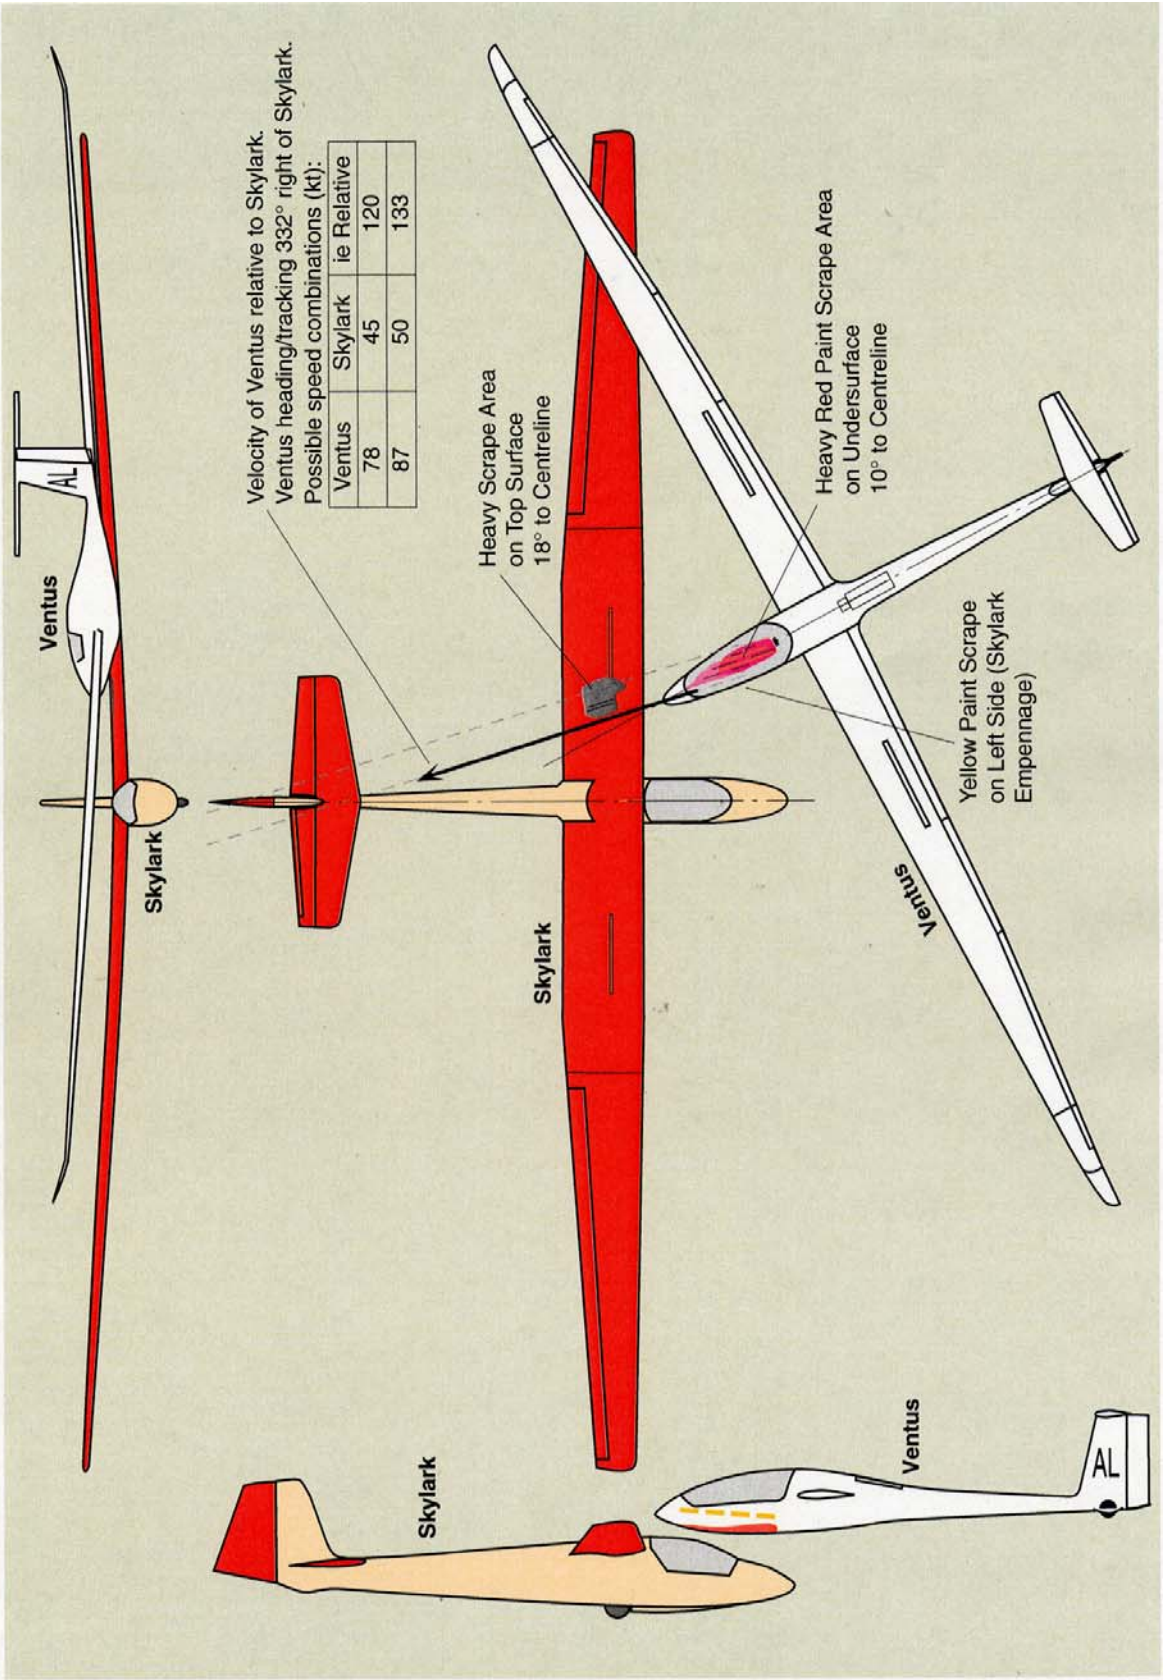
Figure 1

VENTUS/SKYLARK COLLISION SCHEMATIC
