## CONTENTS

### COMMERCIAL AIR TRANSPORT

<b>Aircraft Type and Registration:</b>	Boeing 737-800, EI-DHD	
<b>No &amp; Type of Engines:</b>	2 CFM 56-7B26 turbofan engines	
<b>Year of Manufacture:</b>	2005	
<b>Date &amp; Time (UTC):</b>	23 December 2009 at 0847 hrs	
<b>Location:</b>	Glasgow Prestwick Airport	
<b>Type of Flight:</b>	Commercial Air Transport (Passenger)	
<b>Persons on Board:</b>	Crew - 6	Passengers - 129
<b>Injuries:</b>	Crew - None	Passengers - None
<b>Nature of Damage:</b>	None	
<b>Commander's Licence:</b>	Airline Transport Pilot's Licence	
<b>Commander's Age:</b>	33 years	
<b>Commander's Flying Experience:</b>	5,557 hours (of which 1,832 were on type) Last 90 days - 113 hours Last 28 days - 78 hours	
<b>Information Source:</b>	Airfield operator's investigation report and further enquiries by the AAIB

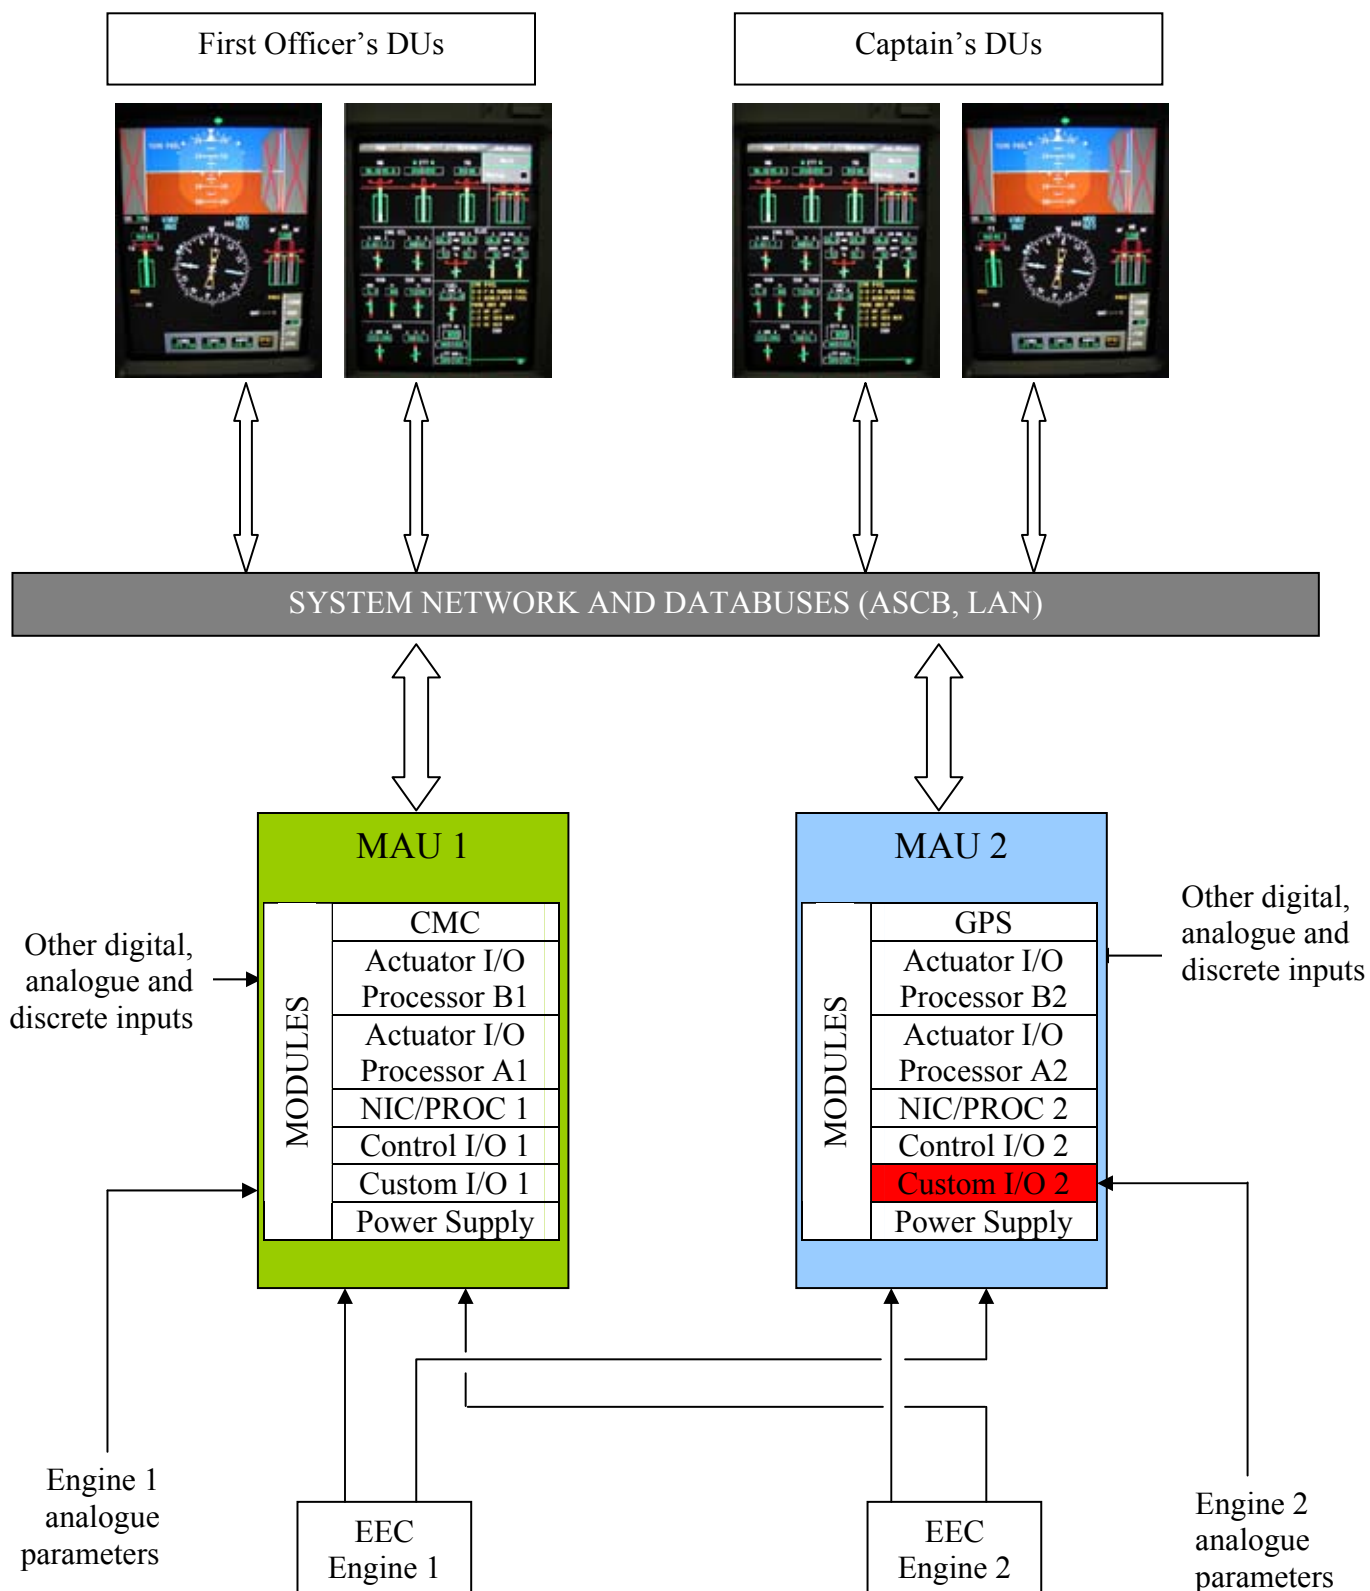
**Figure 1**  
AW139 MAU installation

Data from all airframe sensors are not wired directly to each MAU but wired separately to ensure segregation and to allow the MAUs to compare between duplicate sensors. Each MAU has visibility of data acquired by the other as, once acquired by the respective MAU, it is digitised and transmitted on the databuses. A majority of these parameters is acquired in the MAU Custom Input/Output module (CSIO).

Engine parameters are acquired by the MAUs from the Electronic Engine Controllers (EECs). Each EEC collects data from sensors installed on its respective engine and digitises it. This data is then transmitted to both MAUs so that in the event of a MAU failure

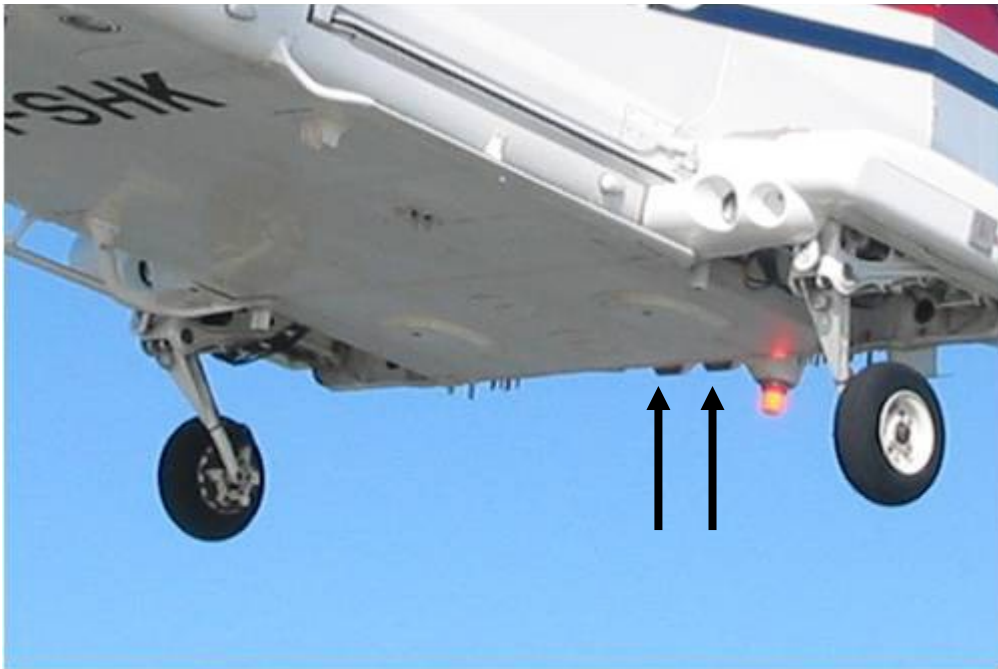
**Figure 2**

In order to meet the MAU installation requirements for the short nose aircraft, the helicopter manufacturer provided ducting that directed cooling air from two scoops on the underside of the rear fuselage. The ducts were asymmetrically disposed, such that the outlet of one of them was immediately underneath the MAU 2 cabinet. No outside air is used for cooling in the long nose MAU installation.

Honeywell specified the MAU installation requirements in an Installation Bulletin which details items such as dimensional, cooling and environmental requirements. Part of this bulletin highlights that, when installed in the airframe, the MAU must be protected against exposure to water.

AW139 MAU Cooling Duct Intake Scoops

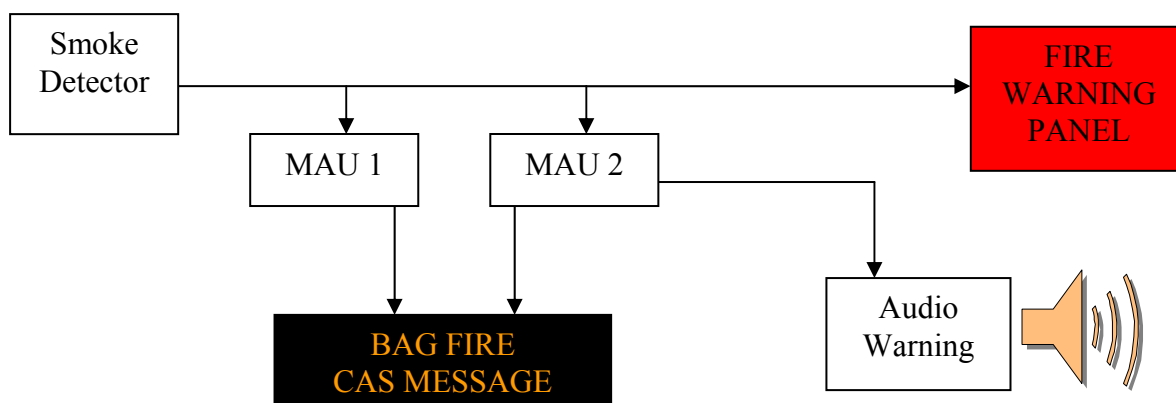
**Figure 3**

The baggage area is monitored by a smoke detector which is connected to both MAUs and the fire warning panel. If a baggage fire warning is detected, the crew should be alerted by a red light on the fire warning panel, a BAG FIRE CAS message and audio warning. The CAS warning will be displayed if either MAU detects a trigger from the smoke detector, but all audio warnings are generated by MAU 2. Figure 3 shows the system schematic diagram.

The baggage compartment fire detection system schematic

2. The data indicated that the CSIO2 module triggered the CAS BAG FIRE caption after water was sprayed between the two circuit boards of the module. Additional messages were generated simply as a result of water shorting out the 'Bag Fire 28V/Open Discrete' signal. However, it should be noted that the warning light on the Fire Control Panel is not connected to CSIO2 (or any other MAU module) and is only illuminated following activation of the bag fire sensor (see Figure 3).

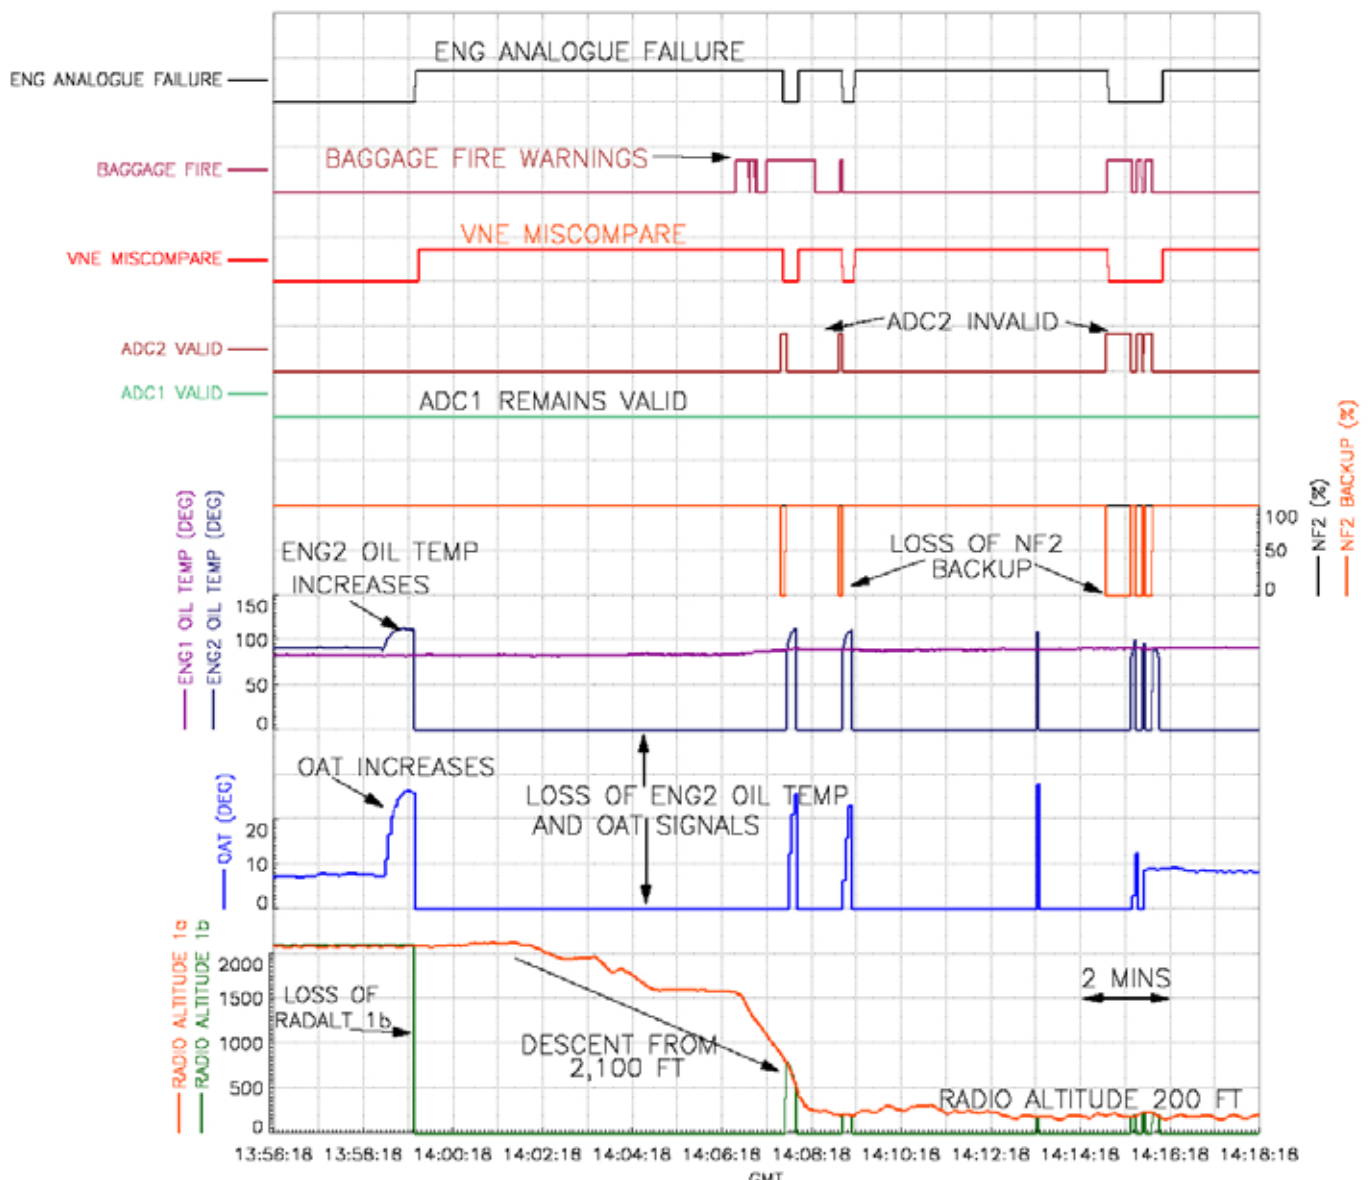
in cruise at a radio height of 2,100 ft, on a magnetic heading of 022°M and an indicated airspeed (IAS) of 145 kt. At 1358:48 hrs, the outside air temperature (OAT) parameter began increasing from 7°C and, over a 30-second period, reached 26°C, before failing (characterised by a drop to 0°C (see Figure 4). No 2 engine oil temperature, the tail rotor gearbox (TGB) and intermediate gearbox (IGB) oil temperatures and No 2 hydraulic system temperature also exhibited this characteristic rise, followed by failure. For clarity, Figure 4 only shows the OAT and No 2 engine oil temperature.

G-CHCV MPFR recorded parameters

data shows loss of further engine analogue parameters and the failure of No 2 ADC (Air Data Computer No 2). This loss of data appeared to be reversible, with some data apparently recovering but then failing again (Figure 4).

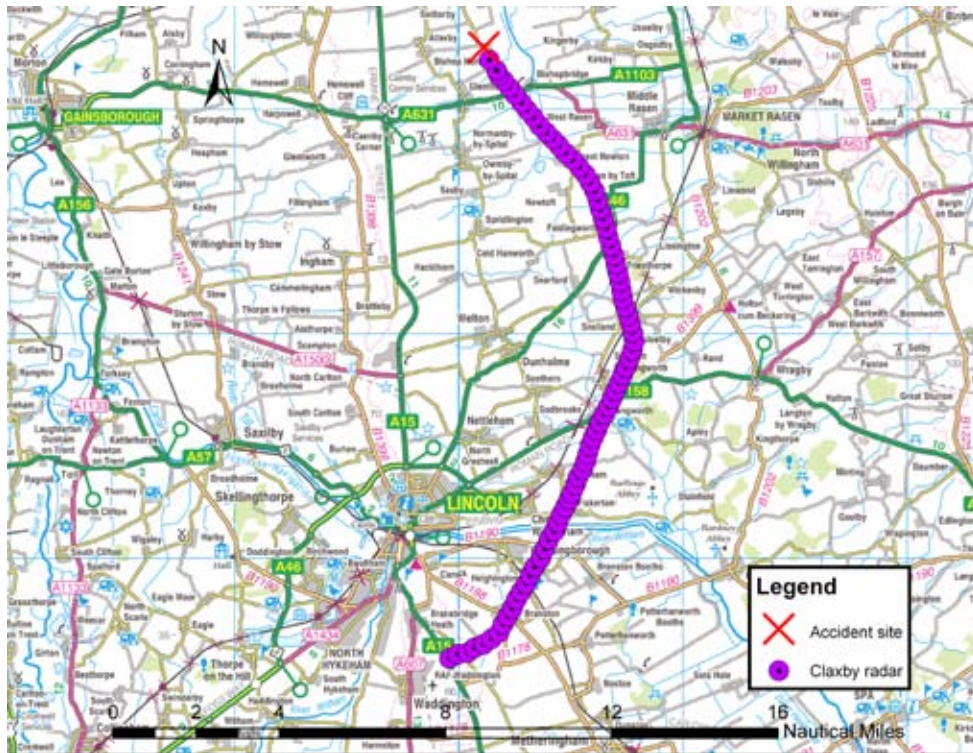
Figure 1 shows the accident track which started at 1323:34 hrs at Waddington Airfield and ended at 1333:41 hrs, approximately 0.33 nm south of the accident site. Figure 2 shows a close-up of the radar track in the vicinity of the accident site.

Radar track of G-AWVF and position of accident site

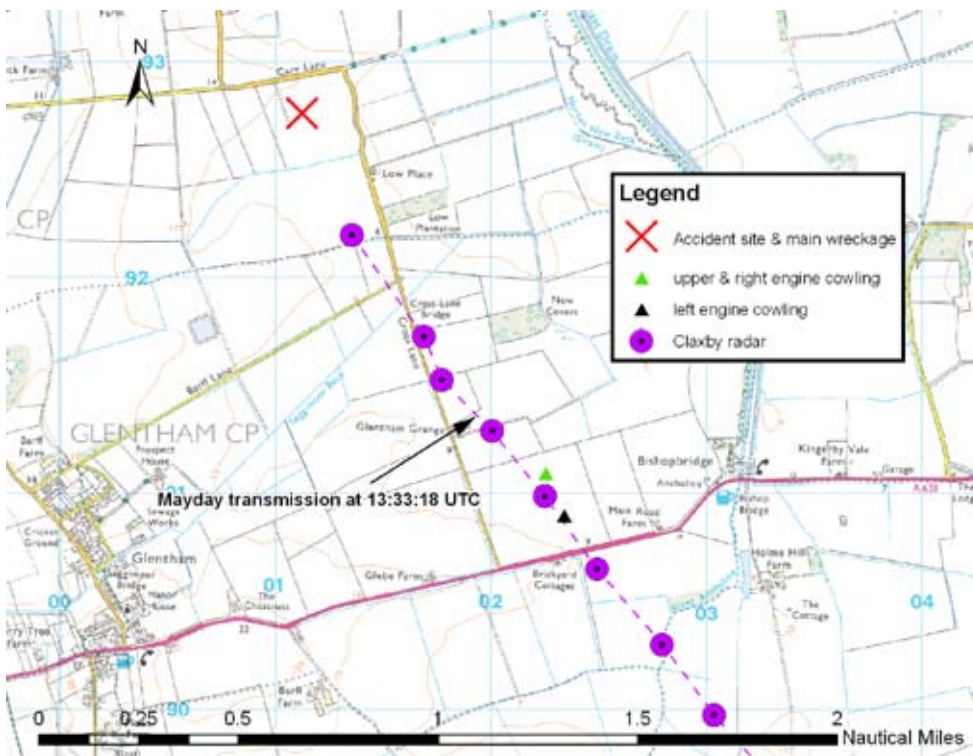
Figure 2

All major aircraft components were accounted for at the accident site, apart from the engine cowlings. The engine cowlings were found, one month after the accident, in a field 1.1 nm south-south-east of the accident site (Figure 2). The upper and right side cowlings were still attached to each other at the hinge. The left side cowling had detached at its hinge and was found 212 m south of the upper and right cowlings. The lower rear corner of the right cowling was burnt and sooted.

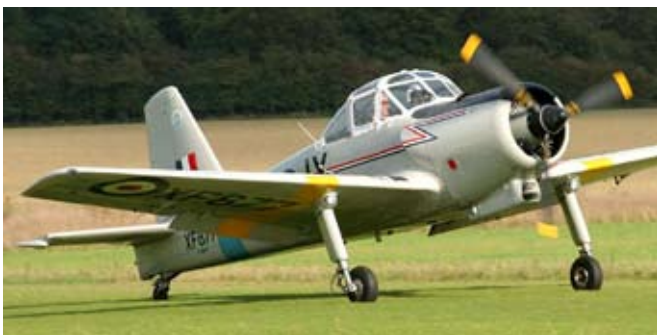
**Figure 4**

The Hunting Percival P56 Provost T1, also known as a 'Piston Provost', is a single-engined two-seat military training aircraft with a fixed landing gear (Figure 4). It is powered by a 550 hp Alvis Leonides 503/6A 9-cylinder radial engine which, through a reduction gearbox, drives a three-bladed constant-speed propeller. The aircraft has conventional flying controls operated by push-pull rods and cables. It has a 24V electrical system and a pneumatic system which powers the flaps, wheel brakes and windscreen wipers.

P56 Provost T1, G-AWVF  
(photograph courtesy Brian Nicholas)

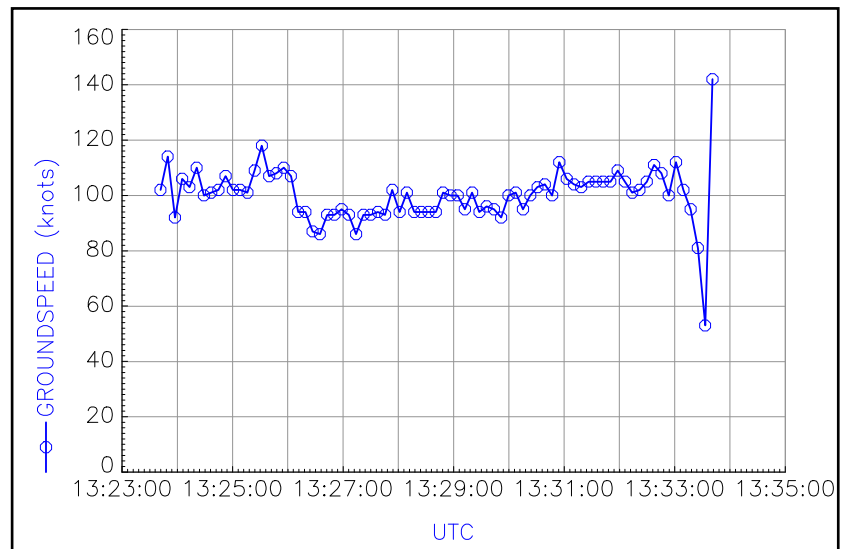
**Figure 3**

The average groundspeed between each radar point was calculated and is presented in Figure 3 (note that these groundspeeds do not have any vertical speed component). This figure shows that the groundspeed during the majority of the flight was about 100 kt. Towards the end of the flight the groundspeed started to

Accident flight calculated groundspeed from radar data

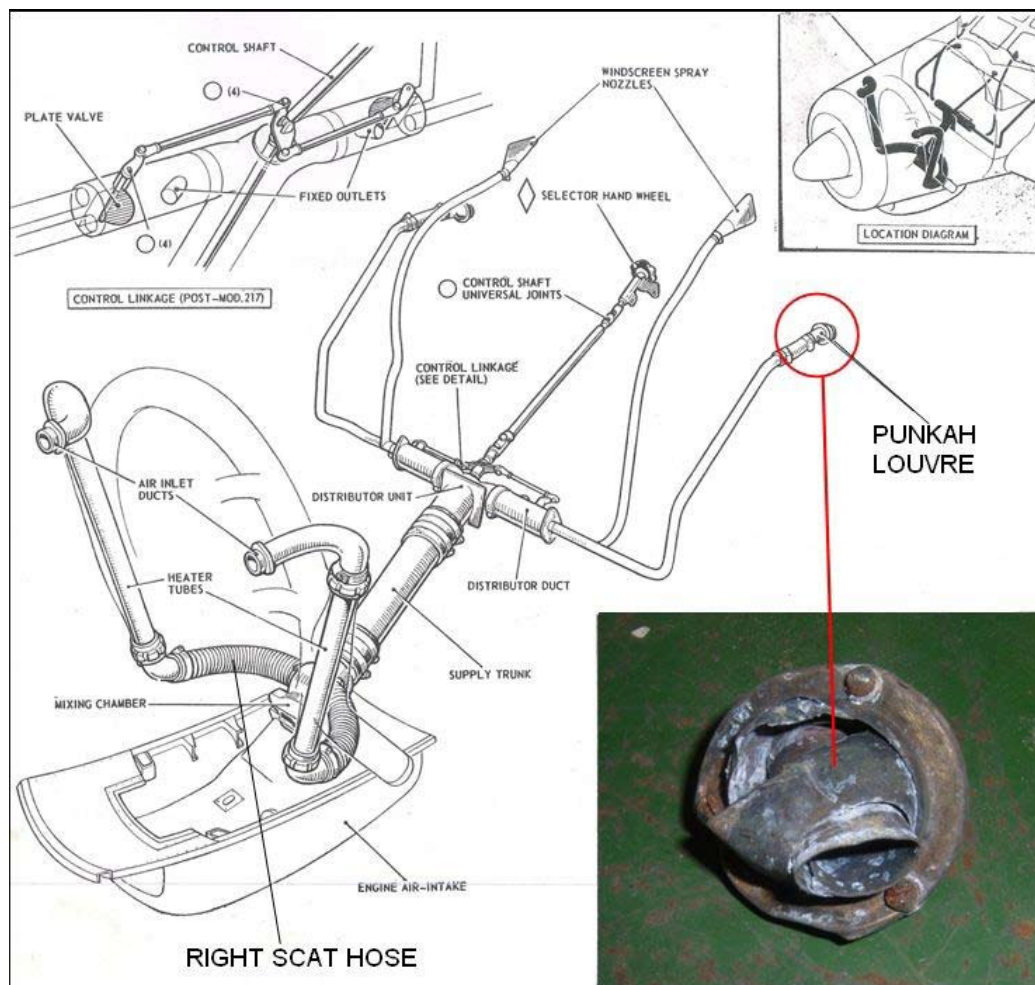
**Figure 8**

The aircraft's ventilation system takes cold air from the engine air-intake and directs it via a series of ducts and pipes to two 'punkah louvres' on the instrument panel and two windscreen spray nozzles mounted below the windscreen (Figure 8). For the hot air supply, separate air inlet ducts, mounted on both sides of the engine, direct

Ventilation system diagram showing location of right SCAT hose and punkah louvres. The burnt punkah louvre shown in the photograph was either from the left or right side of the instrument panel.

The majority of the components of the ventilation system, including the SCAT hoses, had suffered from severe fire damage and it was not possible to determine if they had been exposed to an in-flight fire before the post-impact fire. However, one of the punkha louvres (shown in Figure 8) was found on the ground, well clear of the main wreckage and surrounded by unburnt crops. Despite this, it exhibited evidence of having been exposed to high temperature and possibly fire. The right SCAT hose, between the heater tube and mixing chamber, passed close to the aft lower corner of the right engine cowling, which had exhibited evidence of in-flight fire.

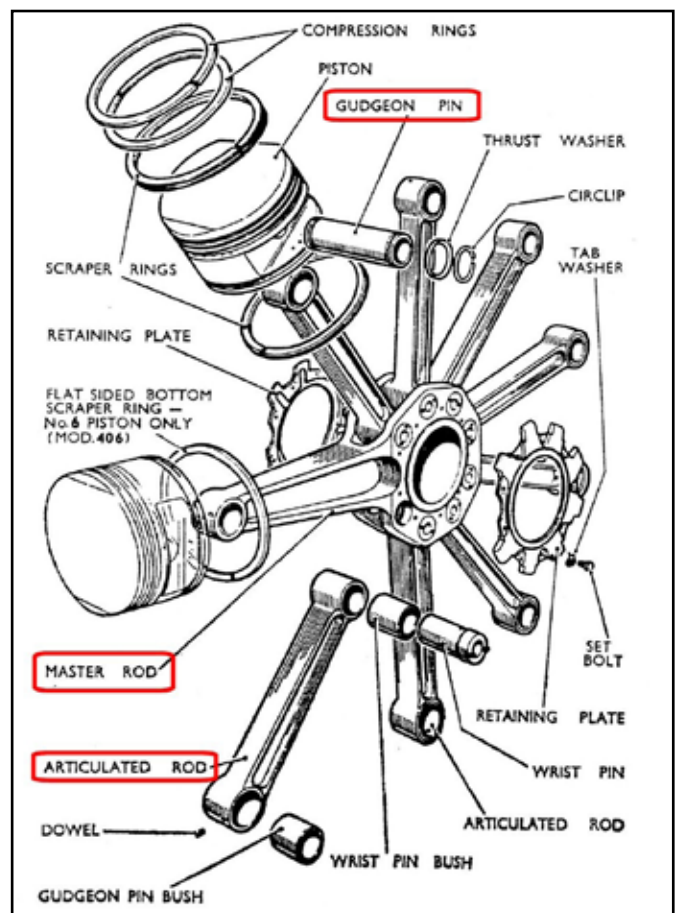
**Figure 9**

The Alvis Leonides 503/6A is a piston engine with nine cylinders mounted radially. The No 1 cylinder is located at the top ('12 o'clock') position, and the No 5 and No 6 cylinders are located at the bottom, either side of the 6 o'clock position. The No 6 cylinder contains the master rod (shown in Figure 9). This is the strongest connecting rod, and the other eight connecting rods, called 'articulating rods', are connected to the master rod. The crankshaft passes through the centre of the master rod which contains a plain bearing. The master rod and the eight articulating rods (the connecting rods) are connected to their respective pistons via a gudgeon pin (Figure 9). Each gudgeon pin is free to rotate within the bores of the piston bosses.

Connecting rod and piston arrangement in Alvis Leonides 503/6A radial engine

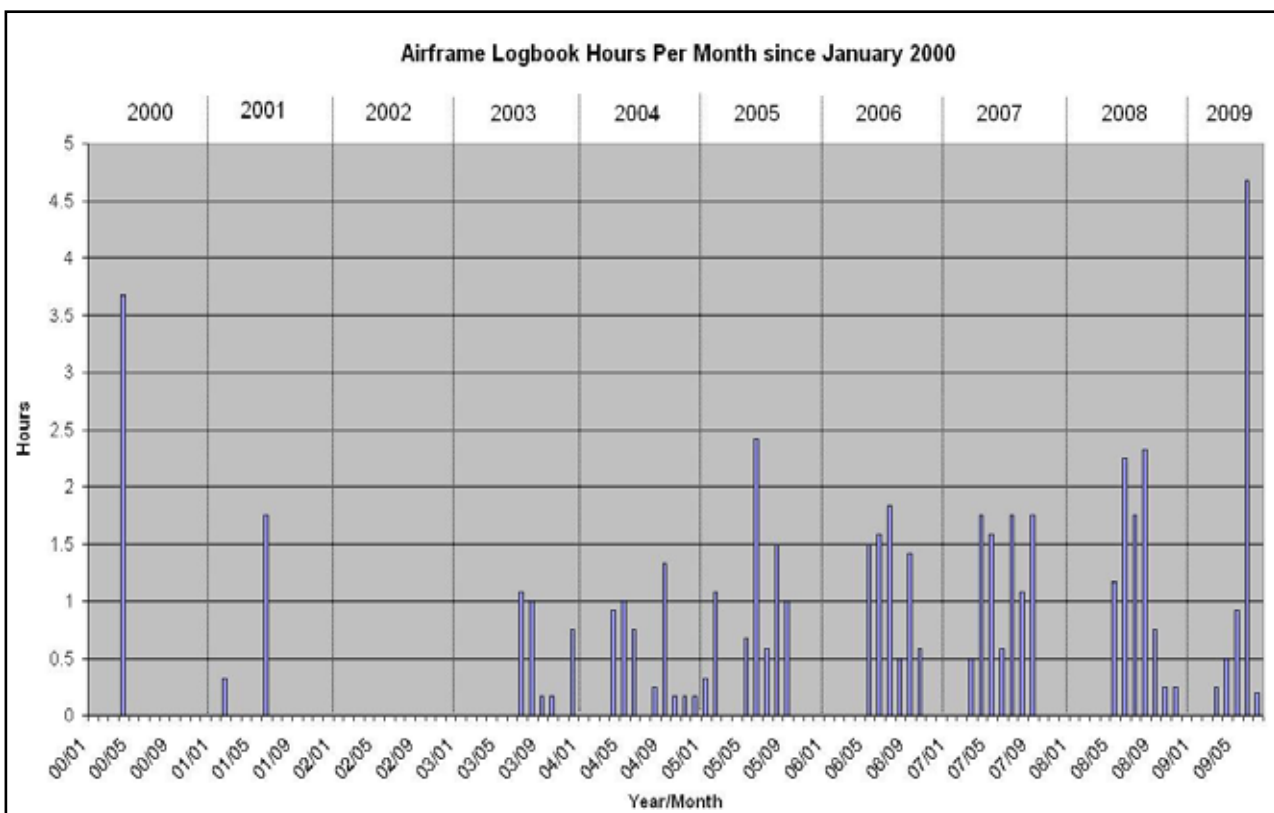
**Figure 17**

From Figure 17 it can be seen that, in the last six years, the aircraft usually flew between 0.5 hours and 2 hours each month, but did not fly during the winter months. The last extended period of no flight was between 22 November 2008 and 15 March 2009. Between 15 March 2009 and the accident date, the aircraft carried out 17 flights. Seven of these flights were 10 minutes in

G-AWVF airframe logbook hours per month between January 2000 and July 2009

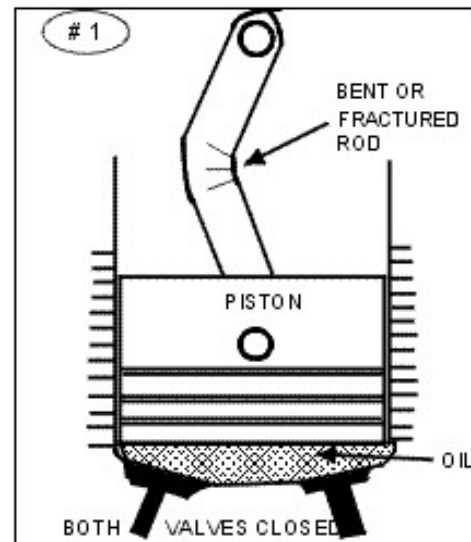
**Figure 18**

Hydraulic lock is a phenomenon that can occur on piston engines that have downward-pointing cylinders, that is, cylinders orientated such that the piston is moving down during the compression stroke. All radial engines have some cylinders that are pointing downwards and are, therefore, susceptible to hydraulic lock. After a radial engine has been shut down for a period, oil may drain into the combustion chambers of the lower cylinders or accumulate in the lower intake pipes, ready to be drawn into the cylinders when the engine starts. As the piston approaches top dead centre (TDC) of the compression stroke (both valves are closed at this point), the oil, being incompressible, can stop the piston movement (Figure 18). If the crankshaft continues to rotate then damage to the engine will occur – this could result in a cylinder being blown out, a bent or fractured connecting rod, or damage to the gudgeon pin. This phenomenon is known as 'hydraulic lock'. A partial hydraulic lock can also occur when liquid is inside the combustion chamber, but is not sufficient to fill the space between the cylinder head and the piston when it is at TDC. In this situation, the air gap is still reduced and, therefore, the pressure rise within the cylinder can still be sufficient to stop the piston or to result in damage if the piston is forced through TDC during engine start. Damage resulting from a

partial hydraulic lock can be more serious as it could go undetected during the engine start, and then result in failure at some later time in flight.

Diagram showing the possible effect of hydraulic lock on a piston connecting rod
