CONTENTS

COMMERCIAL AIR TRANSPORT

List of recent aircraft accident reports issued by the AAIB

(ALL TIMES IN THIS BULLETIN ARE UTC)

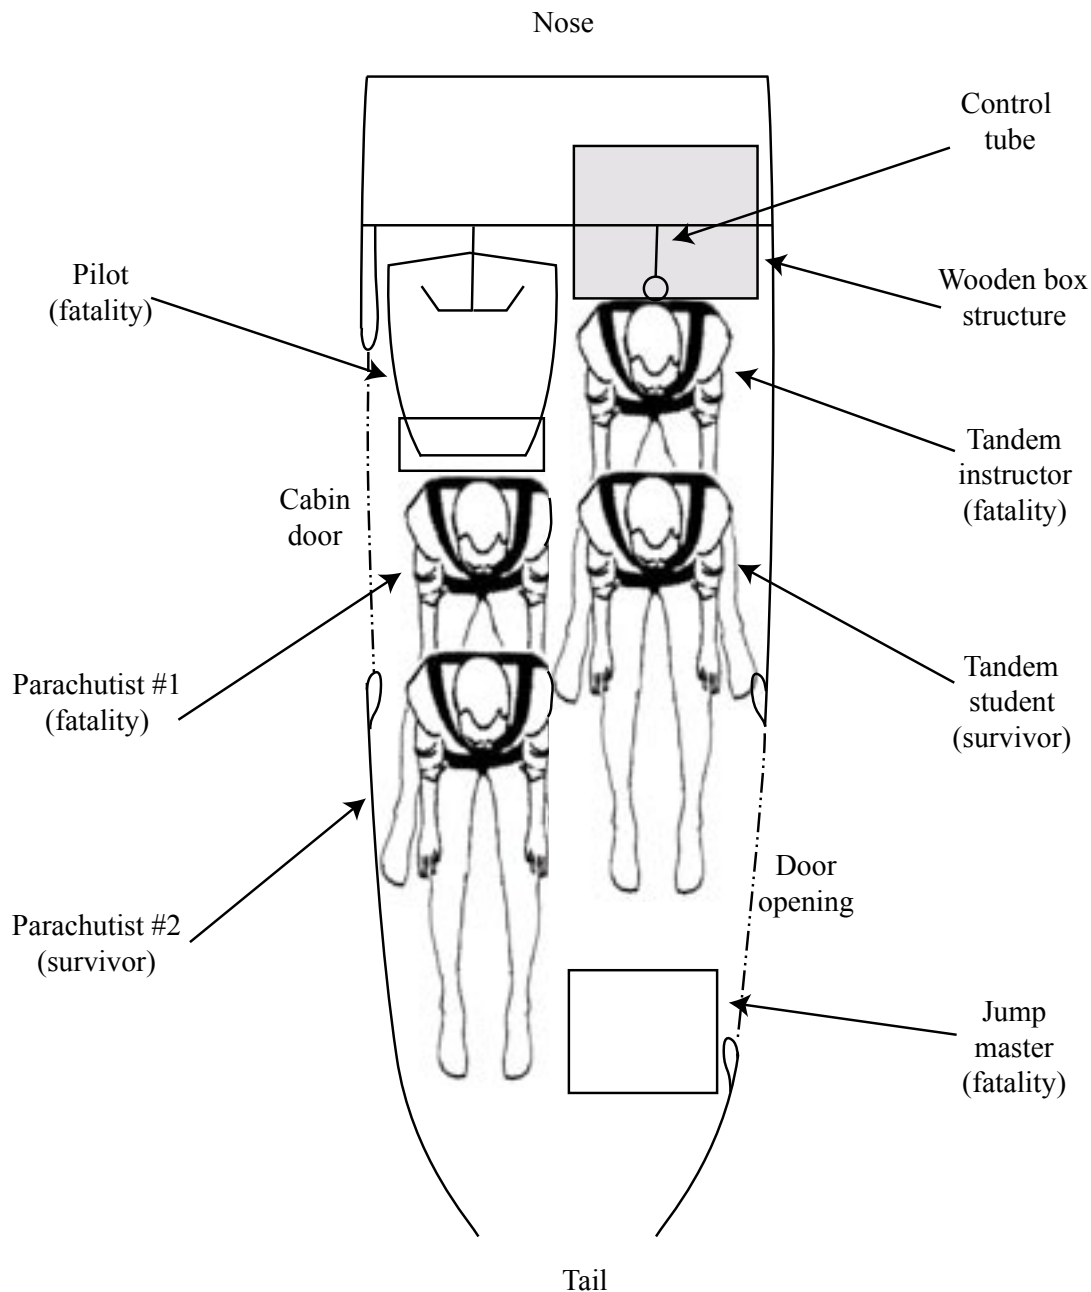
Figure 1
Seating layout for G-BGED

Figure 1 illustrates the probable locations of those parachutists aboard G-BGED at the time of the impact, all of whom were seated on the floor and unrestrained. The 'tandem' instructor and student were seated beside the pilot leaning against the wooden box and facing

rearwards. The two single parachutists, identified as Parachutist No 1 and 2, were facing rearwards, with No 1 leaning against the back of the pilot's seat. Parachutist No 1 was fatally injured and had sustained a fracture of the pelvis and been struck in the face. Parachutist No 2, seated against Parachutist No 1, survived and, although he had sustained spinal injuries, his pelvis was intact. He was able to exit the aircraft after the impact and subsequently was treated by the emergency services. The tandem parachutists both sustained pelvic fractures. The fatally injured instructor had a deep laceration to the back of his head, indicative of striking his head on the right side control wheel tube. There was evidence to suggest that the harness of the surviving tandem student attaching him to his instructor, had been cut, although it was not established whether this occurred pre- or post impact or by whom. The injuries to these four parachutists were consistent with high longitudinal and vertical forces resulting from the aircraft's impact with the ground.

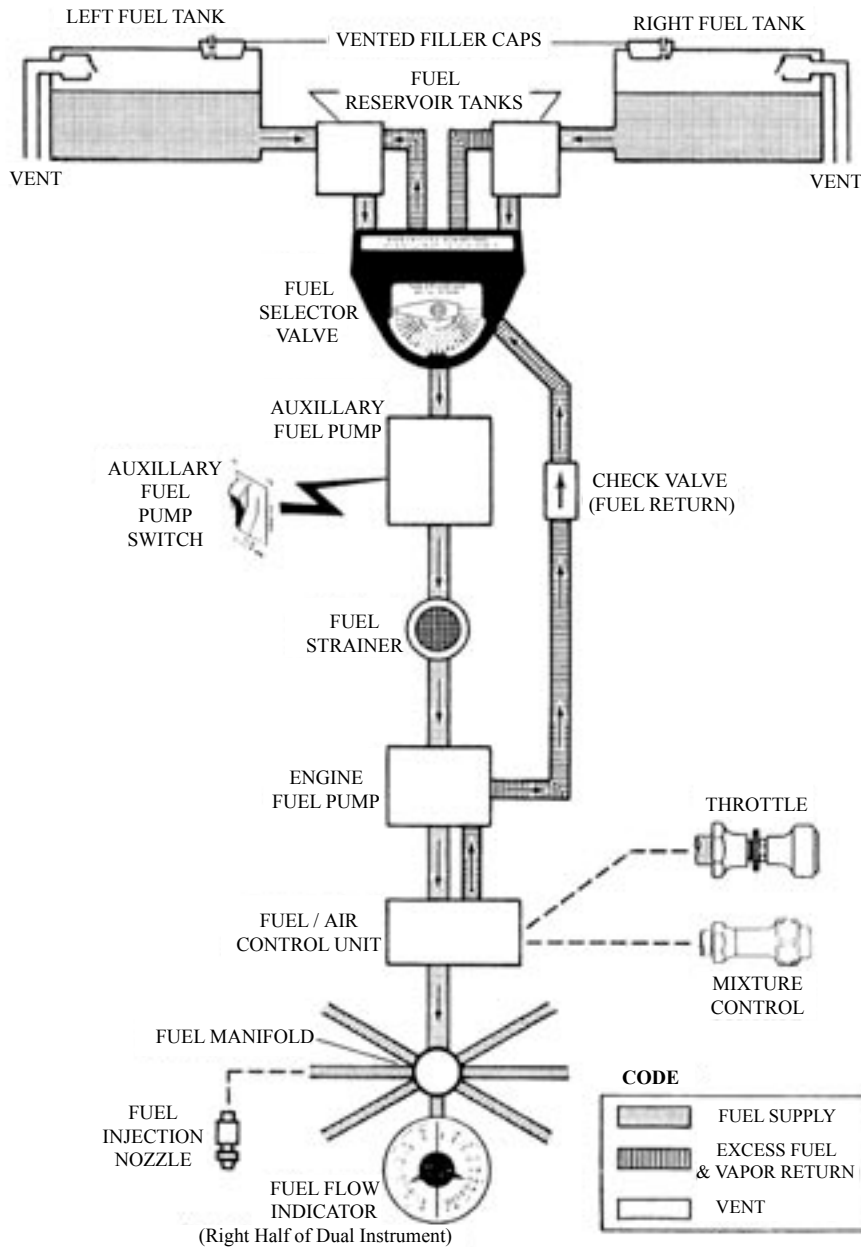
Figure 2
C206 Fuel system

A diagram of the aircraft fuel system is shown in Figure 2. This type of aircraft has two bag tanks, one in each inner wing with a capacity of 119 litres each. Fuel is gravity fed through two reservoir tanks (left and right) to the fuel selector valve, all of which are located beneath the cabin floor. This valve is operated manually through a linkage from a handle positioned on the cockpit floor between the front seats. Depending upon the setting of the selector valve, fuel from the left or right tank flows via an electric auxiliary fuel pump and a fuel strainer to the engine-driven fuel pump. A pressurised supply of

fuel is sent to the fuel metering unit which then regulates the fuel to the distribution manifold and finally to the engine fuel injector nozzles. The fuel/air mixture is controlled by means of the throttle and mixture control knobs. Excess fuel from the metering unit is returned by way of the selector valve to the reservoir tank of the wing tank being used. There is an additional filter within the fuel metering unit.

The engine-driven fuel pump provides sufficient fuel flow/pressure for normal engine operation with the electric auxiliary fuel pump acting as a back-up in the event of an engine-driven pump failure. The electric auxiliary pump is manually selected by means of a yellow and red split rocker switch on the lower left side of the instrument panel. The yellow right half of the switch is labeled START, and its upper ON position is used for normal starting and minor vapour purging during taxi. The red left half of the switch is labeled EMERG and its upper HI position is used in the event of an engine driven pump failure during takeoff or high power operation. The HI position may also be used for extreme vapour purging. With the right half of the switch in the ON position, the pump operates at one of two flow rates dependant on throttle setting. Maximum fuel flow is produced when the left half of the switch is held in the spring loaded HI position. When this is selected, an interlock automatically trips the right half of the switch to the ON position. The auxiliary pump is also required to assist in restarting the engine should fuel exhaustion from the selected tank occur. However, if the engine-driven pump is functioning normally, with a good supply of fuel, and the auxiliary pump 'START' switch is placed in the ON position, an excessively rich fuel/air ratio can result and lead to a loss of power and/or a 'rich cut'.

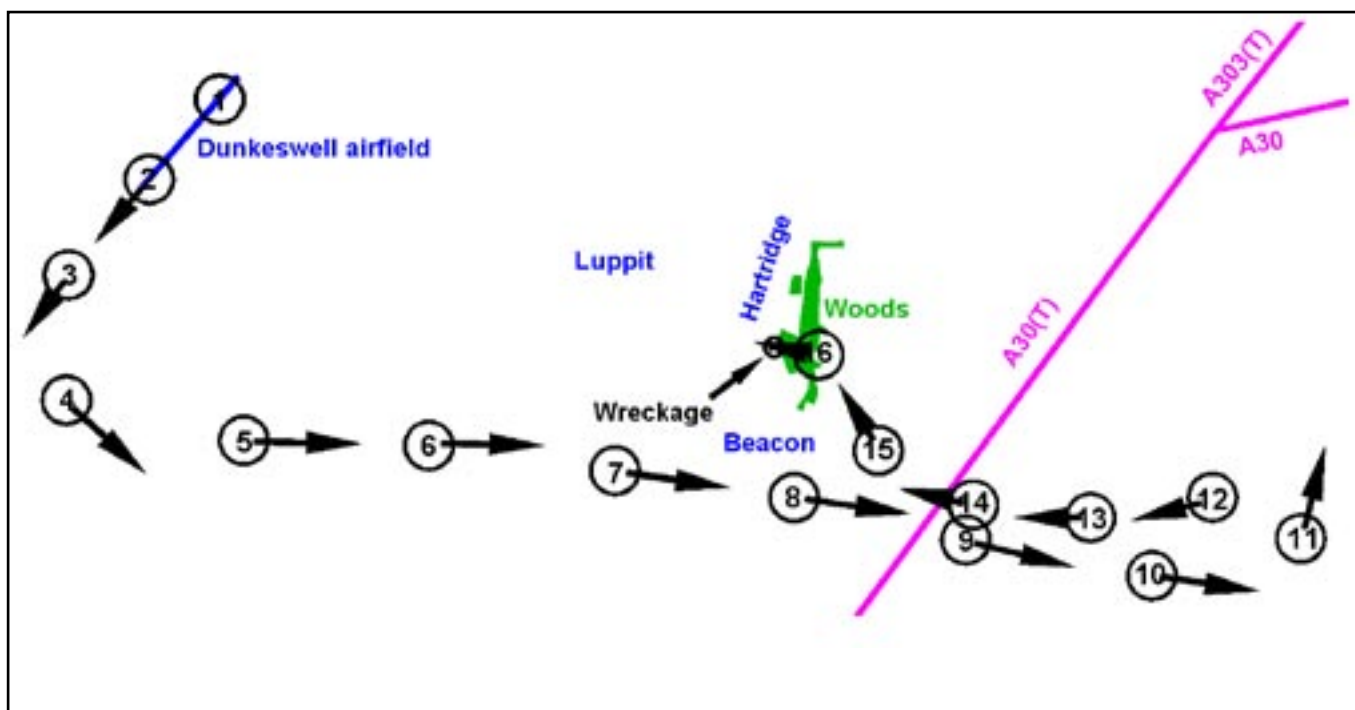
Figure 5 shows the plan view of the accident flight which identifies the last GPS position before equipment power or antenna connectivity was lost. This location is consistent with the wreckage location. The recorded track shows that the aircraft turned away from an area of high ground near Dumpdon Hill. This track took the aircraft towards another area of high ground, Hartridge, upon which it crashed.

Plan view of the accident flight
Accident to G-BGED on 27 June 2004 at Beacon Village

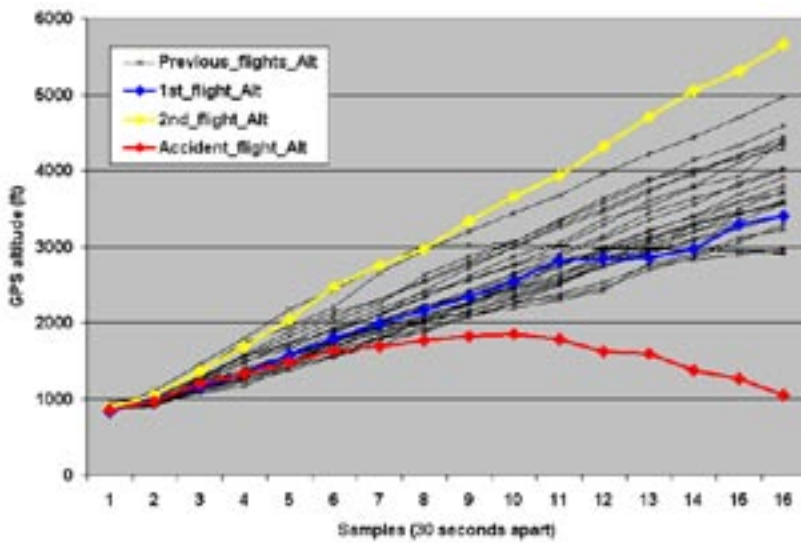
Figure 6

Figures 6, 7 and 8 show the altitude, altitude rate and true air speed parameters respectively, of the accident flight against the first 16 samples of the previous 27 recorded flights. These indicate that the rate of climb was apparently normal for the first 2.5 minutes (6 samples). After this, the climb rate reduced below that of all the previous flight profiles. Given that the airspeed was maintained during this period at approximately 80 KTAS, it would

Take-off altitude profile of the 1st and 2nd flights of the day, the accident flight (3rd) and other previous flights.

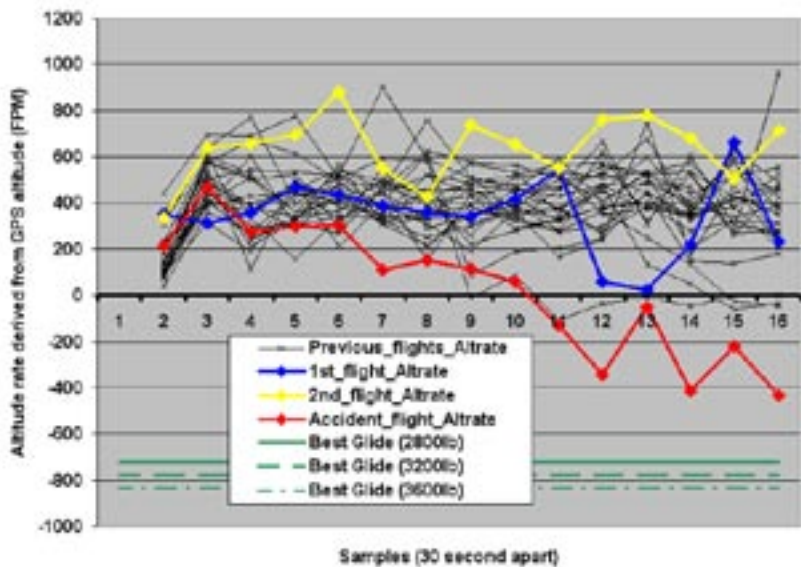
Figure 7

Take-off altitude rate profile of the 1st and 2nd flights of the day, the accident flight (3rd) and other previous flights.

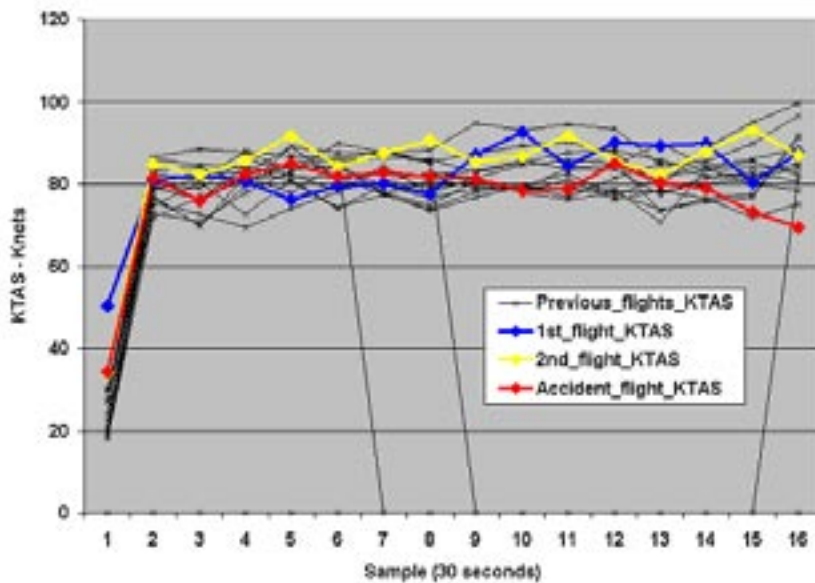
Figure 8

Take-off true airspeed profile of the 1st and 2nd flights of the day, the accident flight (3rd) and other previous flights.

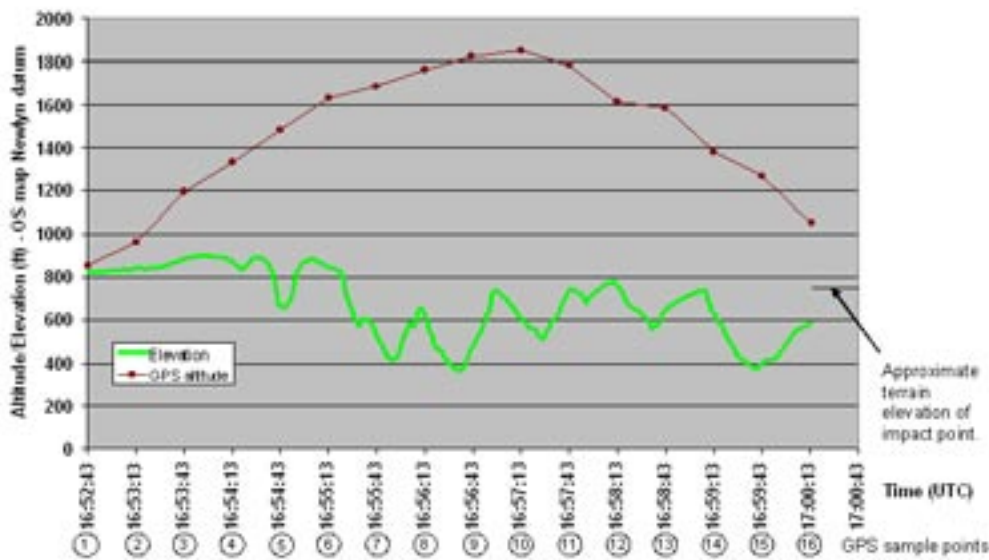
Figure 9
Aircraft altitude relative to terrain
Accident to G-BGED on 27 June 2004 at Beacon Village.

Figure 9 shows the altitude of the aircraft relative to the terrain beneath the aircraft. This shows that at the highest point of the flight, the aircraft had on average approximately 1,100 ft terrain clearance. During the last minute of recorded flight the terrain immediately below the aircraft was undulating such that the aircraft terrain clearance was never more than 900 ft.

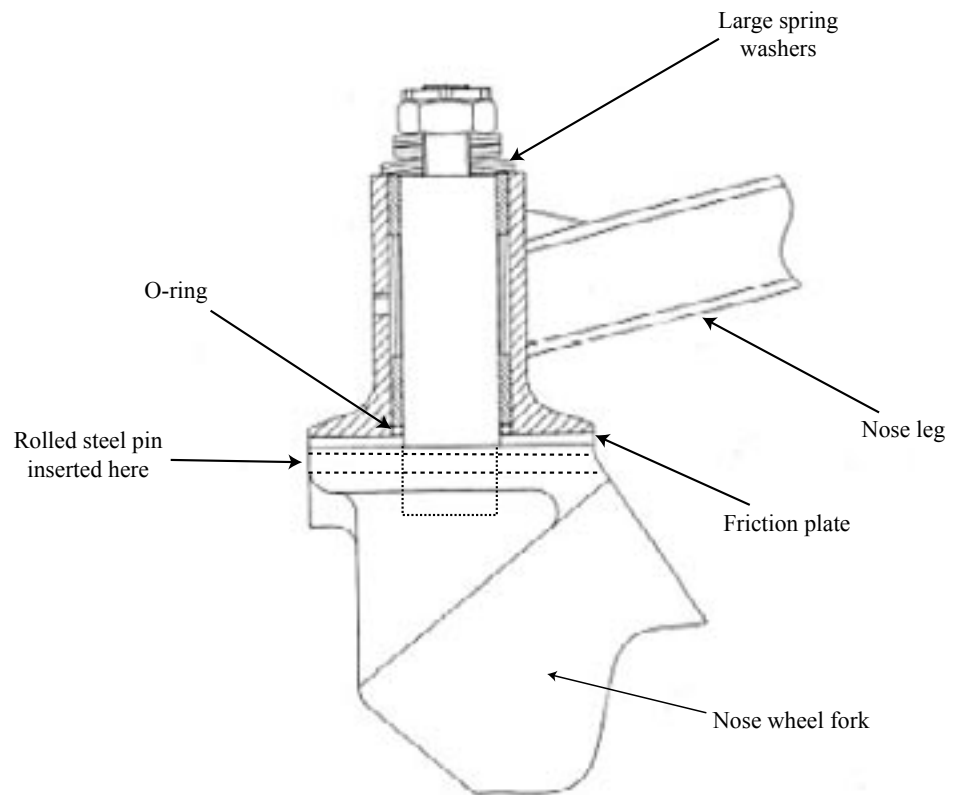
Figure 1

The nose landing gear leg on this type of aircraft comprises a length of steel bar attached to the aircraft structure at the rear of the engine compartment. The geometry is such that the leg makes an angle of approximately 30° to the horizontal. The nose wheel fork assembly is attached by means of a shaft to a cylindrical housing welded to the lower end of the leg; - see Figure 1. The shaft is a light interference fit in the top of the fork assembly, with positive location achieved by means of a rolled steel pin inserted into fore-aft drillings in the fork and the lower portion of the shaft. The threaded upper end of the shaft is inserted through a bushed hole within the cylindrical housing and is secured by means of a nut,

Details of attachment of nose wheel fork to leg

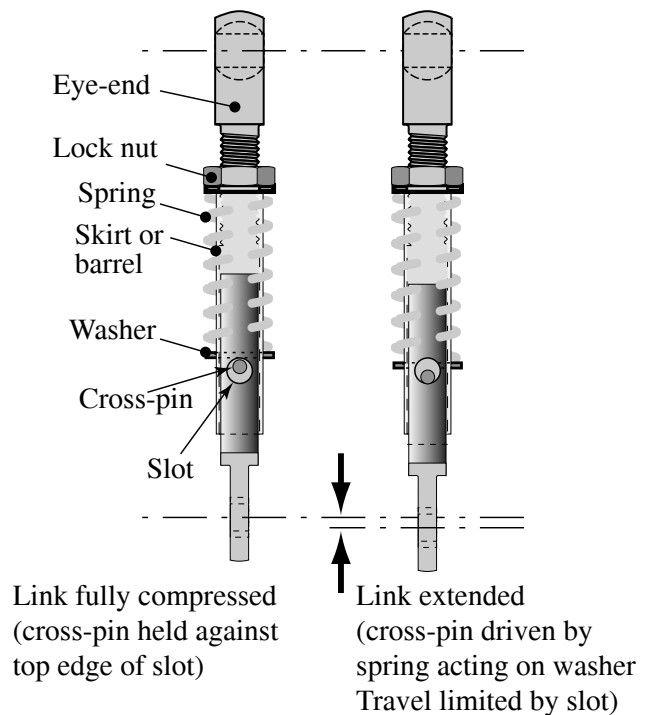
Figure 2
Downlock link
Sectioned assembly)

The lower part of the downlock link assembly is a spring strut (see Figure 2, below) which has a spring force of about 2-3 lbs and is compressible by about 0.06 inch. The sprung travel is limited by a cross-pin, fitted through the shank of the lower eye fitting, running in a control aperture in the barrel of the lower downlock link body. This aperture is described in the Service Manual as a 'slot'. The length of the lower downlock link is adjustable and is correct if, when the drag link assembly is driven to the fully over-centre position, the lower downlock link is almost fully compressed. The clearance of the cross-pin from the upper end of the slot, established by the rigging procedure, is a half turn of the adjustment thread, which is about 0.018 inch.

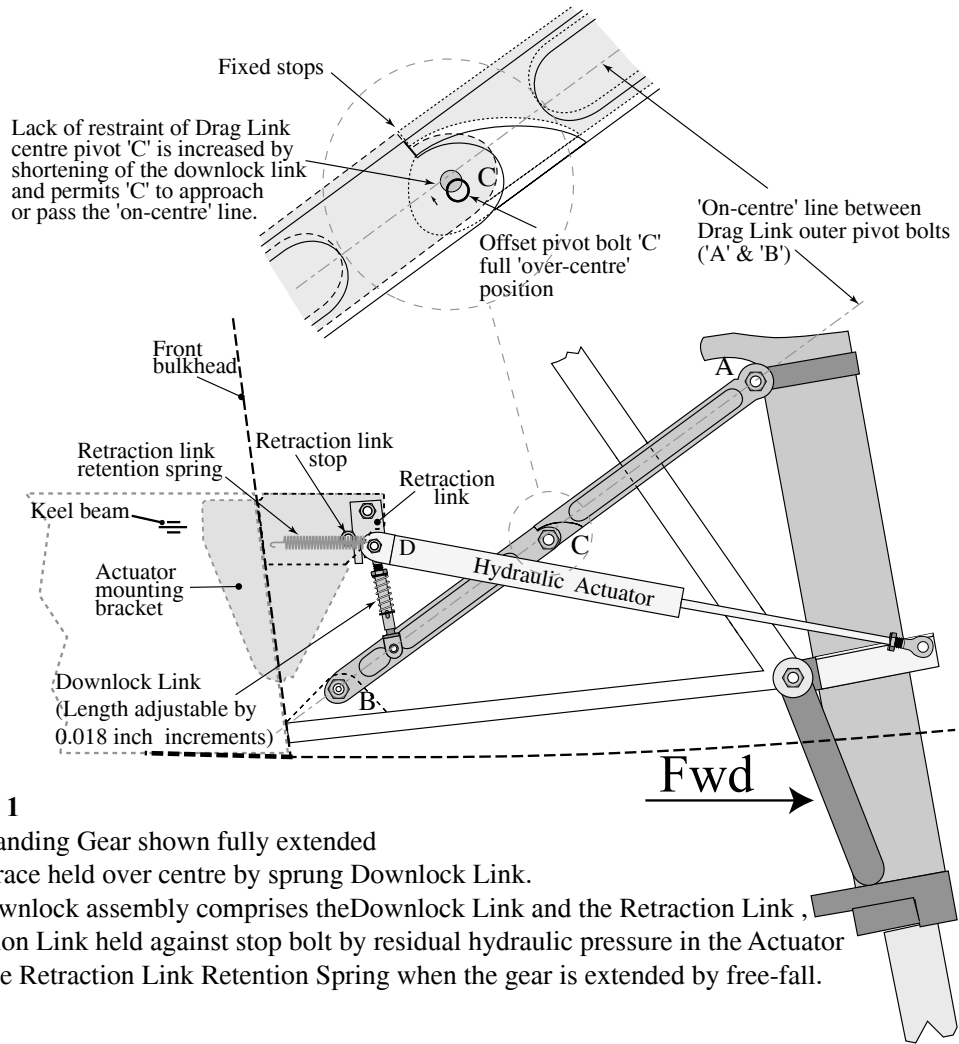
Figure 1

Nose Landing Gear shown fully extended
 Drag Brace held over centre by sprung Downlock Link.
 The Downlock assembly comprises the Downlock Link and the Retraction Link ,
 Retraction Link held against stop bolt by residual hydraulic pressure in the Actuator
 or by the Retraction Link Retention Spring when the gear is extended by free-fall.

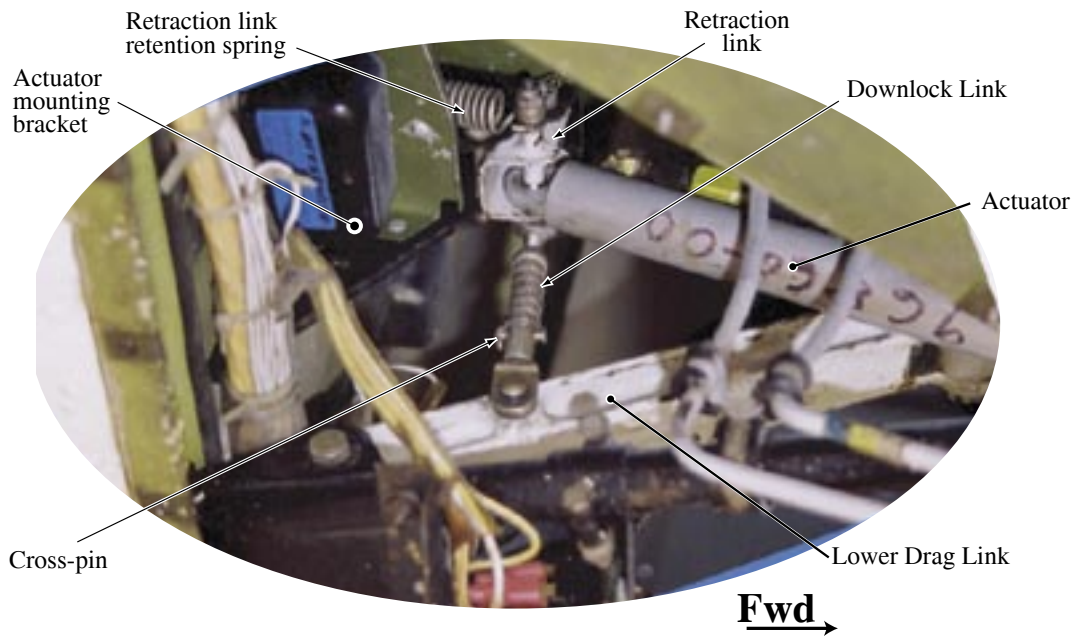
Figure 1a

PA-34 nose landing gear - view from below and right side showing lateral stagger of downlock linkage components.

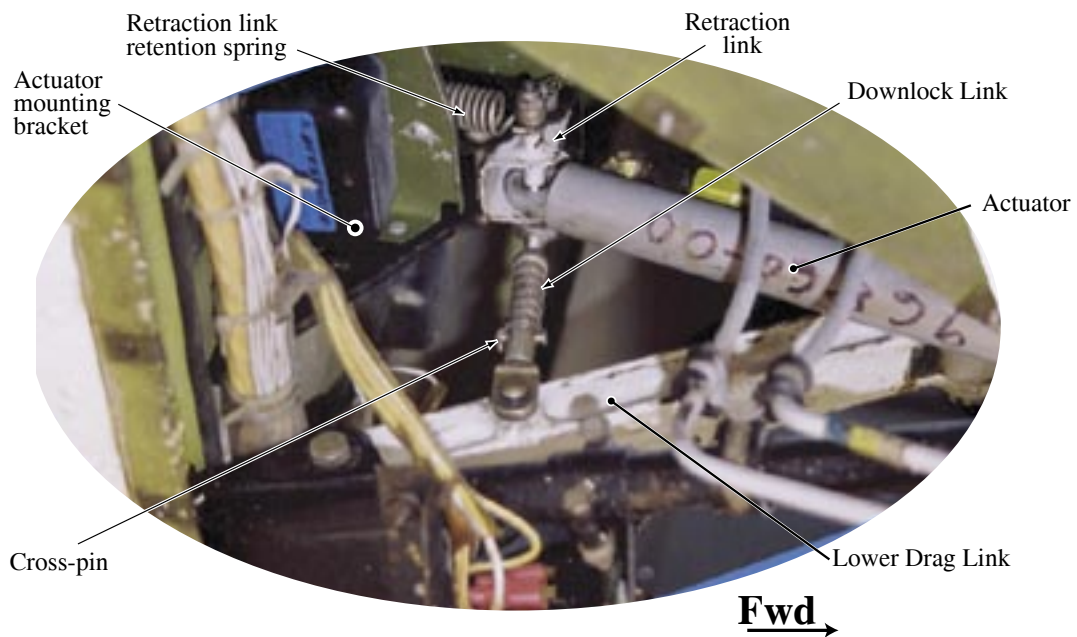
Figure 1a

PA-34 nose landing gear - view from below and right side showing lateral stagger of downlock linkage components.
