## ACCIDENT

<b>Aircraft Type and Registration:</b>	Bombardier BD700 Global Express, VP-CRC	
<b>No &amp; Type of Engines:</b>	2 Rolls Royce BR 710 series turbofans	
<b>Year of Manufacture:</b>	2007	
<b>Date &amp; Time (UTC):</b>	29 January 2008 at 0808 hrs	
<b>Location:</b>	London Luton Airport	
<b>Type of Flight:</b>	Private	
<b>Persons on Board:</b>	Crew - 3	Passengers - 1
<b>Injuries:</b>	Crew - None	Passengers - None
<b>Nature of Damage:</b>	Left inboard main landing gear tyre burst, flap drive shaft and two hydraulic pipes fractured, wiring loom damaged and localised wing structural damage	
<b>Commander's Licence:</b>	Airline Transport Pilot's Licence	
<b>Commander's Age:</b>	36 years	
<b>Commander's Flying Experience:</b>	3,759 hours (of which 92 hrs were on type) Last 90 days - 78 hours Last 28 days - 38 hours	
<b>Information Source:</b>	AAIB Field Investigation

## Synopsis

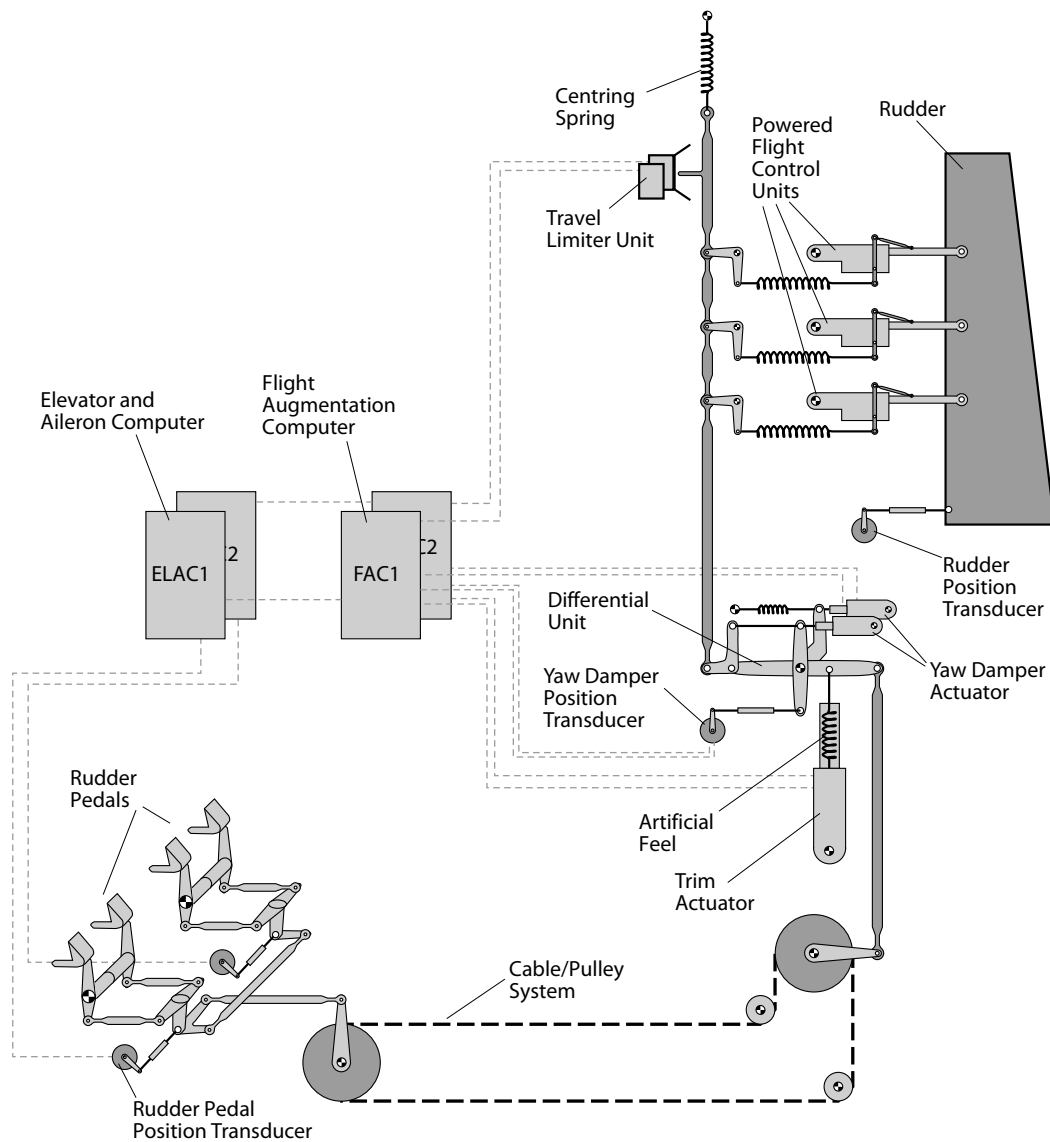
**Figure 1**

The rudder is controlled by three hydraulic Powered Flight Control Units (PFCUs) in the fn, each fed from a different hydraulic system and signalled mechanically (Figure 1). A transducer mechanically linked to the rudder surface provides rudder position signals. Commands from the pilots' rudder pedals are

A319 Rudder Control System Schematic

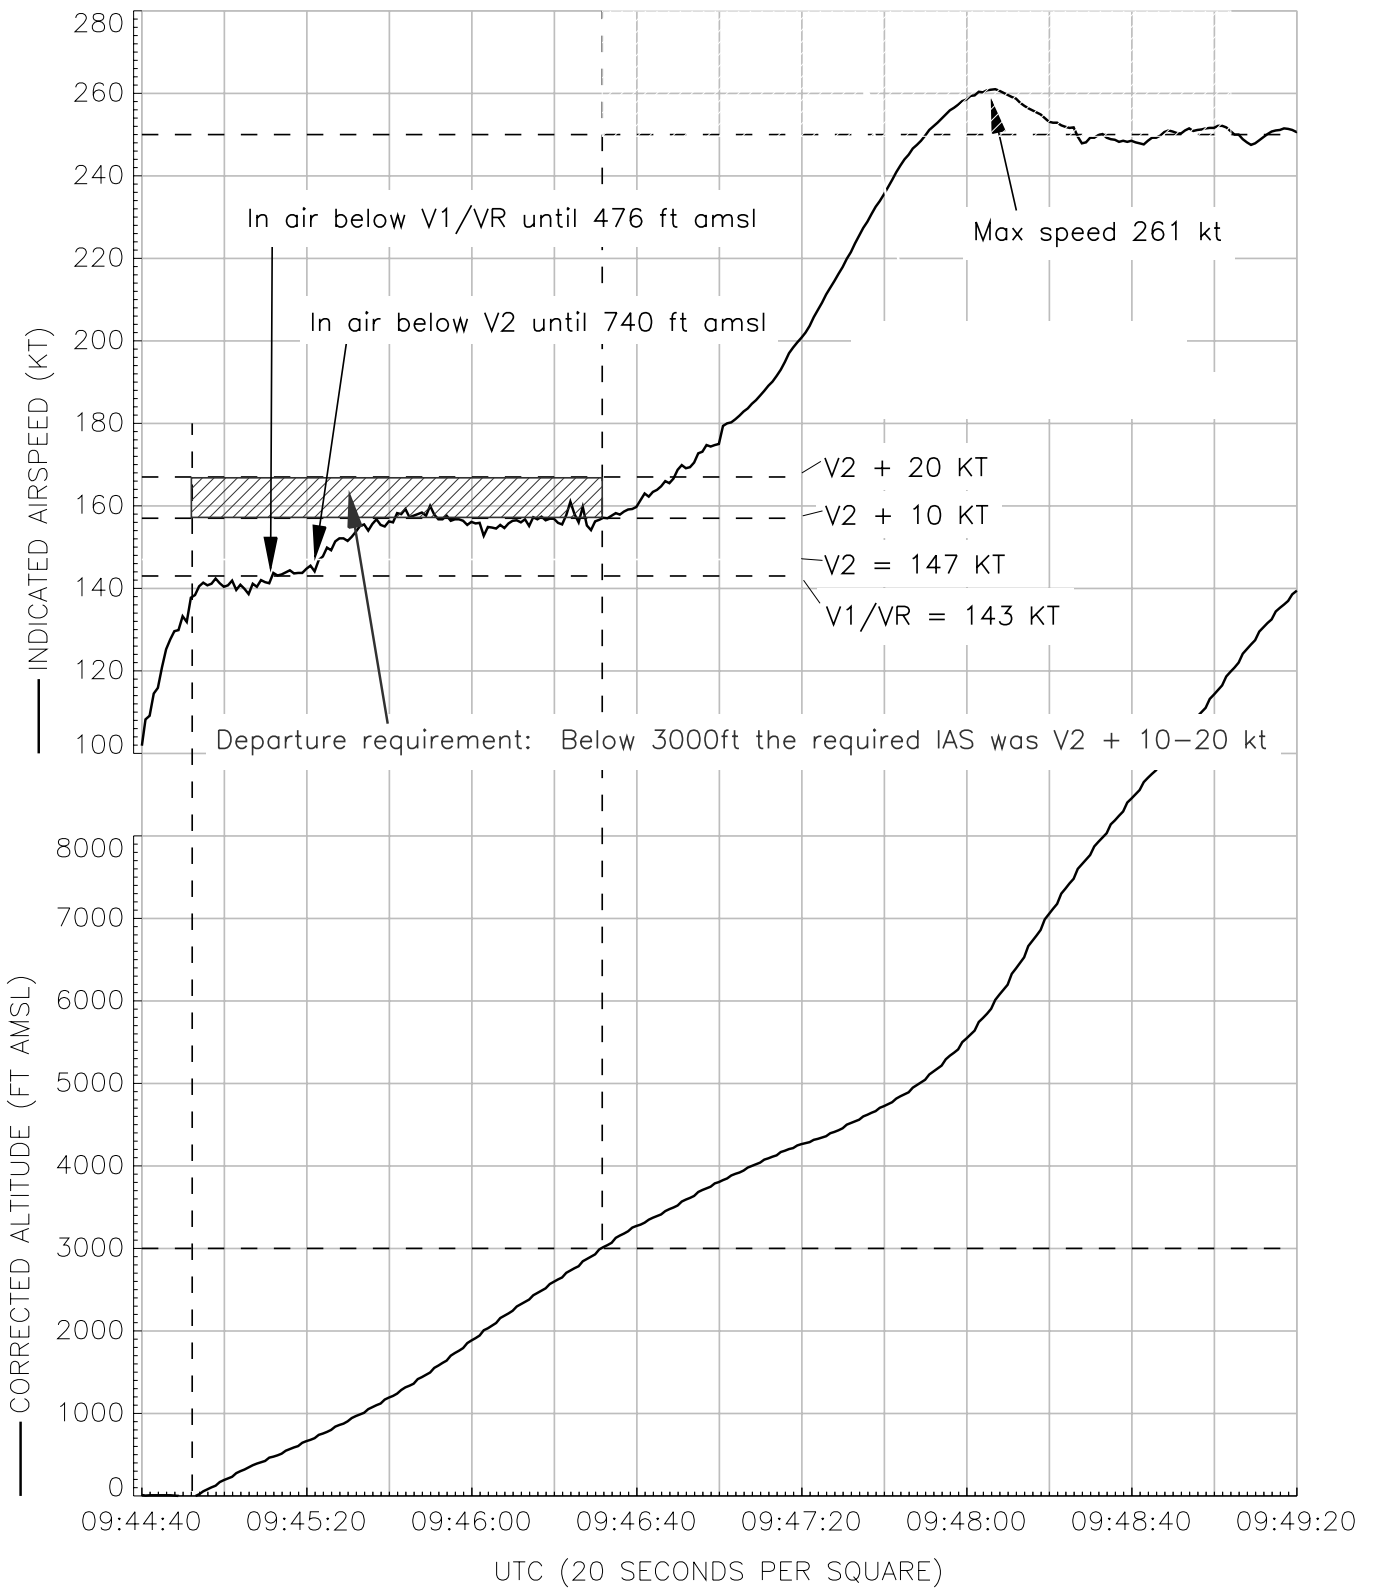
**Figure 5**

Figure 5 shows the aircraft speed and altitude compared to the noise abatement procedure requirements applicable to the departure from Schiphol Airport. The aircraft did not reach the  $V_1/V_R$  speed of 143 kt until passing 460 ft amsl (about 470 ft aal) and did not reach  $V_2$  until passing 740 ft amsl (about 750 ft aal). The target initial climb speed was achieved at a height of 1,100 ft aal.

FDR parameters showing recorded airspeed relative to required airspeed after takeoff  
(Incident to G-DBCI on 18 April 2007)
