CONTENTS

SPECIAL BULLETINS

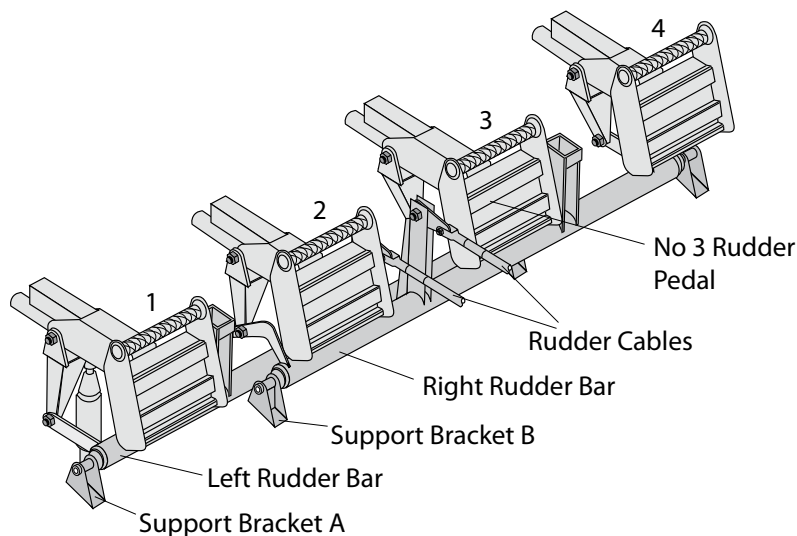
Figure 2

Primary flight controls are conventional, operated by dual cockpit controls. Rudder pedal assemblies are numbered from 1 to 4 across the aircraft from left to right (Figure 2). The pedals are mounted on two rotatable cross-shafts in the cockpit, known as rudder bars, with the left pedal of each pair (Nos 1 and 3) fixed to the left bar and the right pedals (Nos 2 and 4) fixed to the right bar. A crank arm on each bar is connected to rudder operating levers by a cable-fairlead system. Thus, a forward displacement of the No 1 pedal, for example, rotates the left bar and moves the No 3 pedal forward in unison, while the connection through the cable loop causes the right bar to rotate in the opposite direction and displace the Nos 2 and 4 pedals aft.

No signs were found that the engine control cable bracket was incorrectly sized or positioned. The aircraft manufacturer reported that, although no witness marks could be found to confirm a positive foul, their inspection showed there was excessive end-float (ie lateral movement) of the left rudder bar, estimated at around 1.5 mm, and that the left support bracket for the left bar (Bracket A in Figure 2) was angled over to the left. After removal of the rudder bars from the aircraft, cracking of the floor beneath Bracket A was found. No

Cases of distortion of Bracket A had occurred previously, attributed by the manufacturer to an excessive steering angle during towing. It was noted that, whereas the left mounting bracket for the right rudder bar (Bracket B, Figure 2) had a lateral web member that would increase its resistance to either elastic or permanent lozenging under lateral loads, this feature was not present on Bracket A.
