**(ALL TIMES IN THIS BULLETIN ARE UTC)**

**ACCIDENT**

<b>Aircraft Type and Registration:</b>	Boeing 777-222, N786UA	
<b>No &amp; Type of Engines:</b>	2 Pratt & Whitney PW4090 series turbofan engines	
<b>Year of Manufacture:</b>	1997	
<b>Date &amp; Time (UTC):</b>	26 February 2007 at 1000 hrs	
<b>Location:</b>	London (Heathrow) Airport	
<b>Type of Flight:</b>	Commercial Air Transport (Passenger)	
<b>Persons on Board:</b>	Crew - 20	Passengers - 185
<b>Injuries:</b>	Crew - None	Passengers - None
<b>Nature of Damage:</b>	Heat and fire damage to the right main power distribution panel, surrounding structure and components inside the Main Equipment Centre	
<b>Commander's Licence:</b>	Airline Transport Pilot's Licence	
<b>Commander's Age:</b>	52 years	
<b>Commander's Flying Experience:</b> (Hours all approximate)	18,000 hours (of which 2,800 hours were on type) Last 90 days - 215 hours Last 28 days - 65 hours	
<b>Information Source:</b>	AAIB Field Investigation

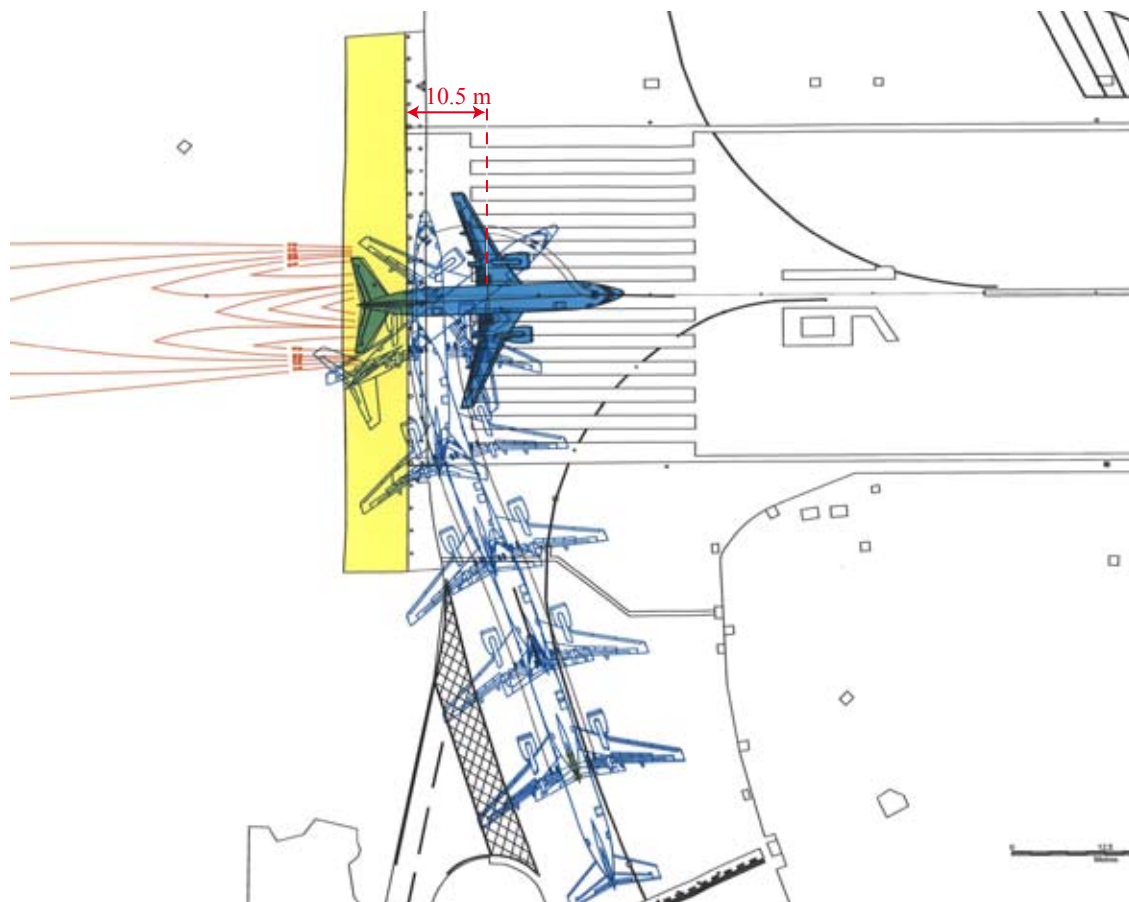
**Figure 4**

Predicted line-up path for a 737-400 trying to maximize takeoff distance available without running over the blast pad (blast pad shown in yellow)

Modelling used by the AAIB (Figure 4) indicated the minimum alignment distance attainable would leave the aircraft's main wheels about 10.5 metres from the threshold. To achieve this the aircraft would have to enter the runway and run its left main wheel along the edge of the threshold before turning around the right main wheel onto the runway centreline. Once lined up in this manner the aircraft's main wheels are positioned 10.5 m in from the runway threshold and the aircraft's tailplane is directly over the blast pad. The modelling further indicated that, if the aircraft had followed the 'lead on' lines onto the runway, its main wheels would have been about 66 metres from the threshold when aligned with the centreline.

The damage to G-DOCT's left tailplane and left elevator was caused by one or more strikes from large sections of asphalt that had been lifted from the blast pad by the force of the aircraft's jet blast. The largest section of dislodged asphalt found was approximately 1.8 m by 1.5 m, but the 2.4 m dent on the underside of the tailplane indicated that it had been struck by a larger section which had then split. The flight crew of the following aircraft, who had observed the lifting of the asphalt sections, estimated the largest to be 2 m by 3 m, and such a section, 6 cm thick, would have weighed approximately 756 kg. It was not possible to determine accurately where the tailplane was located relative to the blast pad at the time of the strikes, but it would have been positioned approximately where it is depicted in Figure 4.

damage because the pad was not designed to withstand the taxiing loads of aircraft. From the modelling shown in Figure 4 it was determined that the left gear would have passed very close to, and possibly directly over, the blast pad in order to place the tailplane in a position to be struck by blown sections of the pad. On this occasion, both the flight crew of G-DOCT and that of the following aircraft stated that no wheel passed over the blast pad. It is probable, however, that in the past other aircraft had taxied over the blast pad surface because aircraft had been observed manoeuvring close to the runway end and an aircraft tyre mark was seen on the re-surfaced blast pad. The cumulative effect of these occasional aircraft taxiing loads could have weakened the blast pad surface.
