MARINE ACCIDENT INVESTIGATION BRANCH

FISHING ACCIDENT REPORT

The Loss of *Solway Harvester*

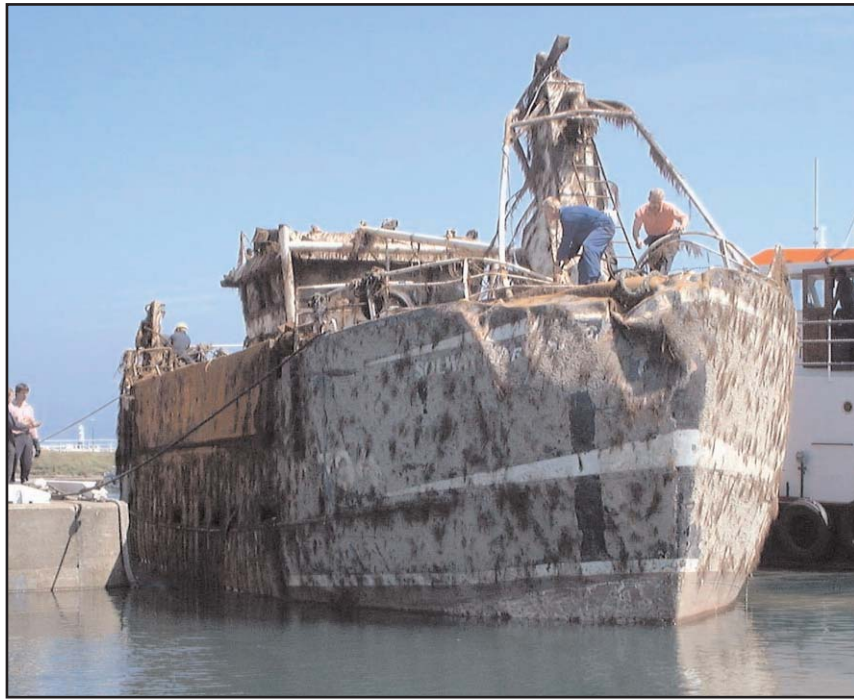
All the evidence indicates *Solway Harvester* began to take water into her fish hold through open ice scuttles while she was making way during the late afternoon of 11 January 2000. She was, at that time, heading for shelter in the lee of the Isle of Man. It was a foul night, and a strong south-westerly wind was blowing. She stopped and, with the way off her, came beam to sea and started to roll heavily. The floodwater in the fish hold reduced her stability to such an extent that she became vulnerable to a capsize. The heavy rolling in large waves caused her cargo of bagged scallops and loose gear to shift and this, together with the reduced stability, caused her to capsize at about 1745.

With about 6 to 9 tonnes of water in her fish room, evidence of a shift in weight on board, the failure of her watertight integrity and the effects of heavy rolling meant she lost her stability. A capsize was inevitable.
