(ALL TIMES IN THIS BULLETIN ARE UTC)

INCIDENT

Aircraft Type and Registration:	Airbus A319-111, G-EZIU	
No & Type of Engines:	2 CFM56 turbofan engines	
Year of Manufacture:	2005	
Date & Time (UTC):	6 February 2007 at 1146 hrs	
Location:	En route to from Barcelona to Liverpool	
Type of Flight:	Commercial Air Transport	
Persons on Board:	Crew - 6	Passengers - 78
Injuries:	Crew - None	Passengers - None
Nature of Damage:	None	
Commander's Licence:	Airline Transport Pilot's Licence	
Commander's Age:	46 years	
Commander's Flying Experience:	Total 12,500 hours (of which 2,166 were on type) Last 90 days - 81 hours Last 28 days - 26 hours	
Information Source:	AAIB Field Investigation

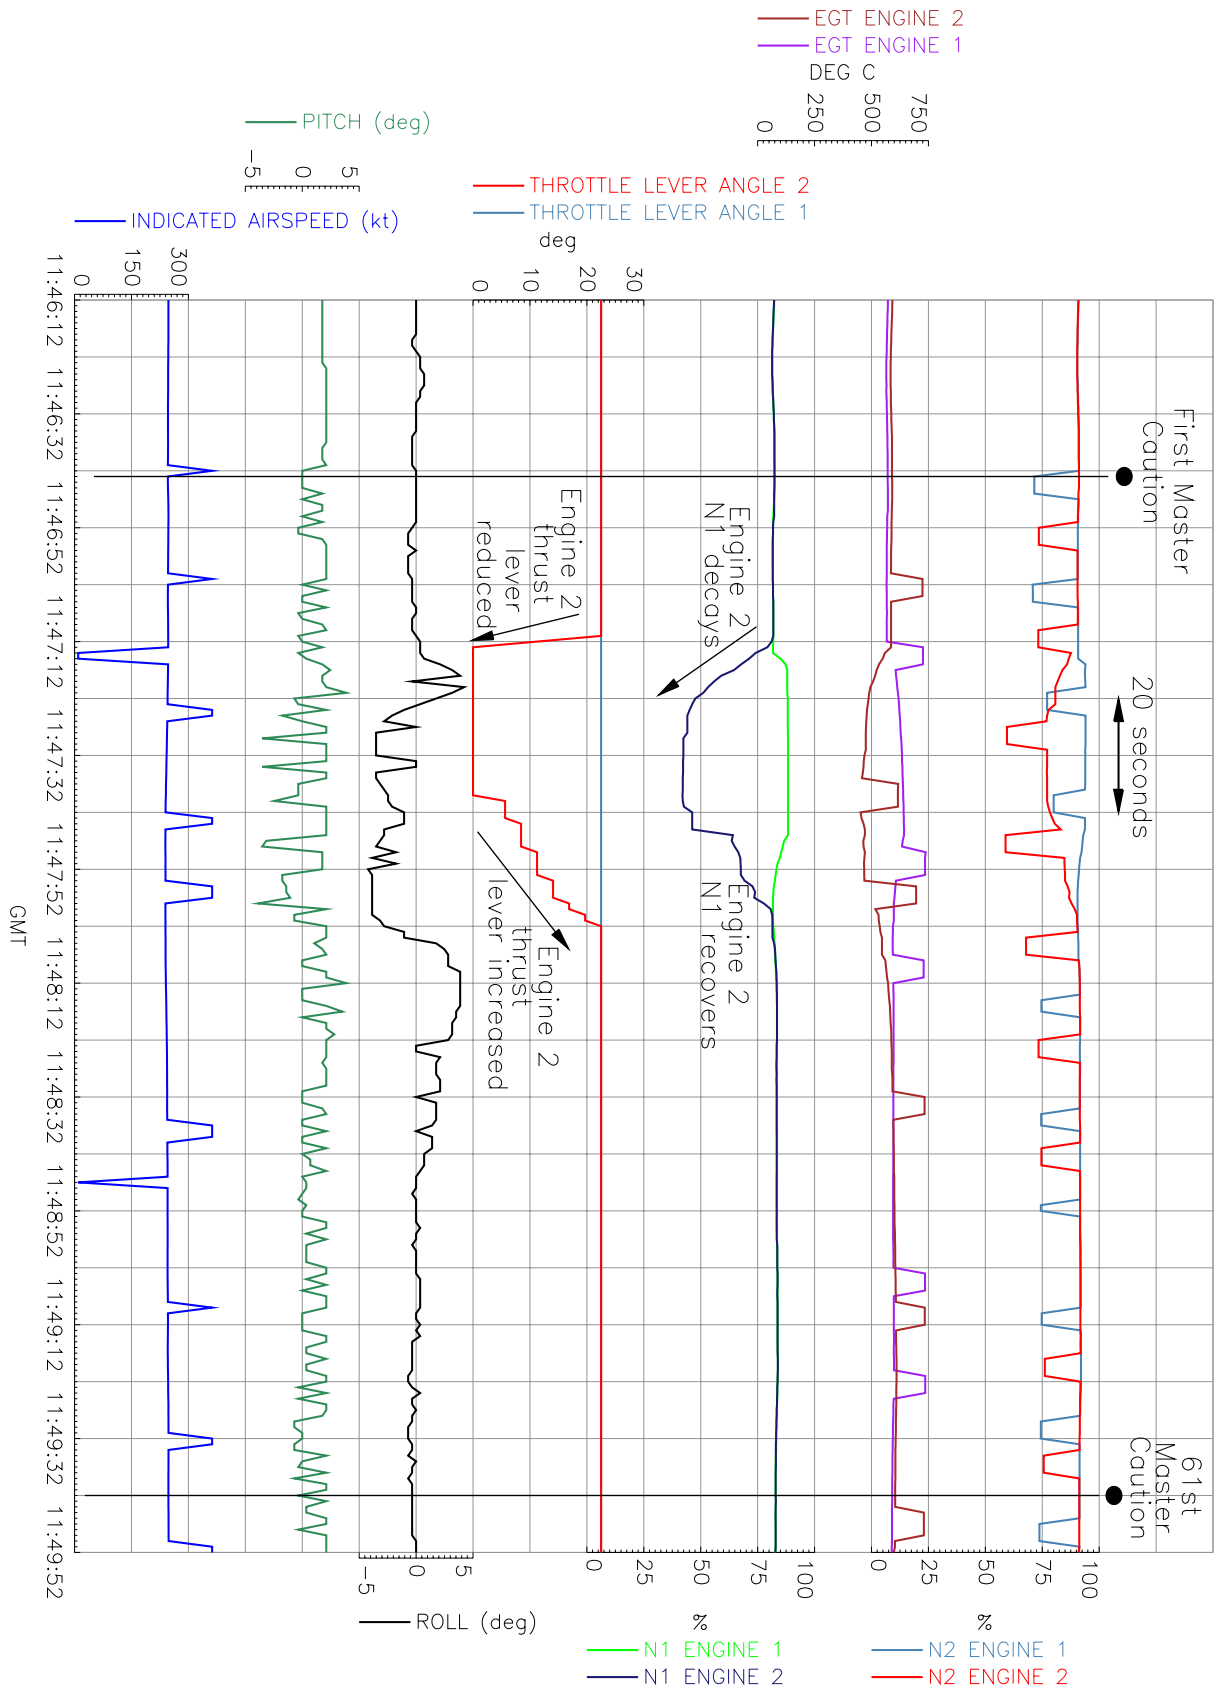
Figure 1

G-EZIU Relevant FDR Parameters

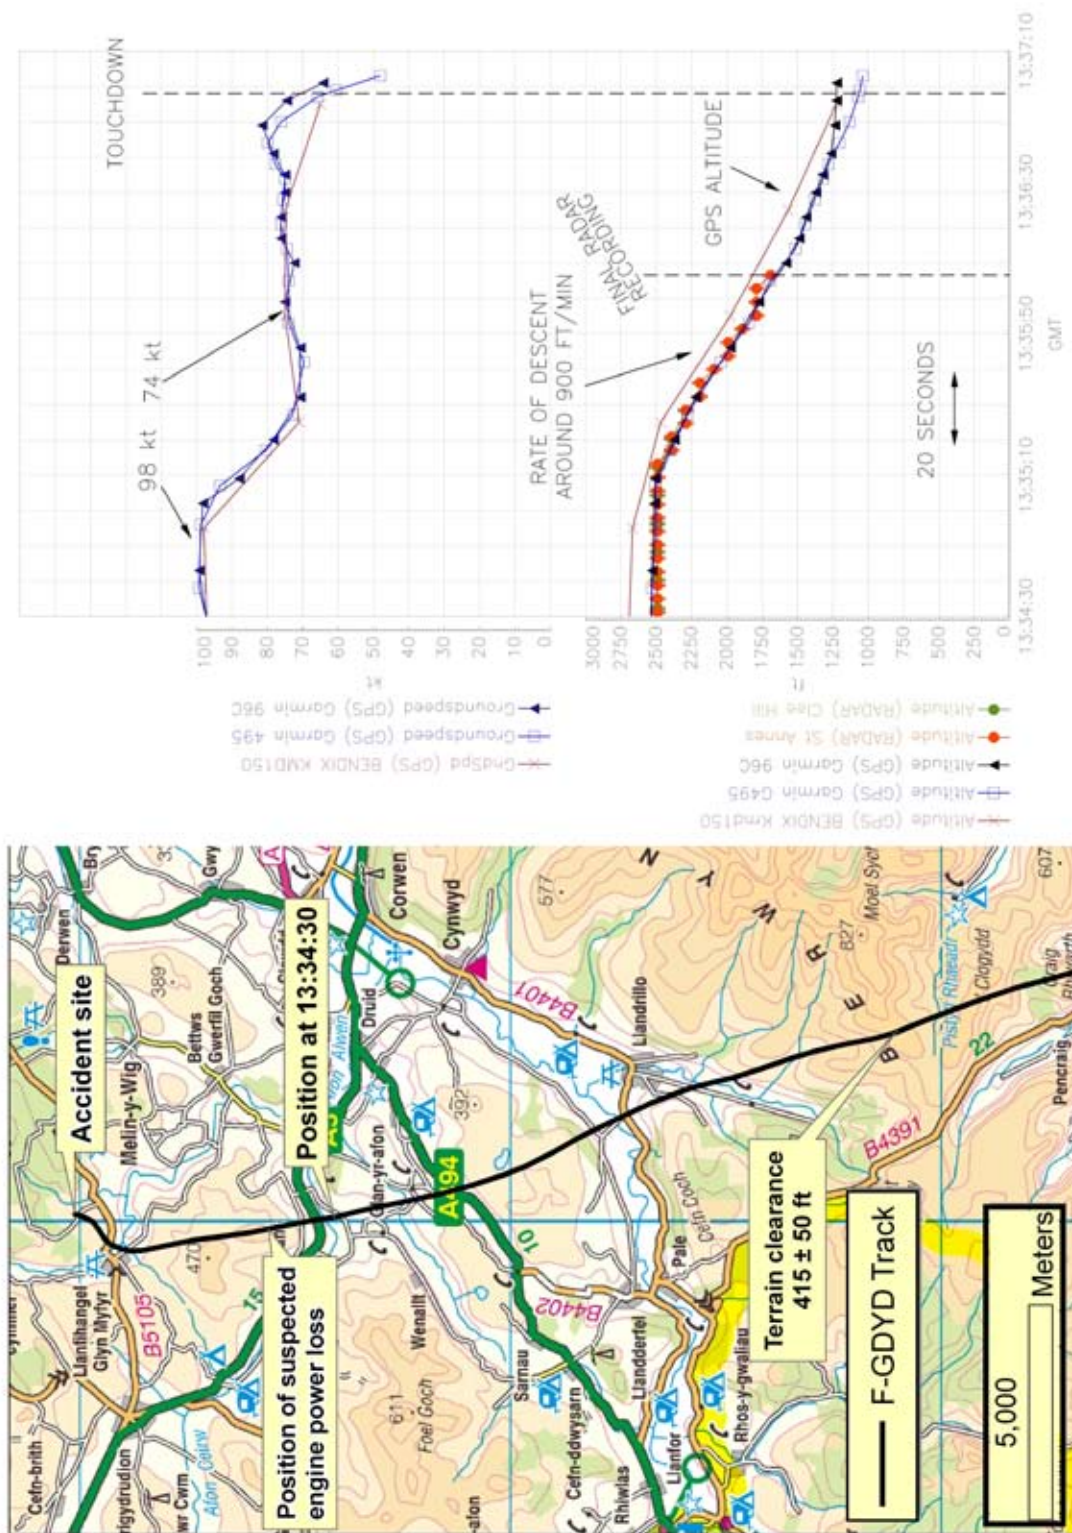
Figure 1

At 13:35:07 hrs, the GPS derived groundspeed showed the aircraft speed starting to decay from 98 kt. This is the point at which it was suspected that loss of engine power occurred. Nine seconds later, recorded radar data confirmed that the aircraft began to descend from 2,500 ft amsl.

Airspeed and altitude continued to decrease for about 35 seconds following the suspected loss of engine power. The groundspeed then appeared to stabilise at approximately 74 kt, while the recorded radar and GPS altitudes suggested a rate of descent of about 900 ft/min. F-GDYD passed overhead Llanfihangel Glyn Myfyr at 13:36:28 hrs at a GPS altitude of between 1,375 ft and 1,530 ft amsl.

F-GDYD GPS and radar data¹

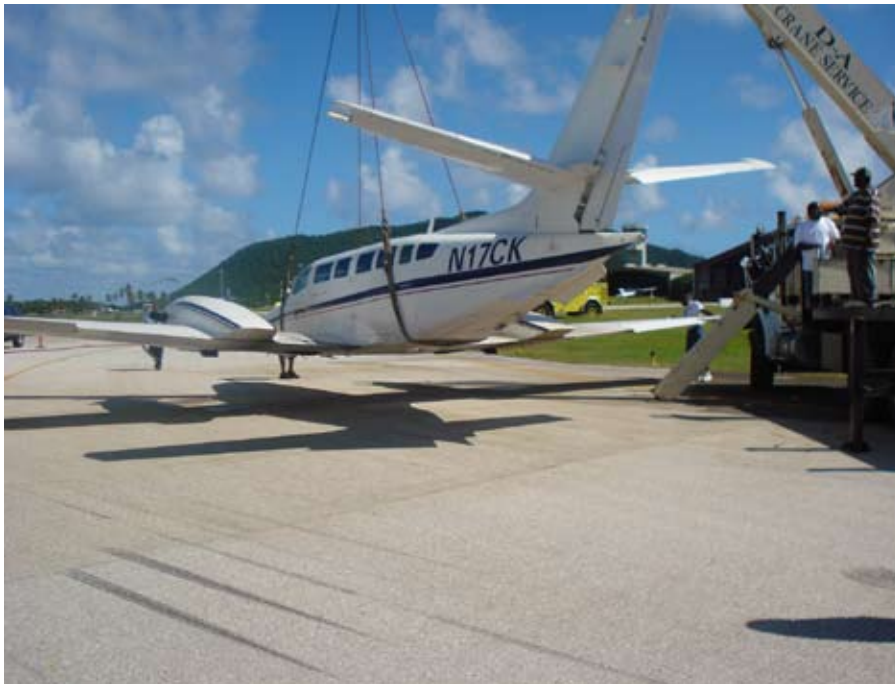
Figure 1
Recovery Operation (courtesy ASSI)

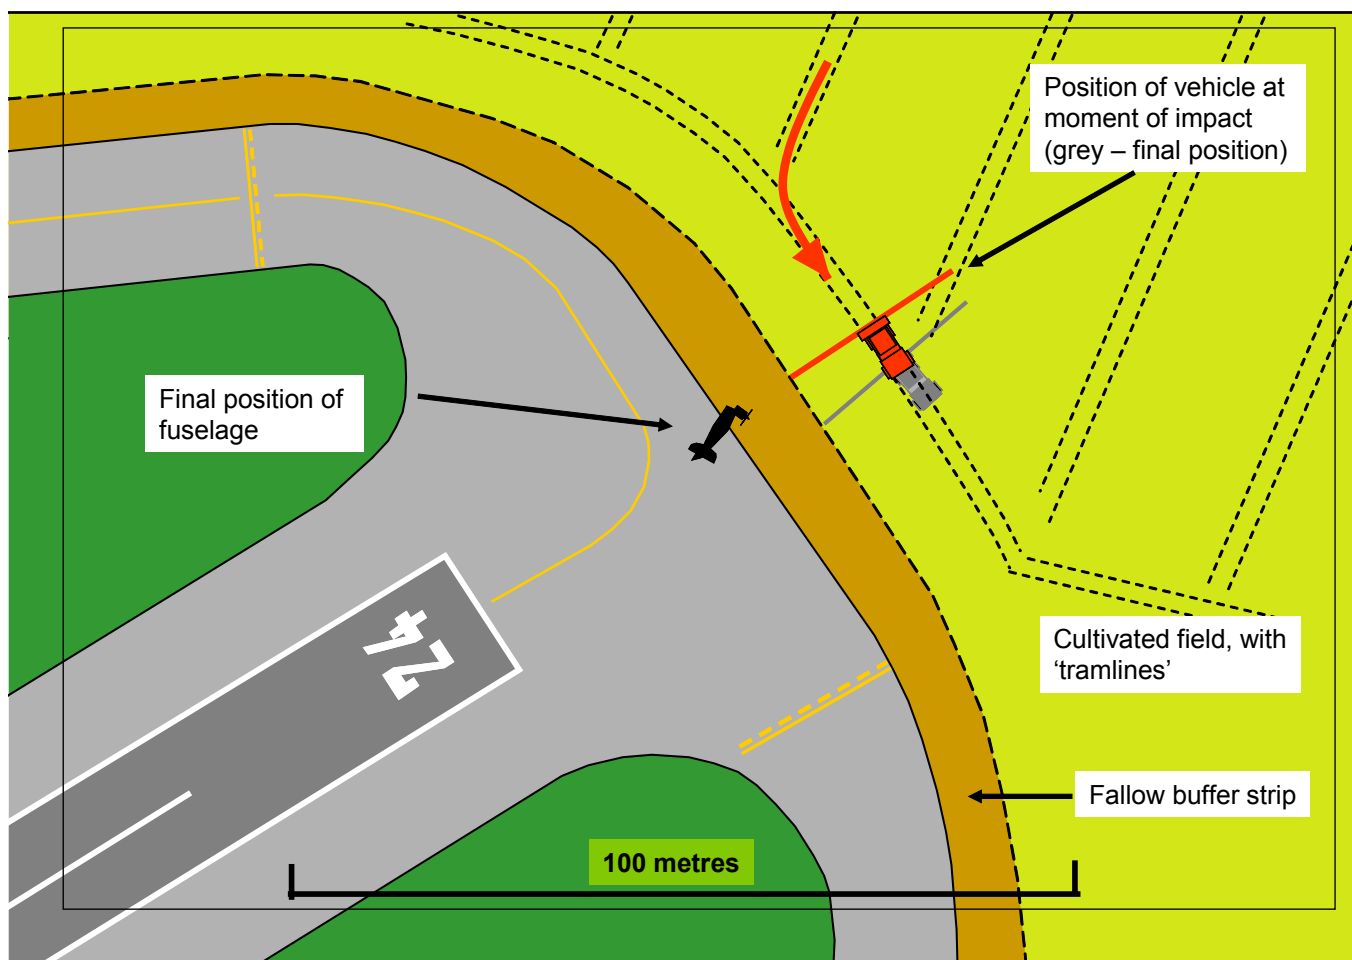
Figure 1

Plan of accident area, showing positions of spray vehicle and aircraft fuselage

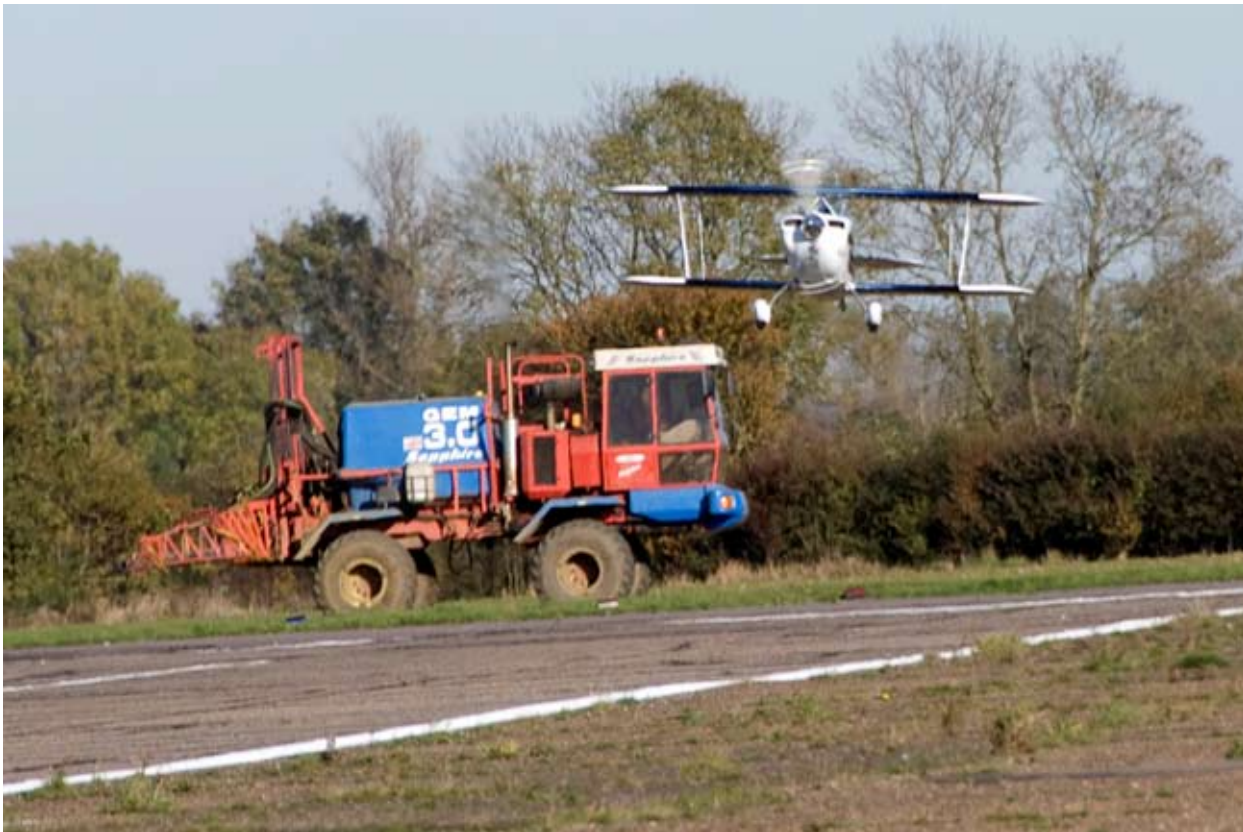
Figure 2 shows a photograph of the aircraft and vehicle shortly before the impact, taken from the photographer's position beside the runway. The crop-sprayer was a

In Figure 2, the blur of the rotating propeller is clearly apparent, and this enabled the angular arc of a propeller blade leading edge to be measured. Together with knowledge of the camera shutter speed, this led to the determination of an engine speed of approximately 1,960 rpm. Potential errors in the measurement process

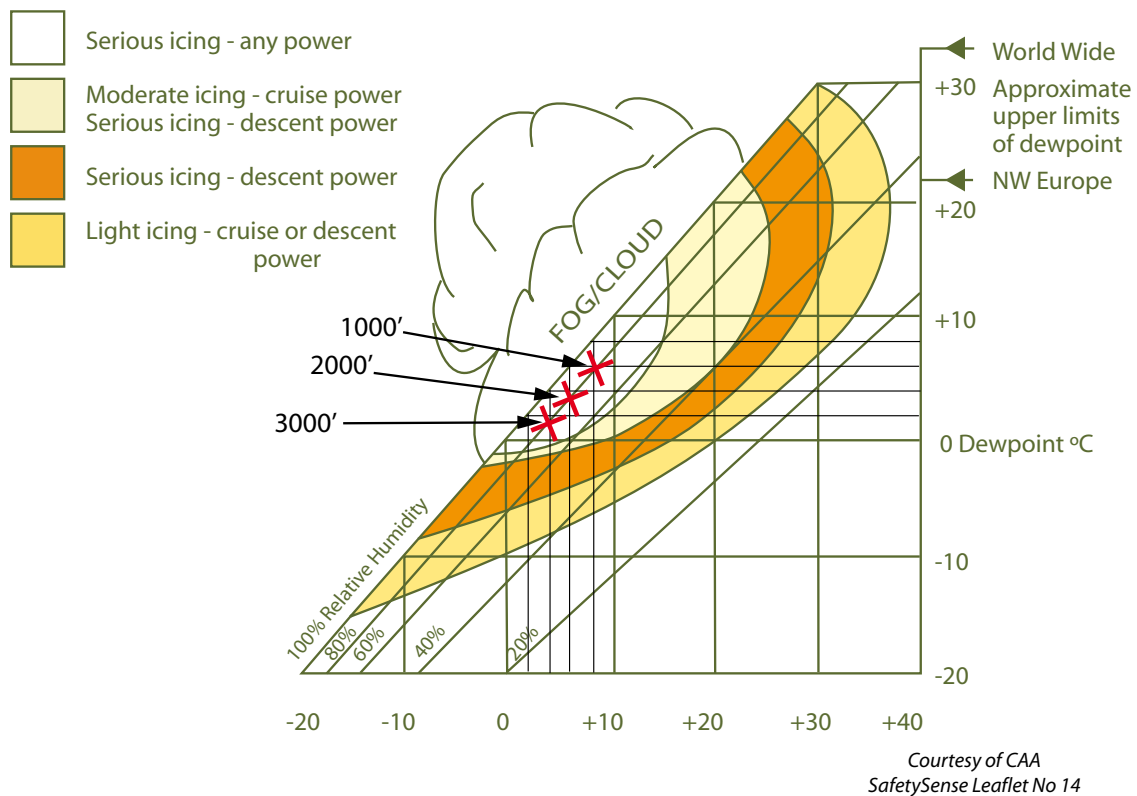
The Met Office aftercast for the Robin Hood's Bay area at the time of the accident gave the air temperature, dew point and humidity from the surface to 3,000 feet in bands of 500 ft. When these figures were plotted on the Civil Aviation Authority (CAA) Carburettor Icing Prediction Chart it gave a prognosis that serious carburettor icing could occur at any power setting between 1,000 and 3,000 feet amsl (Figure 1).

Figure 1
CAA carburettor icing probability chart

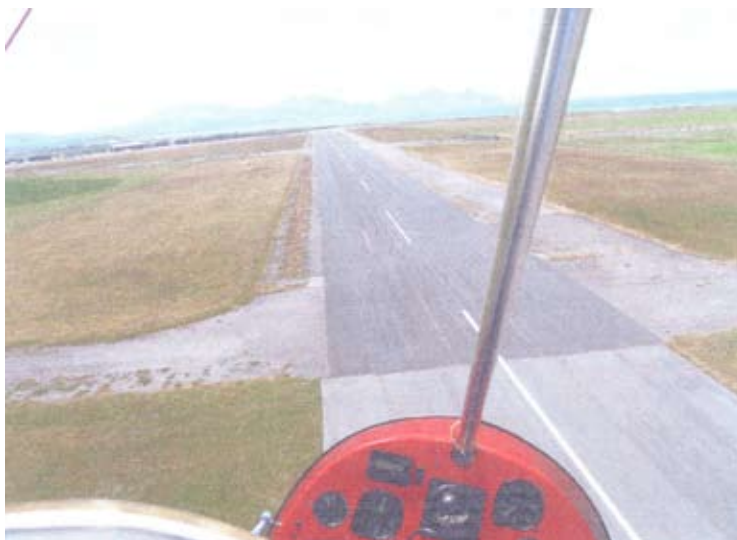
Figure 1

making the necessary corrective control movements in turbulence and realised afterwards that he had been low and slow, about 42 mph to 45 mph. He reported that this had been corrected shortly before touchdown. However, over the threshold the aircraft was destabilised, possibly by a gust of wind, and drifted to the left of the runway centreline (see Figure 1). The aircraft touched down on the left main wheel first, then rolled to the right and pivoted about the right main wheel. The starboard wing contacted the ground, both wings folded backwards and the trike rolled onto its right hand side and slid along the ground until it stopped. Both occupants were able to get clear of the aircraft without assistance, suffering only minor injuries.

View on short final approach from on board the aircraft before the accident
