CONTENTS

Summary of:	Aircraft Accident Report No: 7/2008	94
	Report on the accident to Aerospatiale SA365N, G-BLUN near the North Morecambe gas platform, Morecambe Bay on 27 December 2006

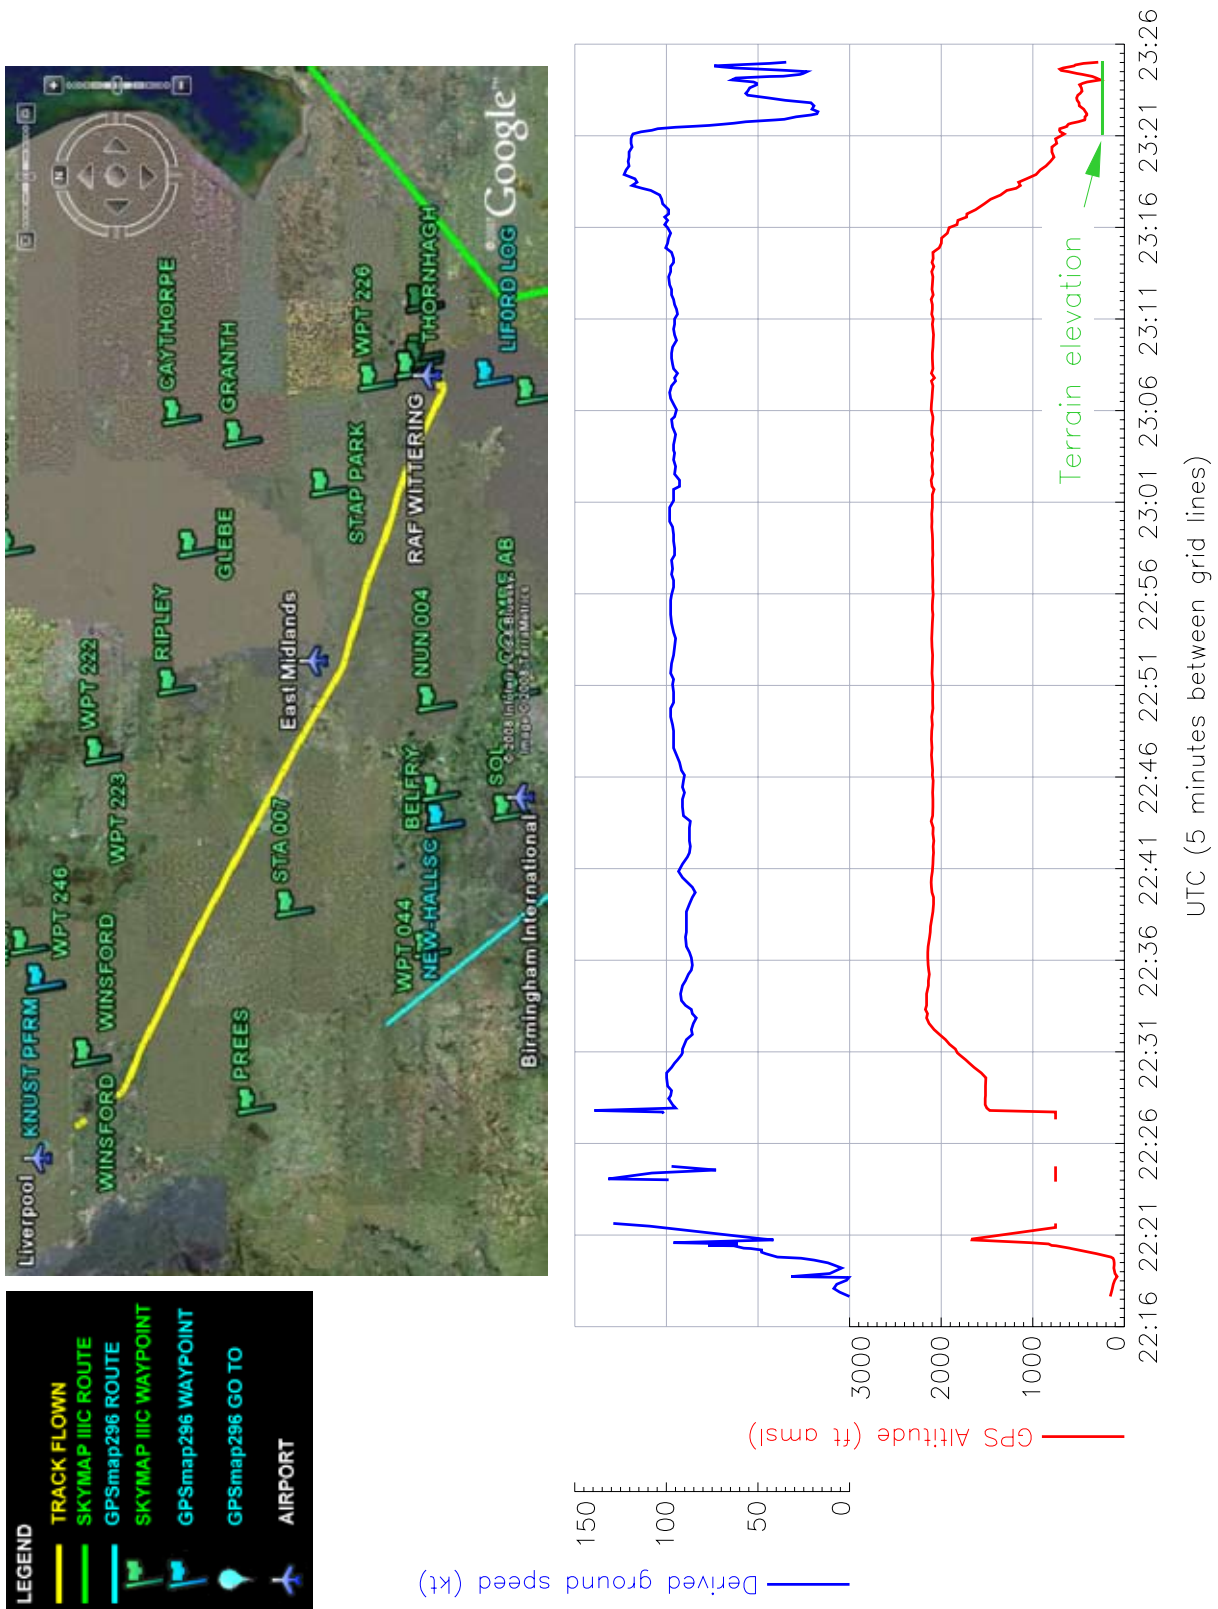
Figure 1 shows the GPS position, altitude and derived ground speed for the accident flight. The data indicates the accident flight departed Liverpool John Lennon Airport at 2219 hrs on 1 May 2007. During its climb after departure, the helicopter initially tracked south-east for 12 nm and then turned onto a track of 120°T. Soon after the turn, the helicopter reached a steady cruise altitude of 2,100 ft amsl and its ground speed stabilised to between 90 kt and 100 kt. When

Track recorded by GPSmap296 and waypoint/route data in the memory of both the GPS receivers.

Figure 1 also shows the waypoints and routes pre-programmed into the GPS units. No pre-programmed route covering any part of the flight from Liverpool to Thornhaugh had been stored in either GPS.

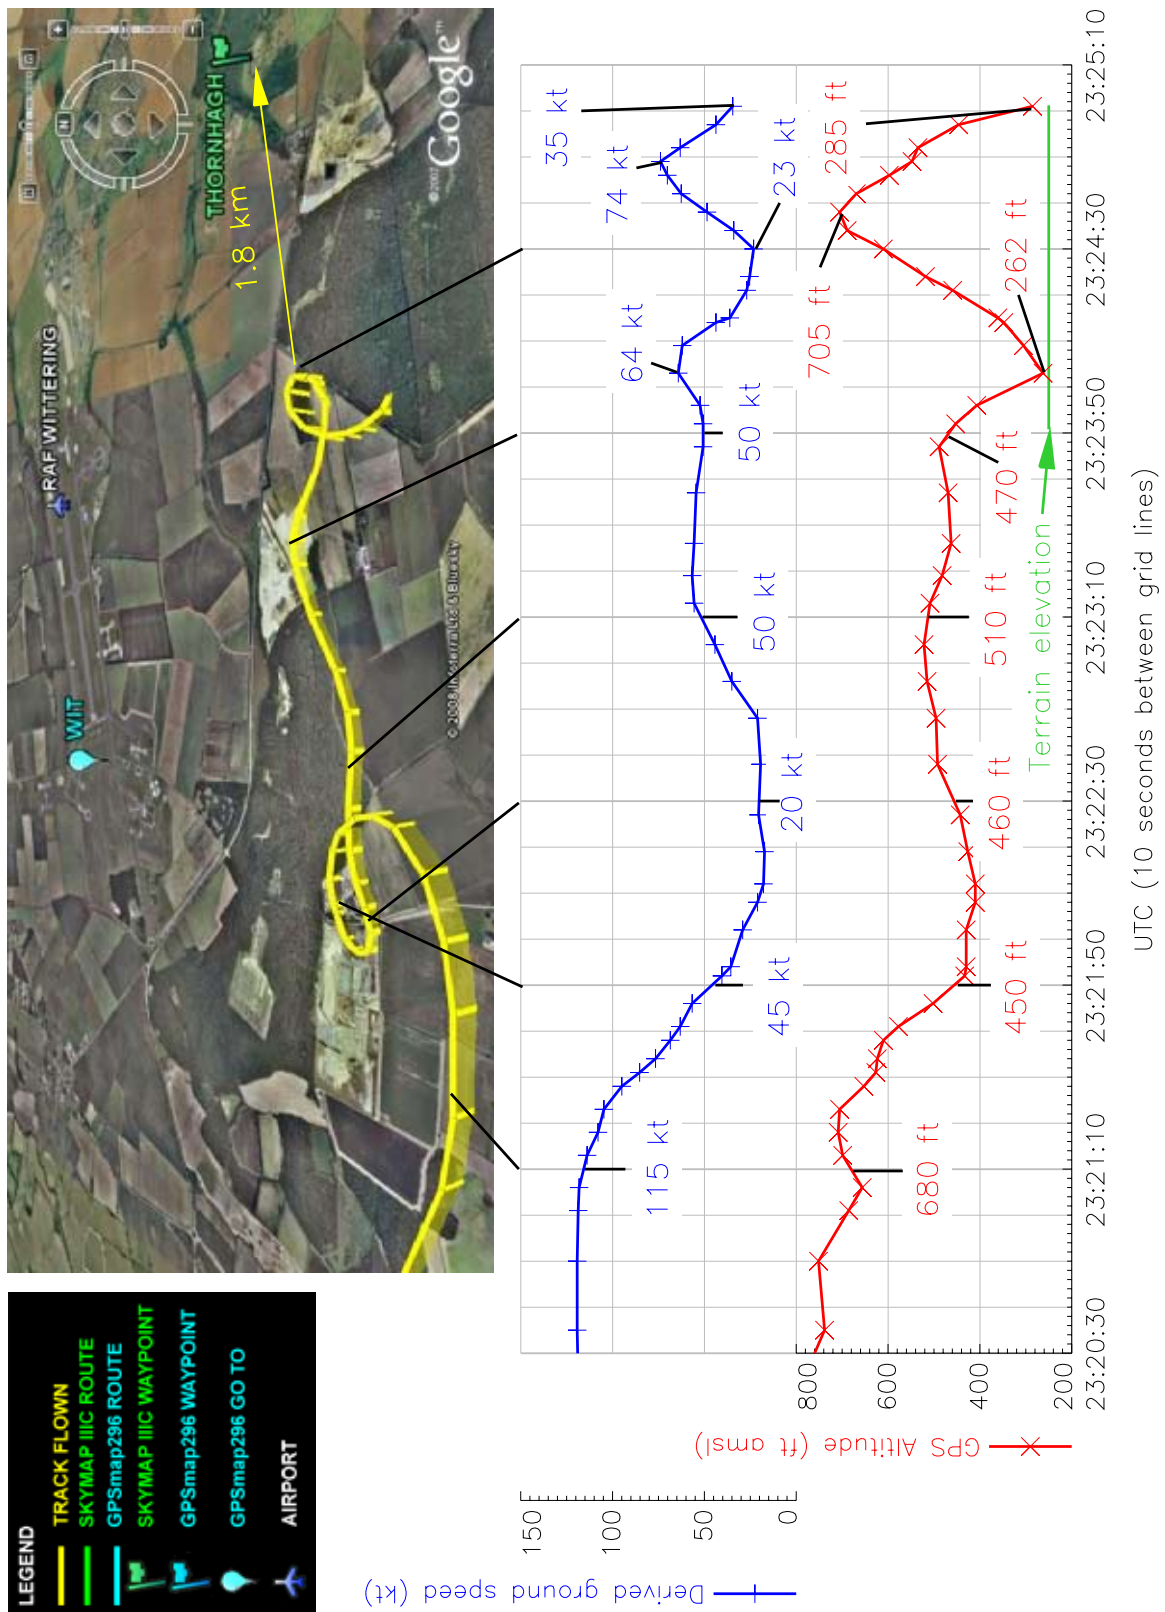
Figure 2 shows the last portion of the flight. The helicopter was briefly levelled at approximately 800 ft amsl before it descended further, with the ground speed reducing. A left orbit was initiated and the helicopter descended to approximately 170 ft agl. The position of this orbit corresponded with the location of a haulage yard. The helicopter then flew further east at less than 300 ft agl, apparently towards a quarry, before altering course approximately 20° to the right. It then dipped to a recorded altitude equating to approximately 20 ft agl³ with a ground speed of 64 kt, following which it immediately climbed and started a left turn. The turn reached a maximum height of 460 ft agl before continuing in a descent that led to the accident site.

Last portion of track recorded by GPSmap296 and waypoint/route data in the memory of both the GPS receivers

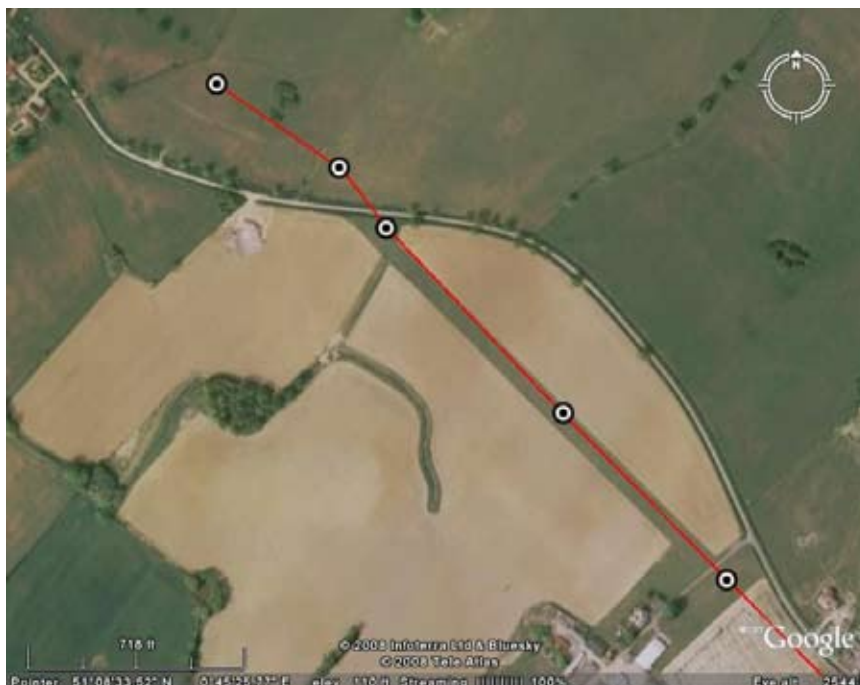
Just before the Runway 32 threshold, the groundspeed derived from GPS position and time was 76 kt with a heading of 315° True. F-PYMD crossed the runway threshold at around 13:51:00, just over two and a half minutes after takeoff commenced. Four further positions were recorded by the GPS as the aircraft continued tracking along the runway. The last five track points represented a ground track distance of 0.4 nm.

Fridd Farm airstrip with final 5 recorded GPS trackpoints
(Google Earth™ mapping service/Infoterra Ltd & Bluesky /Tele Atlas)

Figure 1 also shows the aircraft groundspeeds as derived from the GPS positions over time. Due to the limited number of points over the runway and the inaccuracy of the final track point, speed measurements for the end of the flight cannot be considered accurate.

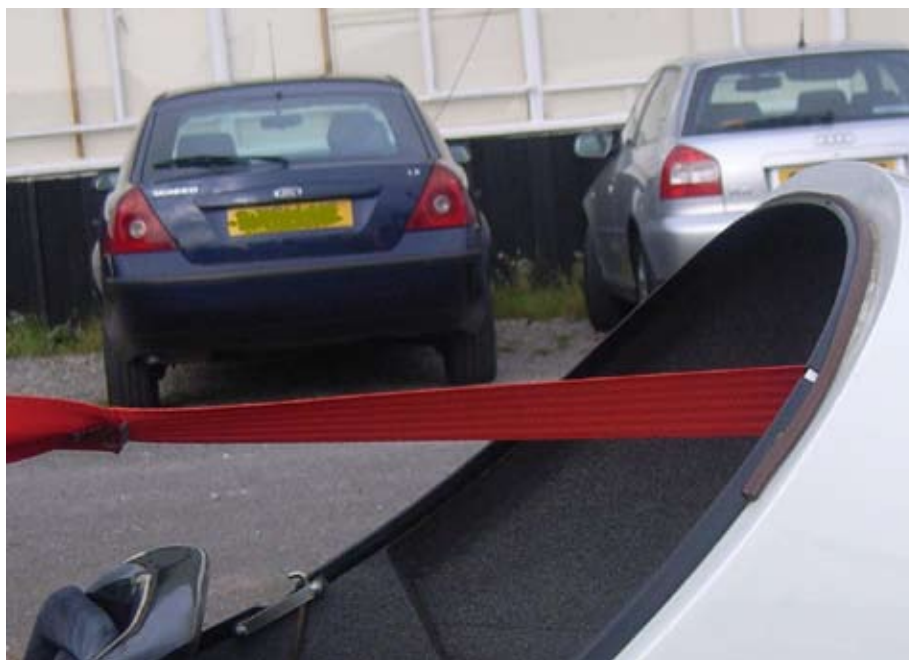
Figure 6 shows the normal position of the shoulder harness. The location of the shoulder harness fittings allows the shoulder harness to remain roughly horizontal when worn; however, given the contour of the fuselage, any application of load on the harness will produce a perpendicular 'peel' load on the bond between the harness fitting and the fuselage. These 'peel' loads would be increased as the size of the occupant of the seat decreased. The bulkhead, constructed of a thin lamination of carbon fibre through which the harness attachment passes, was found to offer little additional resistance to the application of peel loads. The curvature of the fuselage cross section in this area means that it is also possible to introduce torque loads into the fitting if it is not accurately aligned.

harnesses and attachments to be capable of withstanding a '9g' forward deceleration (JAR-VLA.561). Shortly after the introduction of the aircraft type to the UK, the Light Aircraft Association, LAA (formerly the Popular Flying Association) issued a mandatory modification, MOD/301/001 to reinforce the harness attachment fittings with additional carbon fibre 'straps' at the rear of each fitting to improve the resistance of the fitting to peel loads. In 1999 the manufacturer issued Service Bulletin BS 201 0005, which required the installation of two 5 mm bolts to provide additional retention of the fittings. This Service Bulletin is mandatory for aircraft serial number 130 and above, together with earlier serial numbered aircraft already on the UK register and was released to satisfy the requirements of LAA MOD/301/001, The accident aircraft, being on the French register, however, was not required to comply with LAA MOD/301/001 or Dyn'Aero Service Bulletin BS 201 0005.

Normal shoulder harness position

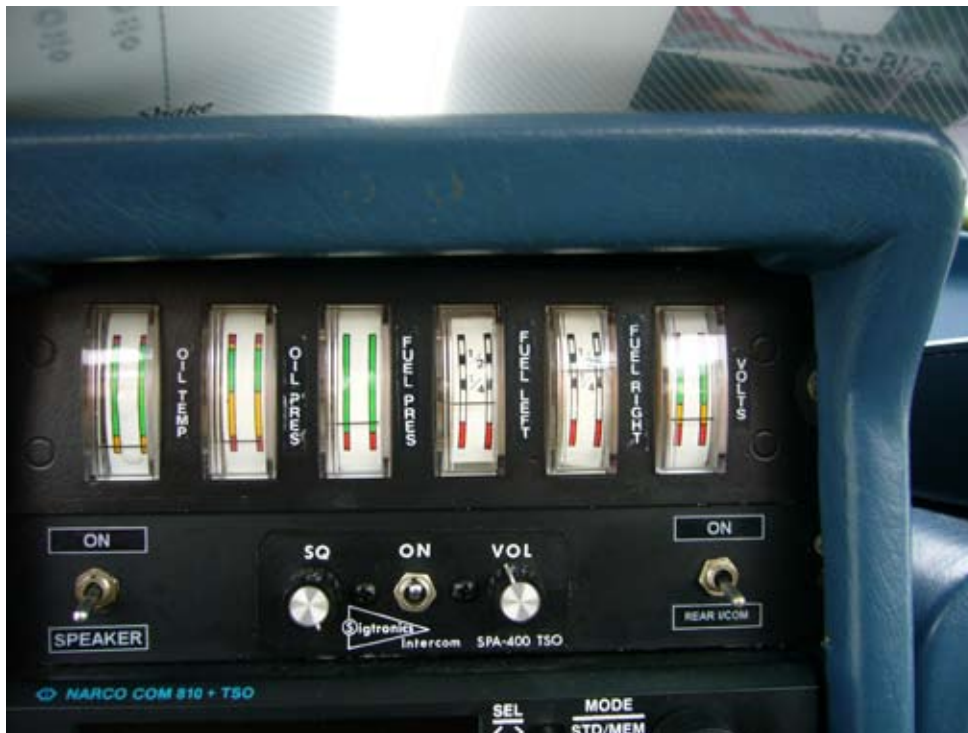
Figure 1

Both the PIC and PNF submitted accident report forms for this accident. Each suggested the cause of the accident was that the PIC did not switch to the appropriate fuel tank to ensure an uninterrupted supply of available fuel to the engine. The PIC candidly observed this was due to inadequate checks being carried out on the downwind leg of the circuit.

The TB9 Pilot Information Manual quotes a figure of 79 litres total and 76 litres usable fuel quantity per tank. After the accident the left tank was drained recovering about one litre of fuel, despite the gauge reading just under a quarter full, between 15 and 20 litres of fuel were later recovered from the right tank, which had indicated just less than half full (Figure 1). This does suggest both gauges were ‘over-reading’ by a similar amount. Airworthiness Directive 1999-062(A) was issued for the TB9 by the DGAC to highlight fuel gauges over-reading at low electrical power supply voltage. However, the maintenance facility repairing the aircraft confirmed the directive was not applicable to this aircraft because of the modification standard. Due to the level of disassembly required to recover the aircraft, it has not been possible to confirm whether any fault existed in the fuel quantity indication system at the time of the accident.

Whilst taking these issues into account, it is generally accepted that light aircraft fuel content gauges should not be relied upon, particularly at low tank quantities and with varying aircraft attitudes. The TB9 Pilot Information Manual reflects best practice in requiring a pre-flight inspection of the physical tank quantity. With knowledge of the approximate engine fuel burn rate this gives a secondary indication of remaining fuel in each tank. The CAA-published General Aviation Safety Information Leaflet (GASIL) Issue 2 of 2008 highlights the importance of this technique, particularly when converting to a new aircraft type.
