CONTENTS

SPECIAL BULLETINS

Airbus A319-111	G-EZAC	15-Sep-06	1
-----------------	--------	-----------	---

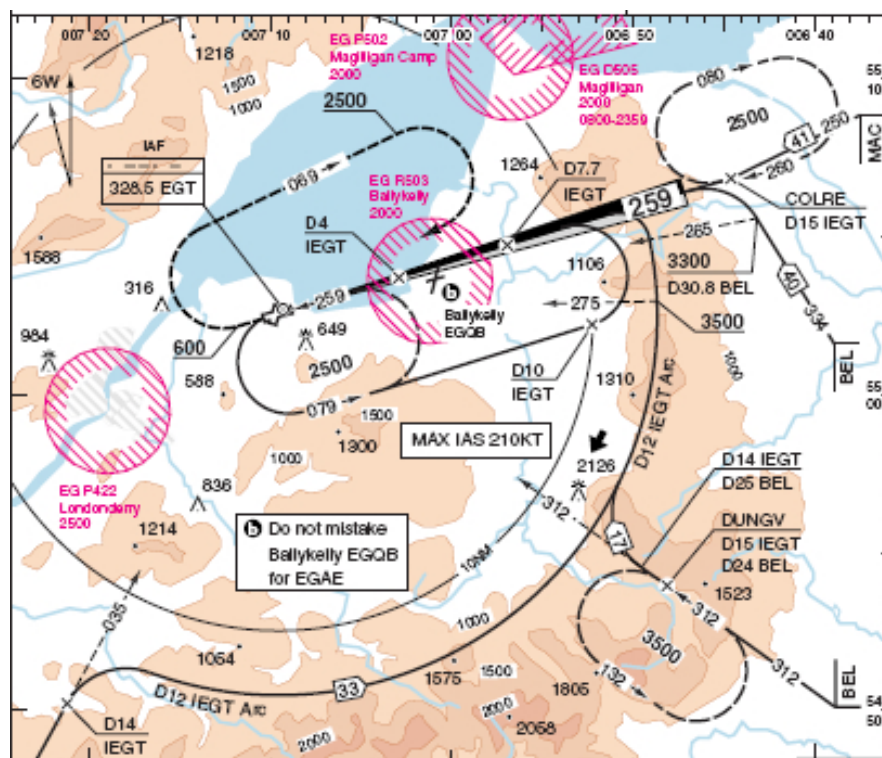
Figure 6

provider of airfield charts. As a result of this incident, they have changed their provider, although their original provider has now amended its charts, including a change to the symbol for BKL, to clarify the information presented to flight crews, Figure 6.

Modified version of the chart shown in Figure 4

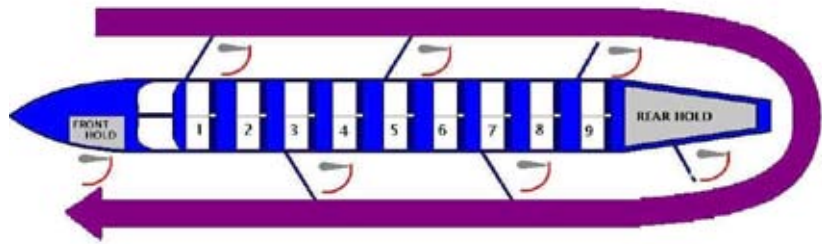
Figure 1

Trislander walk-round route for ground staff

instructed ground staff to walk clockwise around the aircraft from its starboard to its port side, checking each door in turn. The new procedure has been successful in eliminating this type of occurrence. The operator of G-LCOC stated that it intends to introduce a similar procedure, the relevant text of which is reproduced below together with a diagram (Figure 1).

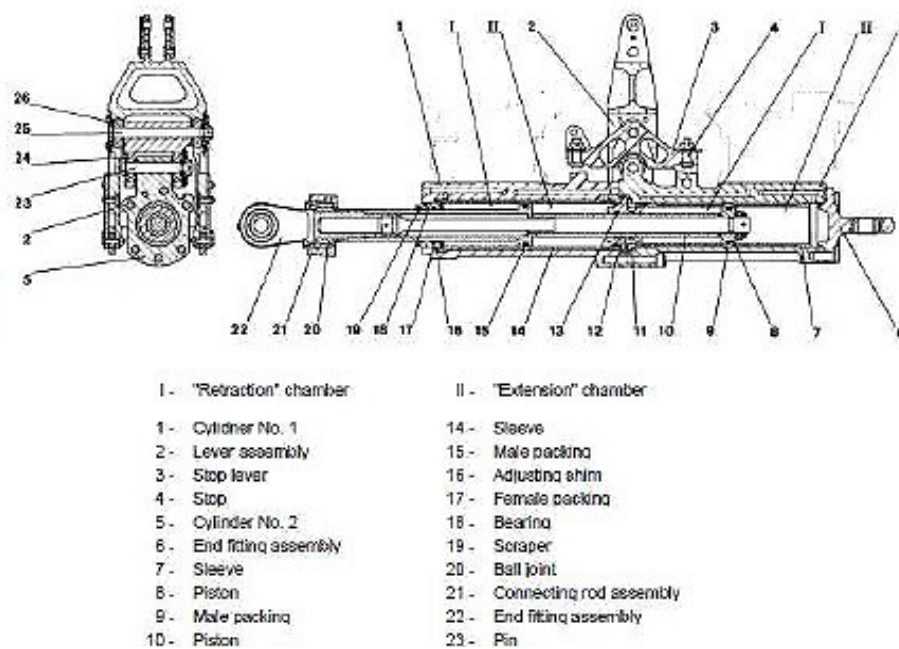
Figure 2

The AS322 has dual hydraulic systems and, to achieve the necessary redundancy in the primary flying controls, the main rotor servo actuators have a tandem arrangement (see Figure 2) in which each hydraulic system supplies power to separate pistons, although the pistons are on a common shaft forming part of a single actuator. Either system can control the helicopter on

AS332L main rotor servo actuator

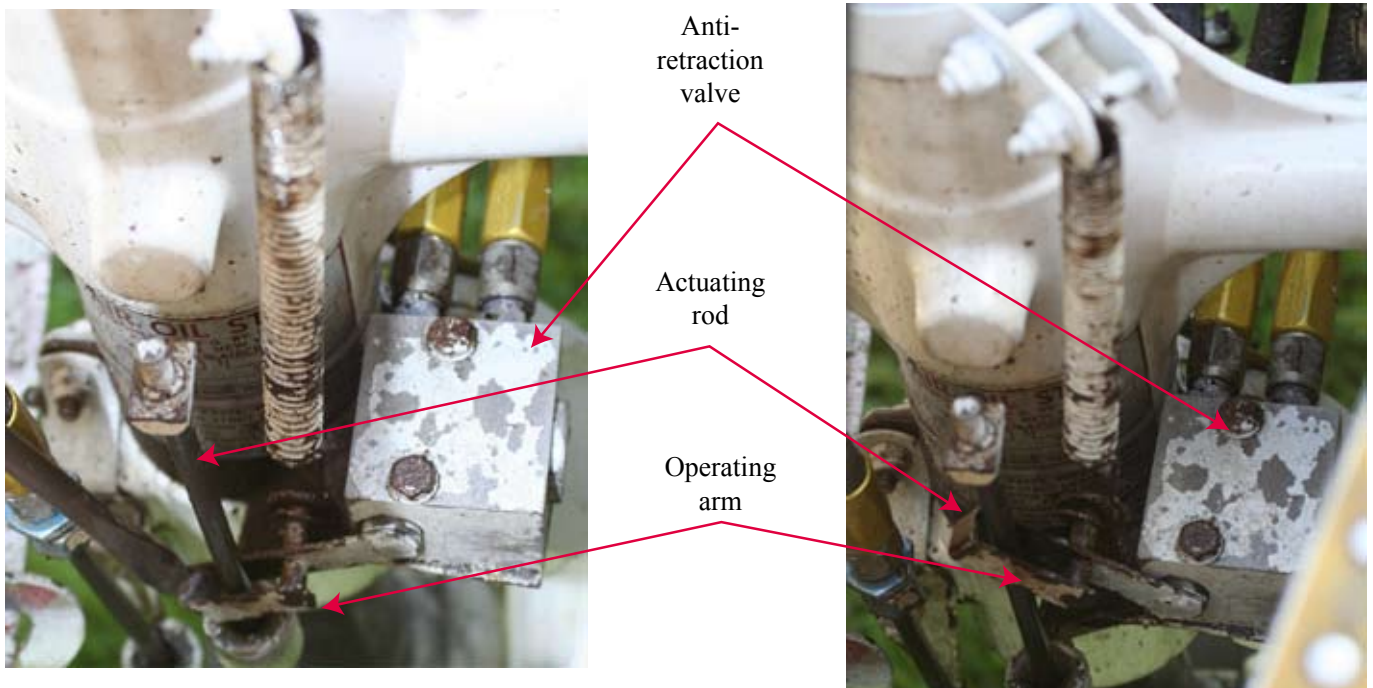
Figure 1

Figures 1 and 2 respectively show the anti-retraction valve in the closed position, ie aircraft in flight, and the open position, ie aircraft on the ground. The actuating rod is attached to the left main landing gear; when the oleo is in the compressed position, the rod is pushed

Anti-retraction valve in closed position
- aircraft in flight
