CONTENTS

Summary of: Aircraft Accident Report No: 1/2011 136
Eurocopter EC225 LP Super Puma, G-REDU
Near the Eastern Trough Area Project Central Production Facility Platform
in the North Sea on 18 February 2009

INCIDENT

Aircraft Type and Registration:	Airbus A321-231, G-MEDJ
No & Type of Engines:	2 International Aero Engines V2533-A5 turbofan engines
Year of Manufacture & Serial No:	2004, MSN 2190
Date & Time (UTC):	24 August 2010 at 0225 hrs
Location:	At FL360 over northern Sudan
Type of Flight:	Commercial Air Transport (Passenger)
Persons on Board:	Crew - 7 Passengers - 42
Injuries:	Crew - None Passengers - None
Nature of Damage:	None
Commander's Licence:	Airline Transport Pilot's Licence
Commander's Age:	34 years
Commander's Flying Experience:	Approximately 7,500 hours (of which approximately 1,400 were on type) Last 90 days - 165 hours Last 28 days - 61 hours
Information Source:	AAIB Field Investigation

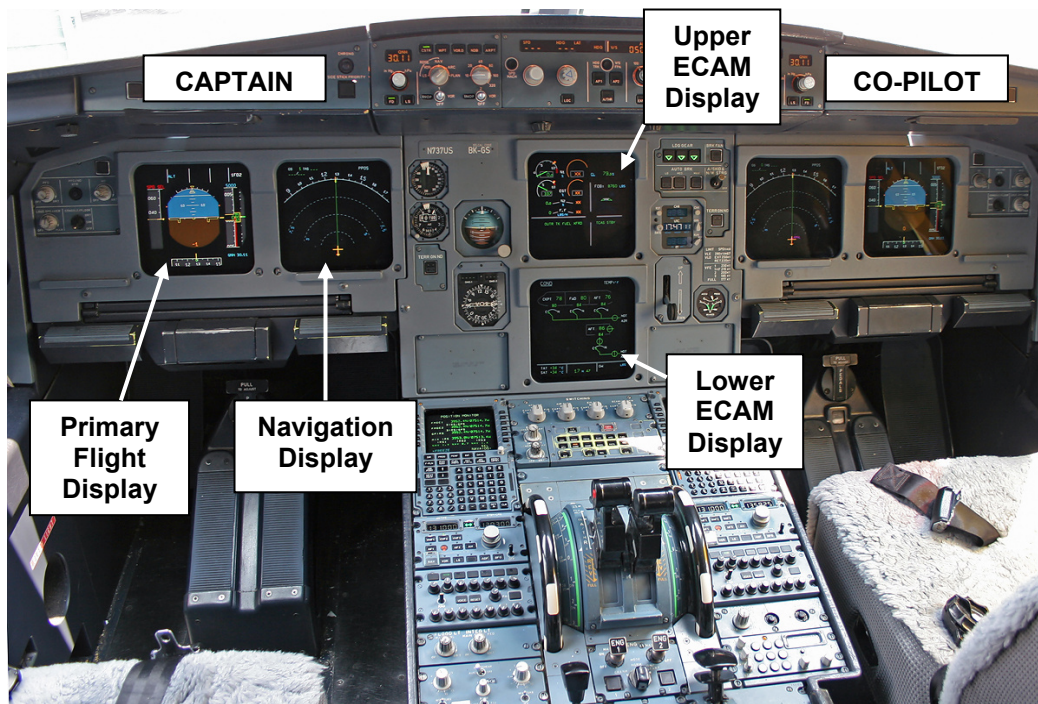
Figure 1

Electronic Flight Instrument System

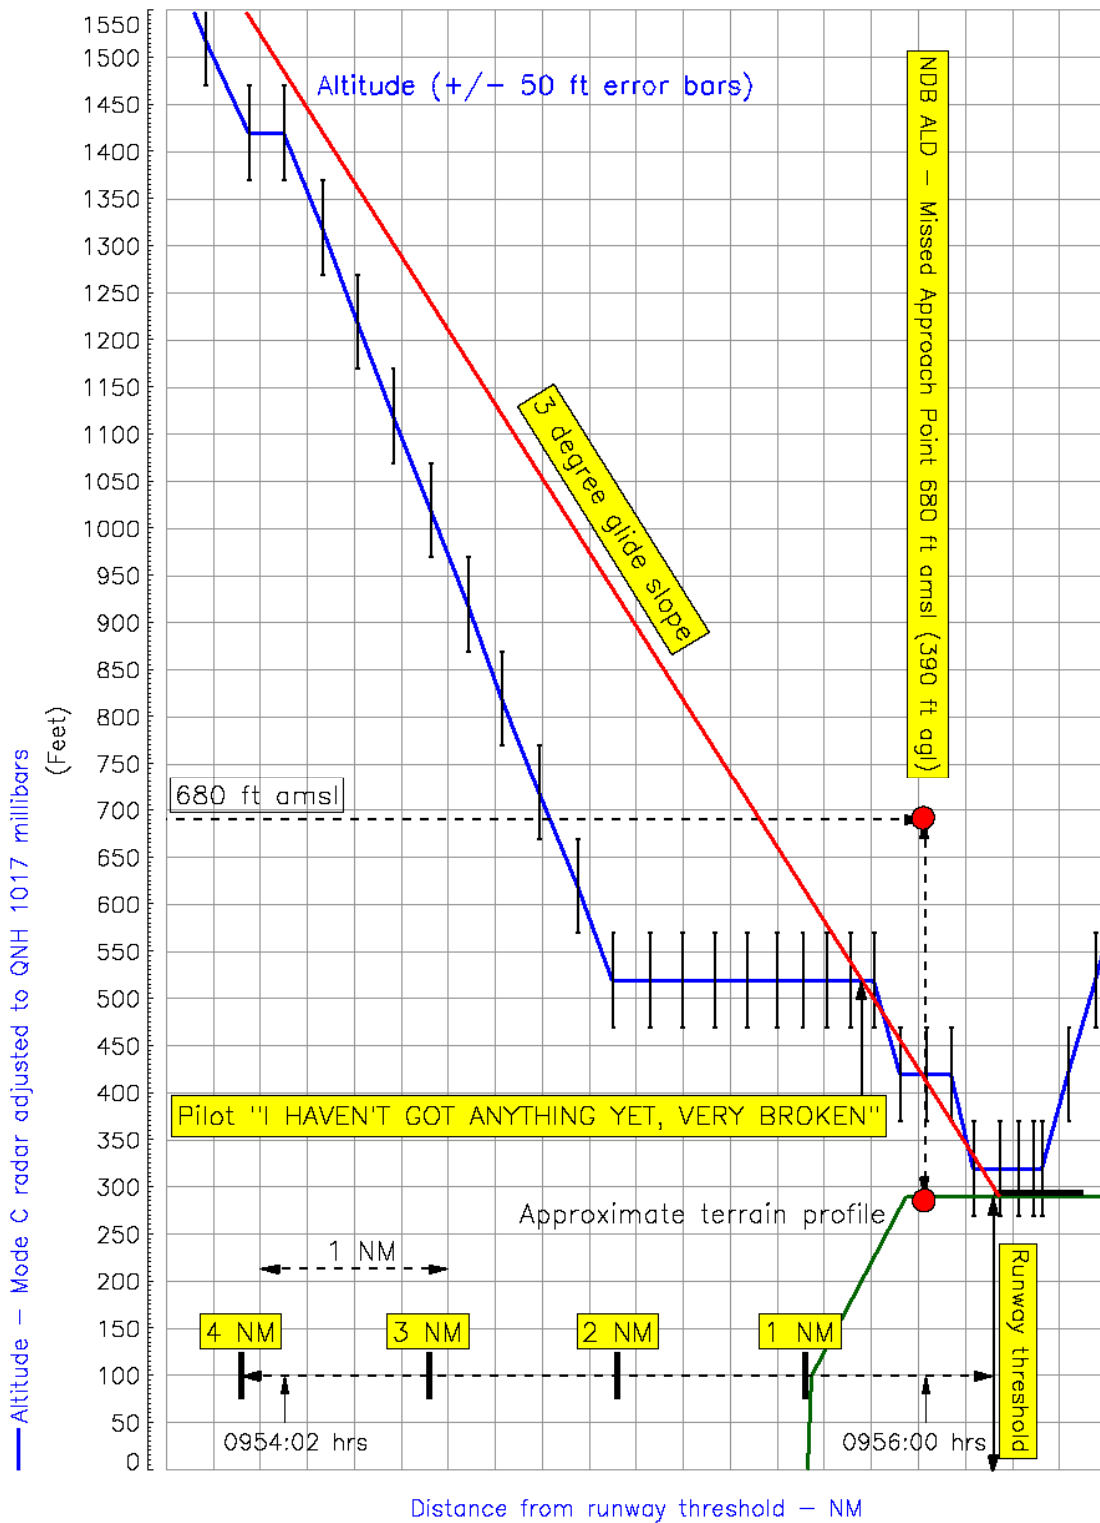
Figure 1

Data from approach and rejected landing at Alderney Airport Runway 26

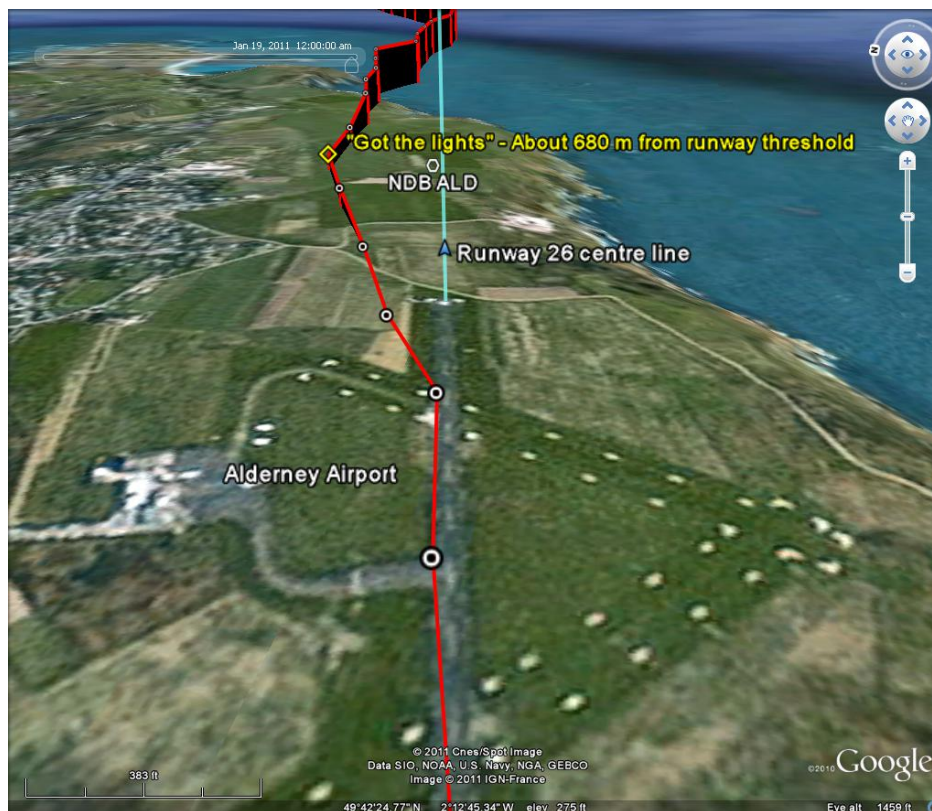
Figure 2

No accident protected data or voice recorder was required or fitted. Primary and secondary¹ radar information available from Jersey was recorded approximately once every six seconds and provided a complete record of the approach and go-around on Runway 26 (Figure 2). Radio transmissions during the flight were also recorded.

Radar track of final approach to Runway 26

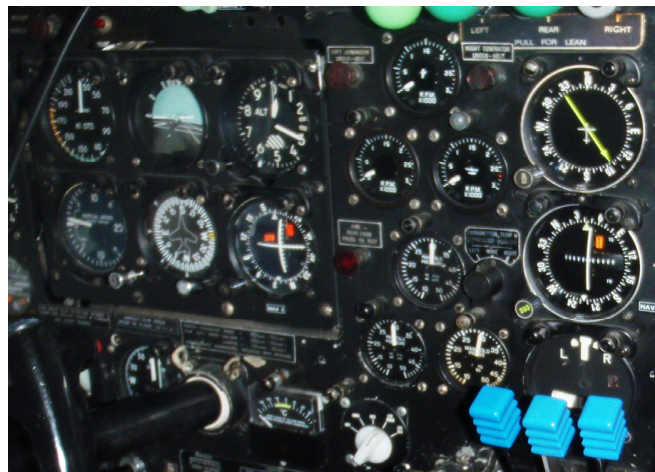
Figure 3

The Britten-Norman Trislander is an 18-seat three-engined piston-powered utility aircraft produced in the 1970s and early 1980s, normally flown by a single pilot. G-FTSE was equipped with basic navigation equipment, including a Relative Bearing Indicator (RBI) positioned in the centre of the aircraft instrument panel, separate from the pilot's primary flight instruments (Figure 3).

Instruments

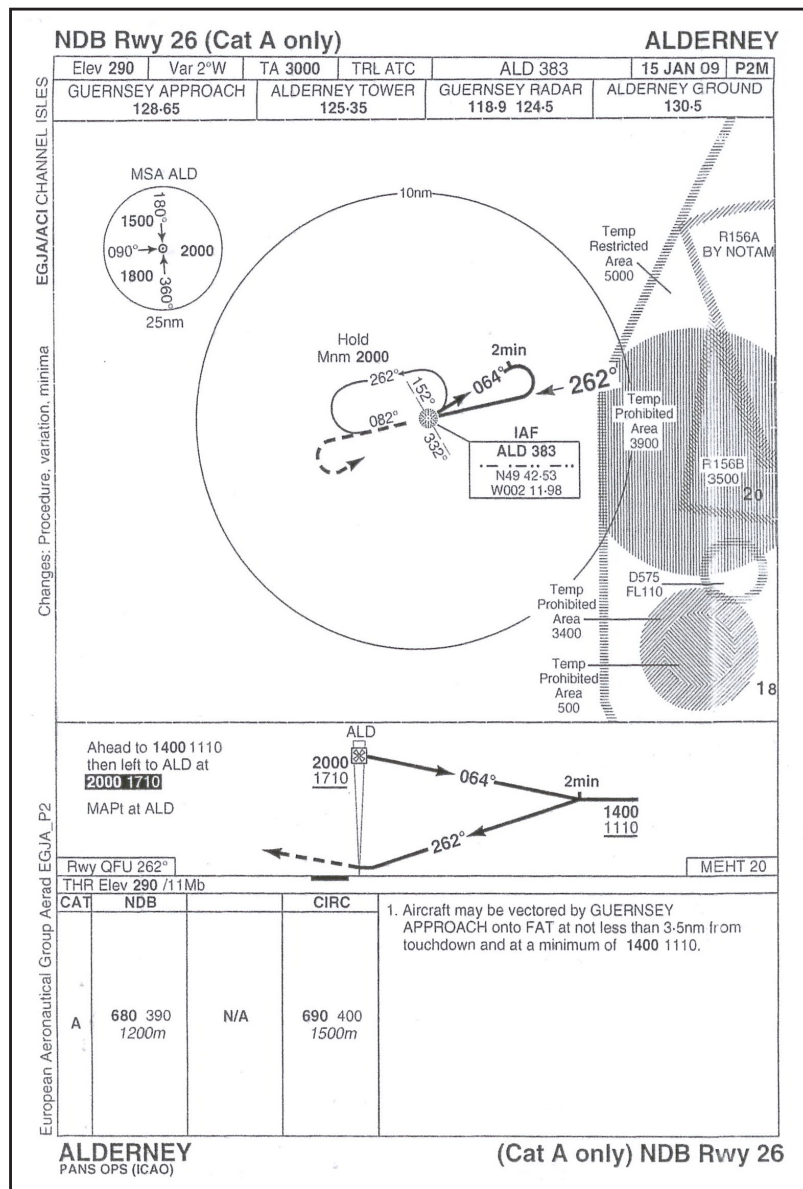
Figure 5
NDB procedure Alderney

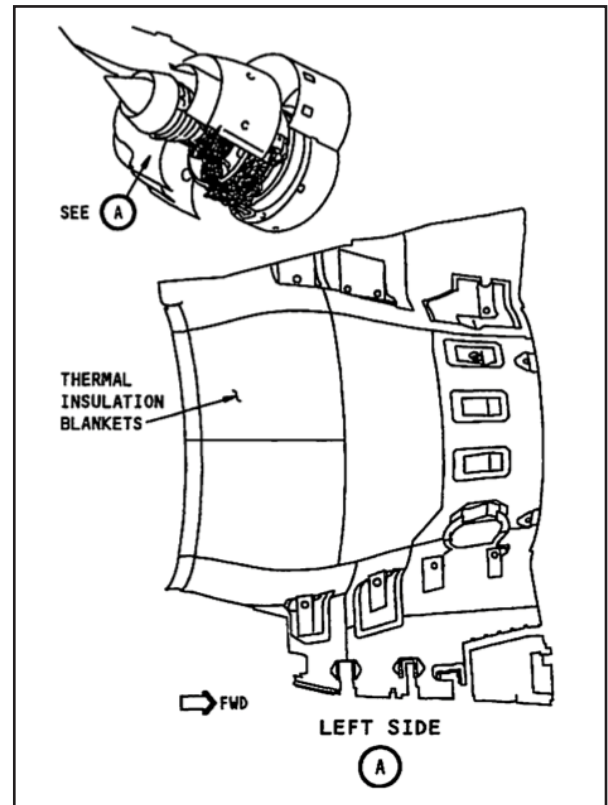
Figure 2

The inner wall of the fan duct cowl (Figures 2 and 3) is a composite material susceptible to;

'radiant heat damage from fires and [normal] engine operation'

Thrust reverser thermal barrier in fan duct cowl
(courtesy Boeing)

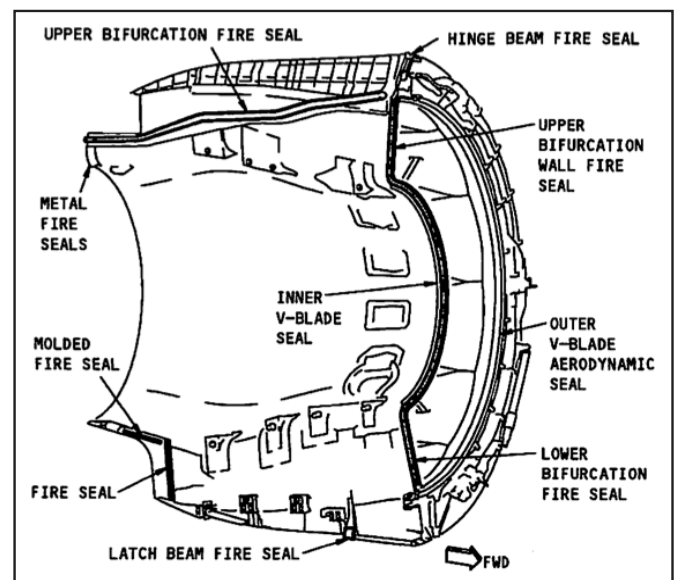
Figure 3

Location of thermal blanket seals in fan duct cowl
(courtesy Boeing)

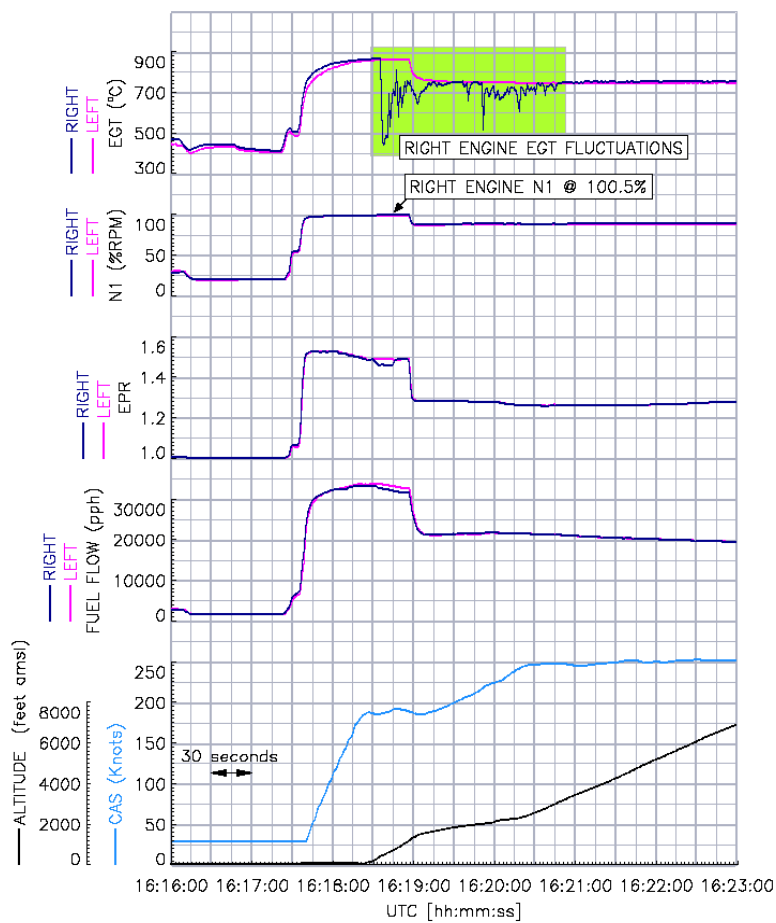
Figure 4
FDR data for the takeoff, showing right engine fluctuations

N1 increased from a nominal 99% to 100.5% and the left engine remained at 99%. At the same time, the right engine EGT dropped from 867°C to 448°C and then fluctuated around 700°C for about 130 seconds, before rising to 750°C; the left engine EGT remained steady at 865°C, dropping smoothly to 750°C as the engine thrust was reduced to climb thrust.

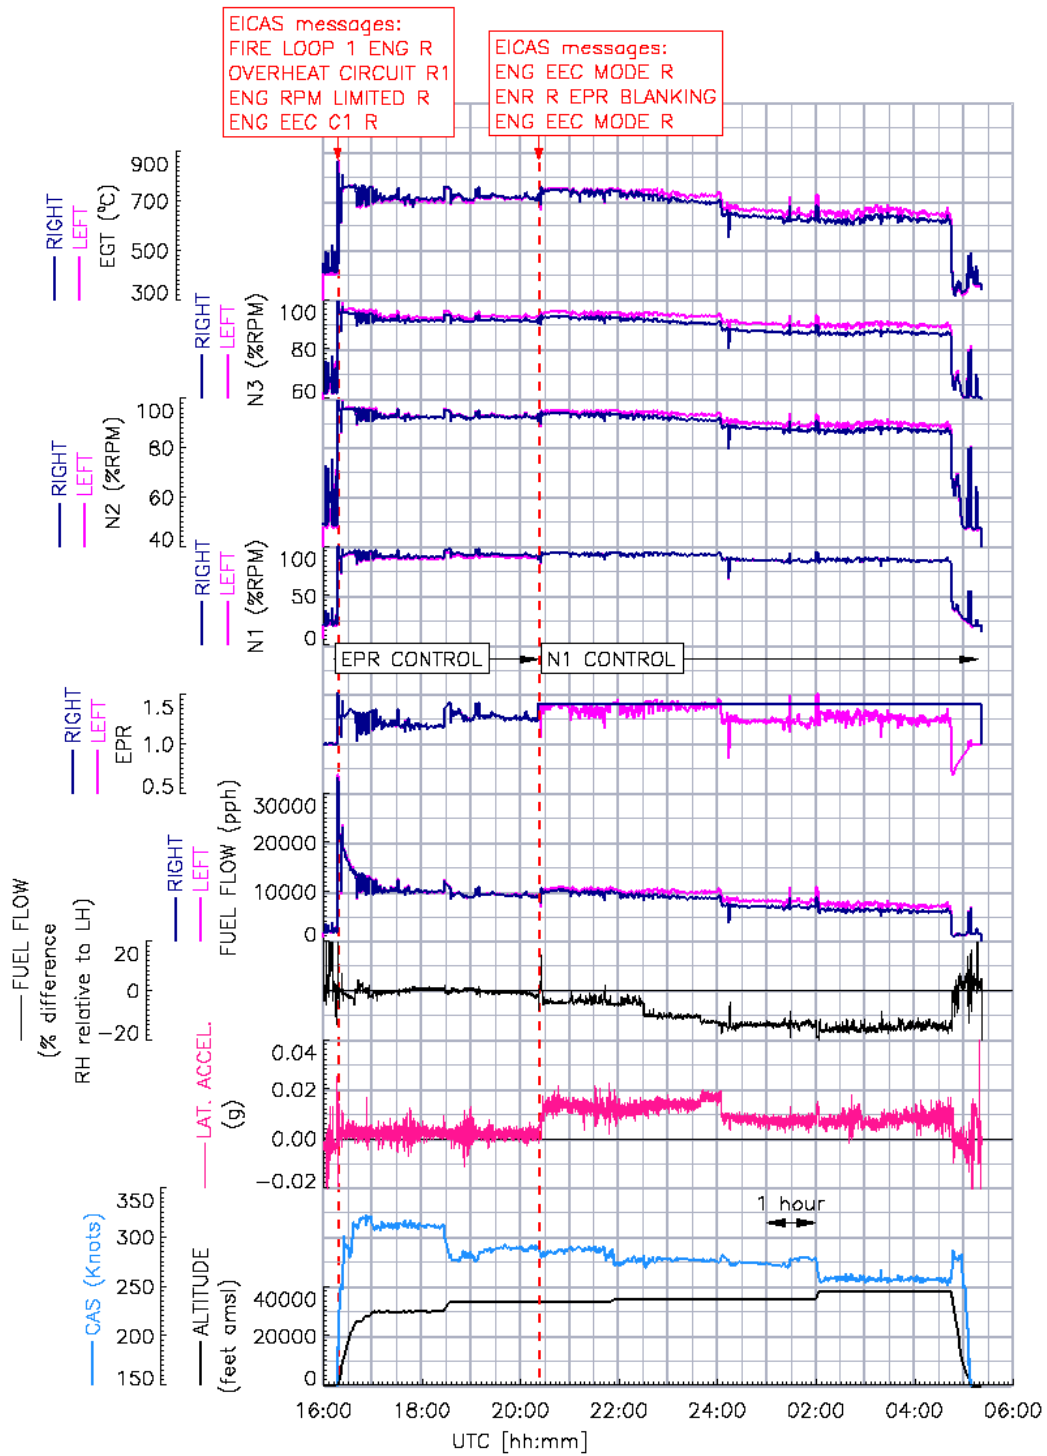
Figure 5
Salient FDR parameters of incident flight

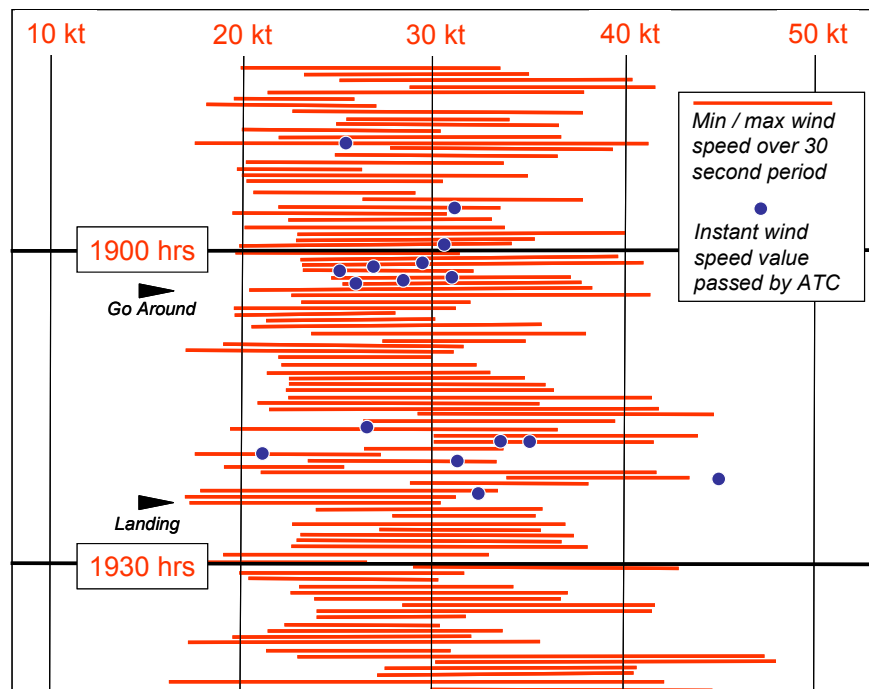
Figure 1

Anemometer data, with blue dots indicating time and value of ATC reported wind strength

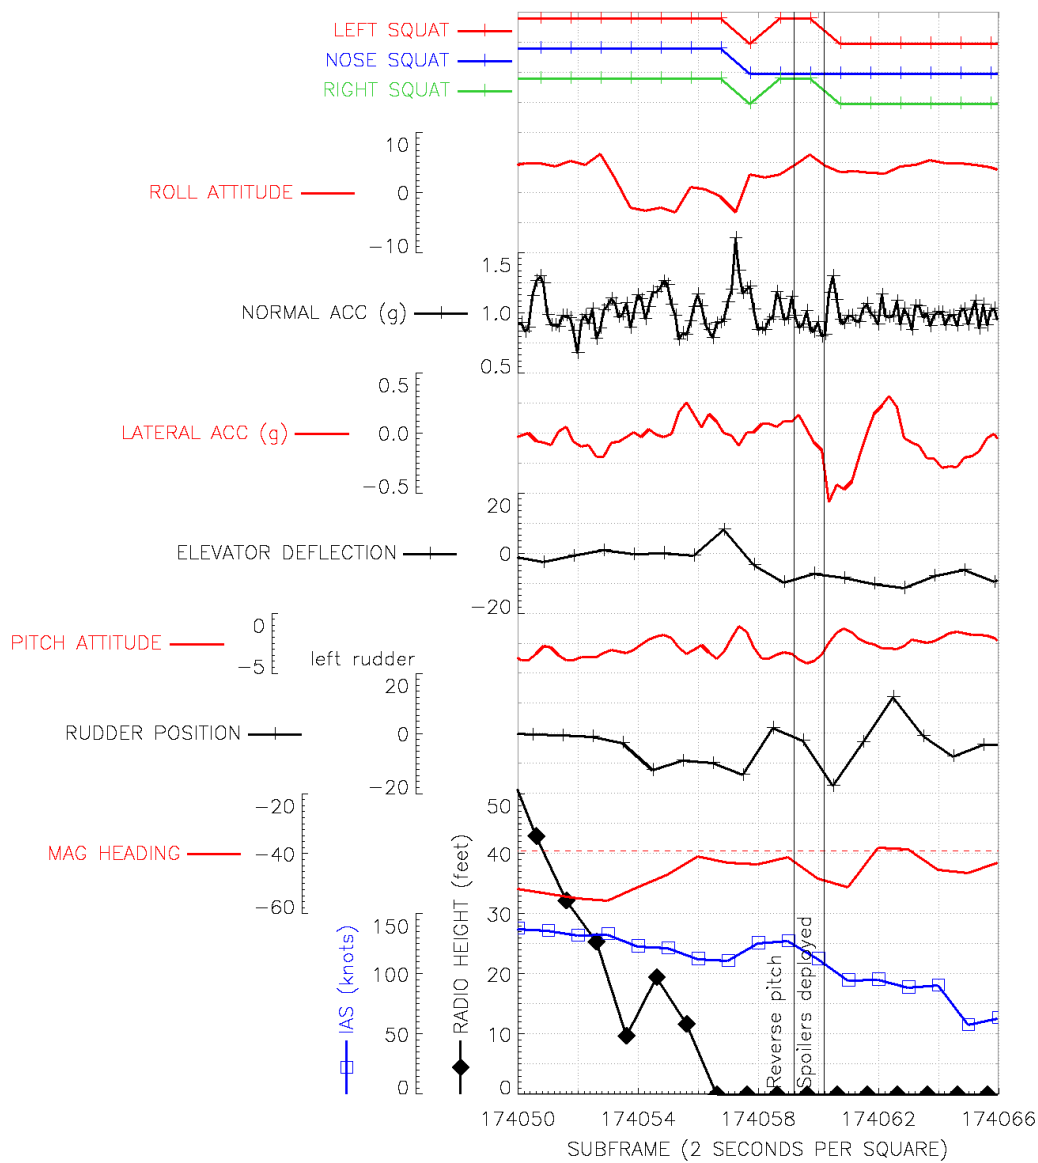
Figure 2
Pertinent FDR data

associated with a peak recorded normal acceleration of 1.6 g and the aircraft slightly rolled to the left. The subsequent two samples, one second apart, showed that the main gears were no longer sufficiently compressed to register as on the ground, with the nose gear still showing on the ground. The aircraft yawed right before being brought back rapidly left in the same timeframe as the main gear recompressing. This was coincident with the peak recorded lateral acceleration of 0.6 g and a normal acceleration spike of 1.3 g.

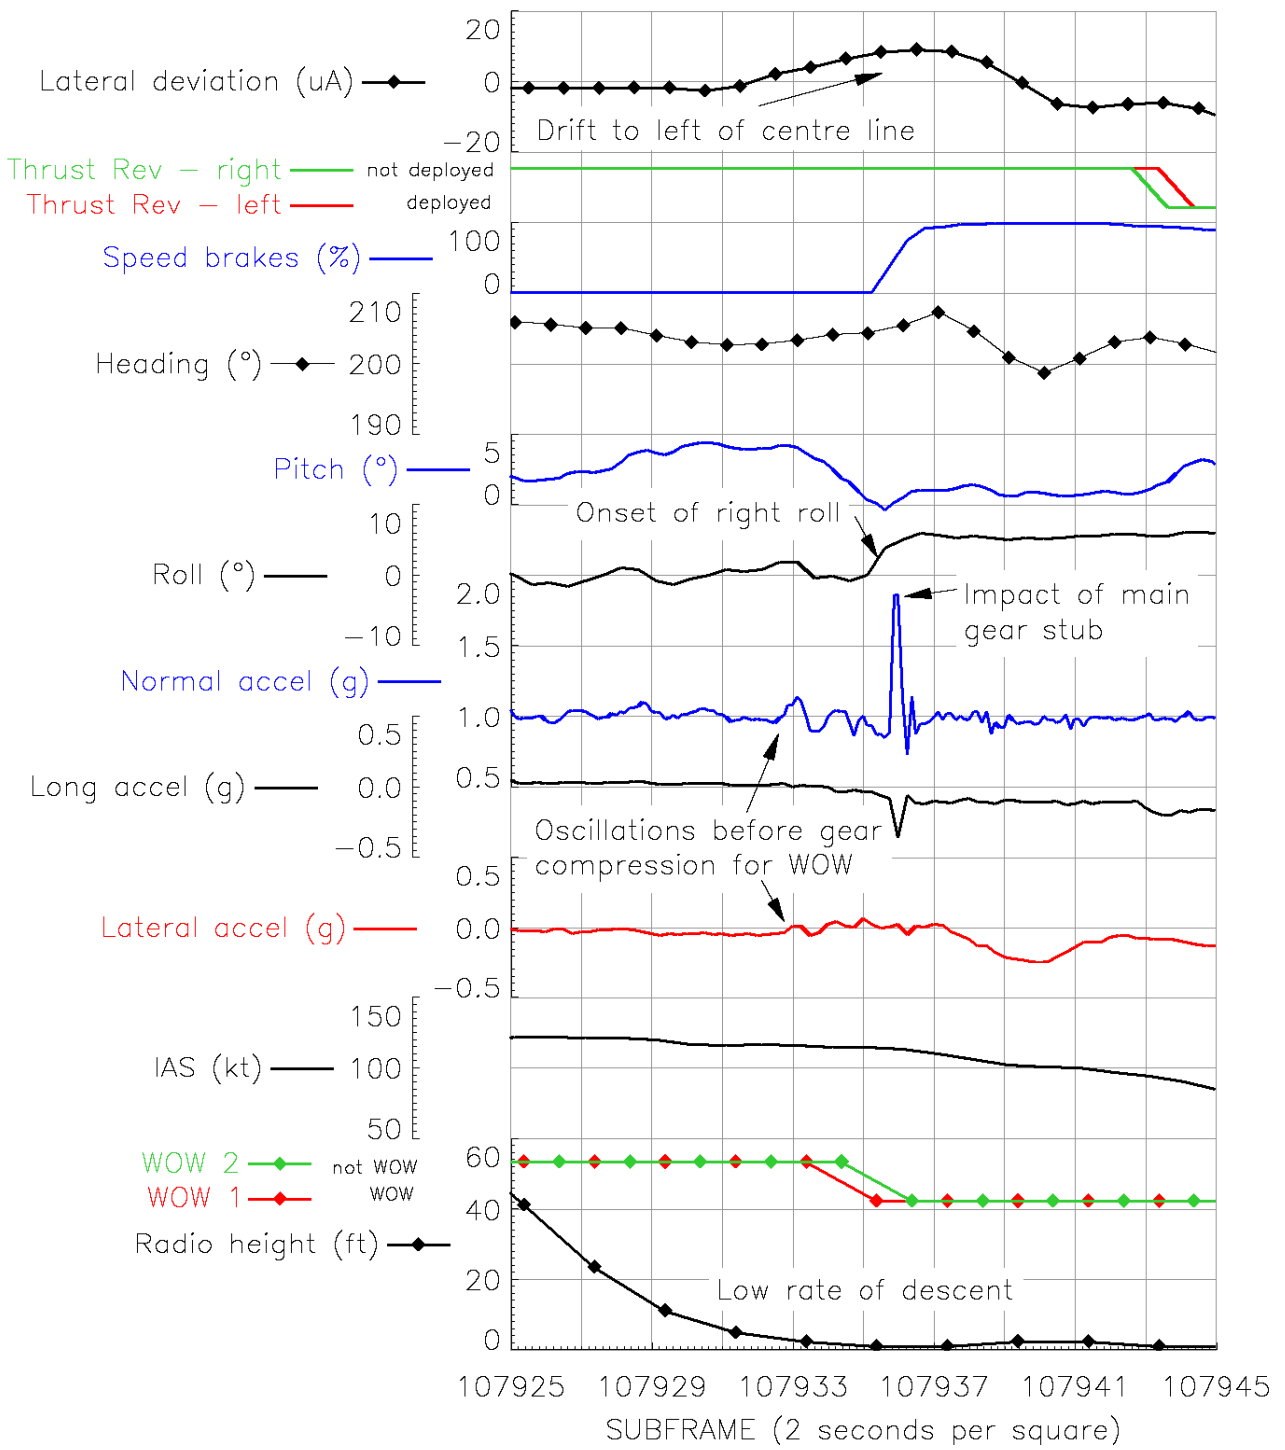
It is likely that the gear detachment occurred during the initial touchdown phase, with a low descent rate. Just prior to this, whilst drifting to the left, small oscillations in the normal and lateral acceleration parameters were recorded, possibly associated with intermittent contact with the runway or ridges of ice observed on the

Figure 1
Pertinent FDR parameters from just before touchdown

runway. A right roll initiated with the failure of the gear component and the accelerometer spikes were the result of the aircraft rolling onto the remaining structure after the wheel assembly had detached.

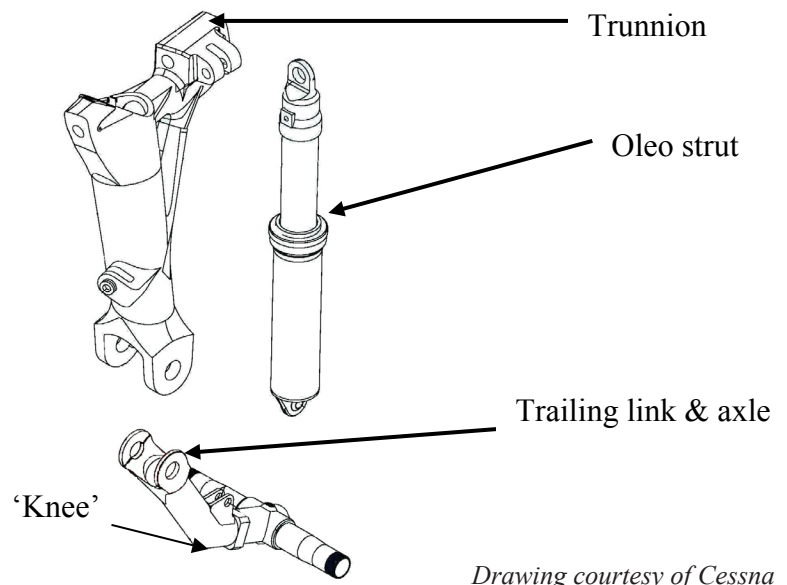
Figure 2
Citation X Main Landing Gear

Drawing courtesy of Cessna

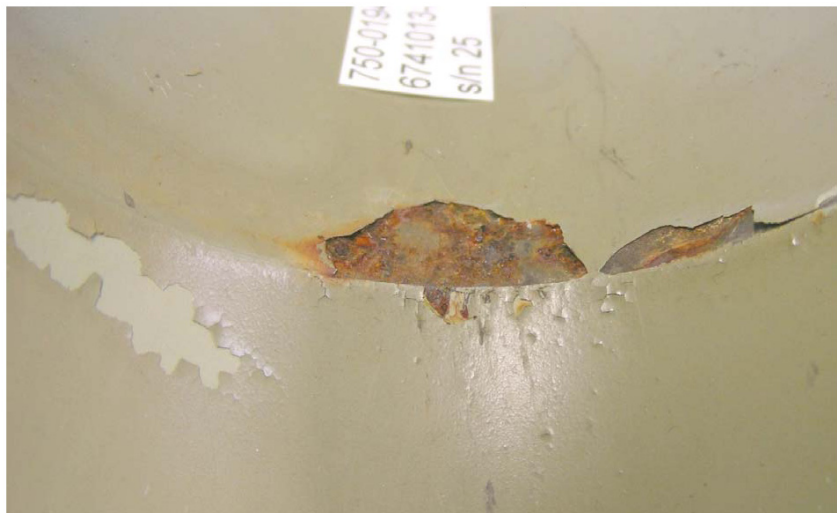
Figure 7

The left MLG trailing link was examined using a borescope and was found to have a patch of corrosion in the same area as the right link, but apparently not as severe or extensive, and with no obvious signs of cracking (Figure 7). It was despatched to Cessna for detailed examination, where it was prepared for examination in a similar manner to the right link.

diameter of the link had been recoated with primer over a wide area around the area of corrosion, appearing to be a darker shade compared with the original paint. This was clearly a second coat applied after a corrosion repair which was performed in October 2004, after an inspection to comply with an Alert Service Letter (ASL) 750-32-19, but much of the chromate had leached out and adhesion was extremely patchy, despite it being of the correct type of primer. Little is known about this repair beyond the fact that it was found to be necessary and had been dressed-out with the correct grade of abrasive pad and primer re-applied.

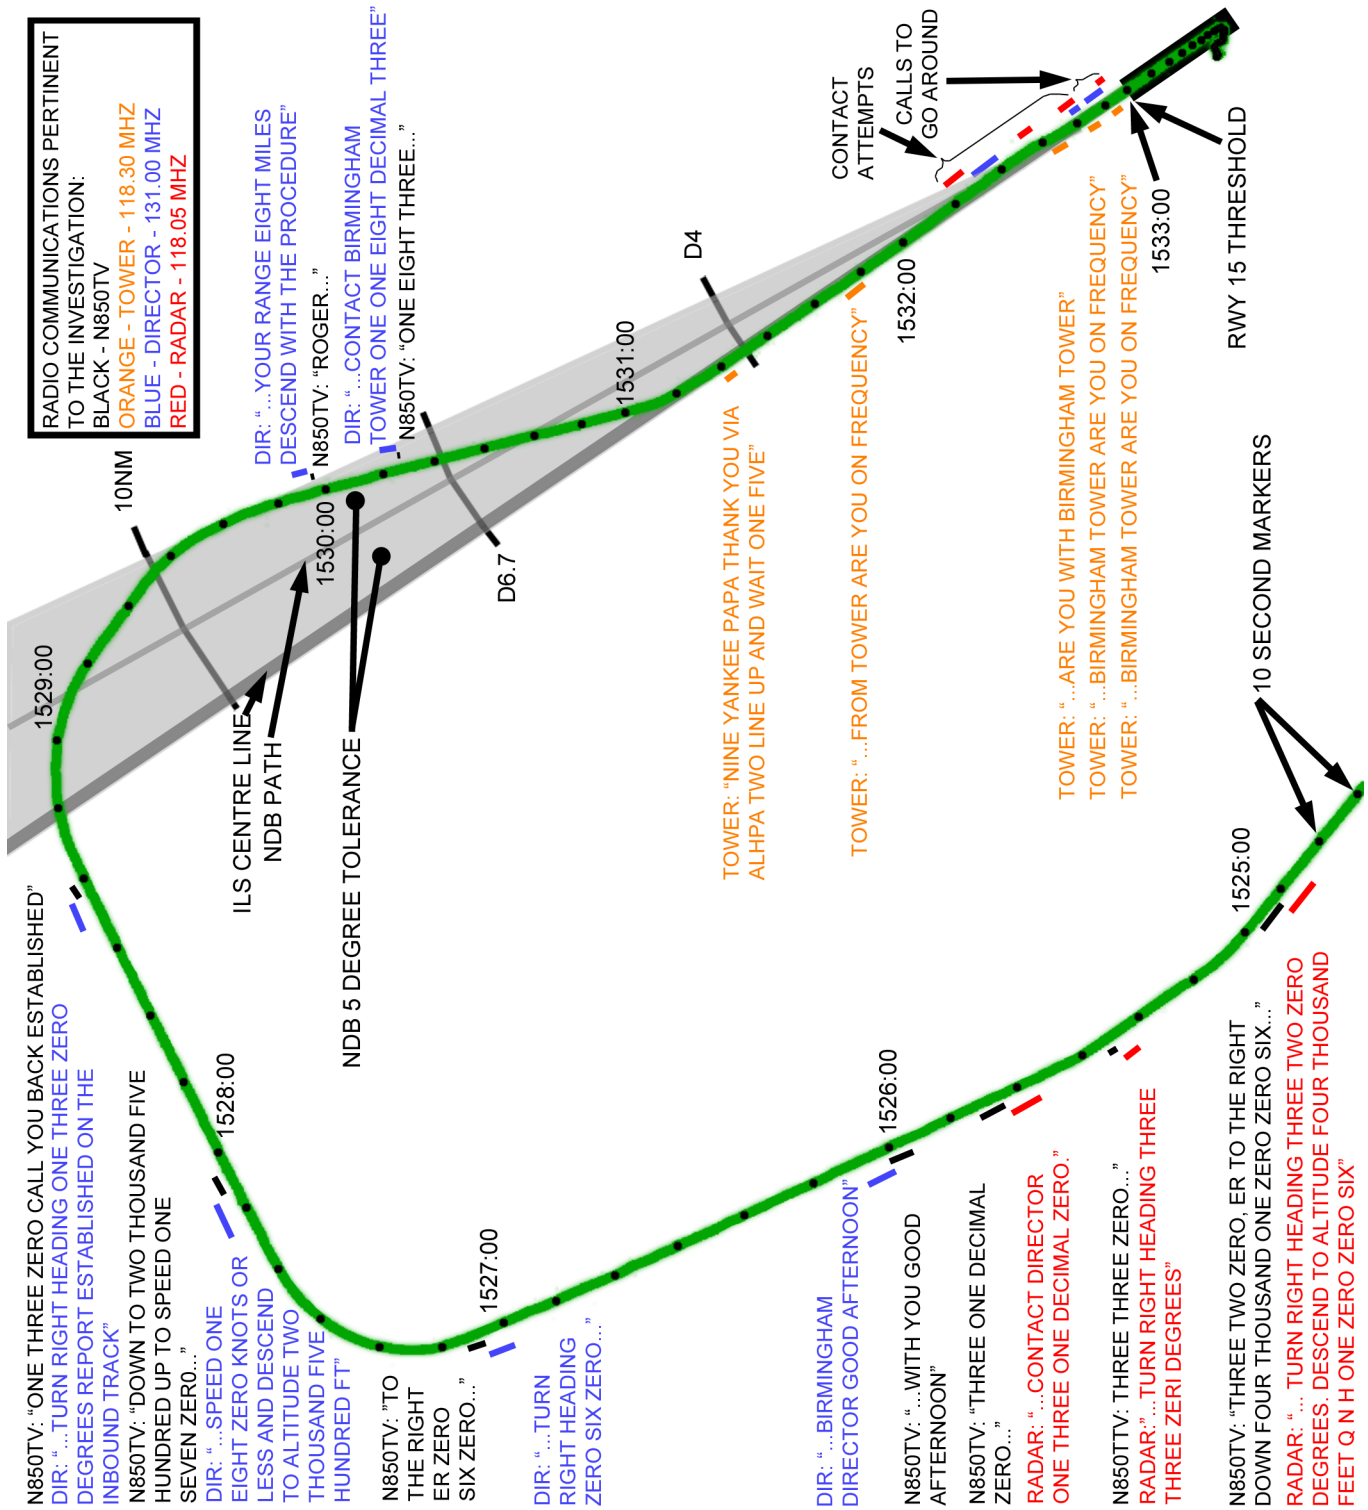
Figure 1

Aircraft track and radio communications, with pertinent procedural track information

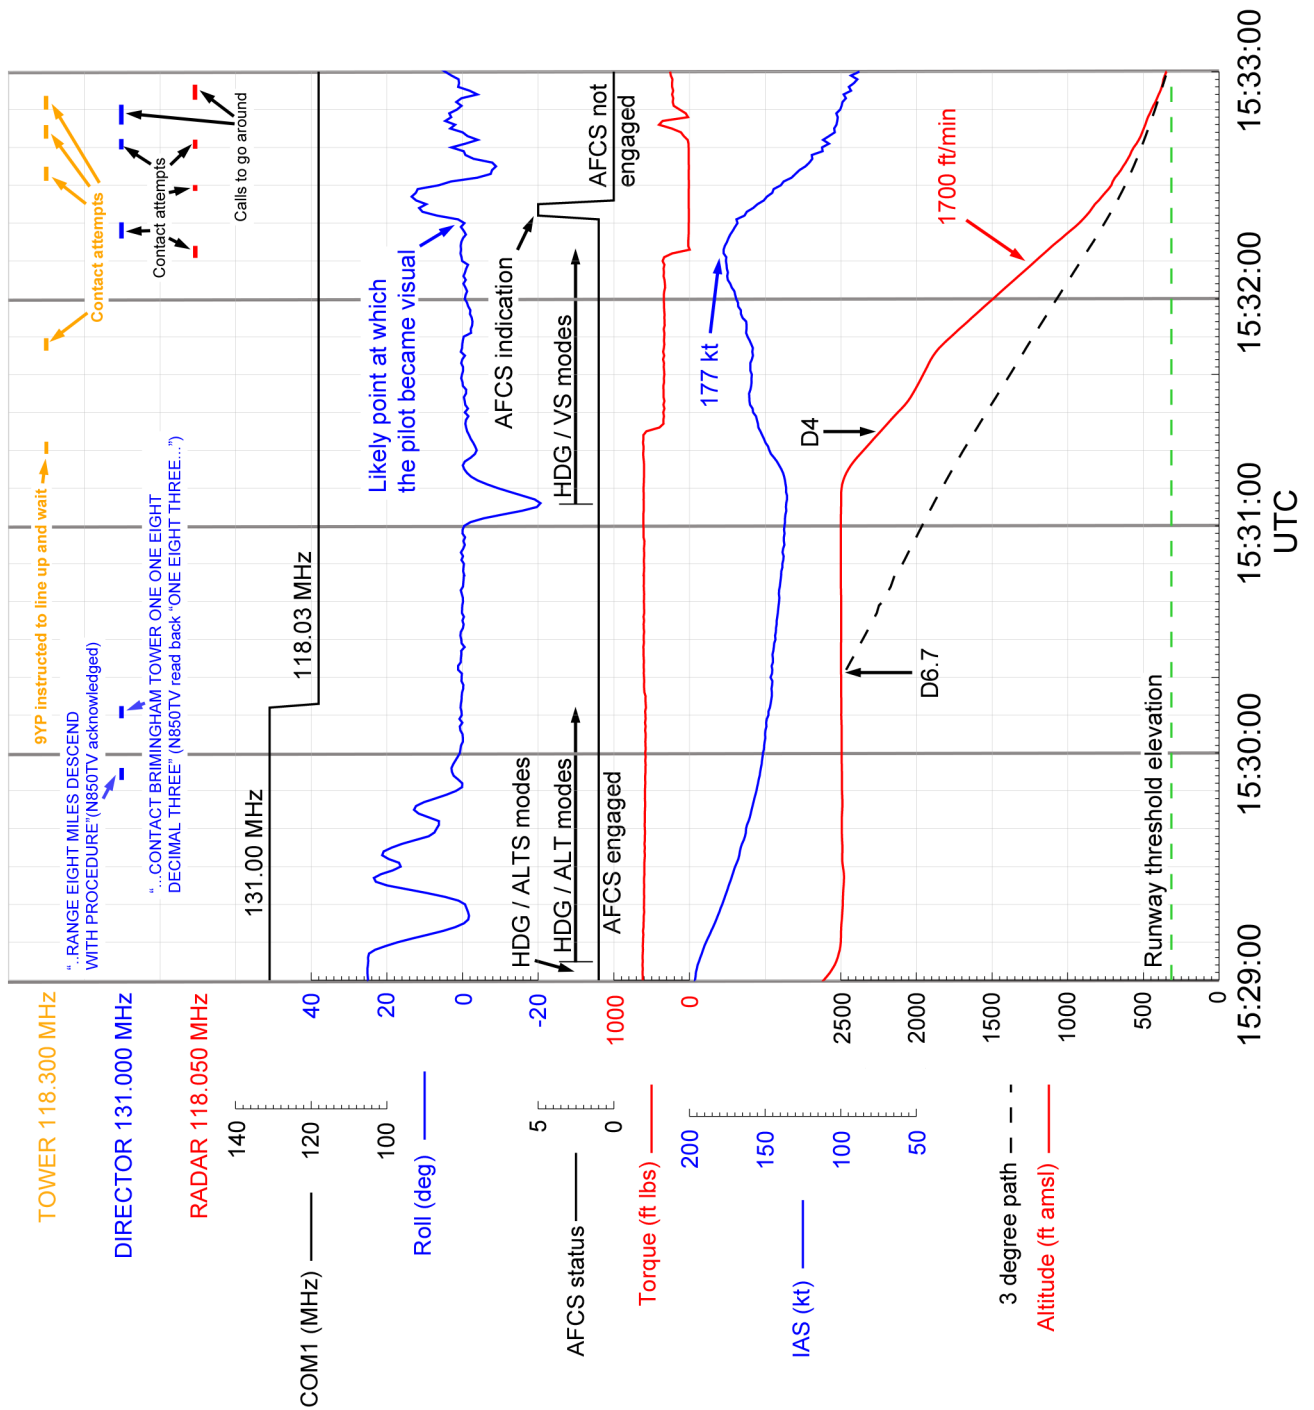
Figure 2
 Pertinent recorded data for the four minutes prior to crossing the runway threshold

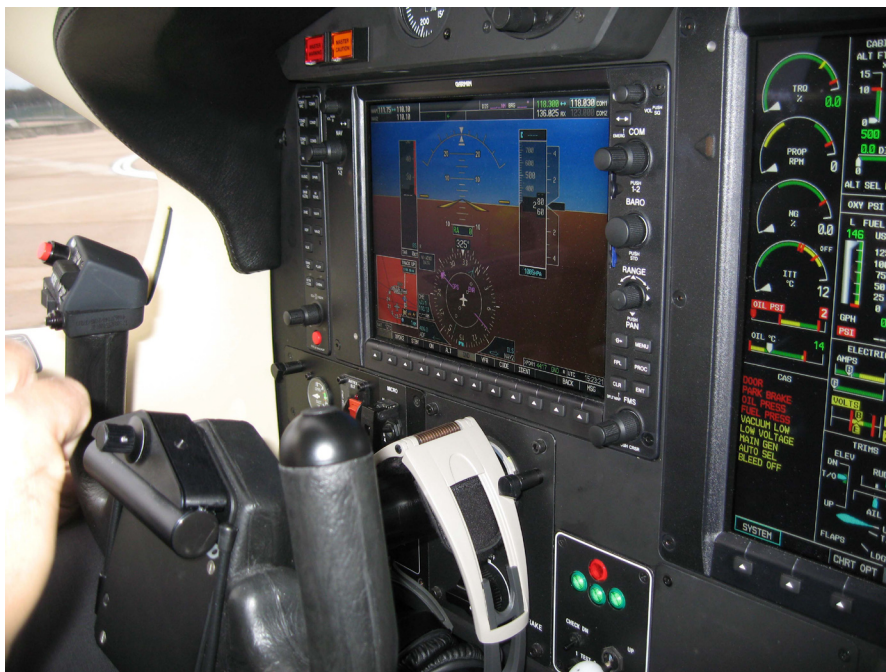
The transponder Mode A code is altered by selecting the XPDR soft key on the PFD, then selecting CODE and entering the required code. The XPDR soft key is the eighth key from the left of the PFD and is therefore located behind the control yoke (shown in Figure 3 below).

Figure 3
Position of transponder controls

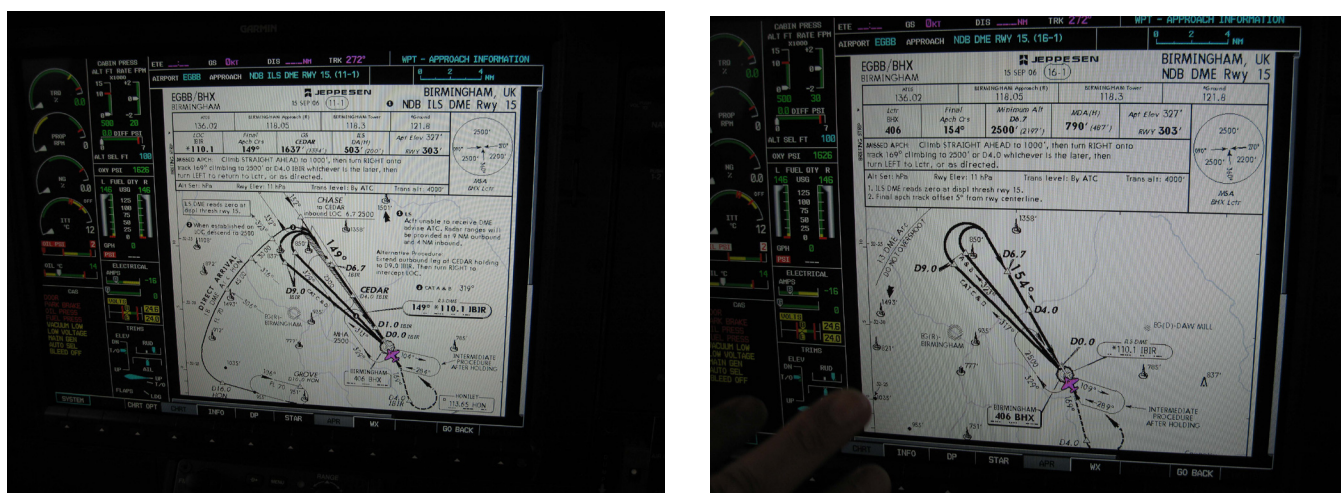
onto the electronic chart as an aid to situational awareness but this is not approved for primary navigation use. The charts are selected by pressing the SHW CHRT soft key then pressing the FMS knob to activate the cursor and entering the airfield identification. The FMS knob is then used to select an approach and a dropdown box with the chart options appears. Turning either FMS knob will scroll through the available charts and enter selects the chart. The electronic menu uses the same identifiers as the paper charts; the ILS for Runway 15 at Birmingham is therefore listed as the NDB ILS DME Rwy 15 (plate number 11-1), while the NDB approach is NDB DME Rwy 15 (plate number 16-1). The chart display can zoom into the chart at a user-set level. The default user-set level set for N850TV displays the top two-thirds of the chart but cuts off the vertical profile at the bottom (see Figure 4 below).

Figure 4
Presentation of ILS and NDB plate images on G1000

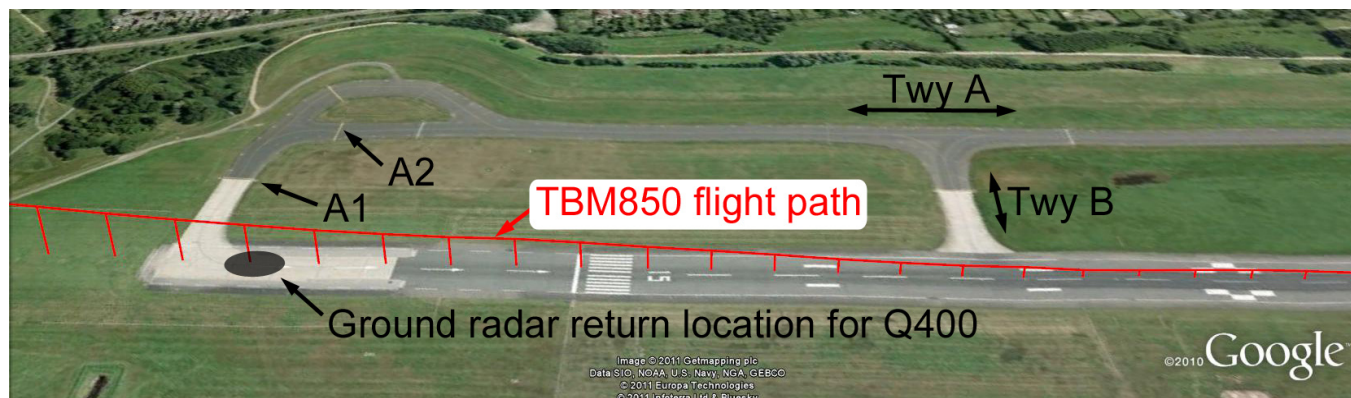
Figure 5
Runway 15 threshold

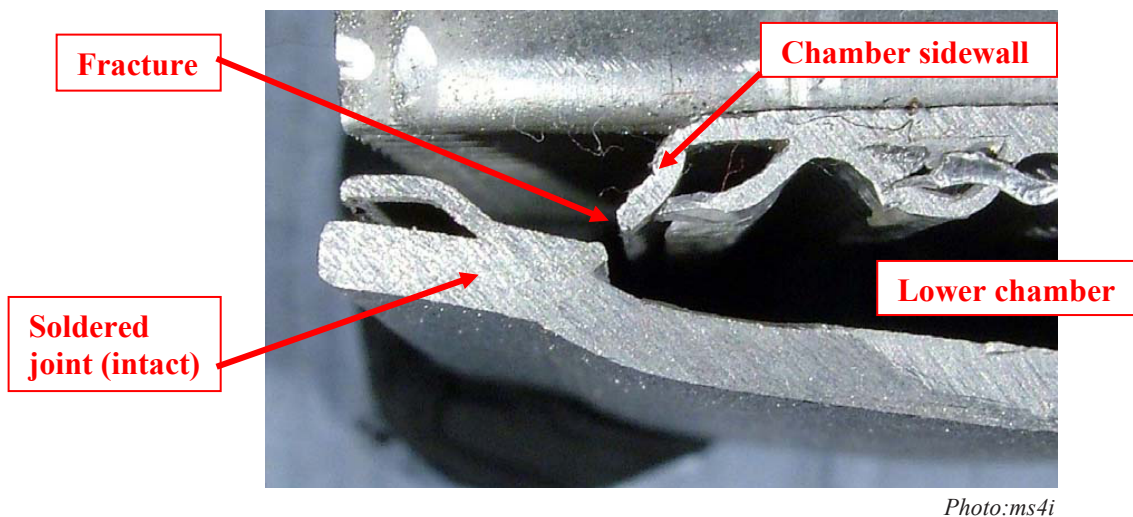
Figure 3

Enlarged view of area of failure

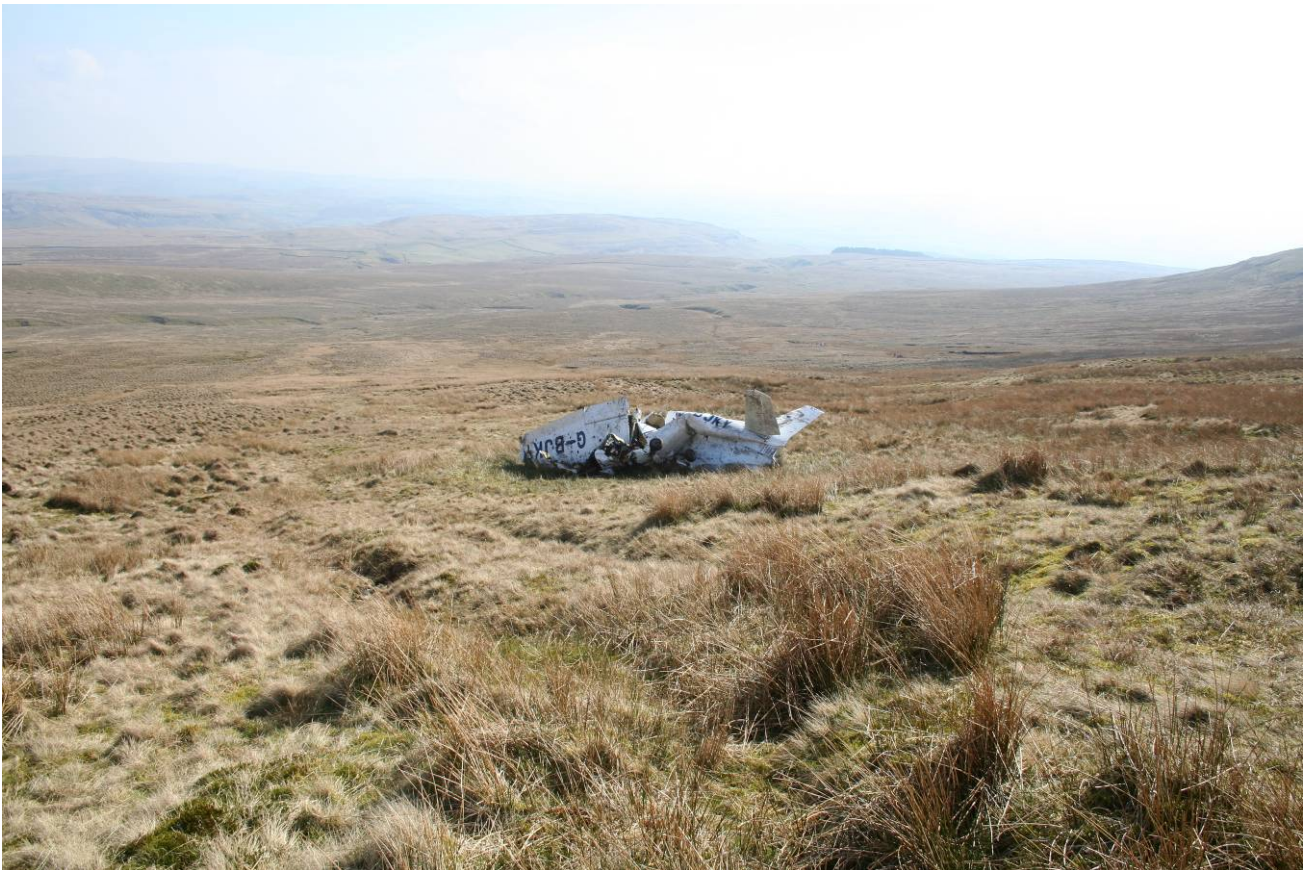
Figure 2

Accident site looking south

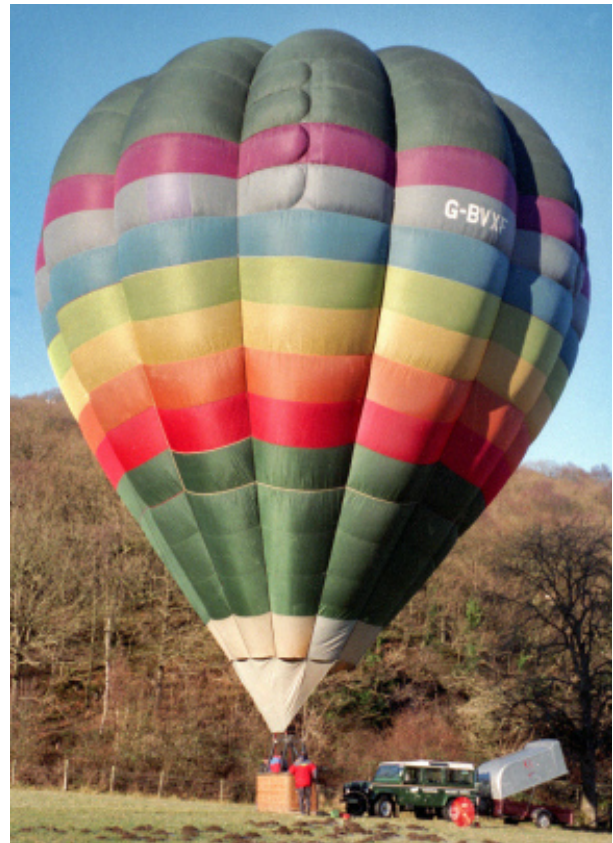
The envelope was a Cameron O-120 which has a volume of 120,000 cubic feet (Figure 1). This type of envelope has a 'parachute valve' which allows the controlled release of hot air (venting) and, for landing, the complete deflation of the envelope. It takes the form of a circular parachute-style panel that seals on a circular opening in the top of the envelope (Figure 2). The parachute valve is held in place by a combination of the internal pressure of the hot air and a set of centralising lines inside the balloon (12 for this design of balloon). For venting, a red line is pulled in the basket and the valve is held open for a few seconds, whereas for deflation it is pulled further and held open until the envelope deflates.

Figure 1
Envelope, G-BVXF

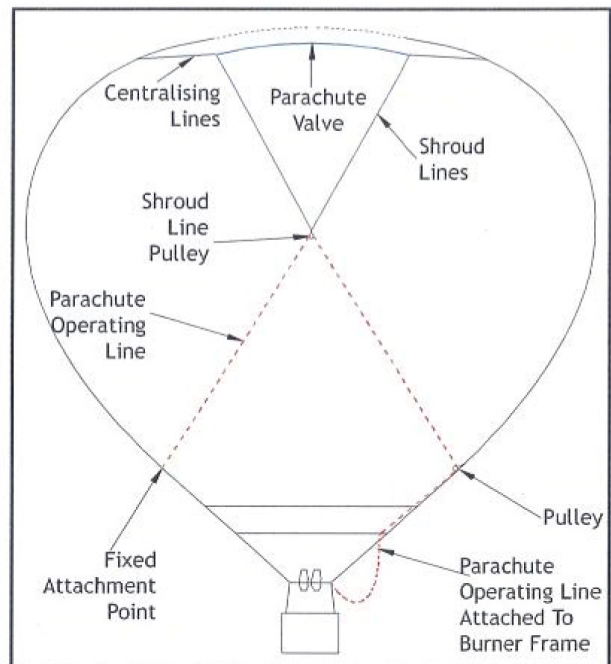
Figure 2
Parachute valve
