CONTENTS

Summary of: Aircraft Accident Report No: 1/2011 136
Eurocopter EC225 LP Super Puma, G-REDU
Near the Eastern Trough Area Project Central Production Facility Platform
in the North Sea on 18 February 2009

INCIDENT

Aircraft Type and Registration:	Airbus A321-231, G-MEDJ
No & Type of Engines:	2 International Aero Engines V2533-A5 turbofan engines
Year of Manufacture & Serial No:	2004, MSN 2190
Date & Time (UTC):	24 August 2010 at 0225 hrs
Location:	At FL360 over northern Sudan
Type of Flight:	Commercial Air Transport (Passenger)
Persons on Board:	Crew - 7 Passengers - 42
Injuries:	Crew - None Passengers - None
Nature of Damage:	None
Commander's Licence:	Airline Transport Pilot's Licence
Commander's Age:	34 years
Commander's Flying Experience:	Approximately 7,500 hours (of which approximately 1,400 were on type) Last 90 days - 165 hours Last 28 days - 61 hours
Information Source:	AAIB Field Investigation

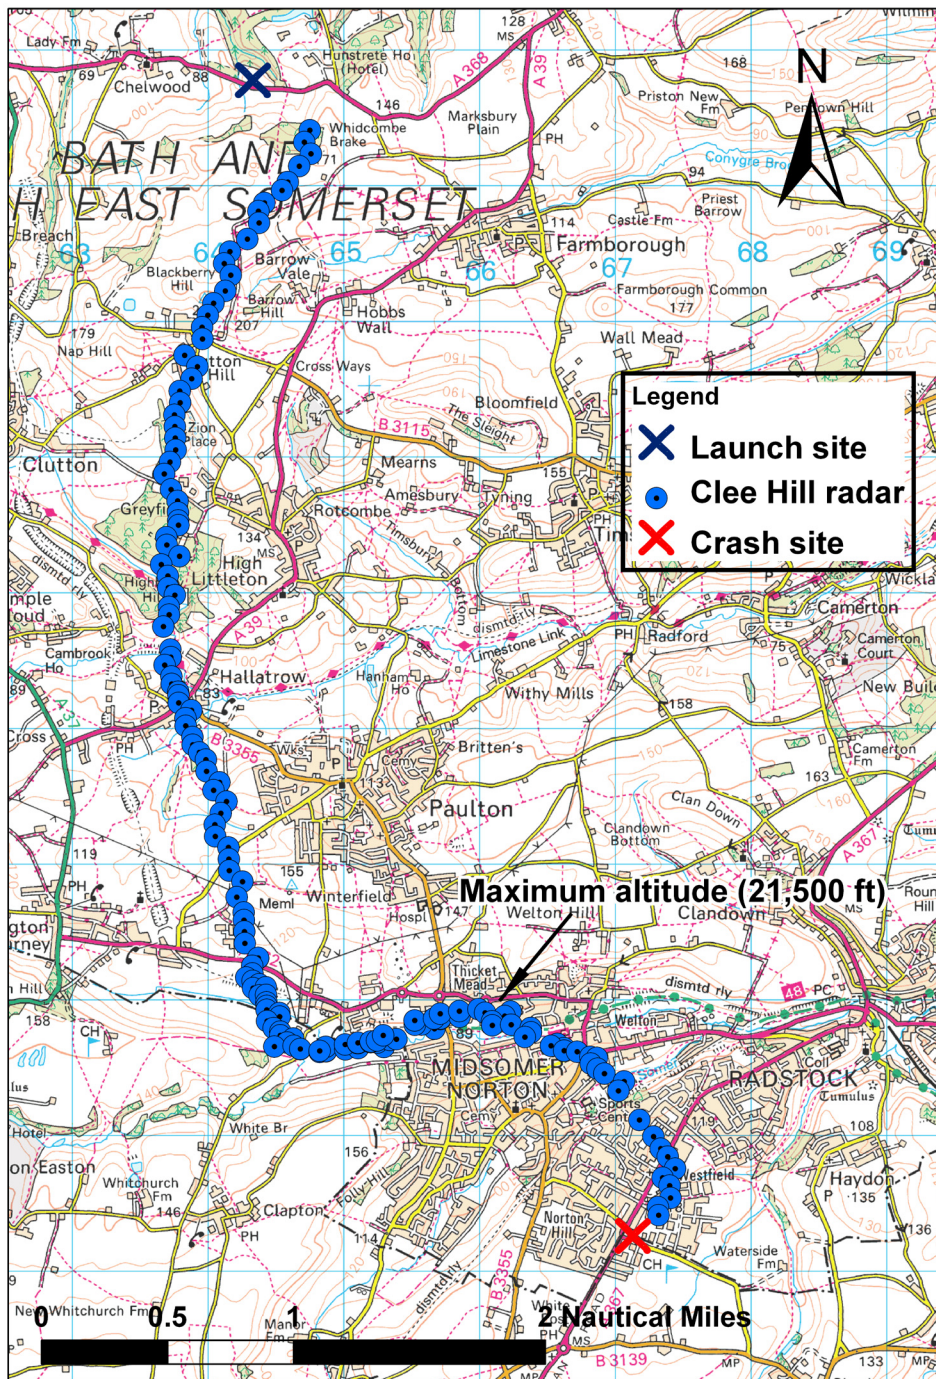
track ends at 0946:30 hrs north-east of the accident site with the balloon at 2,000 ft amsl (ie about 1,600 ft agl), descending rapidly.

Figure 4
Accident track of G-BVXF from radar information

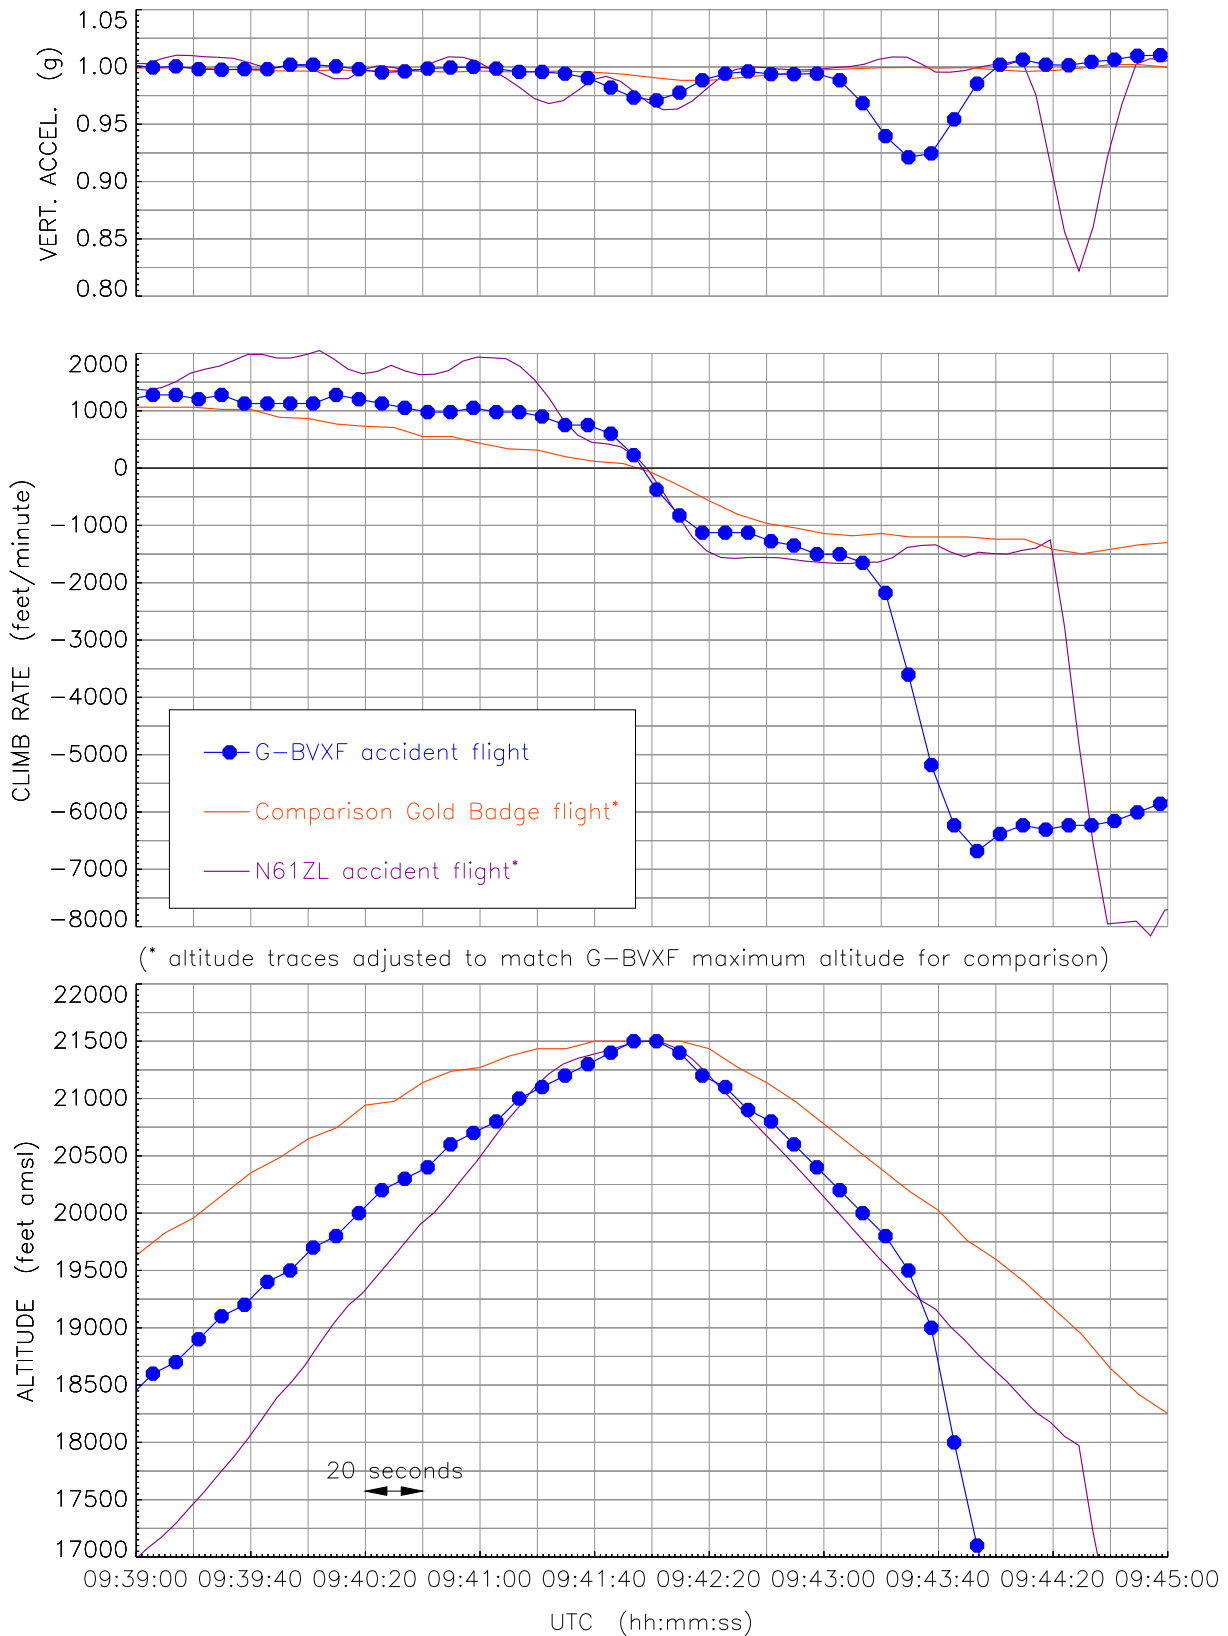
Figure 5

Altitude, climb rate and acceleration comparison at top of climb of G-BVXF, 'Gold Badge' flight and accident flight of N61ZL. Climb rate and accelerations calculated from altitude and time information

A key piece of evidence was the height profile from the radar, Figure 5. Comparing the altitude profiles of the accident flight with another Gold Badge flight (for which the descent was initiated by not using the burners and not venting) strongly suggests either the envelope of G-BVXF was vented or there was a significant leakage of hot air due to an envelope failure. The high rate of ascent, which reduced only slightly prior to the apogee at 21,500 ft, is indicative of an intact balloon envelope at that stage; it is likely that the CAA approval to FL210, already passed, could have led the pilot to decide to initiate a more rapid descent than he had originally planned.

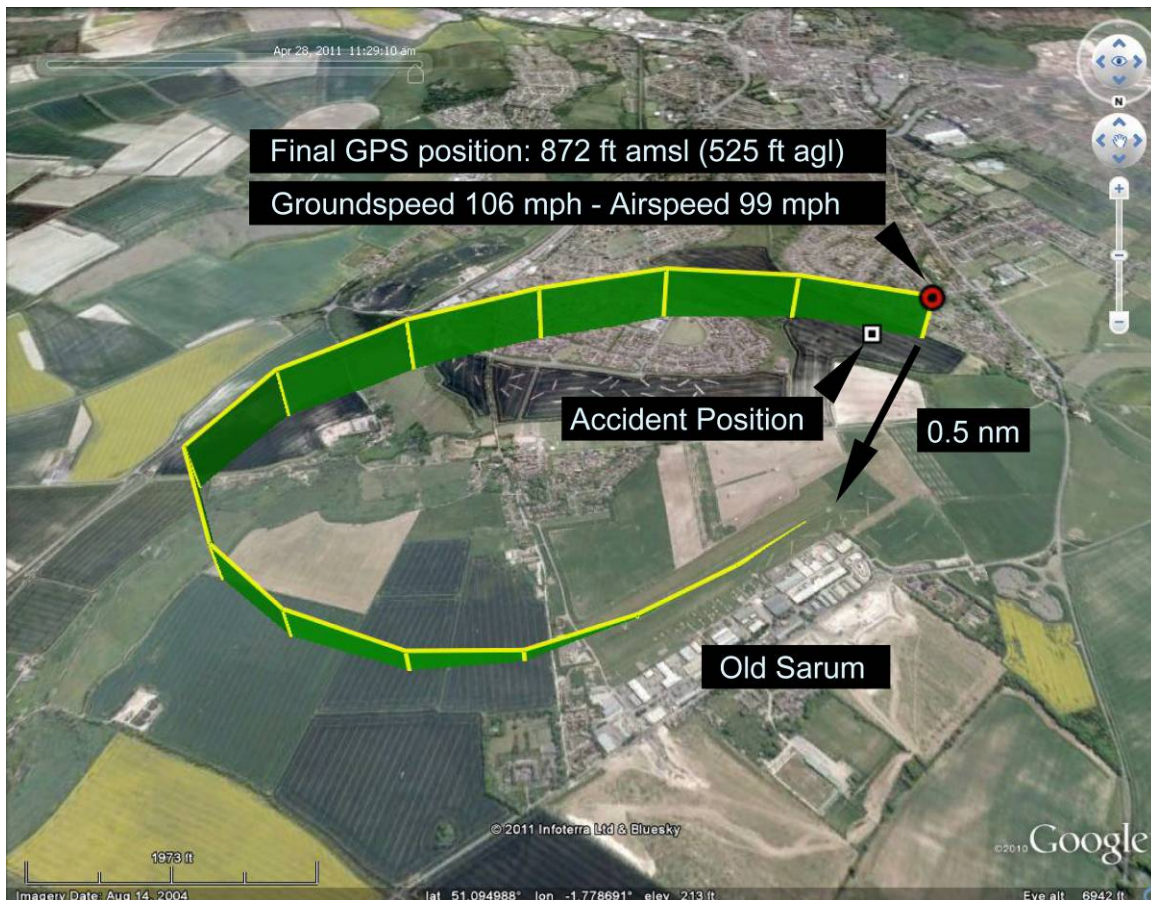
The altitude was the same as the previous data point, being 872 ft, although the airspeed had increased from approximately 84 mph to about 99 mph, which is faster than the typical airspeed of 60 to 70 mph. The aircraft was on a track of 291° and due to rising ground the approximate height reduced to 525 ft. The final position placed the aircraft 160 m to the west of the accident position and approximately 0.5 nm from the threshold of Runway 06.

The track log file was closed at 1130:04 hrs, indicative that the GPS signal had been lost for the past 30 seconds. The reason for the loss of the GPS signal could not be fully established. However, as no external GPS antenna was fitted, it is most likely that the aircraft entered a series of

Figure 1
GPS Track from Old Sarum (view looking south)

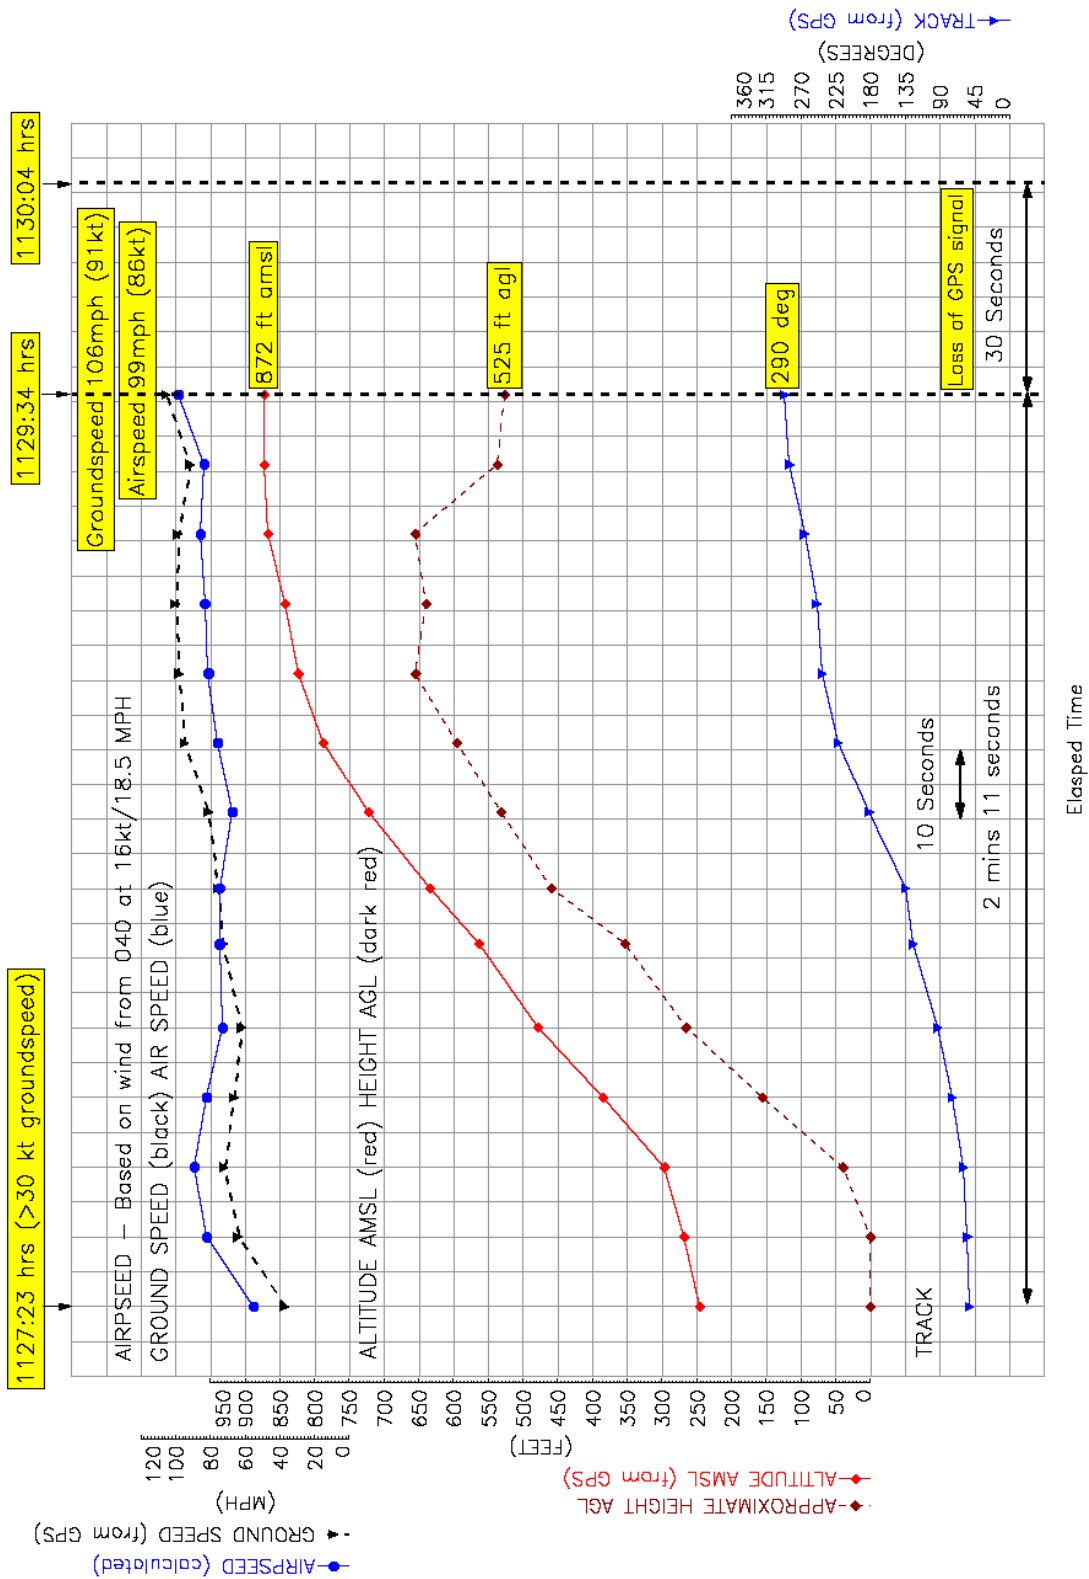
Figure 2
GPS Track points with derived airspeed

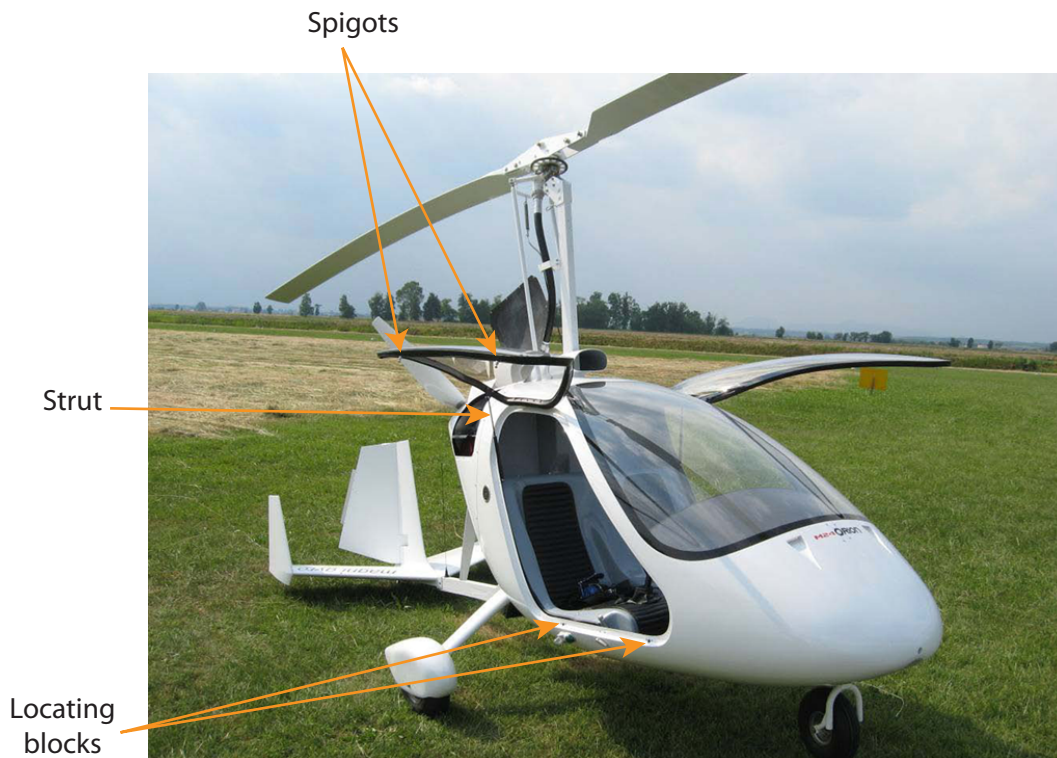
A ‘gull-wing’ (upward opening) door is fitted to each side of the cockpit and is attached to the aircraft by a hinge fitted to the top edge of the door frame, see Figure 3. A strut is fitted to the rear of the door and holds the door open when the aircraft is on the ground; the strut also limits the upward movement of the door. The door is secured in the closed position in flight by two spigots mounted on the lower section of the door frame, which

Figure 3
Door arrangement

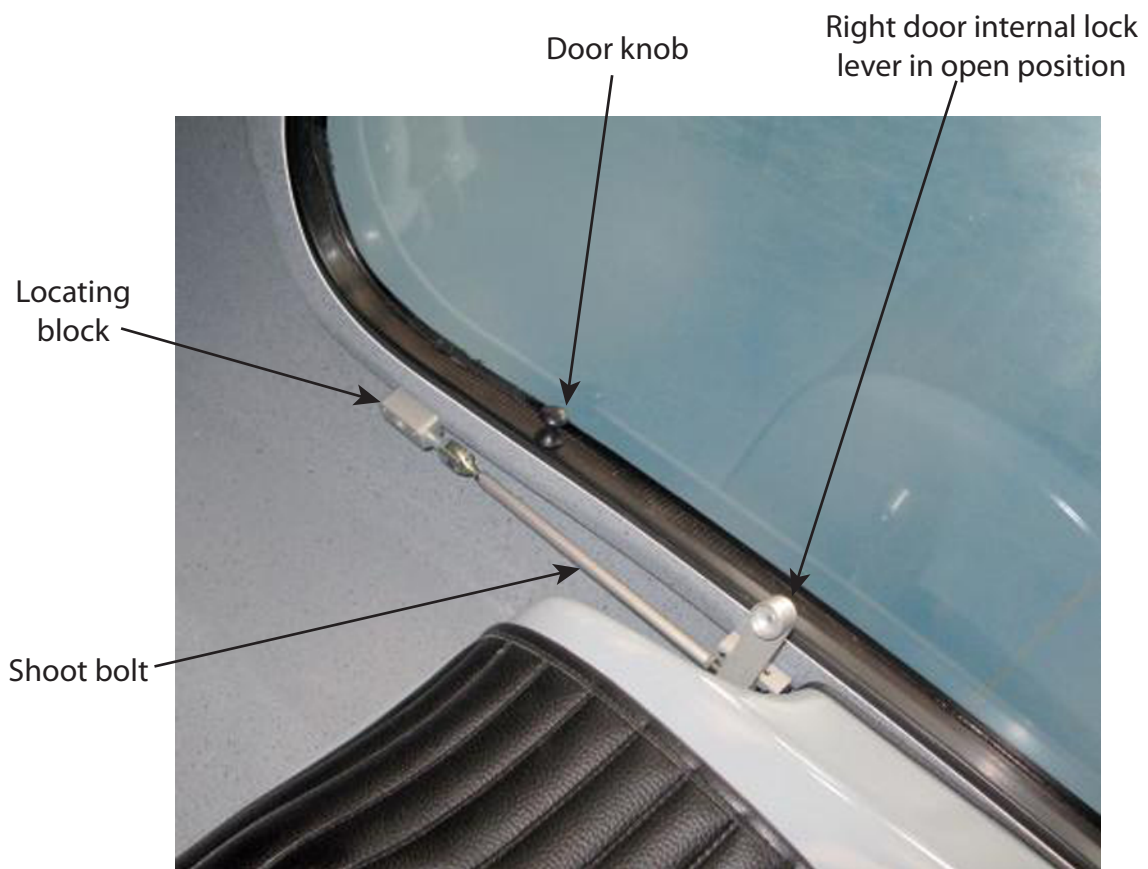
Figure 4

The investigation determined that it requires two hands to close and lock the door. Moreover, it is not possible to check visually, while seated in the aircraft, that the rear spigot is latched in the locating block by the shoot bolt. The only way to check that the spigots are correctly engaged and latched is to push on the door.

Right door operating mechanism
