## CONTENTS

### SPECIAL BULLETINS / INTERIM REPORTS

S7/2012 EC225 LP Super Puma	G-CHCN	22-Oct-12	3
-----------------------------	--------	-----------	---

<b>Aircraft Type and Registration:</b>	EC225 LP Super Puma, G-CHCN
<b>No &amp; Type of Engines:</b>	2 Turbomeca Makila 2A1 turboshaft engines
<b>Year of Manufacture:</b>	2007 (Serial no: 2679)
<b>Date &amp; Time (UTC):</b>	22 October 2012 at 1418 hrs
<b>Location:</b>	In the North Sea, approximately 32 nm southwest of Sumburgh, Shetland Islands
<b>Type of Flight:</b>	Commercial Air Transport (Passenger)
<b>Persons on Board:</b>	Crew - 2                      Passengers - 17
<b>Injuries:</b>	Crew - None                      Passengers - None
<b>Nature of Damage:</b>	Fracture of the Main Gear Box bevel gear vertical shaft
<b>Commander's Licence:</b>	Airline Transport Pilot's Licence
<b>Commander's Age:</b>	46 years
<b>Commander's Flying Experience:</b>	Approximately 12,000 hrs (approx 1,000 hrs on type)
<b>Information Source:</b>	AAIB Field Investigation

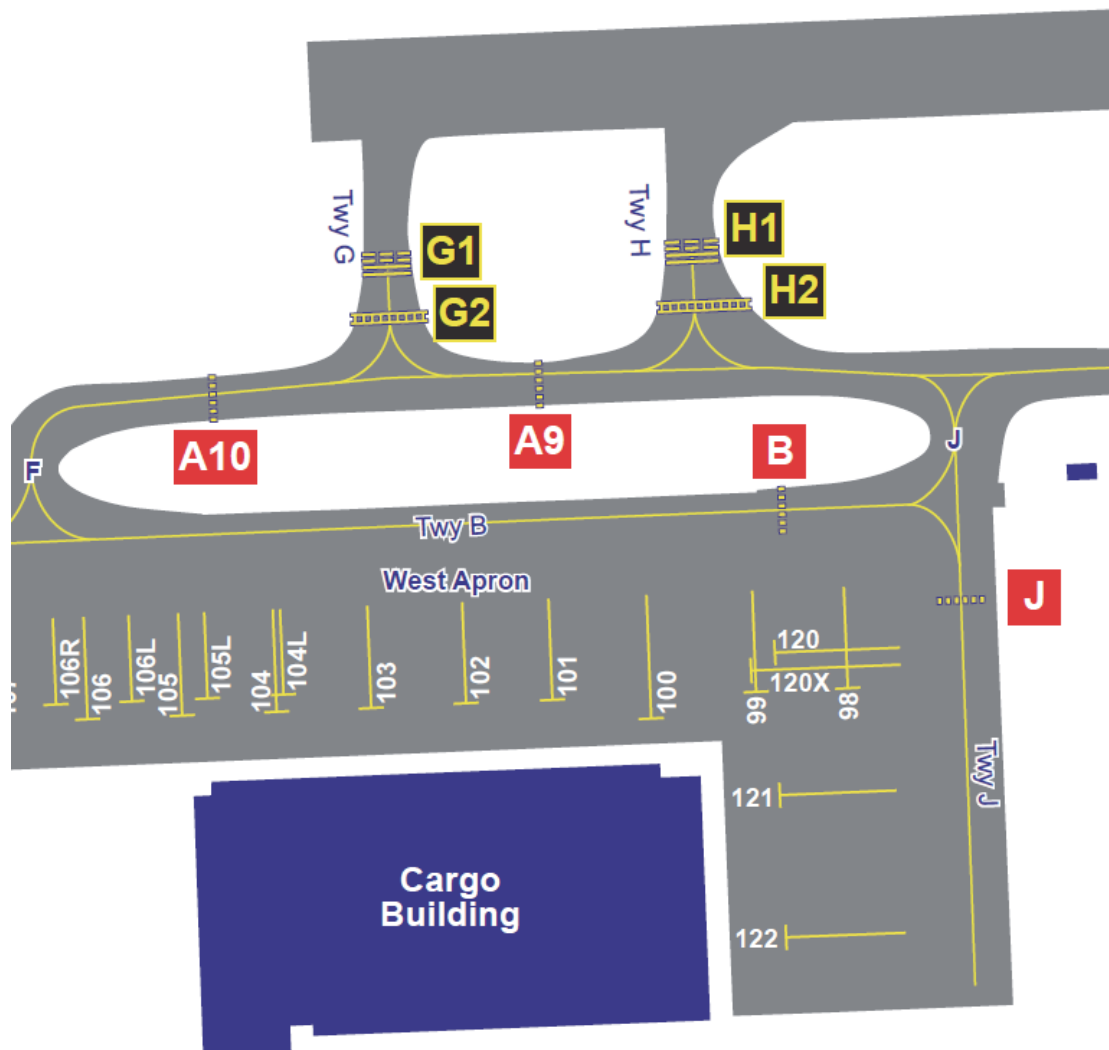
**Figure 1**

The aircraft was parked on Stand 102 on the West Apron at East Midlands Airport, a dedicated cargo area (see Figure 1). At 1744 hrs, when the aircraft was ready to depart the commander made a radio call to ATC to request start and pushback clearance. The PF completed the Before Start scan and called for the Before Start checklist. When start clearance had been obtained, he contacted the ground crew headset operator on the flight interphone and advised him that the aircraft was ready to push.

Cargo ramp area at East Midlands Airport

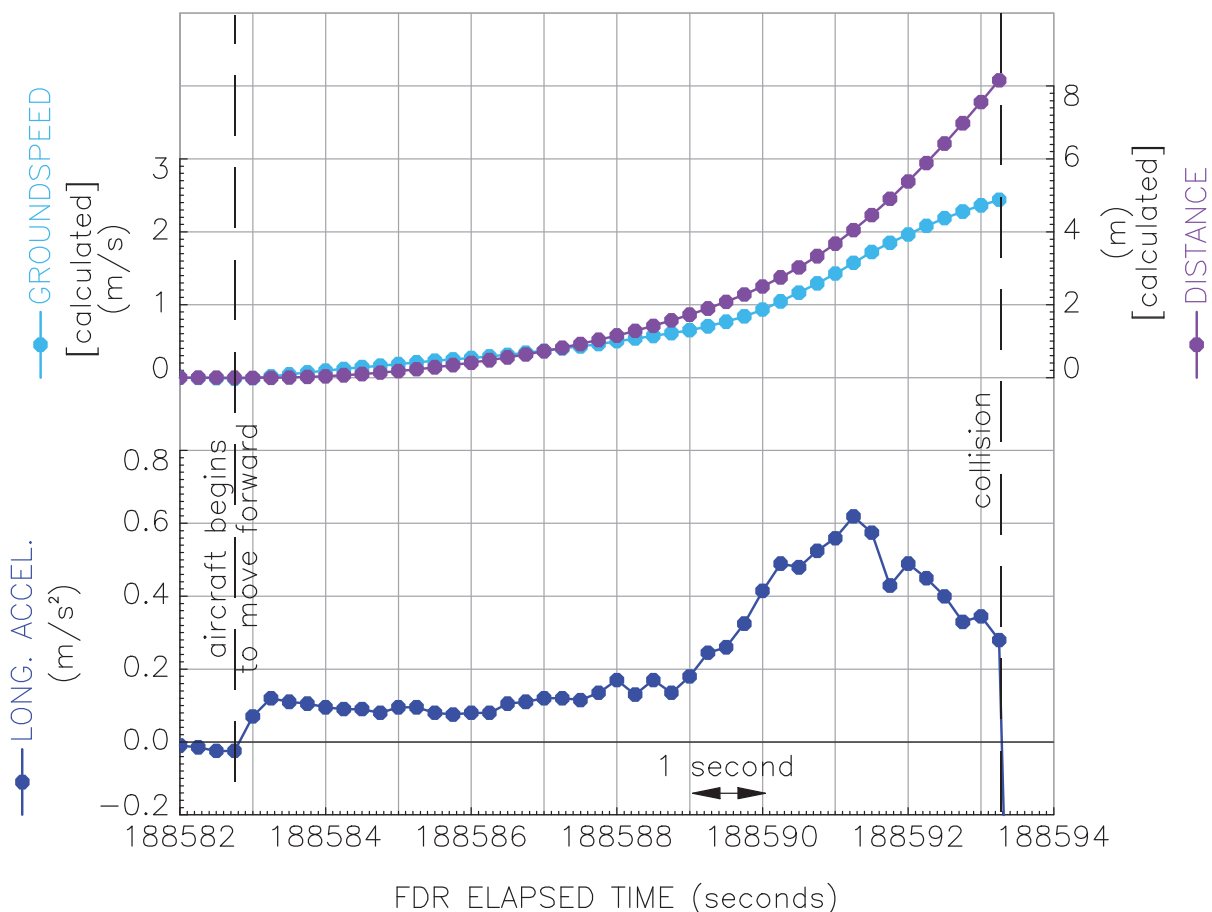
**Figure 2**

associated with the use of aircraft's brakes. However, the recording of the longitudinal acceleration enabled the calculation of the speed of the aircraft at the point of collision ( $2.4 \text{ m/s} = 4.7 \text{ kt}$ ) and the distance travelled (8 m) (see Figure 2).

FDR derived groundspeed and distance

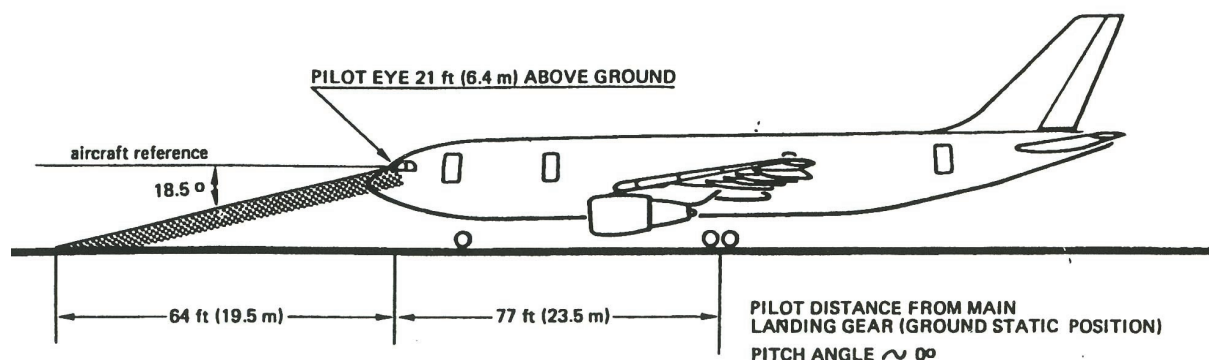
**Figure 3**

The forward and downward visible segment from the flight deck to the ground is restricted by the aircraft

Field of view from pilot's seat

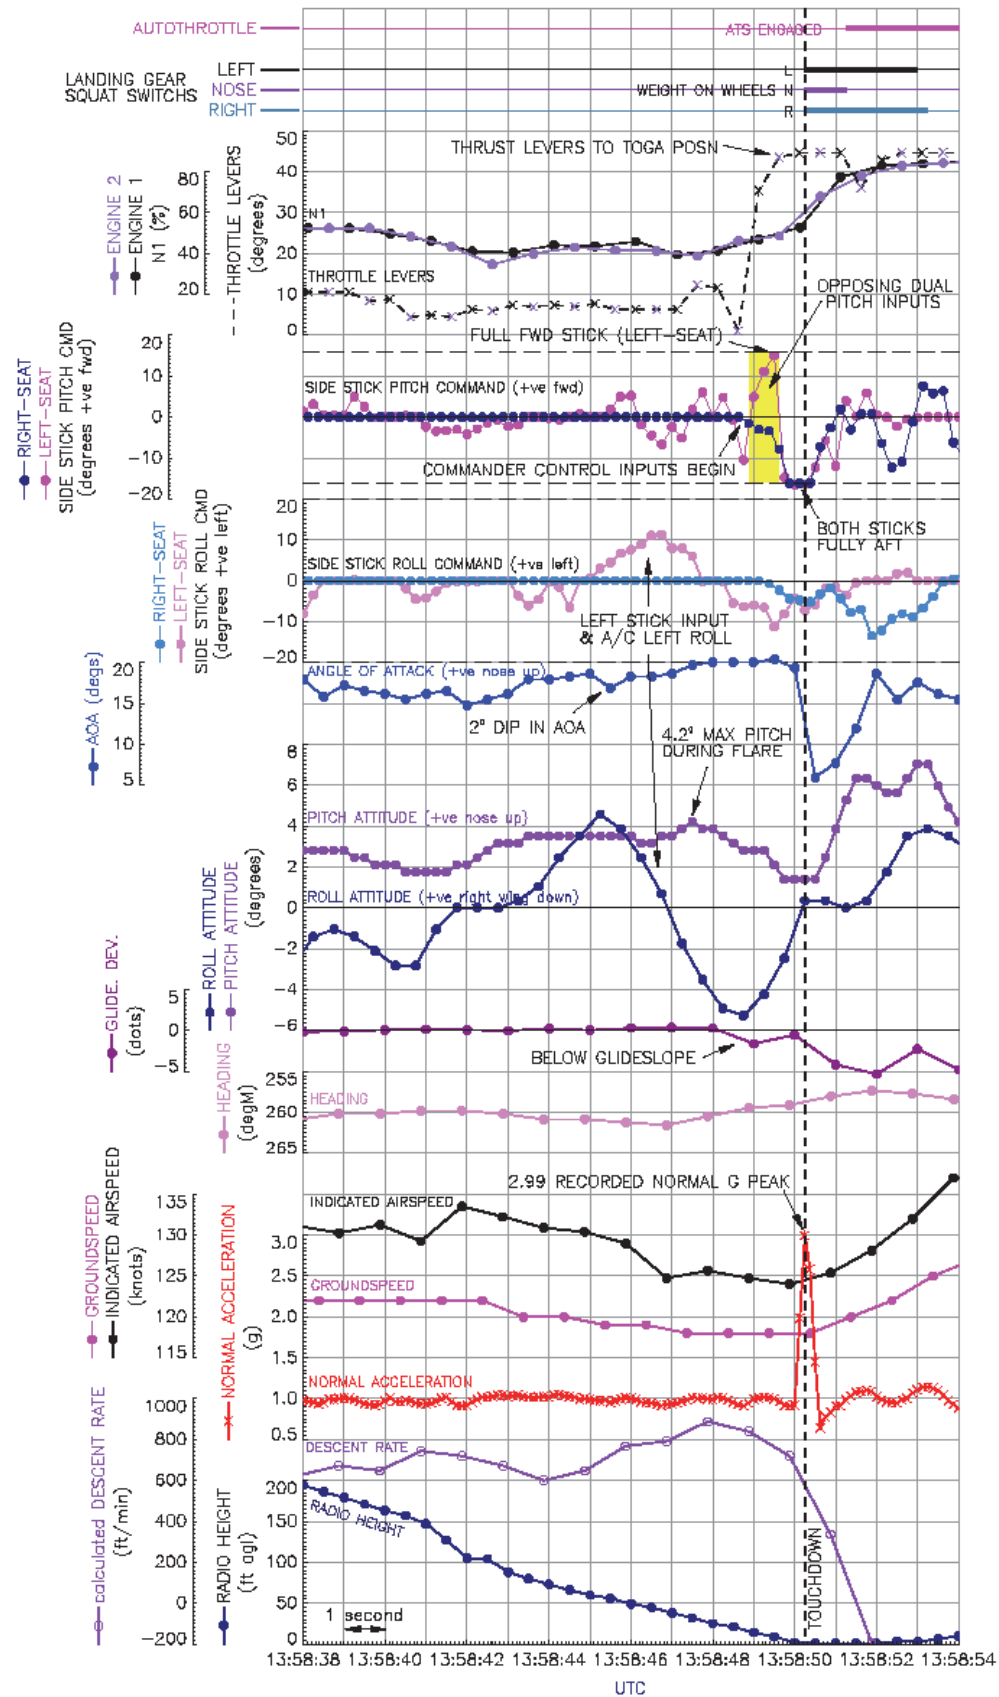
Figure 1

Once established on the ILS in the landing configuration, the remainder of the approach was stable and it was only at a late stage that it deviated from what would normally be expected. There was a momentary reduction in angle of attack at about 60 ft agl and an increasing rate of descent below around 50 ft agl, with an increasing

Salient FDR parameters for incident touchdown at Luton

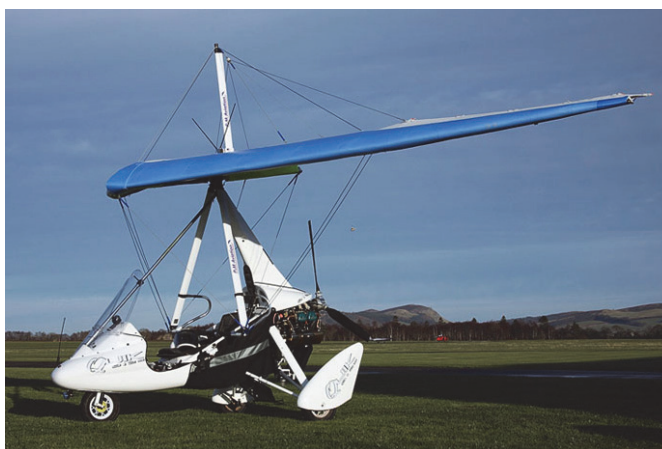
**Figure 1**

The Pegasus Quik is a tandem two-seat weight-shift microlight, powered by a Rotax 912 ULS piston engine driving a Warp Drive three-bladed propeller (Figure 1).

Accident aircraft G-CWIK

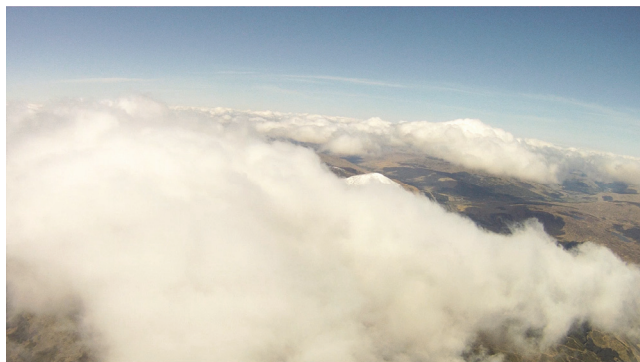
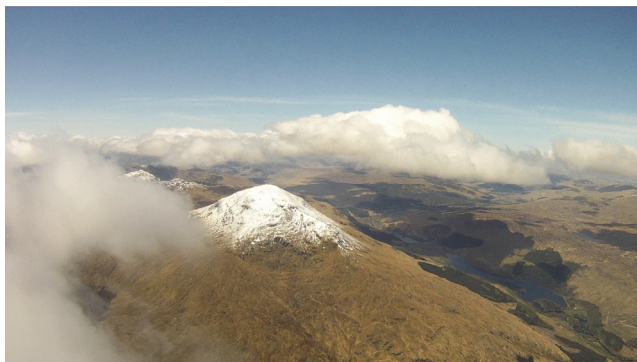
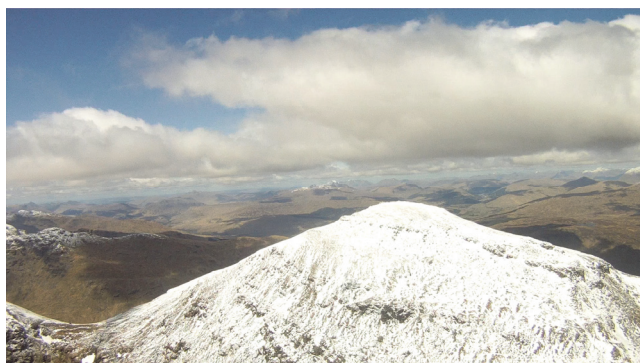
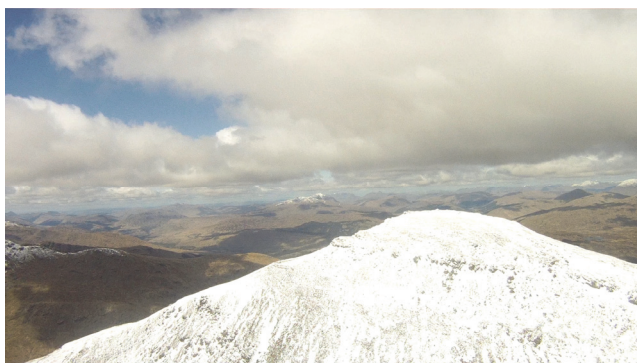
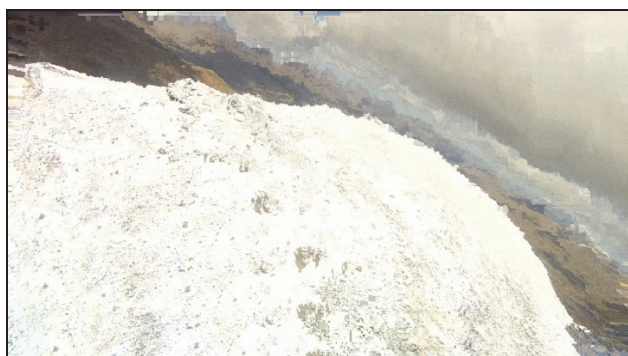
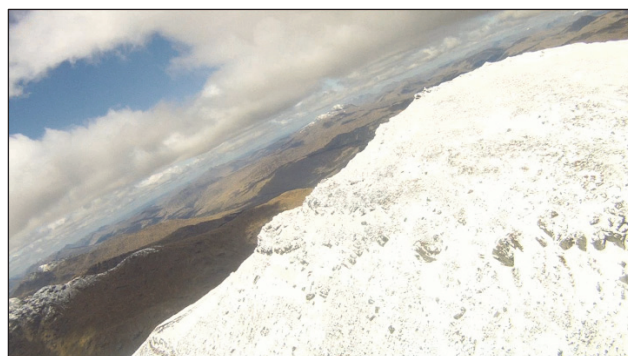
**5 seconds to final frame****Figure 3**

The video images provided good evidence of the weather conditions and flight path, shown in Figures 3 and 4 and described in the 'History of the flight' section of this report. The Figure 3 images at '6 seconds' and '5 seconds' indicate a roll rate of about 55°/sec and subsequent images showed a nose-down pitch.

Snapshots extracted from the recovered video, showing the approach to Ben More

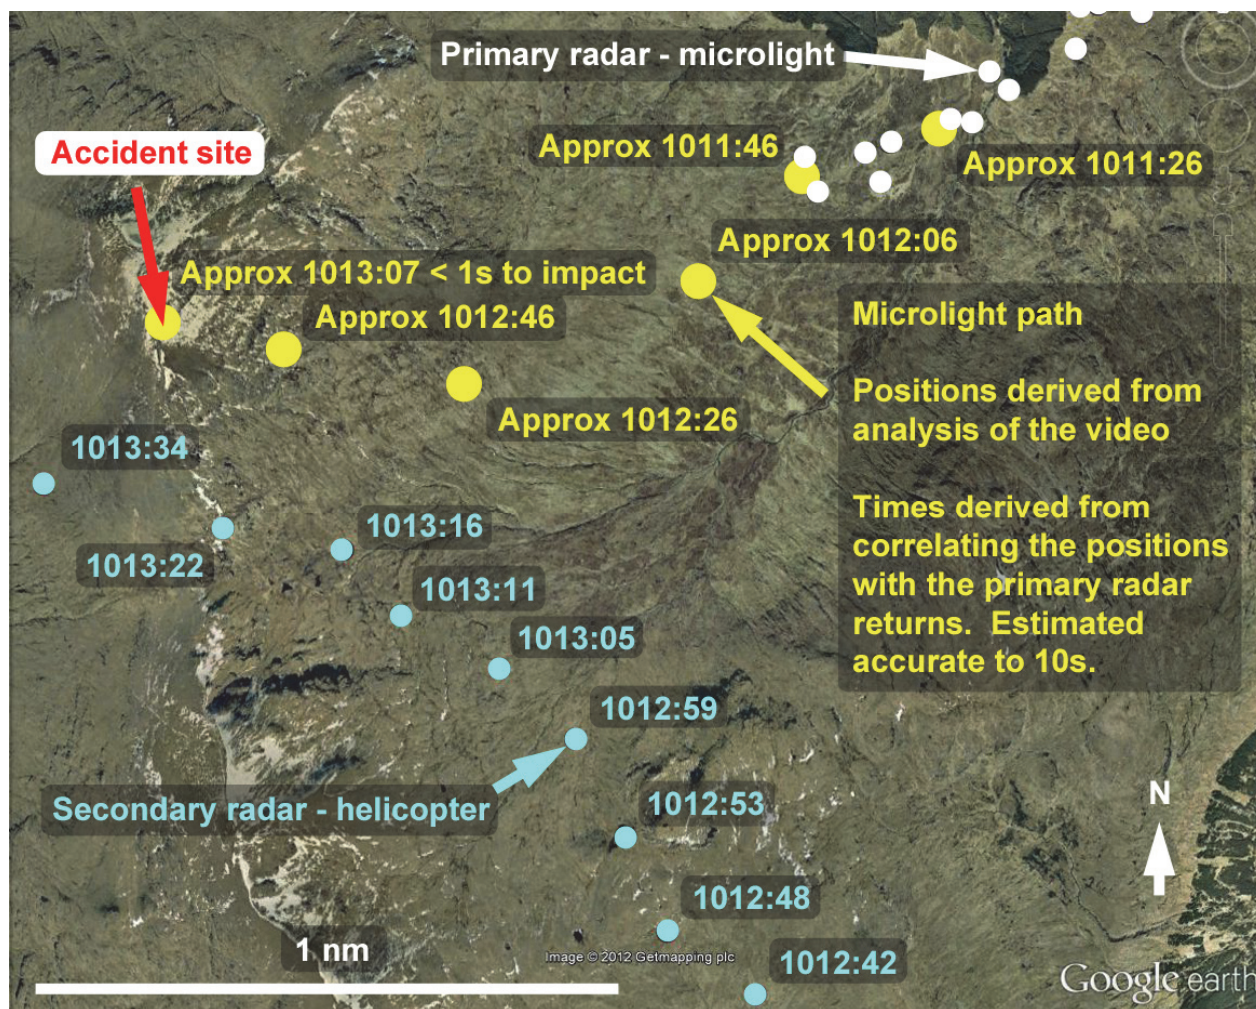
Figure 4

A secondary radar track from a helicopter in the area at the time was also reviewed. The helicopter flew from the south-east, between Ben More and the adjacent peak, below the height of the peaks, and then to the north-west (Figure 4). Photographs and video taken from this helicopter at about the time of the accident were reviewed but did not capture the accident aircraft.

was used to derive the approximate timings for the video (Figure 4).

Flight paths and timings of the microlight and helicopter

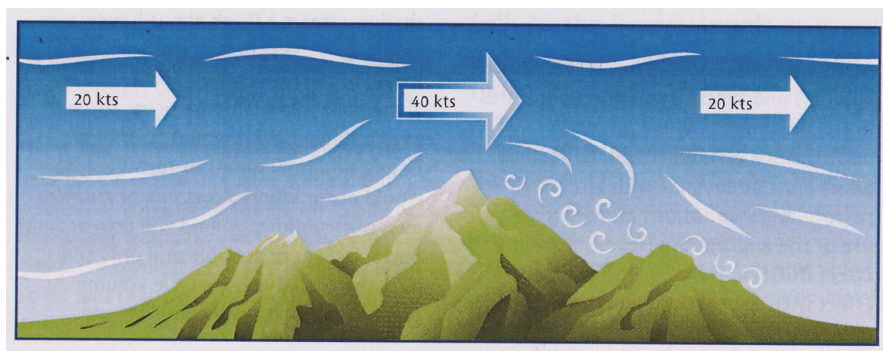
**Figure 5**

This fact is illustrated in Figure 5, with wind speeds for illustrative purposes only.

The Venturi effect of the mountain increasing the wind speed at the summit

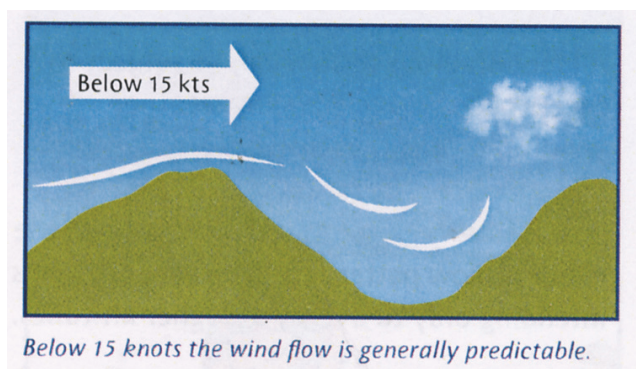
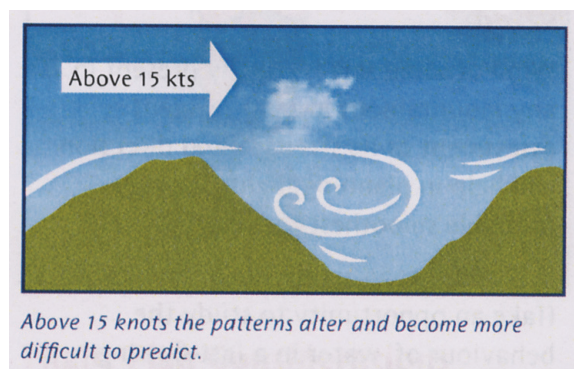
**Figure 6**

The strength of the ambient wind will govern the degree of turbulence created. A gentle wind will simply flow over the terrain following the contours but as the strength increases the wind will curl over and around features, forming up and down drafts as well as vortices, the severity of which will increase with the strength of the wind. This effect is shown in Figure 6.

The creation of hazardous turbulence in the lee of high ground related to wind strength
