## CONTENTS

### AAIB FIELD INVESTIGATIONS

| Robinson R22 Beta | G-CHZN | 06-Jan-12 | 3 |

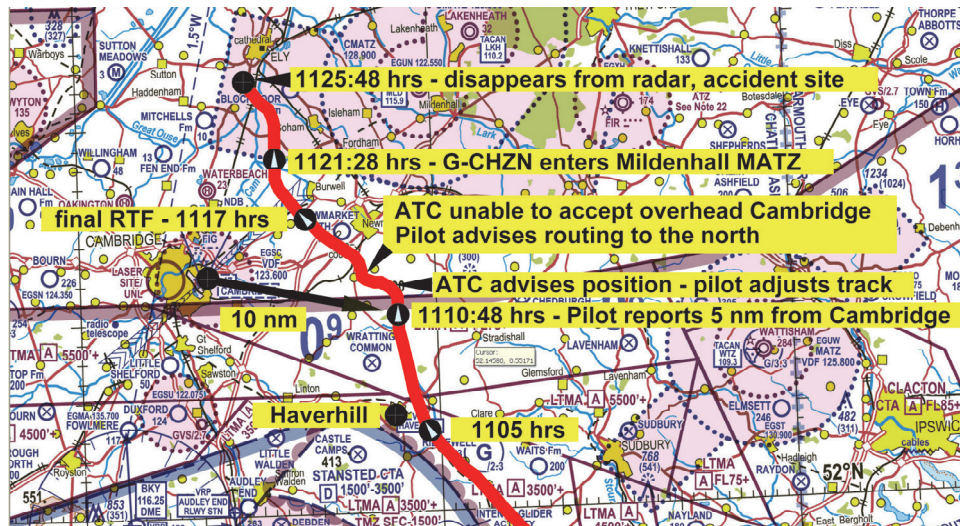
Figure 2

Information relating to the final 20 minutes of flight

At 1121 hrs, G-CHZN was on a northerly track when it entered the western stub of the Mildenhall Military Aerodrome Traffic Zone (MATZ). The helicopter was at 1,350 ft amsl and the MATZ stub extended from 1,033 ft to 3,033 ft amsl. At 1123 hrs, approximately 3 nm south of the town of Ely, the pilot turned left towards Fenland and, at 1125:48 hrs, G-CHZN disappeared from radar. Wreckage of the helicopter was found in a field 2 miles south-west of Ely.

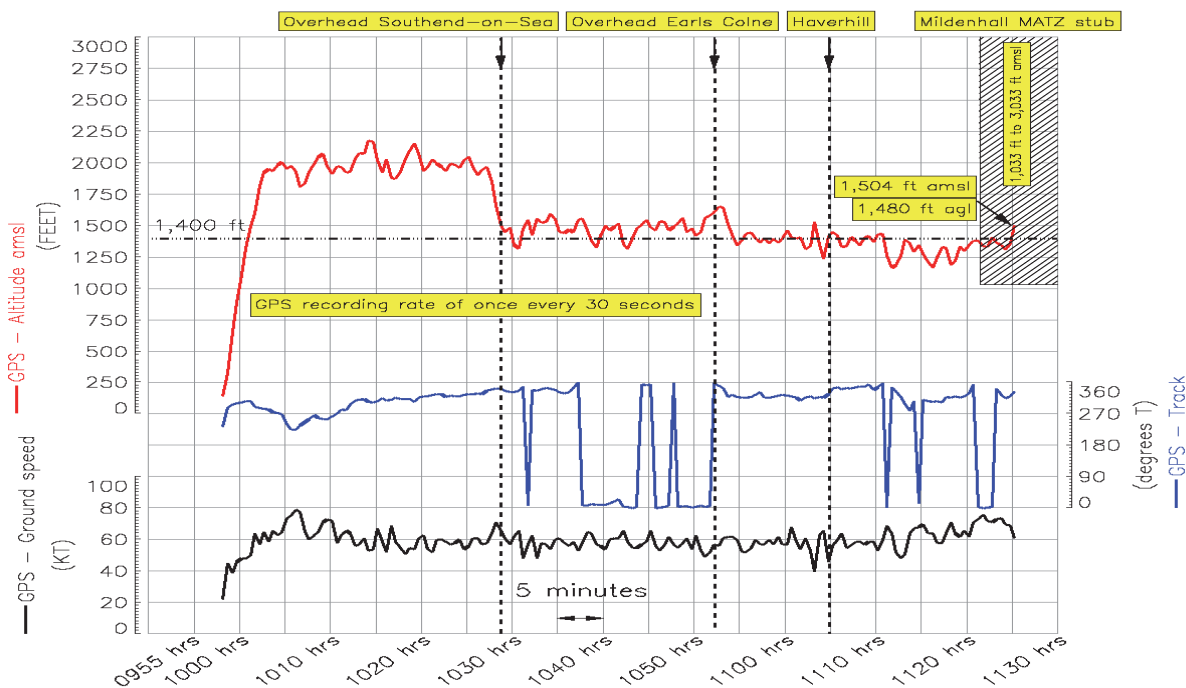
The GPS unit, which was normally attached to the top of the instrument panel in G-CHZN, was found 50 m away from the main wreckage. Although damaged, a track log of the flight was recovered containing aircraft GPS-derived position, track, altitude and groundspeed recorded at a nominal rate of once every thirty seconds. The GPS track log commenced at 0958 hrs as the helicopter departed Manston Airport and ended at 1125:20 hrs. The final GPS position was 875 m to the south-east of where the helicopter’s fuselage impacted

**Figure 3**  
G-CHZN – GPS-derived information

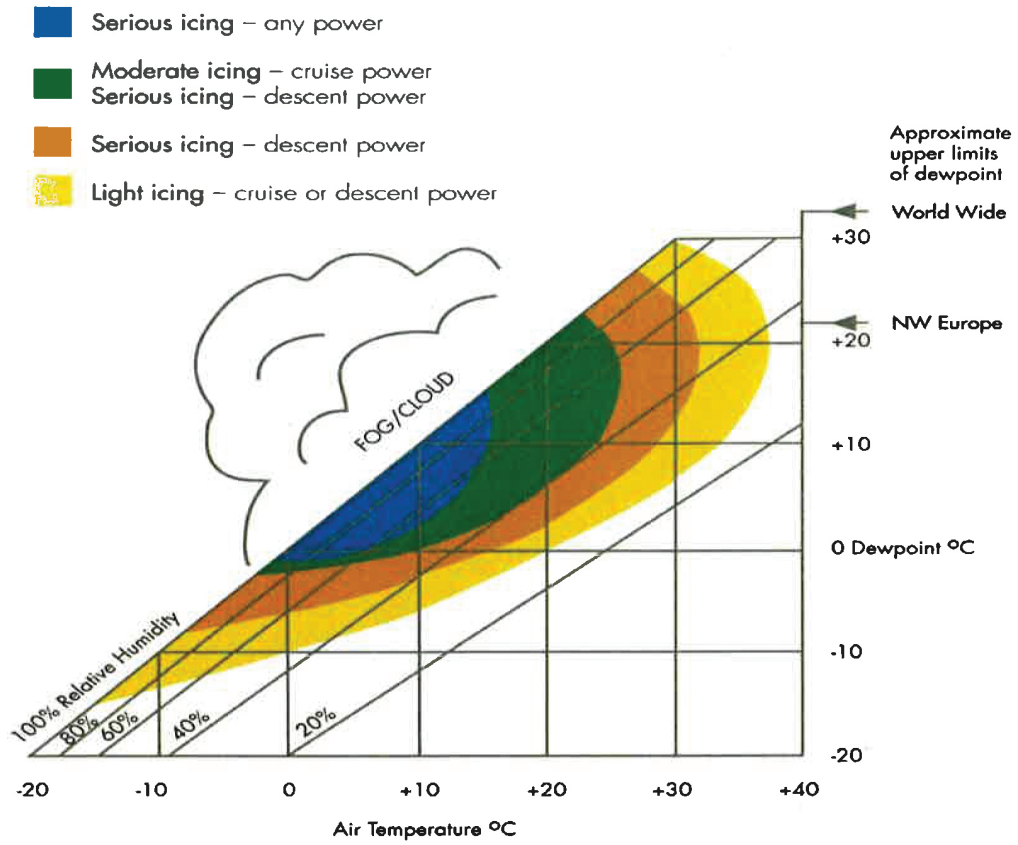
**Figure 4**

Data from the Larkhill radiosonde<sup>5</sup>, launched at 1000 hrs on 6 January 2012, suggested that the temperature in the area of the accident at 1,500 feet amsl was approximately 5°C and the dewpoint was approximately 0°C. Figure 4 shows that moderate or serious carburettor icing is possible at any engine power with this combination of temperature and dewpoint.

**Carburettor Icing Chart**

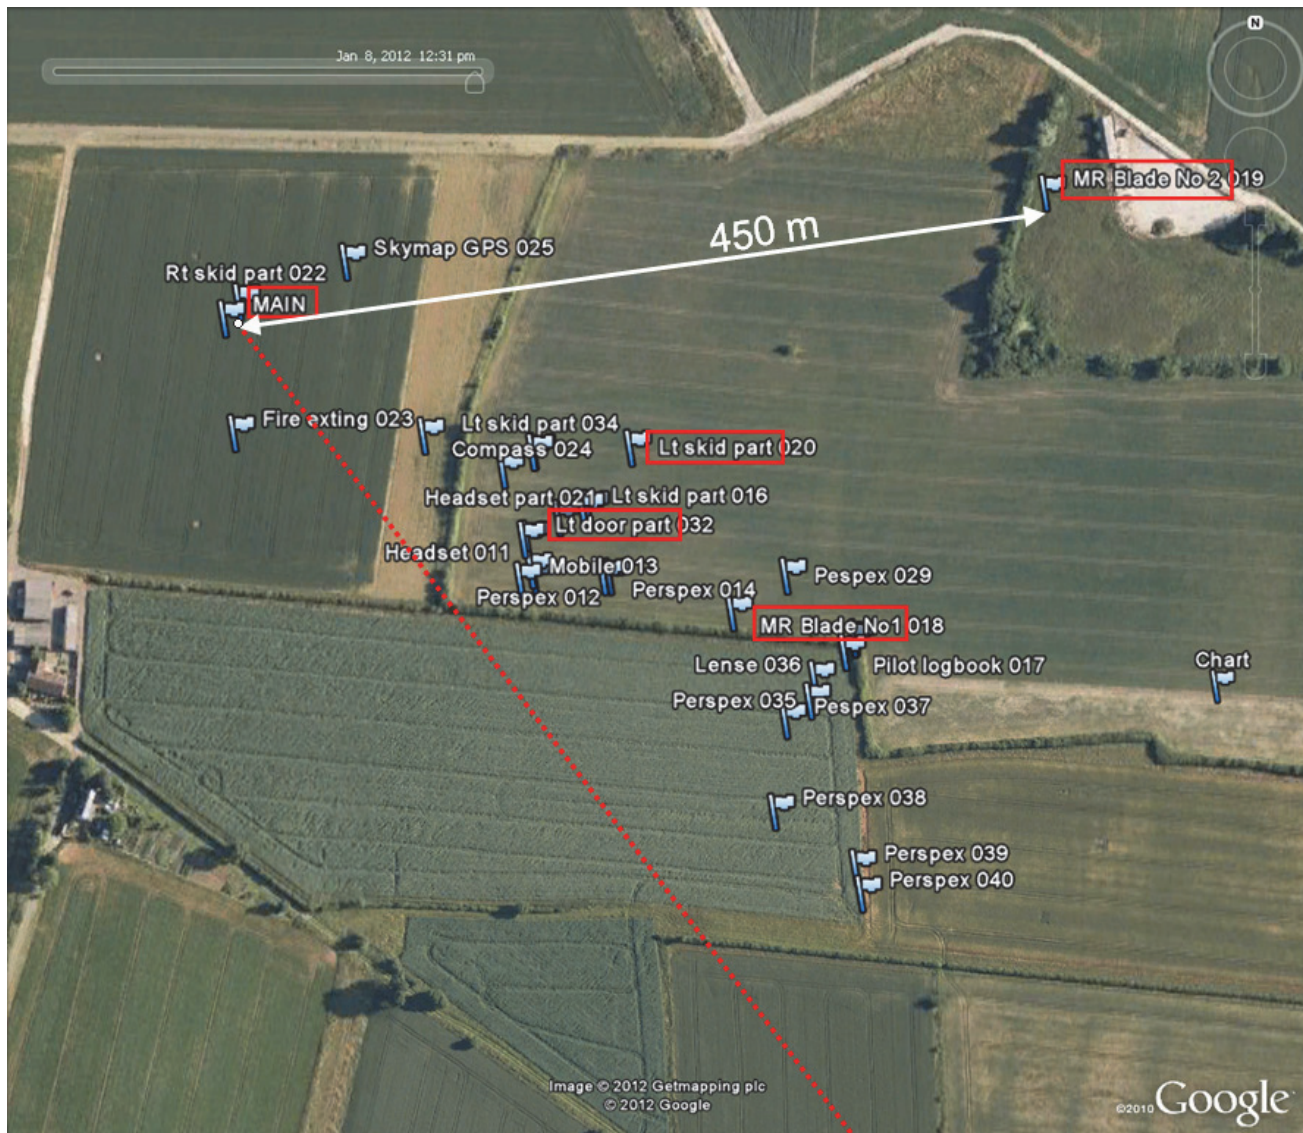
**Figure 8**

The main wreckage was found lying inverted in a field 2 miles south-west of Ely with its main rotor shaft buried in the ground (Figure 7). The lack of ground marks surrounding the wreckage indicated that the helicopter had struck the ground in an inverted attitude with very little horizontal speed. The main rotor (MR) blades were missing and one blade was found 315 m south-east of the main wreckage, in a hedge with its root embedded in the ground and its tip in the air (this will be referred to as MR blade No 1). The other MR blade was found 450 m east of the main wreckage lying flat in a field (this will be referred to as MR blade No 2). Both blades had separated from the main rotor hub at the coning hinge. Scattered along the length of a 500 m wreckage trail (Figure 8) orientated to the south-east of the main wreckage were multiple pieces

of broken 'perspex' transparency and items from the cockpit. The left door, a small part of the right door and parts from the front left skid were located about 220 m from the main wreckage.

Wreckage plot overlaid with probable final track (dashed red line)  
 (image copyright Google Earth™ mapping service/Getmapping plc)

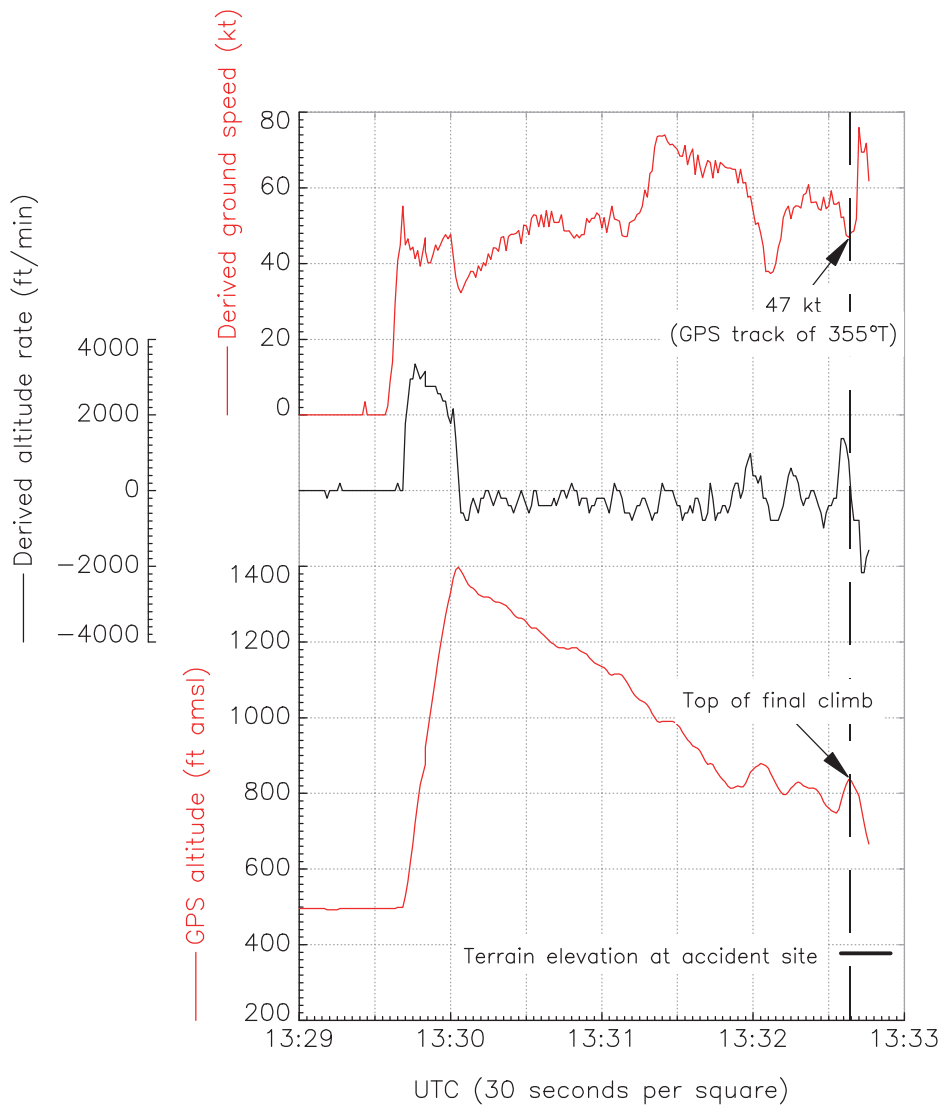
**Figure 2**

Figure 2 shows the iPAQ recorded GPS altitude data for the accident flight, as well as the derived altitude rate and derived groundspeed. The accident flight started at 1329 hrs and the recording ended approximately three minutes later.

Recorded GPS altitudes and derived altitude rates and ground speeds for the accident flight, sourced from the iPAQ

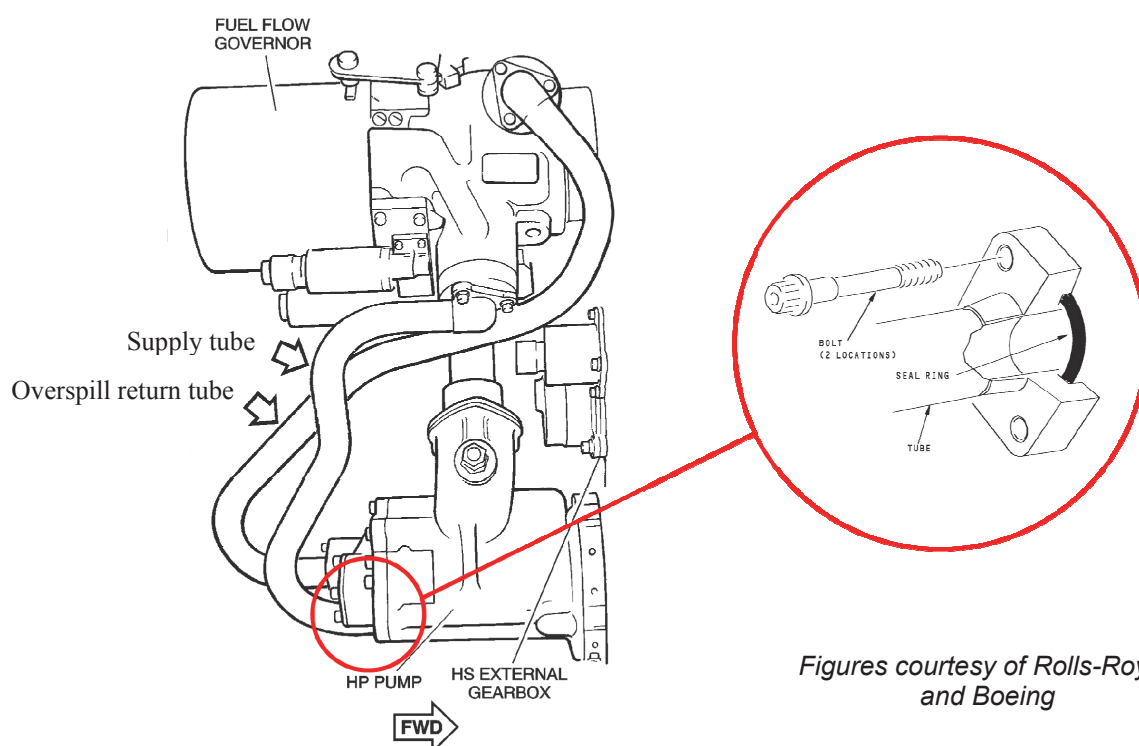
**Figure 1**

Inspection of the right engine's fuel system revealed that the source of the fuel leak was the pump-end flanged joint of the fuel supply tube running between the high pressure (HP) fuel pump and the fuel flow governor (Figure 1). This fuel tube had been installed during the C-check as part of a recommended Service Bulletin, RB.211-73-G230. This Service Bulletin recommends the replacement of earlier standards of fuel tube that were the source of previous fuel leaks; the AAIB report on G-TCBA, published in AAIB Bulletin 4/2011, refers to one such incident.

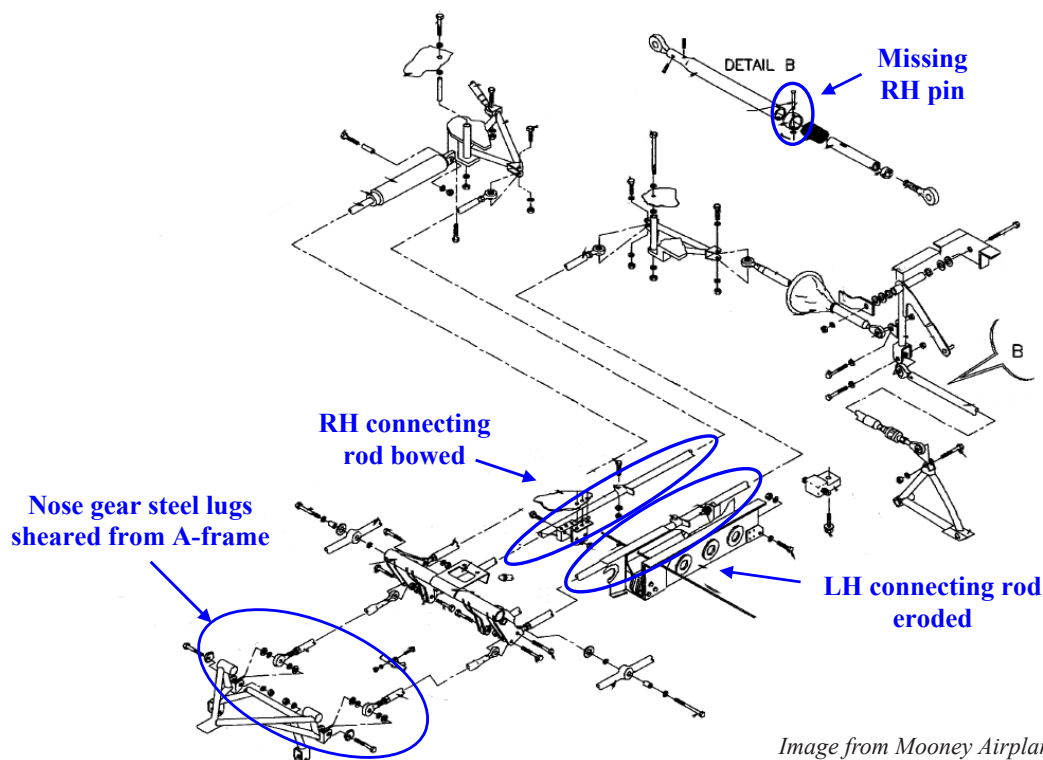
**Figure 1**

A recovery team removed the aircraft from the runway shortly after the incident and it was stored in a hangar at Oxford Airport. It was reported that initially the salvage crew were not able to extend the right main gear and had found a broken connecting rod in the mechanical linkage (Figure 1). Once this was removed they were able to extend the gear. The condition of the linkage prior to the accident is unknown and it is possible this damage was caused during the landing.

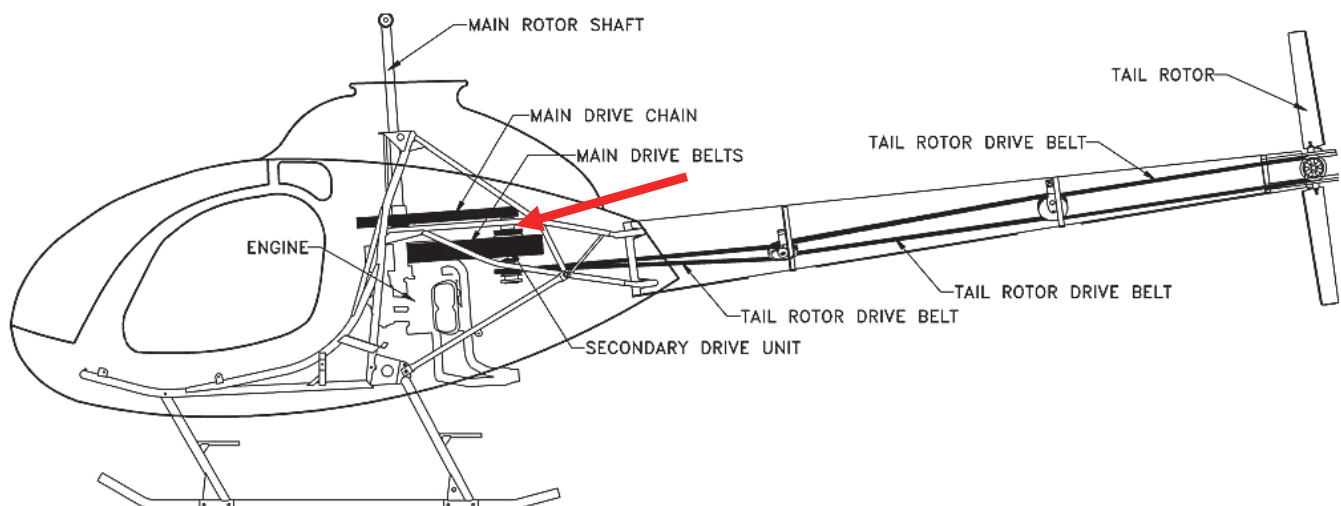
**Figure 1**

It subsequently became apparent that there had been a failure of the secondary driveshaft, such that the engine was no longer driving the main rotor. The drive-train components of the helicopter are illustrated in Figure 1.

Main components of the drive-train, position of shaft failure arrowed

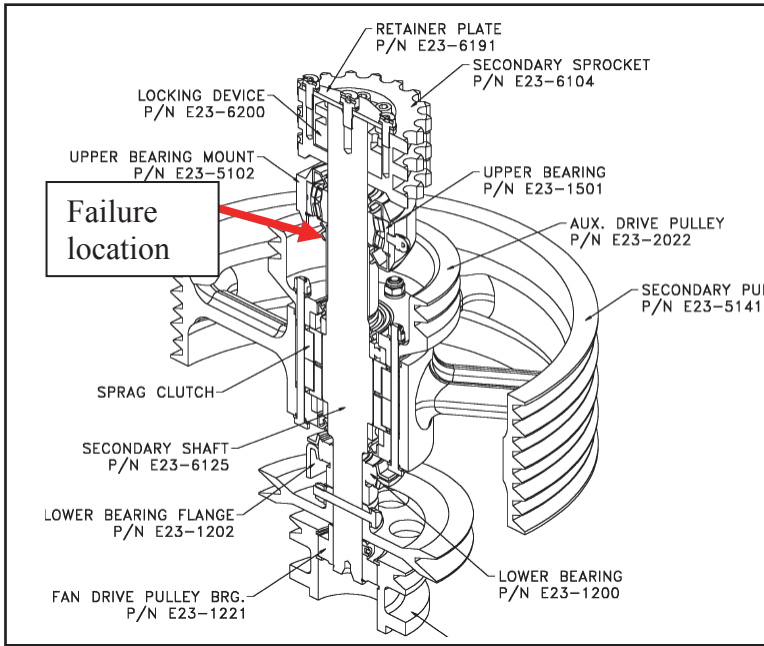
**Figure 2**  
Diagram of shaft assembly

Figures 2 and 3 show a diagram of the secondary shaft assembly, together with a photograph of the failure. It can be seen that the failure occurred adjacent to the lower edge of the inner race of the upper bearing. The components were returned to the manufacturer in the USA, where the shaft, which is solid, was subjected to a metallurgical analysis. Figure 4 shows the two shaft halves following removal.
