CONTENTS

SPECIAL BULLETINS

INTERIM REPORTS

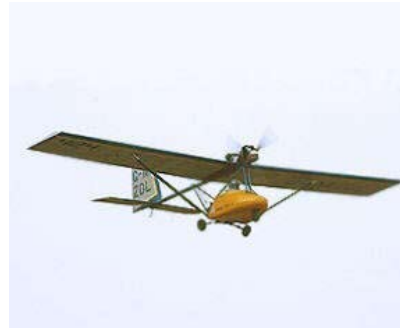
a faster speed at touchdown. During the landing, the combination of the aircraft's speed and the rough stubble surface of the field caused the aircraft to turn over, damaging its nose landing gear and fuselage. The pilot and his passenger received minor injuries and exited the aircraft through the right door. There was no fire.
