CONTENTS

INCIDENT

Aircraft Type and Registration:	Boeing 757-3CQ, G-JMAB	
No & Type of Engines:	2 Rolls-Royce RB211-535E4-B-37 turbofan engines	
Year of Manufacture:	2001	
Date & Time (UTC):	12 December 2007 at 1935 hrs	
Location:	Stand 32, Manchester Airport	
Type of Flight:	Commercial Air Transport (Passenger)	
Persons on Board:	Crew - 10	Passengers - 283
Injuries:	Crew - None	Passengers - None
Nature of Damage:	Front of No 1 engine nacelle dented at one o'clock position	
Commander's Licence:	Airline Transport Pilot's Licence	
Commander's Age:	48 years	
Commander's Flying Experience:	10,048 hours (of which 6,119 were on type) Last 90 days - 94 hours Last 28 days - 55 hours	
Information Source:	Aircraft Accident Report Form submitted by the pilot

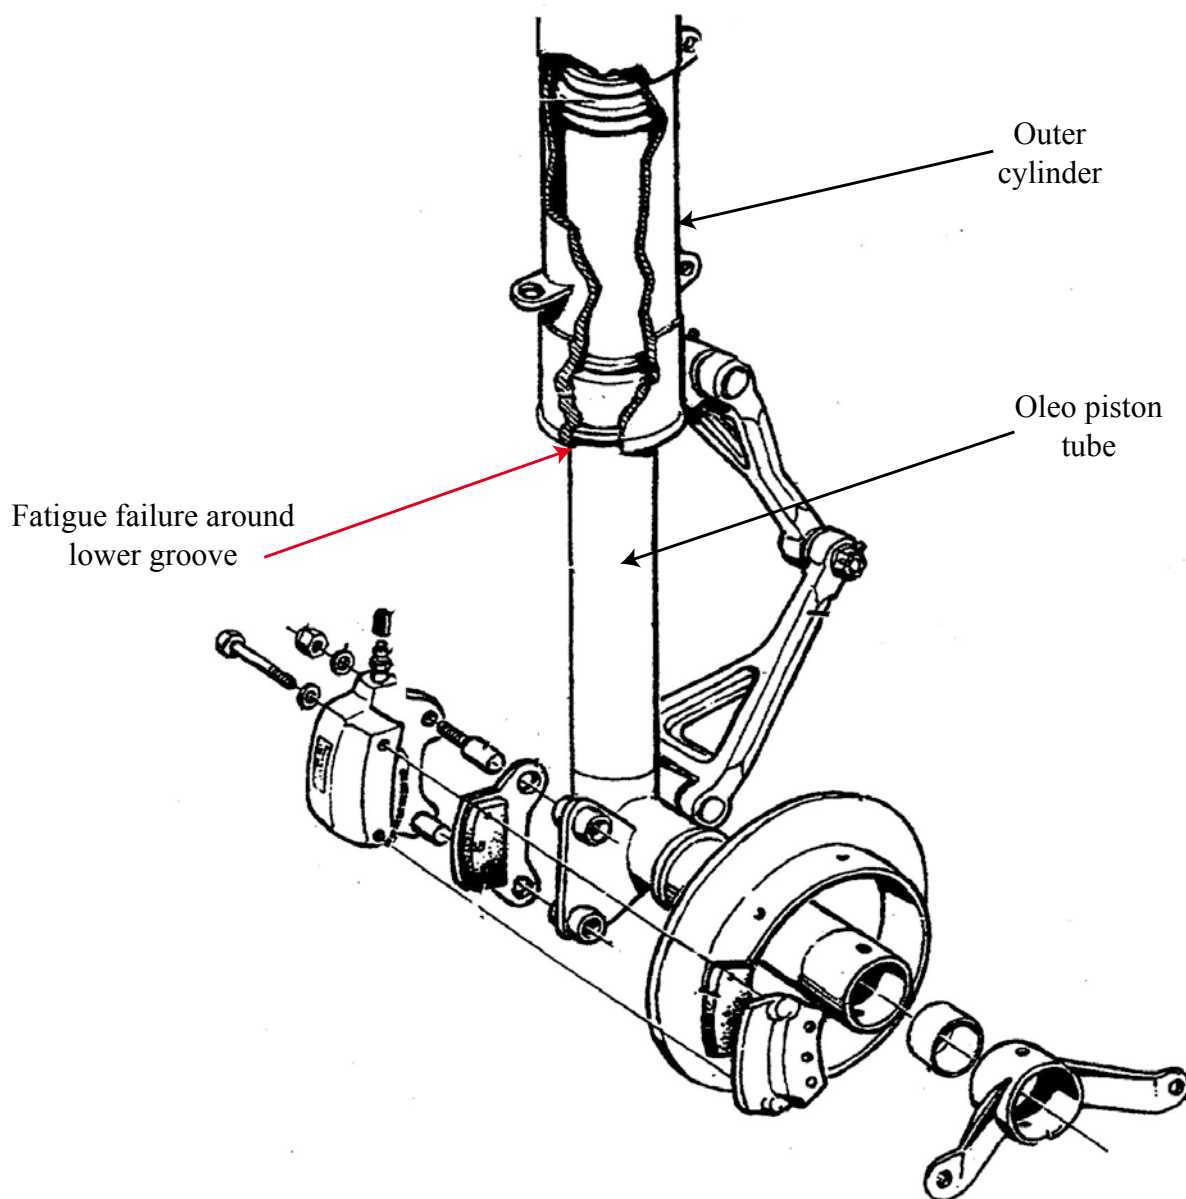
Figure 1

oleo piston tube, integral with the wheel axle, which operates within the outer cylinder to attenuate loads from the landing gear to the airframe on touchdown (Figure 1). The cylinder is connected to the axle via a torque linkage. The landing gear is maintained 'on condition' and there had been no history of loss in oleo pressure, or fluid leaks from the seals on the subject leg. It was not possible to establish the service history of the failed unit.

Diagram of the Robin HR200 Main Landing Gear unit

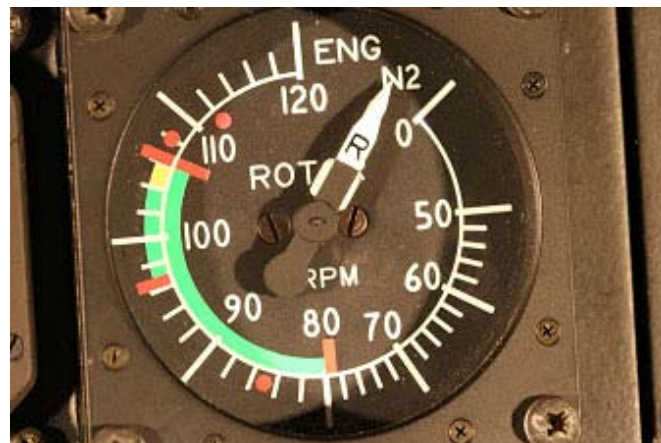
Figure 2

The pilot would have been naturally concerned about rotor rpm, and did interrogate the triple tachometer gauge (see Figure 2). However, controlling the helicopter attitude and selecting a suitable landing site would have demanded most of his visual attention during the short time available and so it is likely that he only gave the gauge a brief glance.

The two N2 pointers are below the NR pointer in this photograph of the gauge at rest.

Note the tail of the NR pointer.

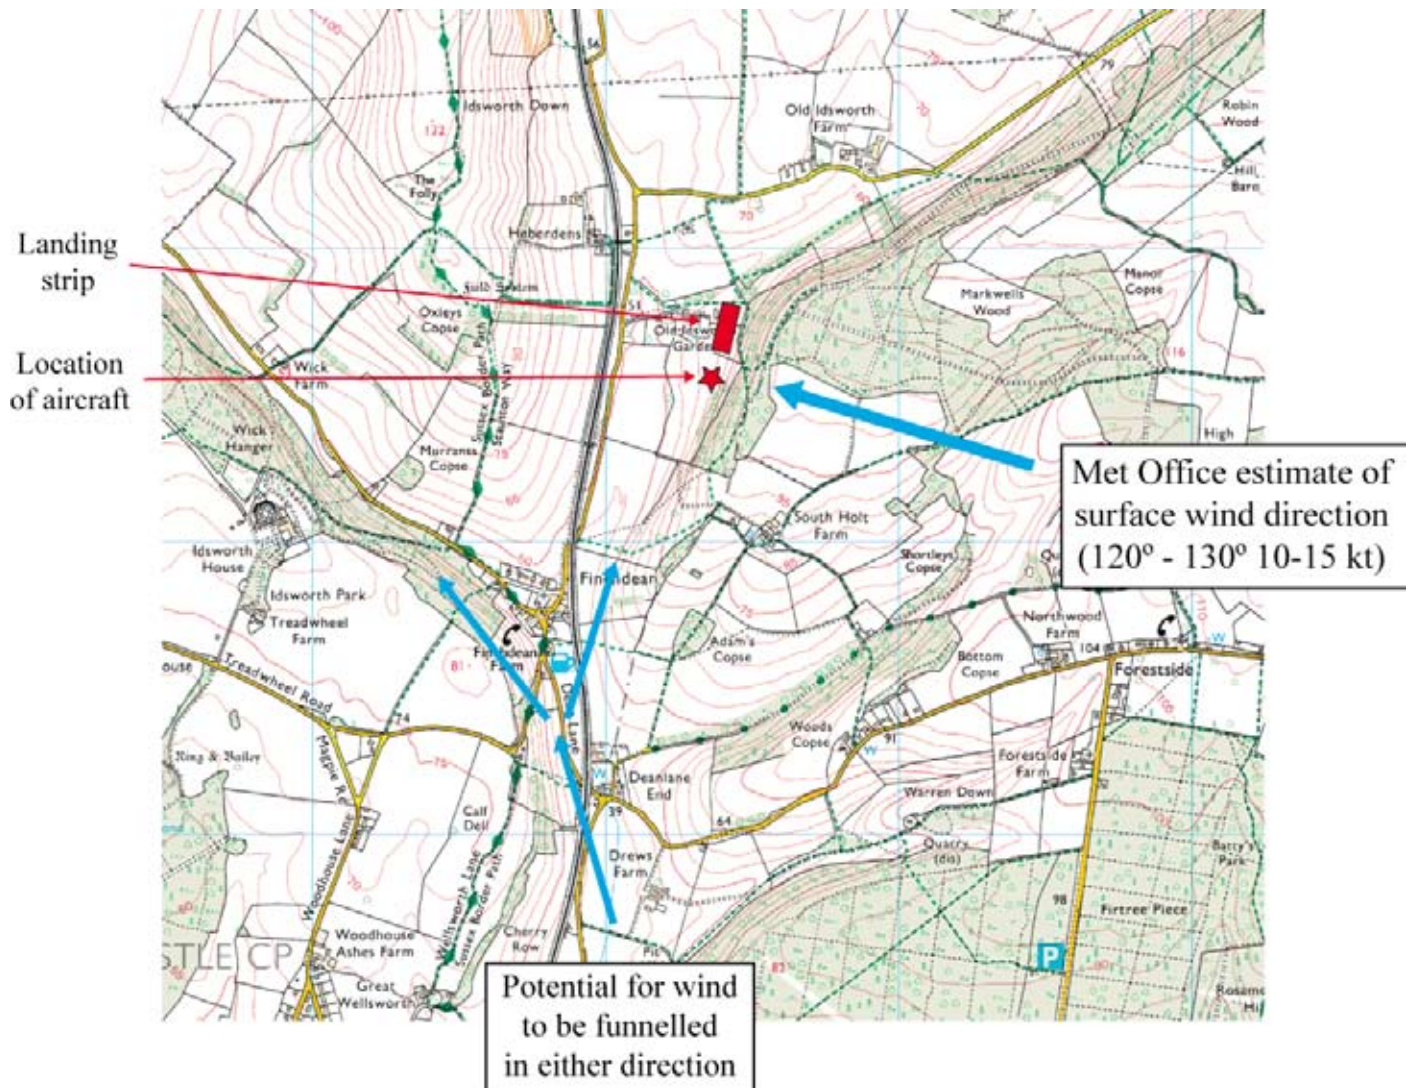
Figure 1

There are ridges to the east and west of the strip, which lies close to the foot of the western ridge (Figure 1). The wind direction at the time would have placed the strip downwind of the ridge and downdraughts and

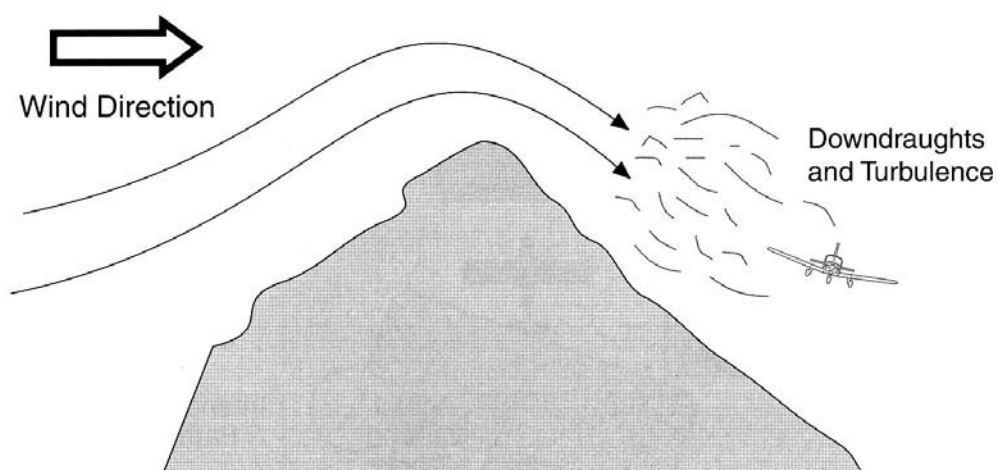
Figure 2

turbulence would be expected at low level (Figure 2). The ridge to the east may also have influenced the local airflow. The combined effect of the two ridges is difficult to assess, although a scenario in which marked changes in vertical and horizontal wind strength for the approach could readily be envisaged.

The pilot attributed the accident to the downdraught created by the adjacent hills. This is a well known phenomenon and pilots are advised against flying at low level downwind of high ground, particularly in strong wind conditions, or in aircraft with low wing loadings that are susceptible to gusts.

Dangers of flying at low level downwind of high ground
(Figure copyright AFE and Jeremy M Pratt)
