AAIB Bulletin

11/2014

Aircraft Type and Registration:	Cessna 310Q, G-BXUY	
No & Type of Engines:	Two Continental IO-470-VO piston engines	
Year of Manufacture:	1970 (Serial No: 310Q-0231)	
Date & Time (UTC):	15 November 2013 at 1158 hrs	
Location:	Hawarden Aerodrome, Chester	
Type of Flight:	Private	
Persons on Board:	Crew - 1	Passengers - 1
Injuries:	Crew - 1 (Fatal)	Passengers - 1 (Fatal)
Nature of Damage:	Aircraft destroyed	
Commander's Licence:	Commercial Pilot's Licence	
Commander's Age:	58 years	
Commander's Flying Experience:	1,645 hours (of which 261 were on type) Last 90 days - 18 hours Last 28 days - 6 hours	
Information Source:	AAIB Field Investigation

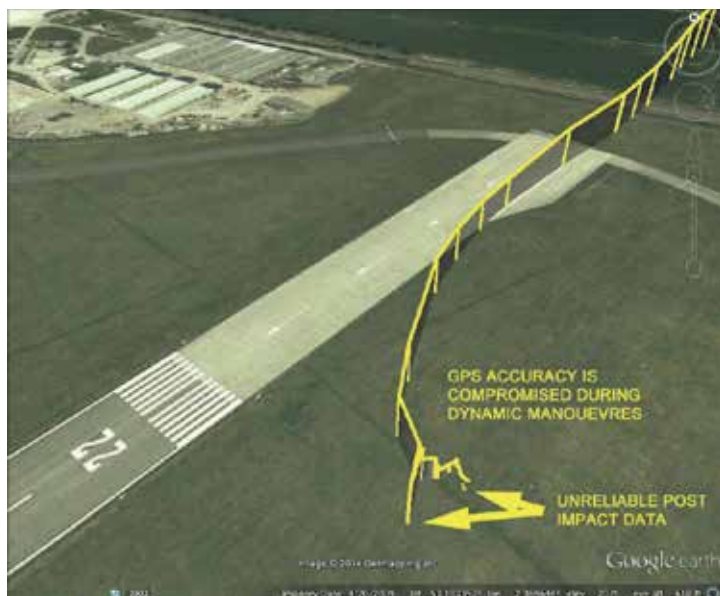
Figure 1

The aircraft was not fitted with a Flight Data Recorder, nor was it required to be. However, the pilot was known to use a flight planning and navigation application on his tablet computer and apparently did so for the accident flight. Although the tablet suffered extensive damage, track points associated with the accident flight had been recorded and were successfully downloaded for analysis. The nature of the system that was gathering the position data is such that it can use different sources of data for position fixes. However, recorded accuracy figures indicate that the system was using GPS satellite data as the source of the positional information. The flight path of the final approach and accident sequence is shown in Figure 1.

Recorded flight path: final approach and accident sequence

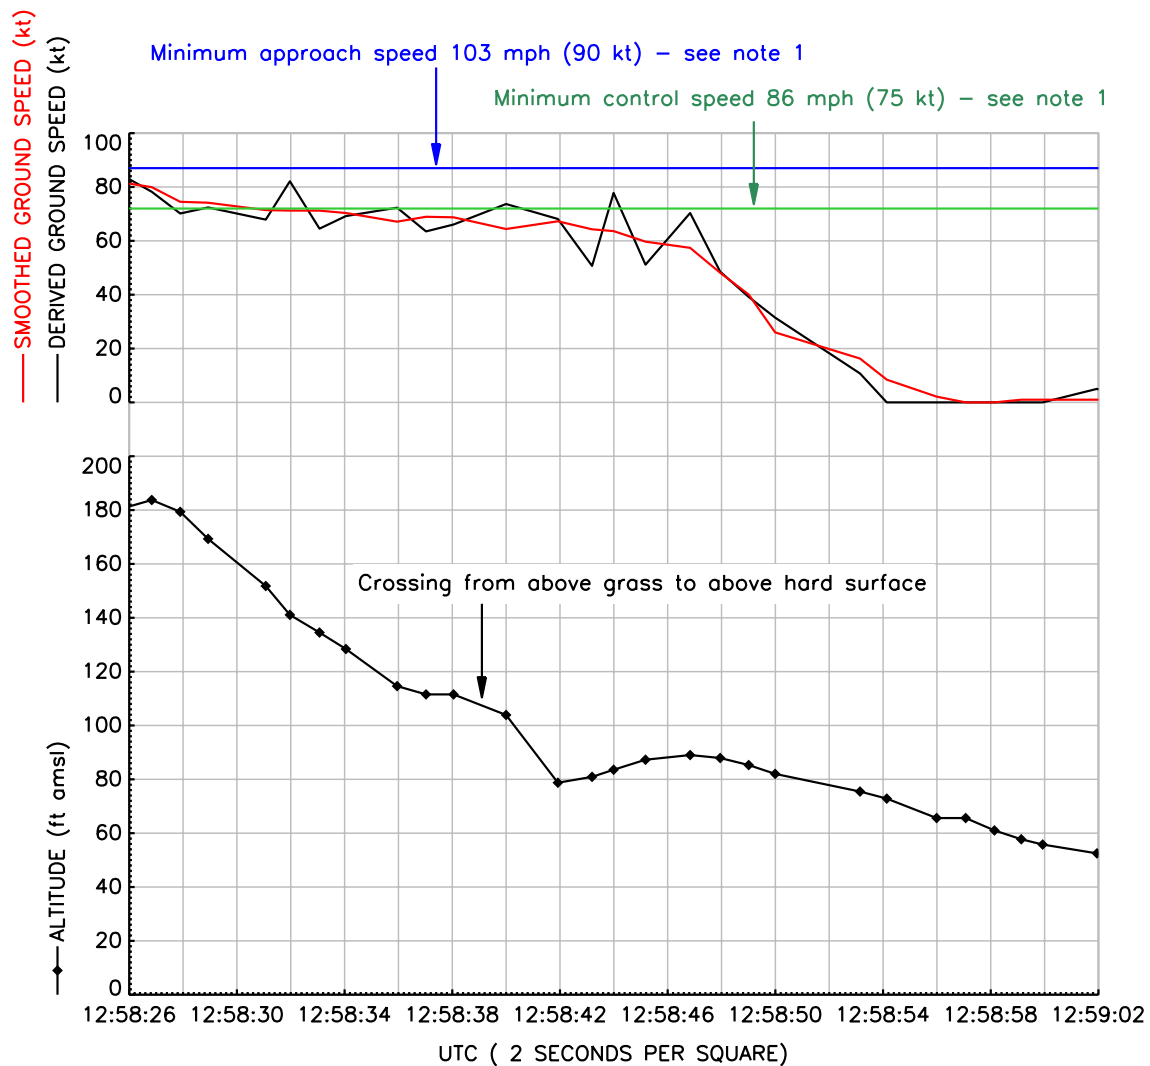
**Figure 2**

Recorded data from the pilot’s tablet computer allowed a speed analysis of the latter stages of the flight. Speed and altitude data for the final approach and accident sequence is shown at Figure 2.

Recorded altitude data and derived speed

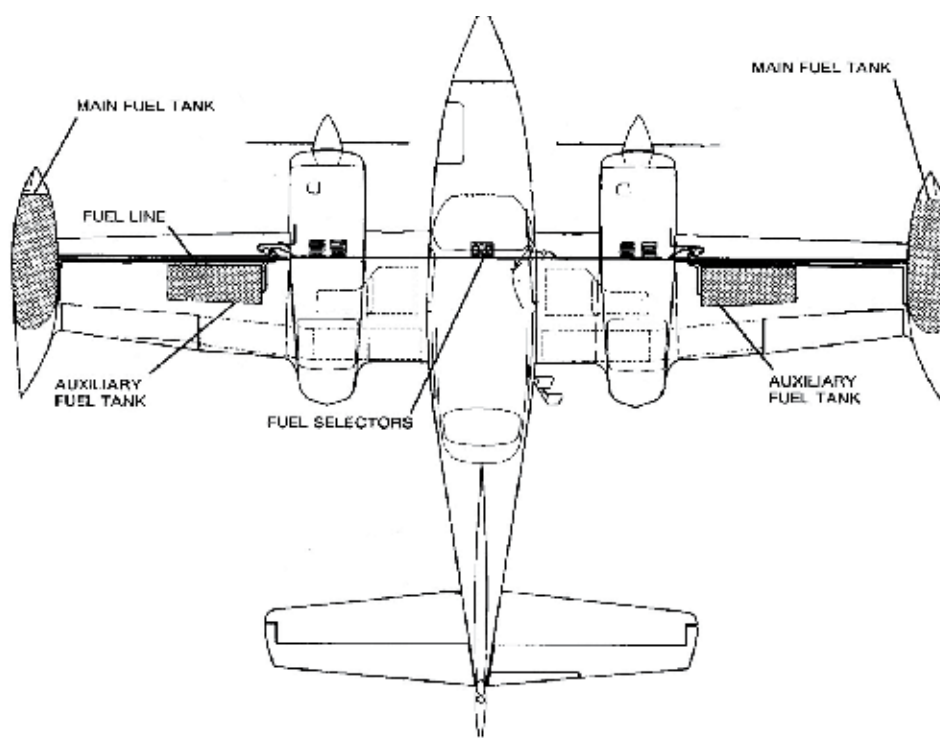
The aircraft was a Cessna 310Q powered by two Rolls Royce Continental IO-470-VO engines. The fuel system for the aircraft consisted of four fuel tanks: two 51 US gallon (193 litre), wingtip-mounted, main fuel tanks and two 20.5 US gallon (78 litre) auxiliary fuel tanks in the outboard section of each wing (Figure 3). A pair of fuel selector switches, mounted on the cockpit floor, operated a fuel selector valve immediately outboard of each engine, which allowed each engine to receive fuel from its respective main or auxiliary tank, or to cross-feed fuel from the other main tank. The cross-feed, which was intended for emergency use, was the only interconnection between the left and right fuel systems.

Figure 3
G-BXUY fuel system

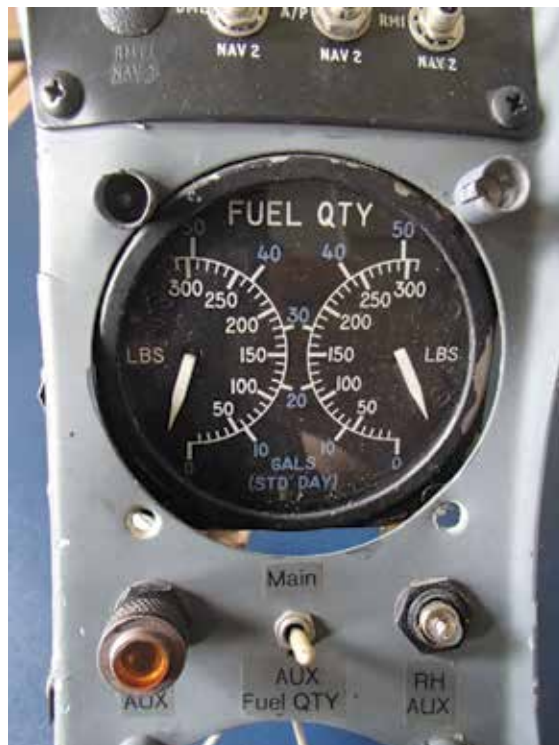
Each fuel tank is fitted with a capacitive sensor which provides fuel quantity readings to a pair of gauges in the cockpit. The gauges (Figure 4) automatically provide an indication of the fuel quantity in the fuel tanks selected by the fuel selector. A self-centring switch below the gauges allows the pilot to verify the contents of the other, non-selected tanks. Auxiliary tank indicator lights below the gauges illuminate when the associated auxiliary tank is selected for engine feed. The optional main fuel tank low quantity warning lights had not been fitted to G-BXUY. A dual fuel flow gauge was also fitted.

Figure 4
G-BXUY fuel quantity gauge
(electrical power not applied)
