## CONTENTS

### COMMERCIAL AIR TRANSPORT

**INCIDENT**

<b>Aircraft Type and Registration:</b>	Avro 146-RJ100, G-JEAV (and others and Embraer 145)
<b>No &amp; Type of Engines:</b>	4 Lycoming ALF502R-5 turbofan engines
<b>Year of Manufacture:</b>	1986
<b>Date &amp; Time (UTC):</b>	17 January 2006 at 1600 hrs
<b>Location:</b>	Between Southampton and Manchester
<b>Type of Flight:</b>	Public Transport (Passenger)
<b>Persons on Board:</b>	Crew - 5                      Passengers - 37
<b>Injuries:</b>	None
<b>Nature of Damage:</b>	None
<b>Commander's Licence:</b>	Airline Transport Pilot's Licence
<b>Commander's Age:</b>	N/A
<b>Commander's Flying Experience:</b>	N/A
<b>Information Source:</b>	Aircraft Accident Report Forms submitted by pilots and subsequent enquires by the AAIB

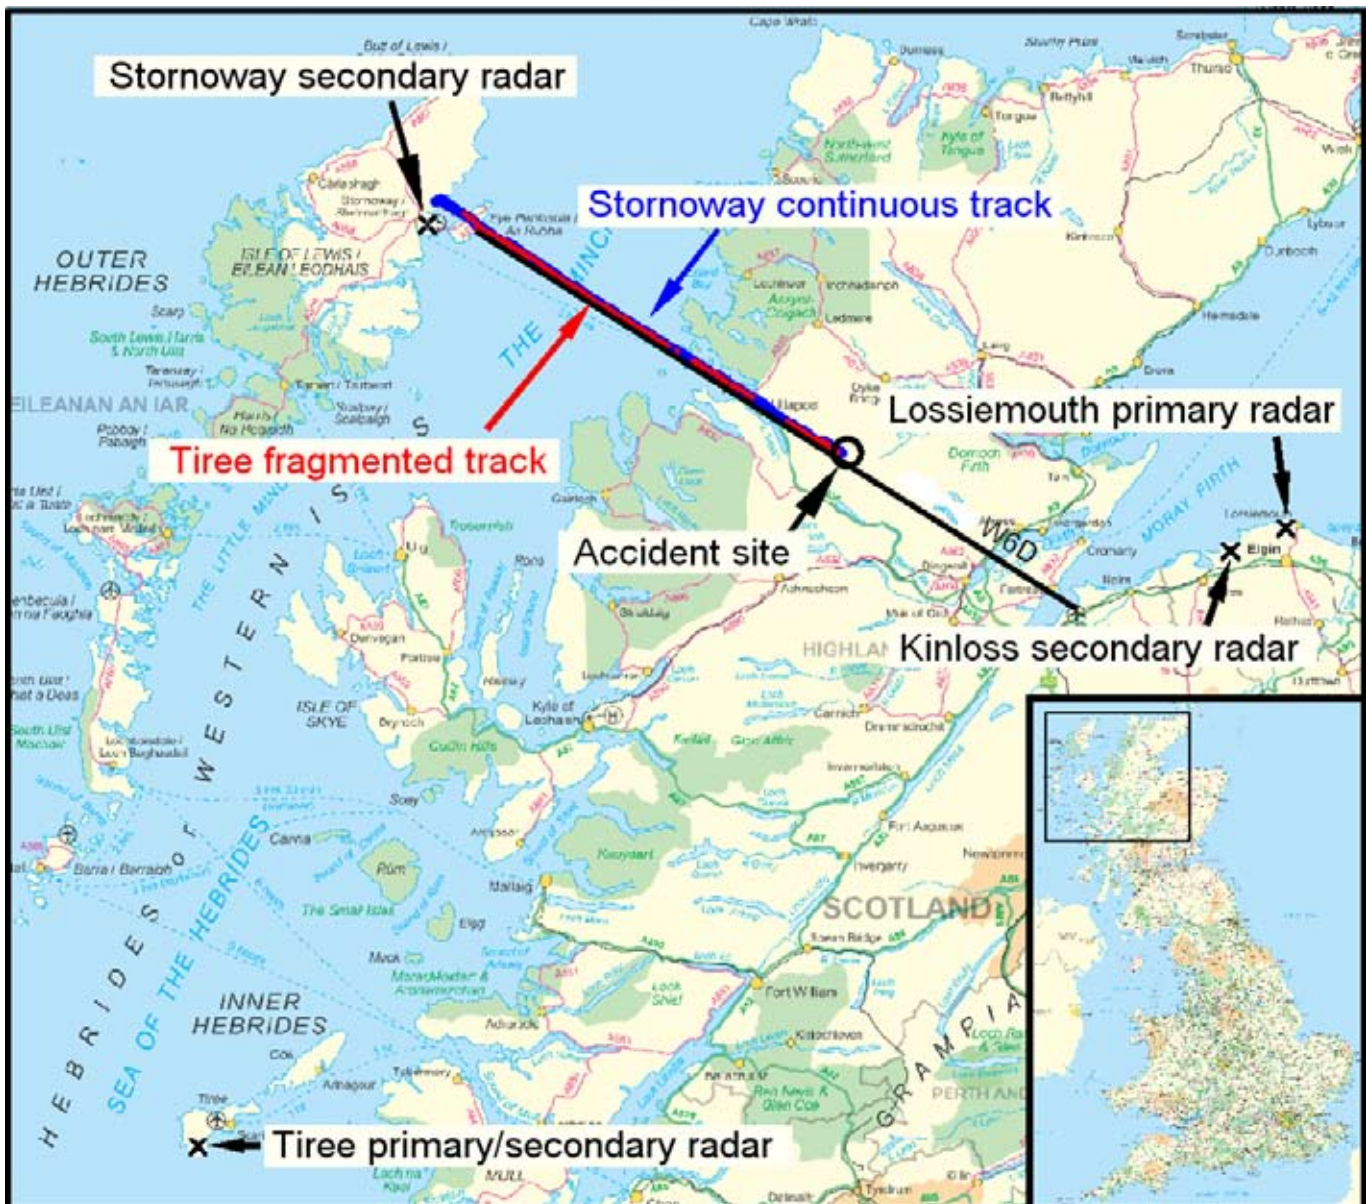
**Figure 3**

The recorded radar tracks from Stornoway and Tiree are given in Figure 3 together with the type of radar, the location of the radar head, the advisory route being flown and the accident site.

Geographical locations of the accident site, radar tracks, advisory route flown and relevant radar heads

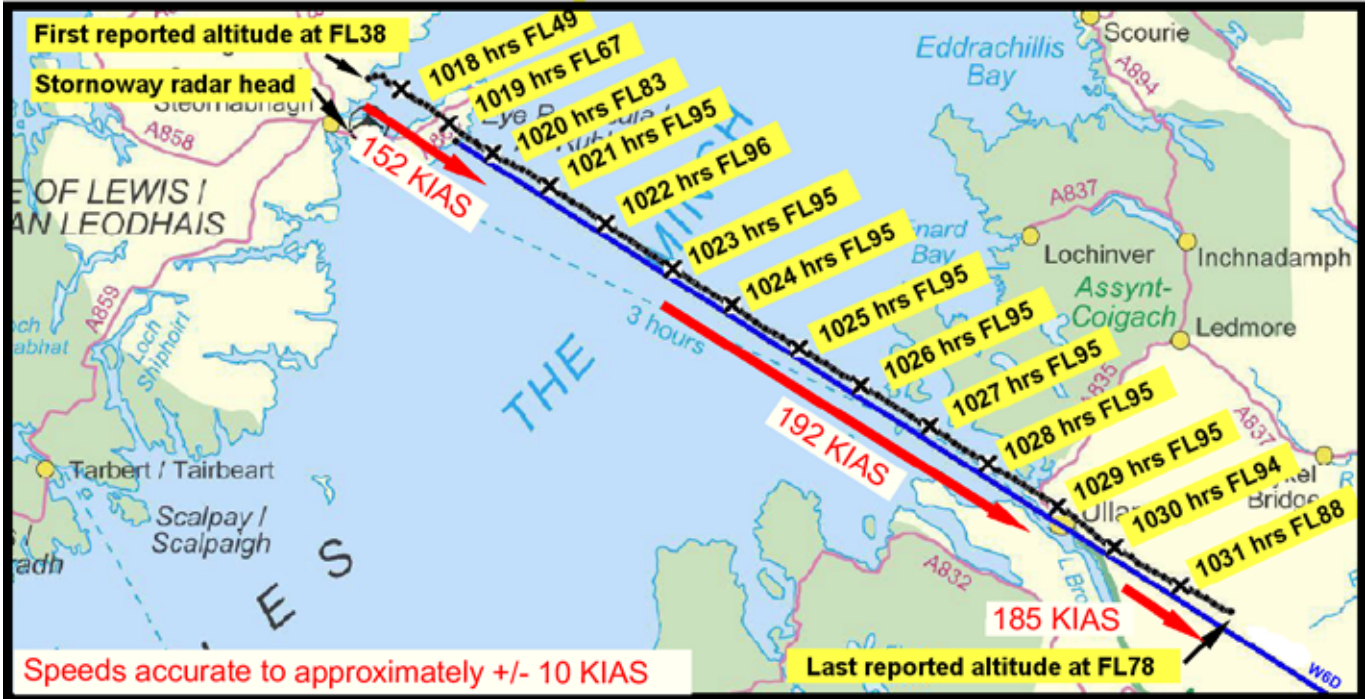
Figure 4a

‘tighter’ range resolution of the radar. Therefore the Stornoway data was used for the general flight overview and speed calculations. Figure 4 shows these in detail.

The Stornoway secondary radar track with reported altitude

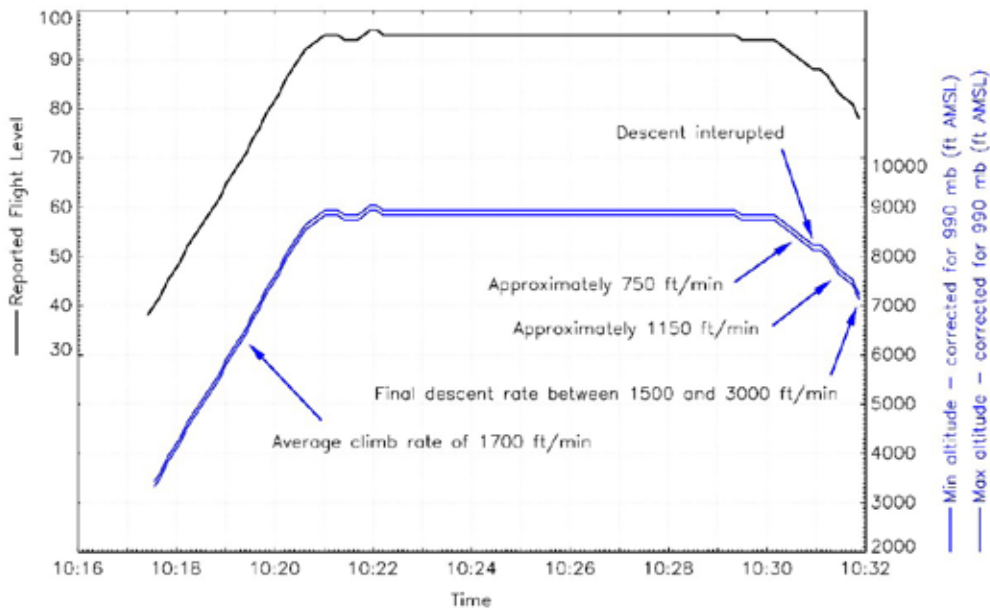
Figure 4b

The Stornoway secondary radar track derived parameters

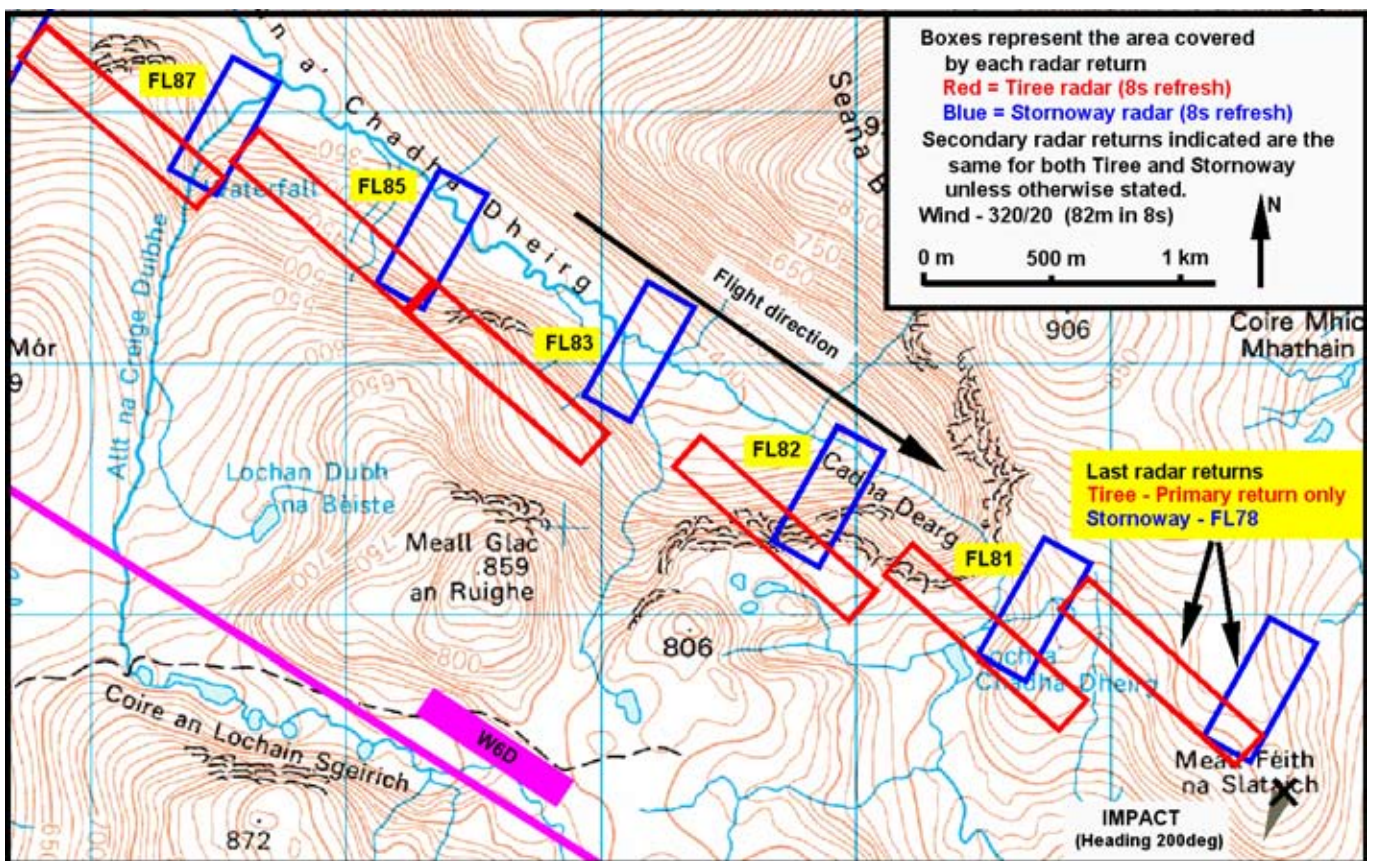
Figure 5

Figures 5 and 6 overlay both the Stornoway and Tiree data to provide a more detailed profile of the aircraft's flight path during the last portion of the flight.

Overview of the final radar track points from Tiree and Stornoway against the impact site, impact orientation and local terrain.

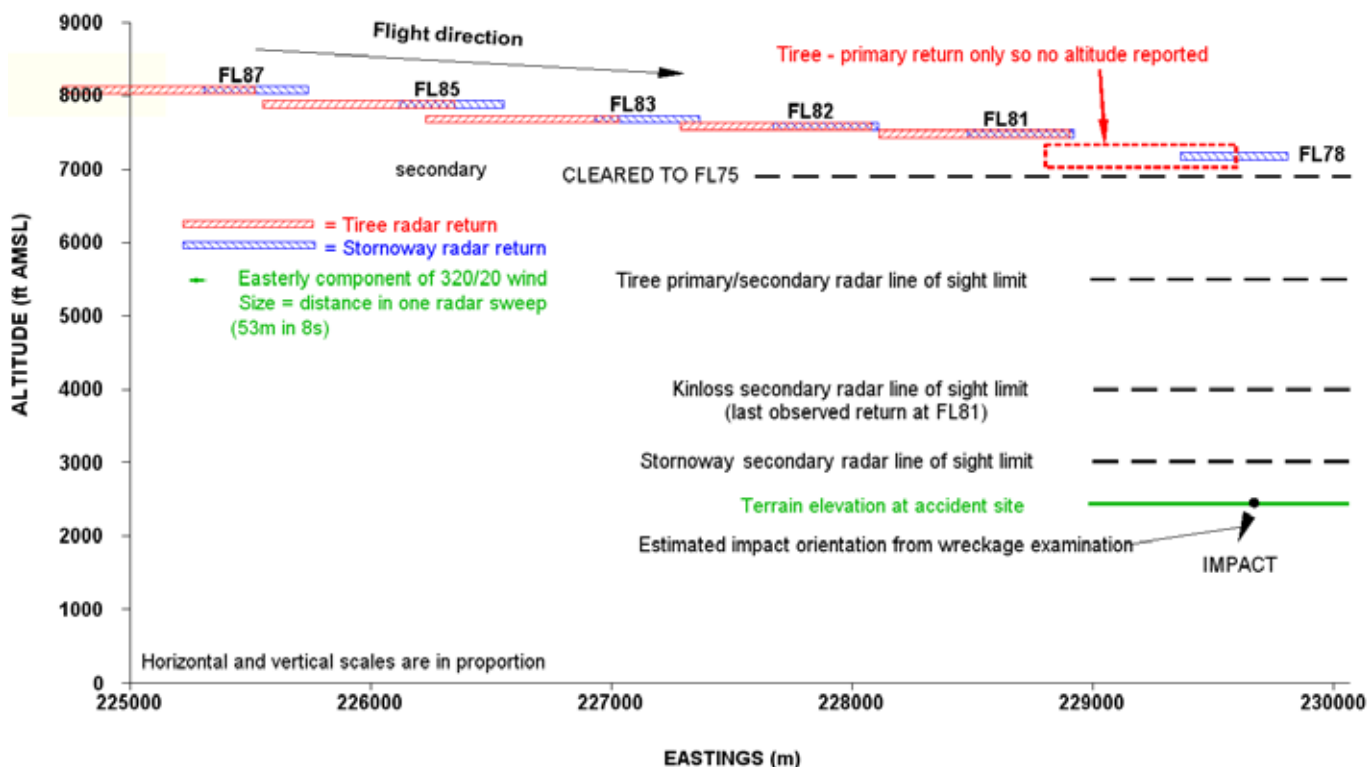
Figure 6

View of the final radar track points from Tiree and Stornoway, as viewed from a point to the South of the accident site

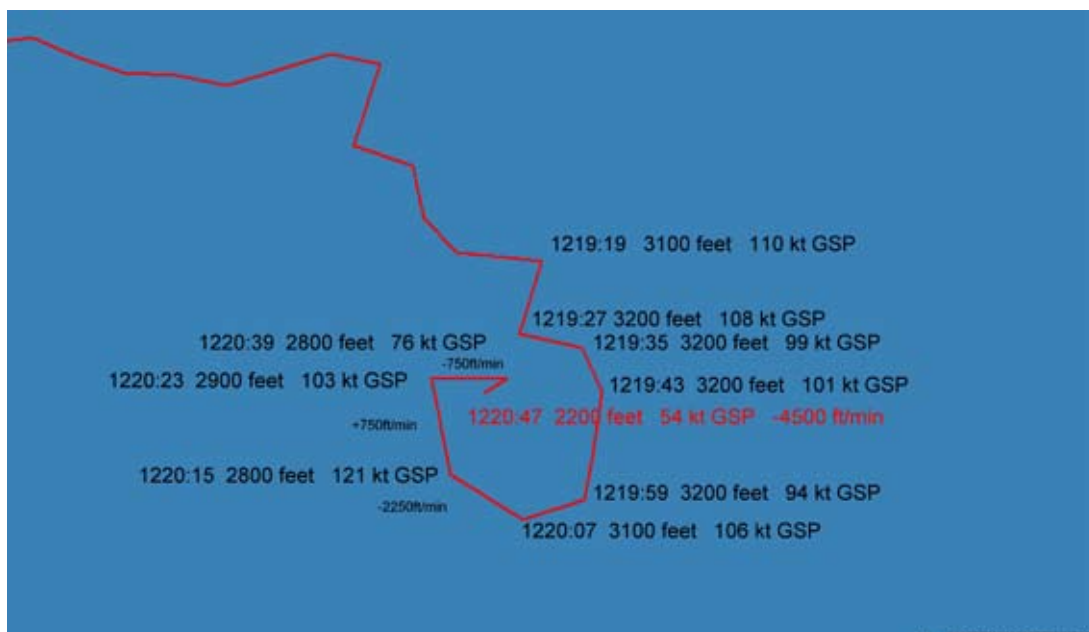
**Figure 1**

The recorded radar information indicates that G-EMAZ coasted out at 1143 hrs just north of Wexford. The radar trace continued until 1148 hrs when radar contact was temporarily lost. The next radar contact was at 1159 hrs when G-EMAZ was in the middle of the St George's Channel, just prior to the FIR boundary. There was then another break in radar contact from 1201 hrs to 1204 hrs. The remainder of the radar trace was continuous until radar contact with G-EMAZ was lost at 1220:47 hrs, 5 nm north-west of Strumble Head, with an indicated height of 2,200 ft. (See Figure 1: Radar Plot).

Radar Plot
