### SPECIAL BULLETINS

S1/2010 Cessna Citation 680 Sovereign	G-CJCC	30-Sep-10	1
---------------------------------------	--------	-----------	---

**Summary of: Air Accident Report No: 6/2010** 89  
Report on the accident between Grob G115E Tutor, G-BYUT  
and Grob G115E Tutor, G-BYVN  
near Porthcawl, South Wales on 11 February 2009

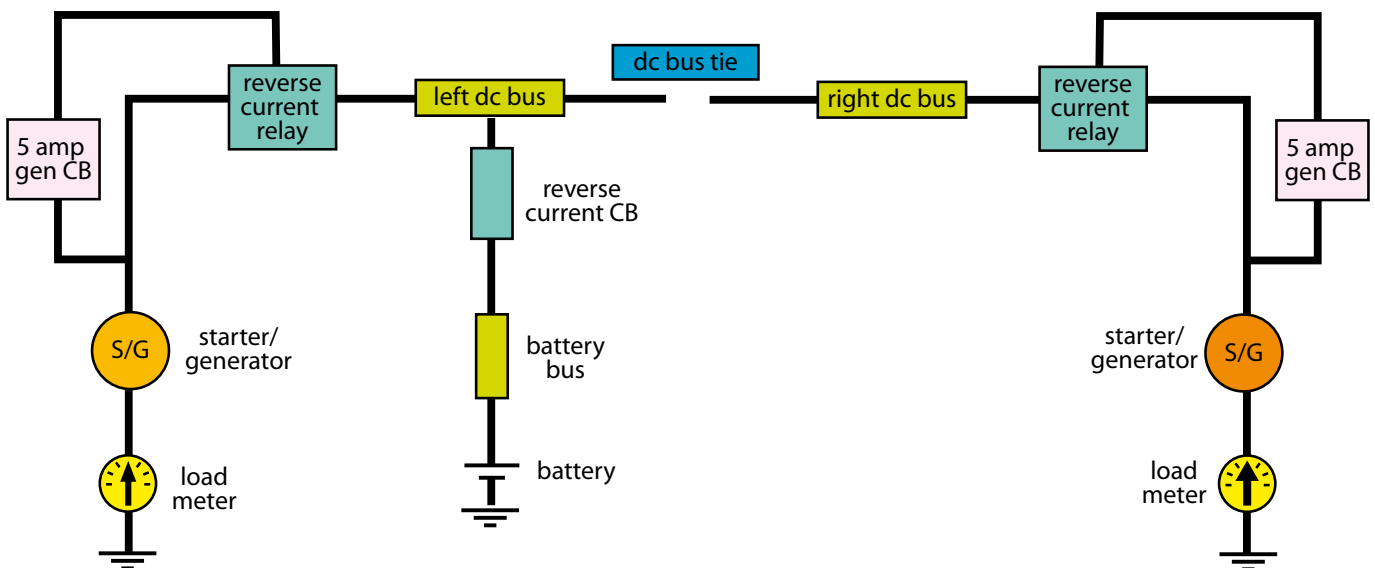
Figure 1

The aircraft is equipped with a 28VDC electrical system. Each engine is fitted with a starter-generator, which supplies electrical power to its respective DC busbar through a reverse current relay (RCR), see Figure 1. A secondary source of DC power is a 24V battery, which feeds the left DC busbar through the battery bus and reverse current circuit breaker. During normal operation the left and right DC busbars are connected by the bus tie, which allows both systems to operate in parallel. The left and right DC electrical systems can operate as separate systems by opening the DC bus tie. A load meter allows the crew to determine the current flowing into or out of the starter generator, its scale indicates between +1 and -1, which corresponds to +200 amps and -200 amps. Movement of the pointer to the instrument stops corresponds to approximately 400 amps.

Simplified diagram of aircraft DC electrical generation

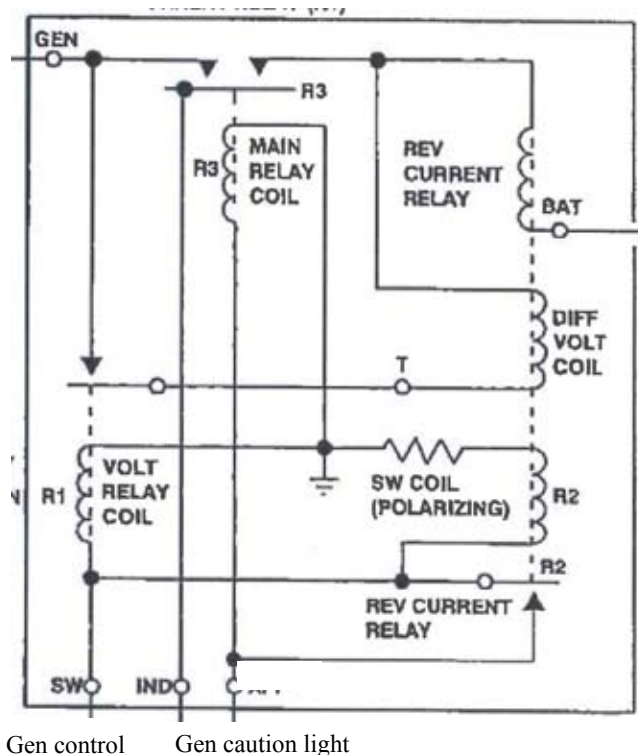
**Figure 2**

The sequence of operation of the RCR is as follows. When the generator voltage reaches approximately 22V, relay R1 closes. This energises relay R2, which is connected across the open main contacts. The voltage on the 'Diff Volt coil' of relay R2 is now the difference between the generator voltage and the battery / bus voltage. When this difference reaches between 0.35V and 0.65V (generator must be the highest voltage) relay R2 will close. This applies a voltage to the 'Main Relay coil' R3, which immediately closes and connects the generator to the bus. If the generator voltage decreases below the battery / bus voltage, a current will flow from the bus to the generator. The 'Rev Current coil' in Relay R2 senses the change in direction of the current and the contact opens. The 'Main Relay' coil in Relay R3 is then de-energised, the main contacts open and the generator is disconnected from the bus.

Schematic diagram of reverse current relay

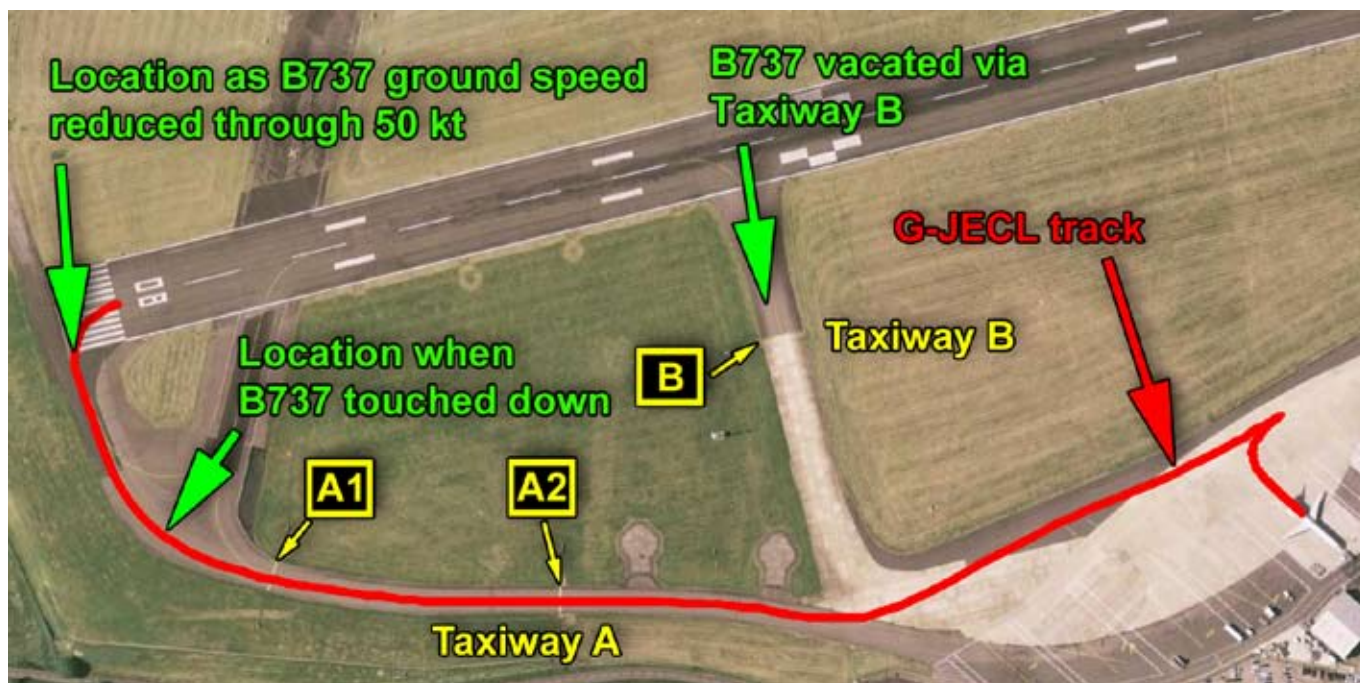
**Figure 1**

The relevant radio communications are given in the history of the flight. The relative aircraft positions during the incident are shown in Figure 1. G-JECL proceeded along Taxiway Alpha without stopping at Holding Point Alpha One and while taxiing along Taxiway Alpha, the crew would have not had the landing B737 in their view. The B737 touched down shortly after G-JECL passed Holding Point Alpha One. As the B737 decelerated through a ground speed of

G-JECL track and G-PJPJ positional information  
(Google Earth™ mapping service/Infoterra Ltd & Bluesky)

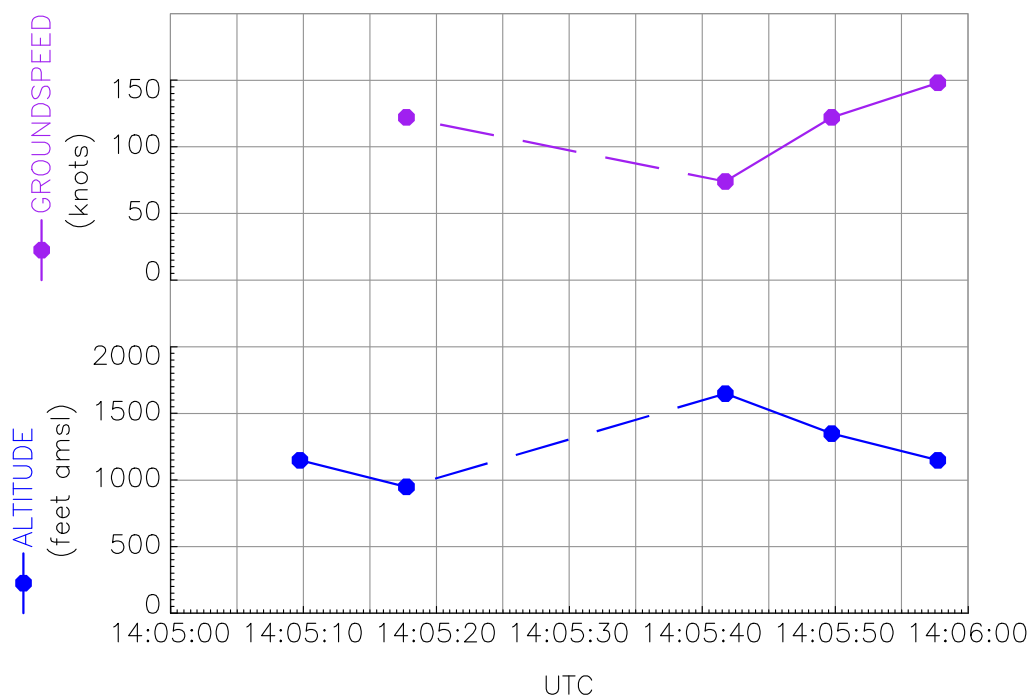
**Figure 2**

The groundspeed and adjusted altitude data are also presented in Figure 2.

Aircraft groundspeed and altitude

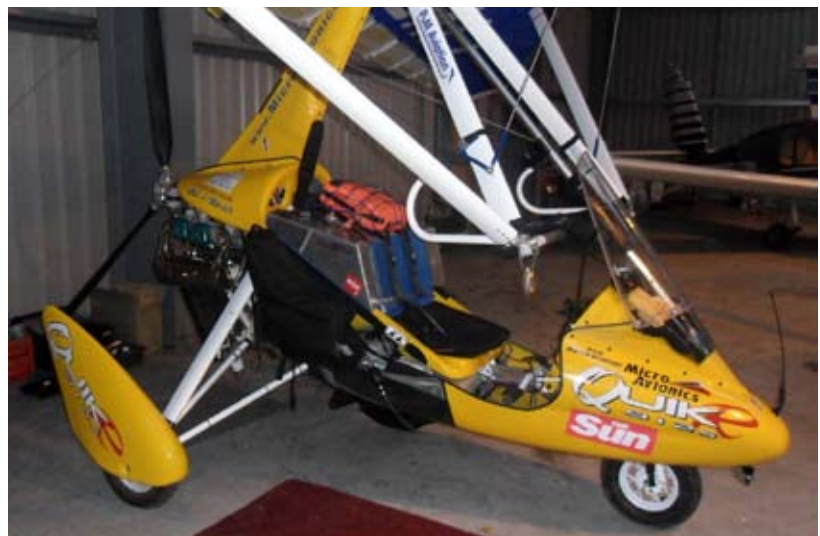
**Figure 1**

Trike unit of G-DALI, showing auxiliary fuel tank with life-raft secured above

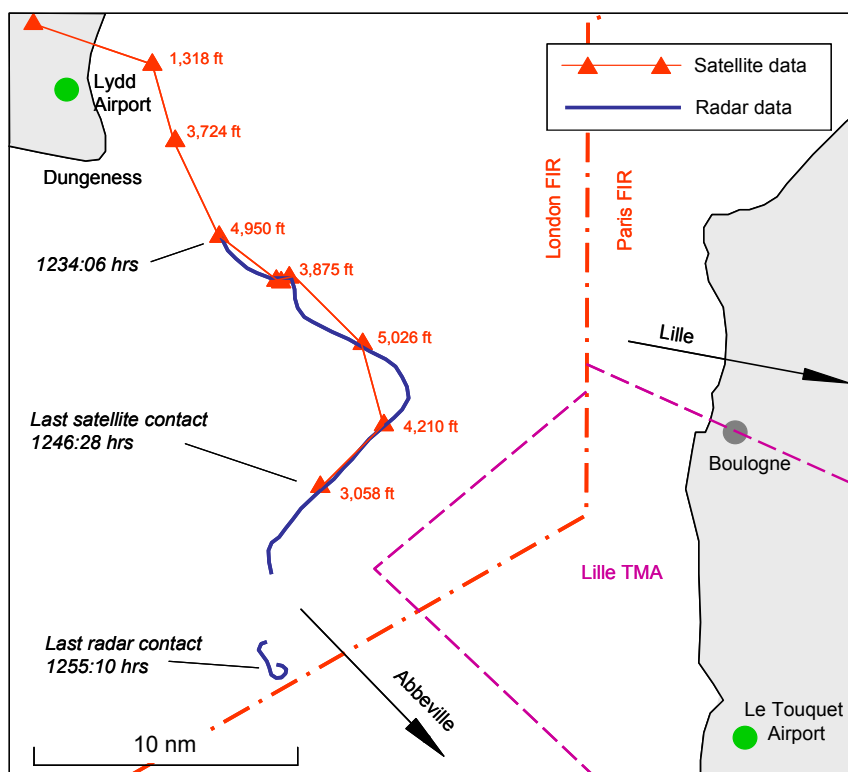
**Figure 2**

Figure 2 shows a composite picture of the final stages of the flight, using data from French radar and the satellite system. The aircraft was equipped with a transponder but no Mode C altitude information was observed. However, each satellite position included GPS derived altitude information.

Radar track of G-DALI over the English Channel, with GPS derived position and altitude information

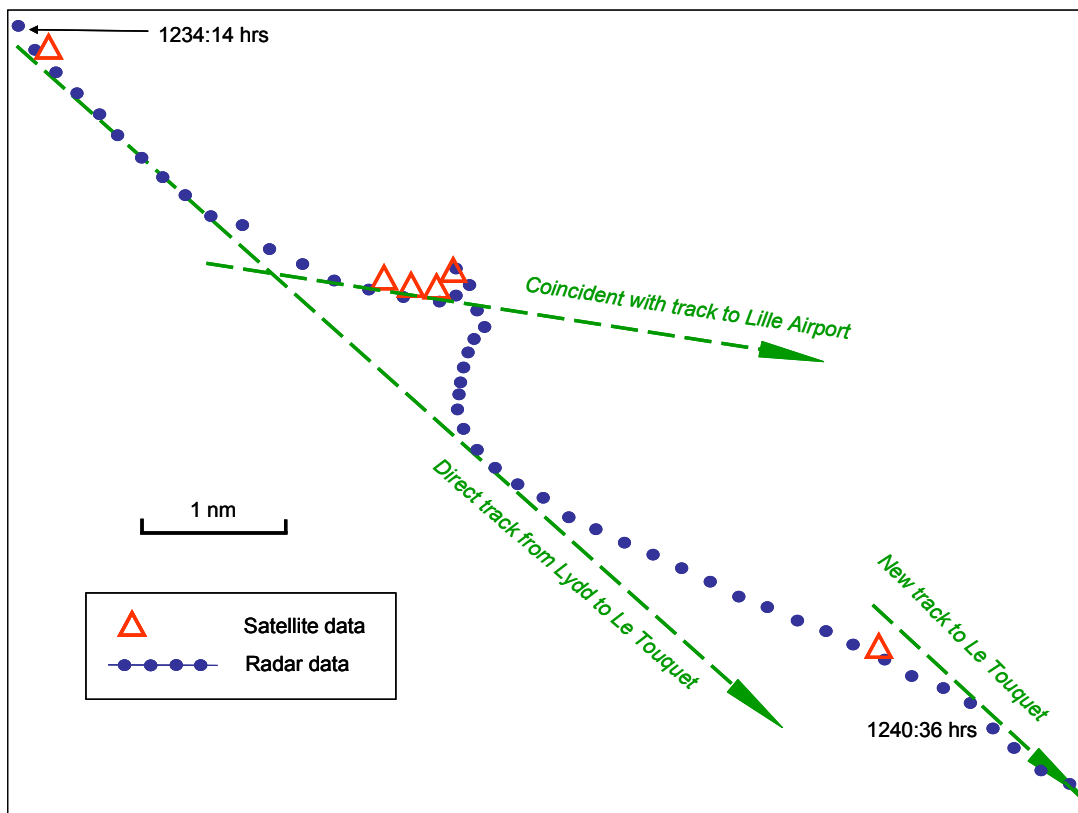
Figure 3 shows G-DALI’s track immediately after the aircraft appeared on French radar at 1234:14 hrs, commencing about two minutes after the pilot declared his intention to divert to Abbeville. The aircraft was initially tracking along a direct line between Lydd Airport and Le Touquet Airport (the aircraft had diverted around Lydd itself, establishing on this track once it was over the Channel). At 1235:34 hrs, the aircraft turned left and was established, for a short while, on a track, possibly coincidentally, for Lille Airport.

As Figure 3 shows, there was then a block of radar returns, which saw the aircraft slow down, possibly make a left hand orbit, and eventually take up a southerly track. Coincidental with this event, four unscheduled satellite positions were recorded, consistent with the ‘emergency button’ having been pushed, with time

After these returns, the aircraft resumed the track from Lydd to Le Touquet, before deviating left of it once again. At 1240:28 hrs, for a period of about one minute, the aircraft stabilised on a new direct track to Le Touquet. The aircraft then turned south-westwards, onto a track approximately parallel with the Lille TMA boundary but some three to four miles north of it. At 1249:36 hrs, the aircraft started a gentle left turn and was tracking about 30° right of the required course for Abbeville when radar contact was lost temporarily.

Track of G-DALI shortly after first appearing on French radar

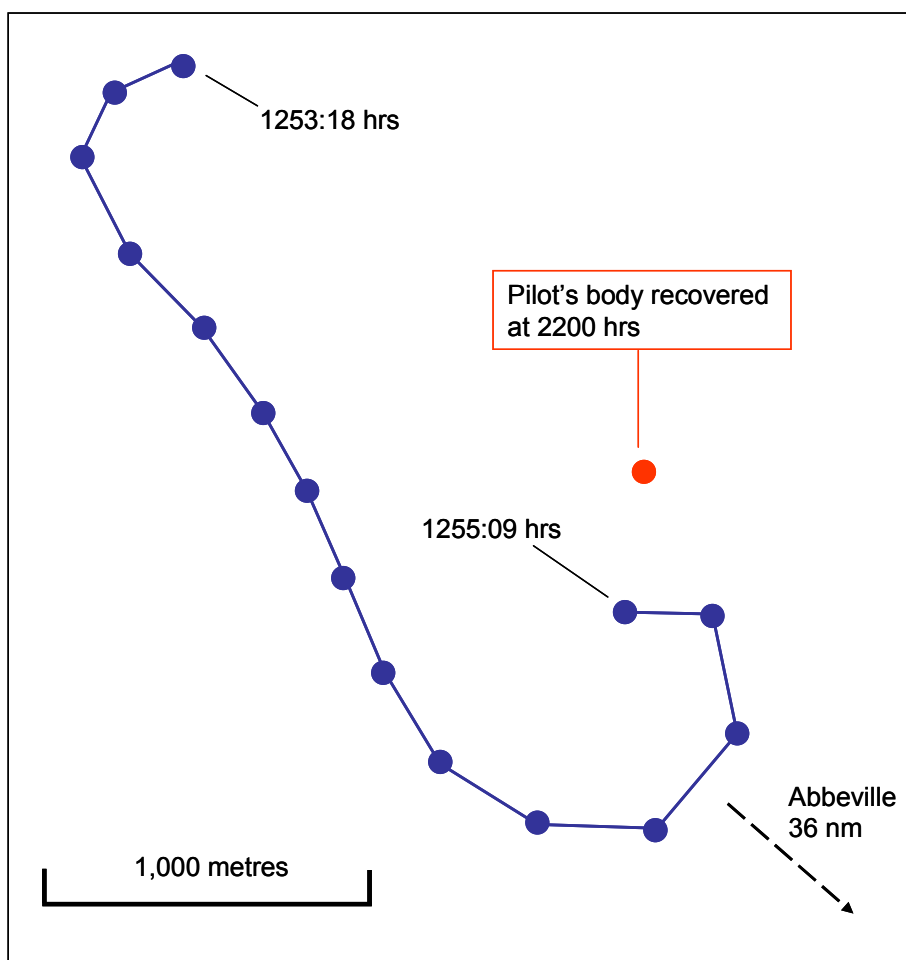
**Figure 4**

Figure 4 shows the last series of radar returns from G-DALI. Radar contact was regained at 1253:18 hrs, at which point the aircraft appears to have been tracking in a left turn at relatively slow speed, before taking up a track of about 160°(T). The aircraft then made a further turn to the left, during which radar contact was finally lost. The last radar return was timed at 1255:09 hrs.

Final radar returns, with the reported location where the pilot was found

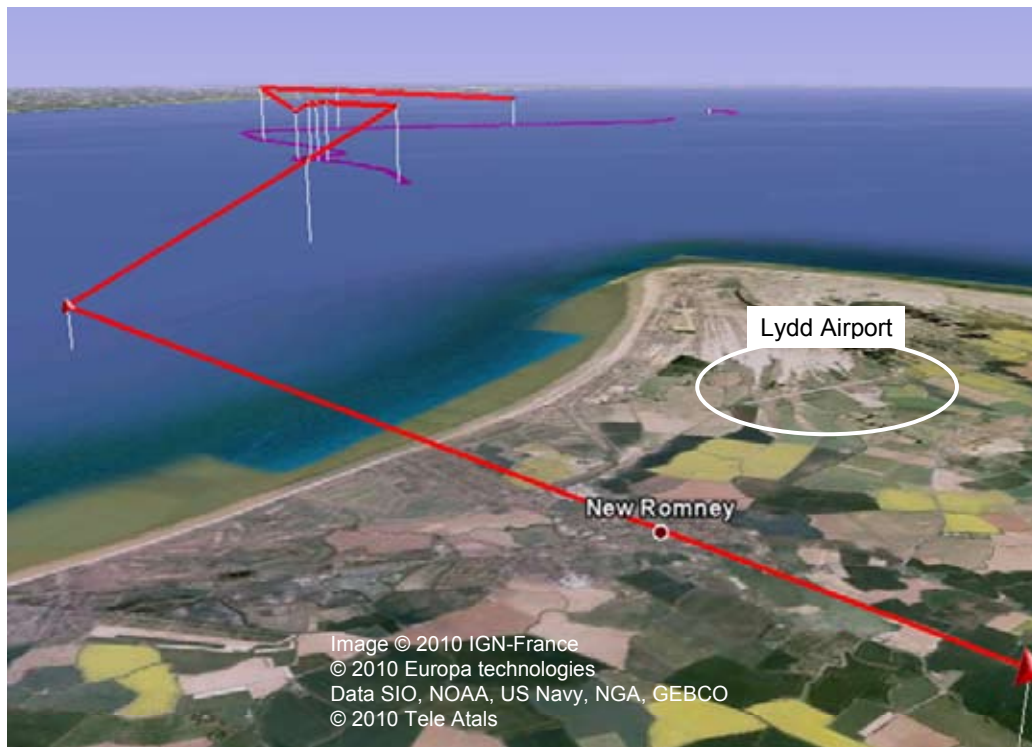
**Figure 5**

communications with London, reaching a maximum of 5,026 ft. At the last recorded satellite position, the GPS altitude was 3058 ft. An oblique view of the recorded satellite track is at Figure 5.

Oblique projection of aircraft satellite track, showing change in GPS derived altitude (radar ground track shown in purple)

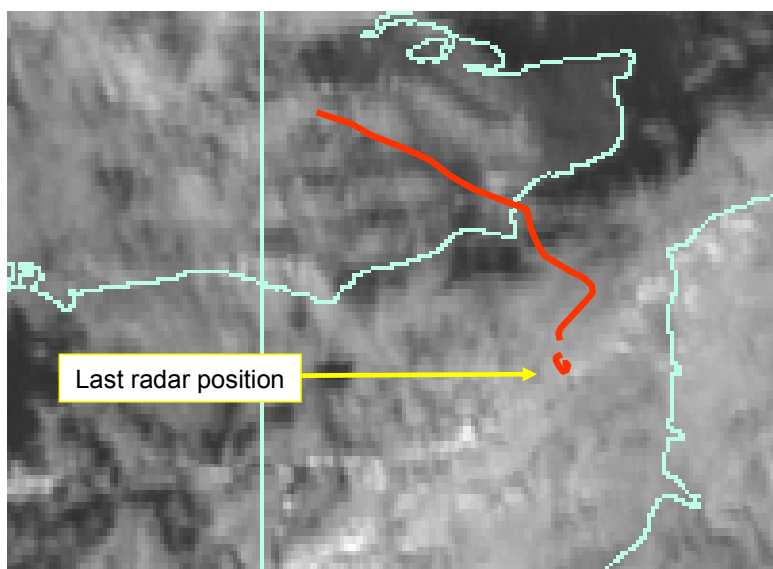
**Figure 6**

It was noted that the forecast information from the MetForm 215<sup>5</sup> and the TAFs conformed reasonably well with the actual information summarised above, in terms of weather and visibility. However, whereas Form 215 forecast areas of isolated cumulus and strato-cumulus, the observations and satellite imagery suggested this cloud was more widespread. Part of the satellite image from the report, overlaid with G-DALI's track and final radar position, is reproduced at Figure 6.

High resolution visible satellite image, 1315 hrs  
(Crown Copyright [2010] Met Office)
