# ***AAIB Bulletin***

# ***10/2014***

BAE Systems Jetstream 31	G-GAVA	15-Aug-14	3
--------------------------	--------	-----------	---

<b>Aircraft Type and Registration:</b>	BAE Systems Jetstream 31, G-GAVA
<b>No &amp; Type of Engines:</b>	2 Garrett Airesearch TPE331-10UGR-516H turboprop engines
<b>Year of Manufacture:</b>	1987 (Serial no: 785)
<b>Location:</b>	Doncaster Sheffield Airport, Yorkshire
<b>Date &amp; Time (UTC):</b>	15 August 2014 at 1836 hrs
<b>Type of Flight:</b>	Commercial Air Transport (Passenger)
<b>Persons on Board:</b>	Crew - 2                      Passengers - 1
<b>Injuries:</b>	Crew - None                      Passengers - None
<b>Nature of Damage:</b>	Left main landing gear, left propeller, fuselage and wing
<b>Commander's Licence:</b>	Airline Transport Pilot's Licence
<b>Commander's Age:</b>	54 years
<b>Commander's Flying Experience:</b>	8,740 hours (of which 3,263 were on type) Last 90 days - 147 hours Last 24 hours - 6 hours
<b>Information Source:</b>	AAIB Field Investigation

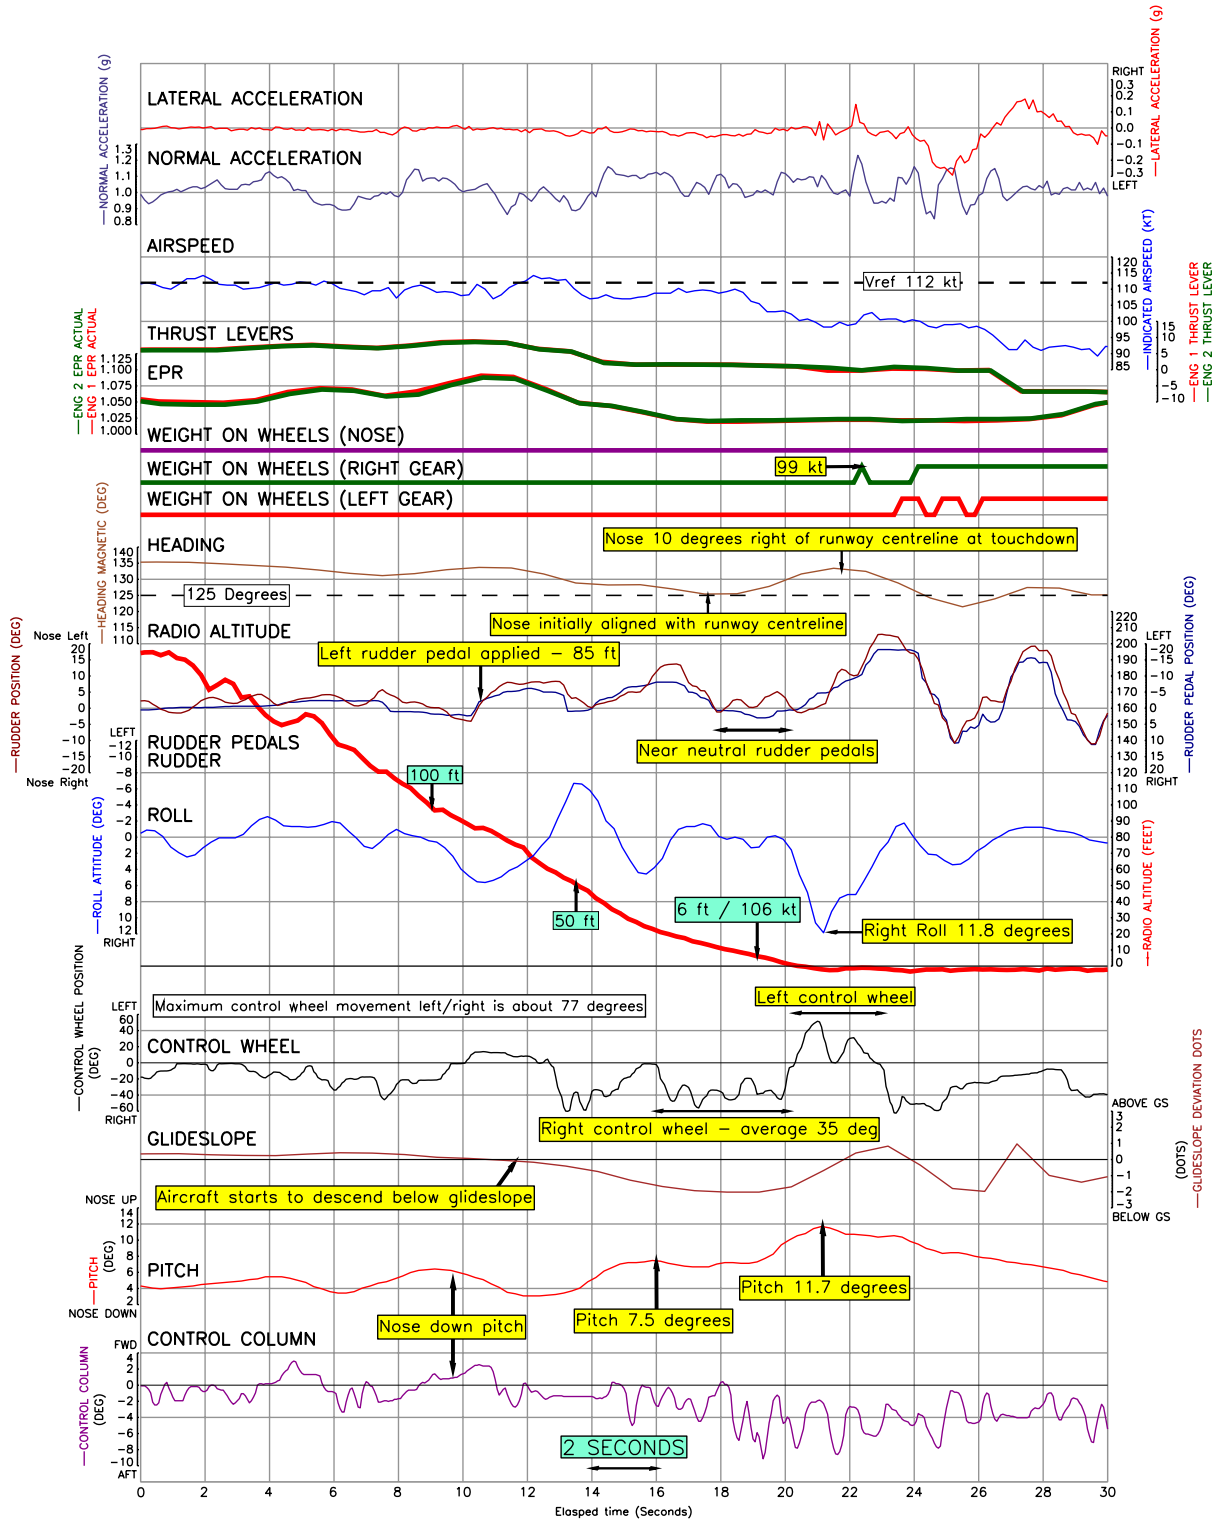
Figure 1

FDR Salient parameters of the approach starting at 200 ft agl

The commander believed that he commenced the de-crab manoeuvre as the aircraft passed over the runway threshold, but the data indicated that rudder was applied to start to align the aircraft with the centreline at 85 ft agl, some 330 m before the displaced threshold. This was well before the point recommended in the manufacturer's training material for a de-crab manoeuvre to be initiated. The aircraft then became de-stabilised in roll and the pilots believed that this was due to a gust of wind.

At around 50 ft agl, a flare was initiated. This was above the height at which the manufacturer recommends a flare to start and was likely to be in response to an increased rate of descent, caused by the pitch-down input made at 100 ft agl. Initially, the nose was pitched up to approximately 7.5° but prior to touchdown the attitude rapidly increased until the nose was 11.7° up. During this prolonged flare the airspeed reduced to 99 KIAS ( $V_{REF}$  minus 13 KIAS), and the data indicated that the commander tried to maintain a wings level attitude. In doing this the rudder pedals were moved near to neutral and the aircraft's nose yawed right. Whilst at this high pitch attitude, the aircraft rolled quickly to 11.8° causing the right wing tip, aileron, slat and flap fairing to contact the runway. The roll to the right was consistent with the recorded control inputs and a reduction of wind strength.

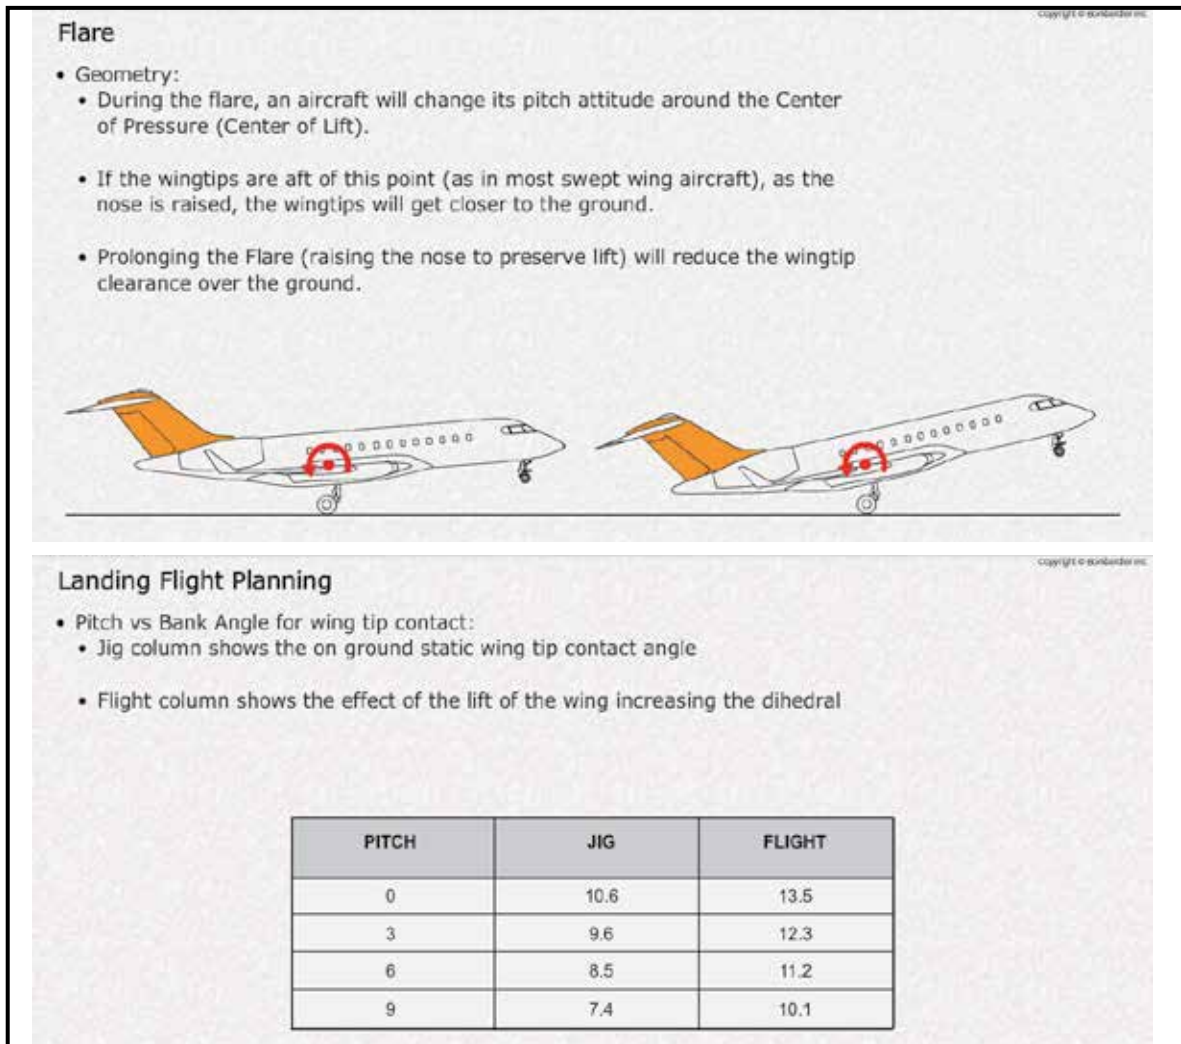
**Figure 3**

*Excessive wing down can cause the wingtip to contact the runway. In order to minimize this possibility, the bank should be limited to less than 3 degrees and the touchdown should occur as soon as the aircraft is aligned with the runway. Prolonging the flare would increase the pitch attitude which brings the wingtip closer to the ground.*

Manufacturer's slides showing effect of pitch on wingtip clearance

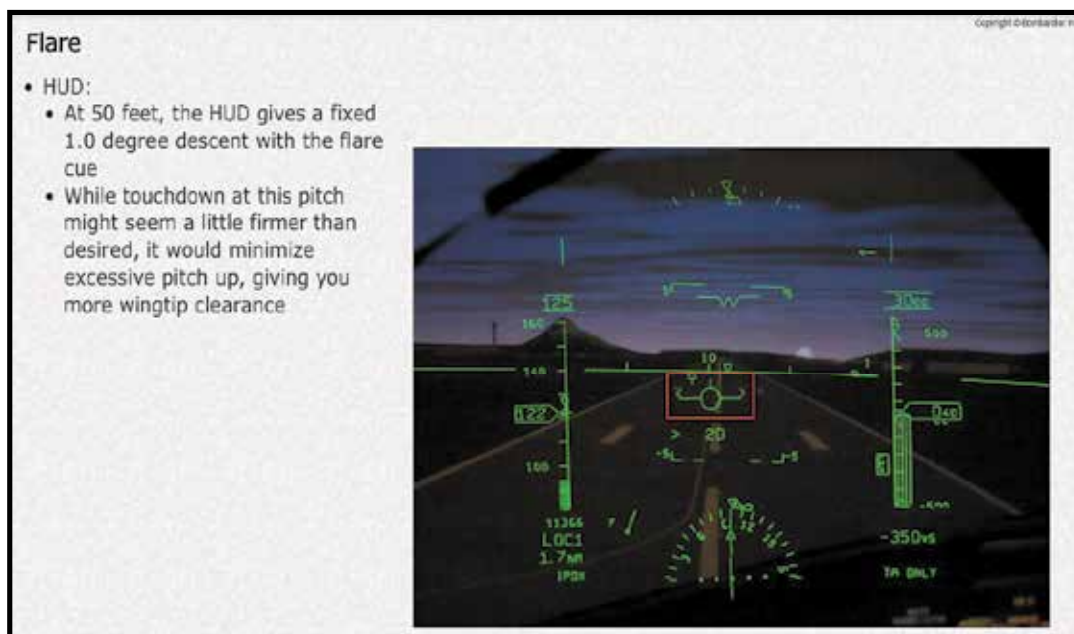
**Figure 4**

A further slide in the material (Figure 4) discussed use of the HUD during a crosswind landing. It mentioned that a flare cue would appear on the screen at 50 ft agl and if this was followed the aircraft would fly a 1° descent path to touchdown. This would lead to a firm touchdown but would protect against a wing strike. The picture in Figure 4 illustrates how the green symbology of the HUD overlays the external vista at night. The red rectangle is not part of the display but is presented on the picture to highlight the flightpath vector with flare cue symbols above each wingtip. When the flare cue appears the pilot is expected to initiate the flare manoeuvre.

Manufacturer's slide indicating HUD guidance during landing flare

The commander of EC-LTF stated on the CVR that he was distracted by the HUD. The symbology on the screen needed to be bright to be discernible against external lights near the runway. The bright symbols may have caused distraction and prevented him from seeing the runway clearly and making it difficult to assess the usual visual cues during the landing.

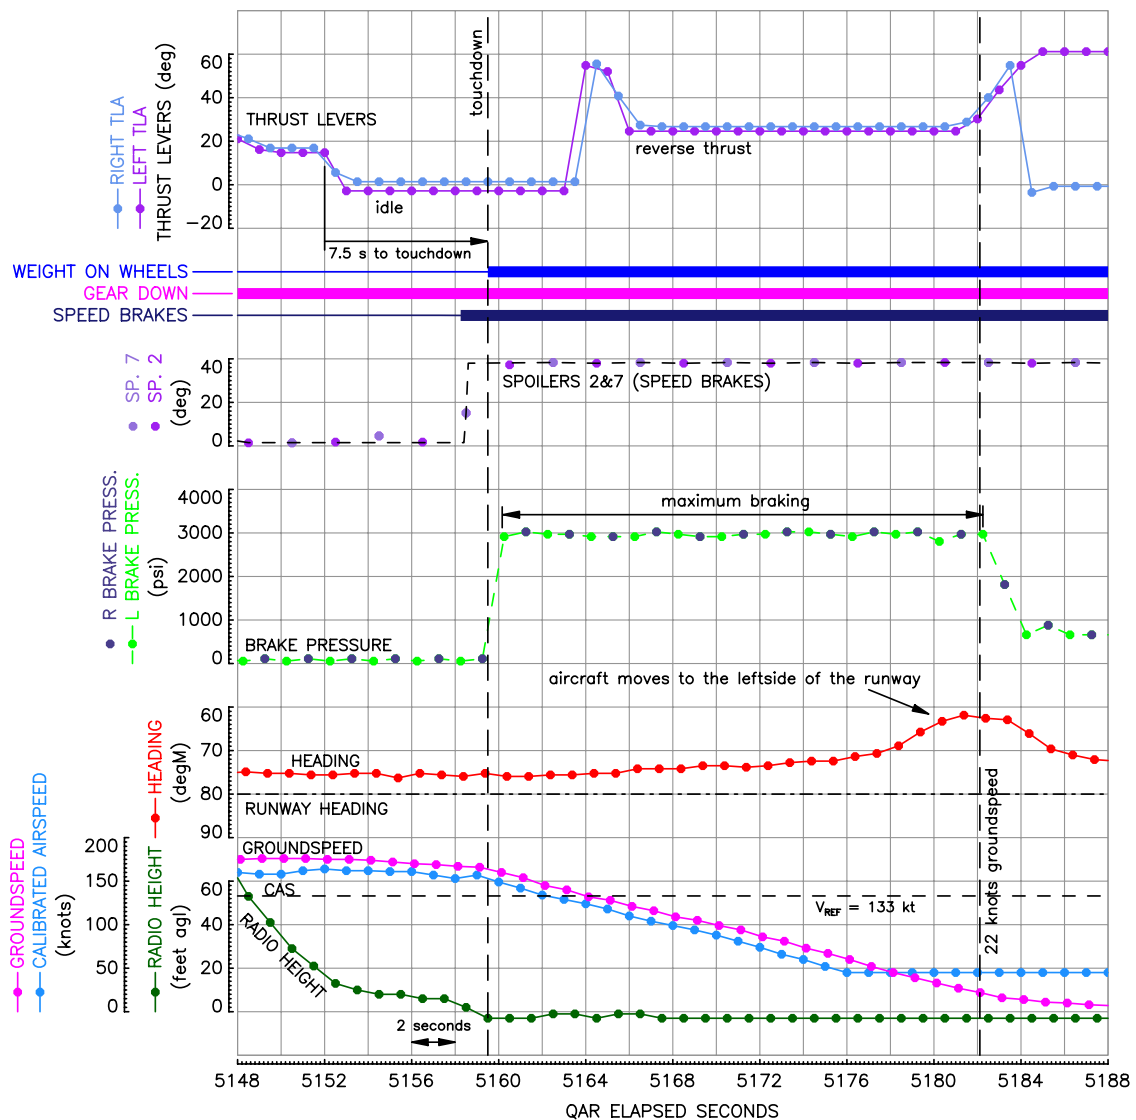
**Figure 4**

Figure 4 starts with the aircraft at 60 ft agl, a little under 12 seconds before touchdown. At 50 ft agl, the aircraft was flying at 160 kt CAS but had a groundspeed of 175 kt. At about 3 ft agl, approximately six seconds after the thrust levers were set to the IDLE position, the speed brakes were deployed and the aircraft touched down approximately one second later at 157 kt CAS (166 kt groundspeed). Maximum braking was then applied, followed four seconds later by the selection of reverse thrust, both of which were maintained until the aircraft slowed to approximately 22 kt groundspeed, by which time the aircraft was being positioned to the left side of the runway. The distance from touchdown to the point that reverse thrust was cancelled was 1,027 m (derived from recorded groundspeed).

Recorded flight data during the landing

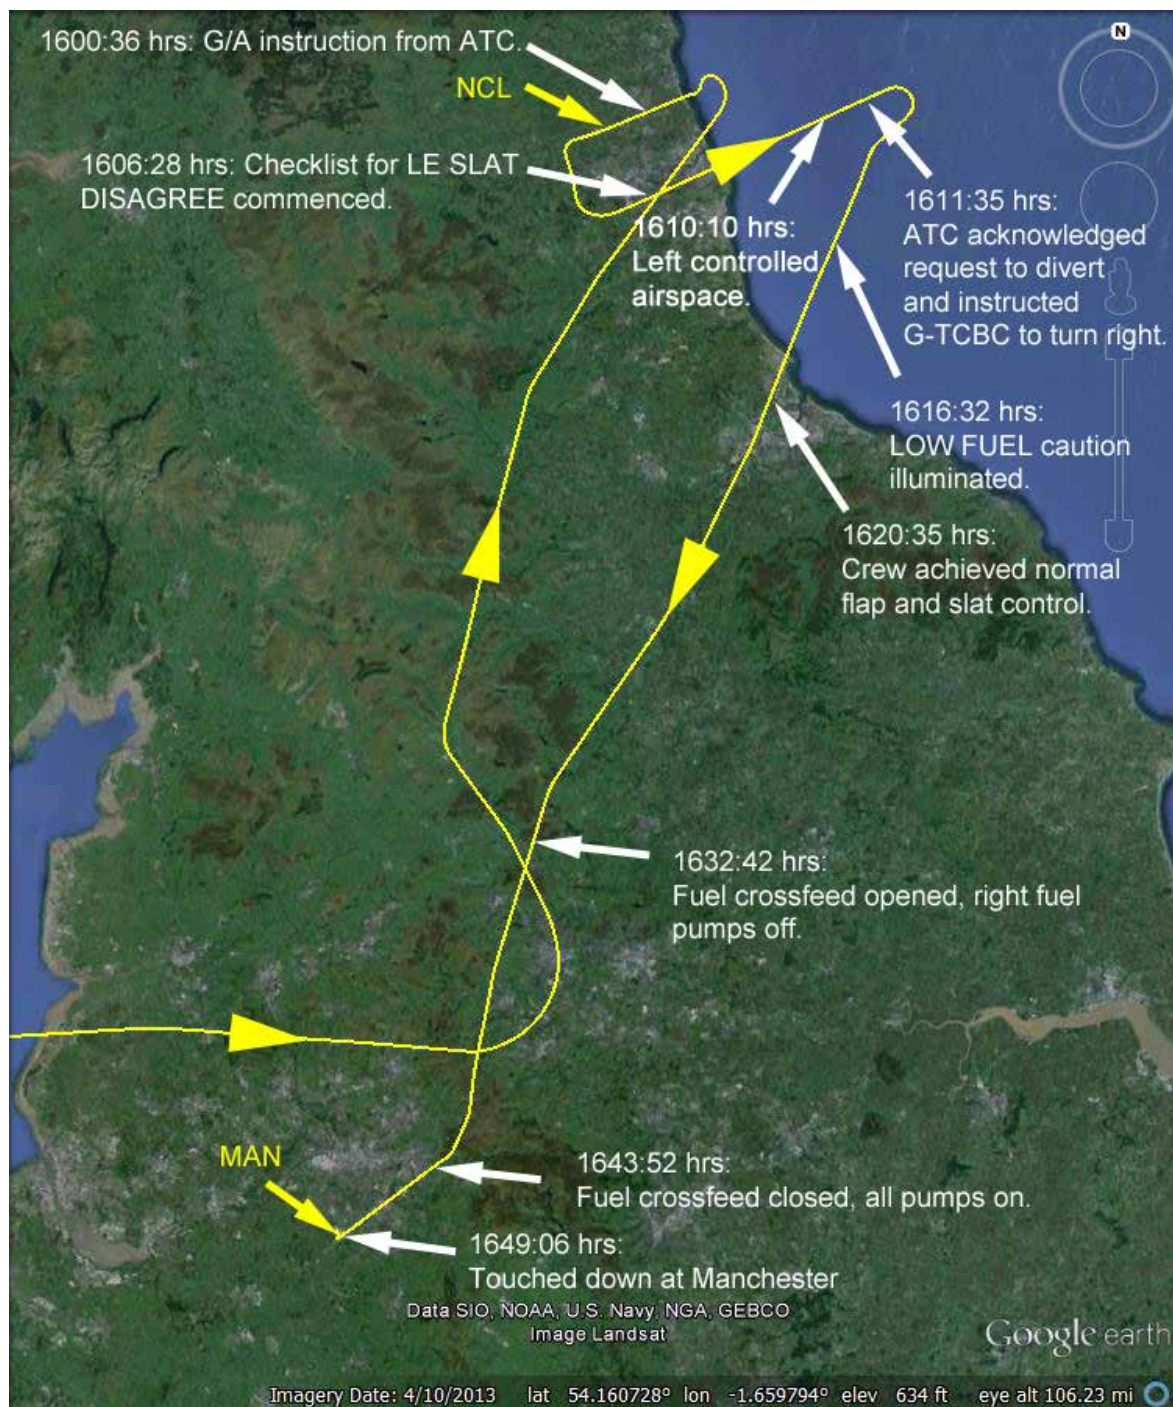
**Figure 1**

Plot of the track for G-TCBC showing inbound and outbound tracks from NCL and the diversion to MAN

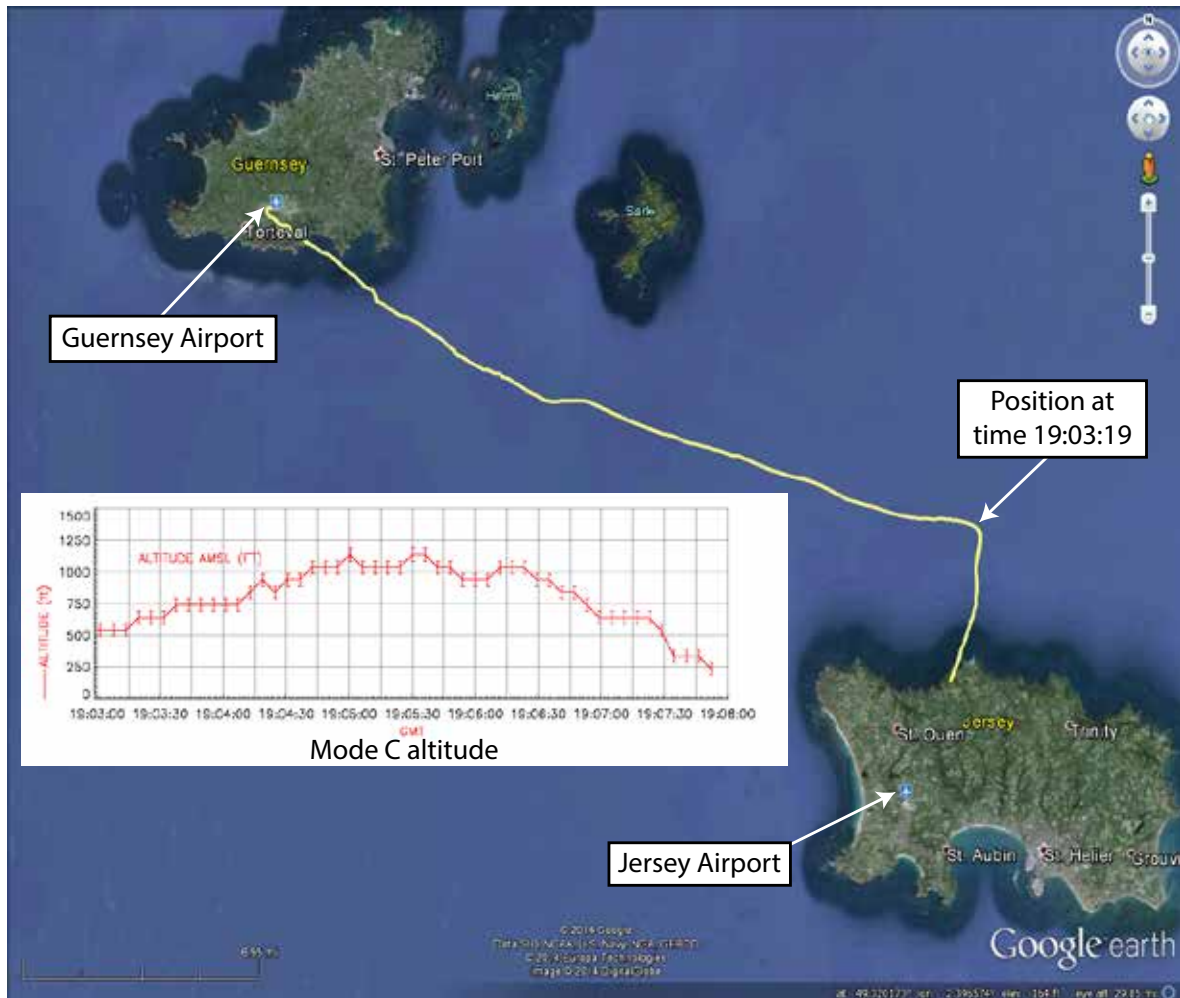
**Figure 1**

The aircraft position and Mode C altitude ( $\pm 50$  ft) were recovered from radar recordings provided by Ports of Jersey Air Traffic Control (Figure 1). The first radar recording was at 18:51:42 hrs as G-CIAS departed Guernsey Airport. At 19:03:19 hrs G-CIAS was located just over 6.3 nm from Jersey Airport at approximately 500 ft amsl when it began a right-hand turn towards Jersey, climbing to approximately 1,100 ft amsl over the next 1 min 40 sec. At 19:05:36 hrs, when 1.2 nm from the coast, the altitude began to reduce until 19:07:52 hrs when the final radar return recorded the aircraft at a position approximately 200 ft from the first ground mark at the accident site.

G-CIAS radar position and Mode C altitude

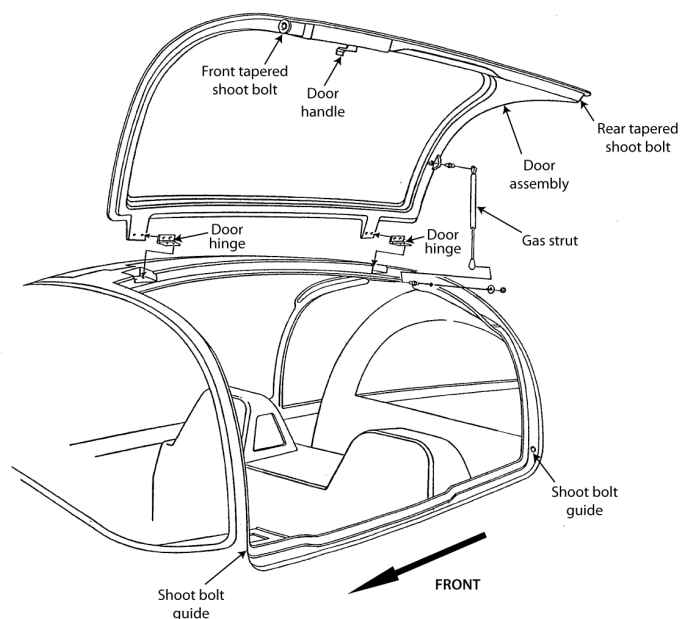
**Figure 1**

The door is held closed by two tapered shoot bolts which extend out longitudinally, from the lower corners of the front and rear sides of the door, into guides in the door frame. If the door is not fully closed at the rear, it is possible to move the door locking lever to the closed position with only the front shoot bolt engaged in its guide. This gives the false impression that the door is closed and fully locked. There have been a number of previous incidents on the Europa fleet where a door has detached due to the rear shoot bolt not engaging in its guide when the door was closed.

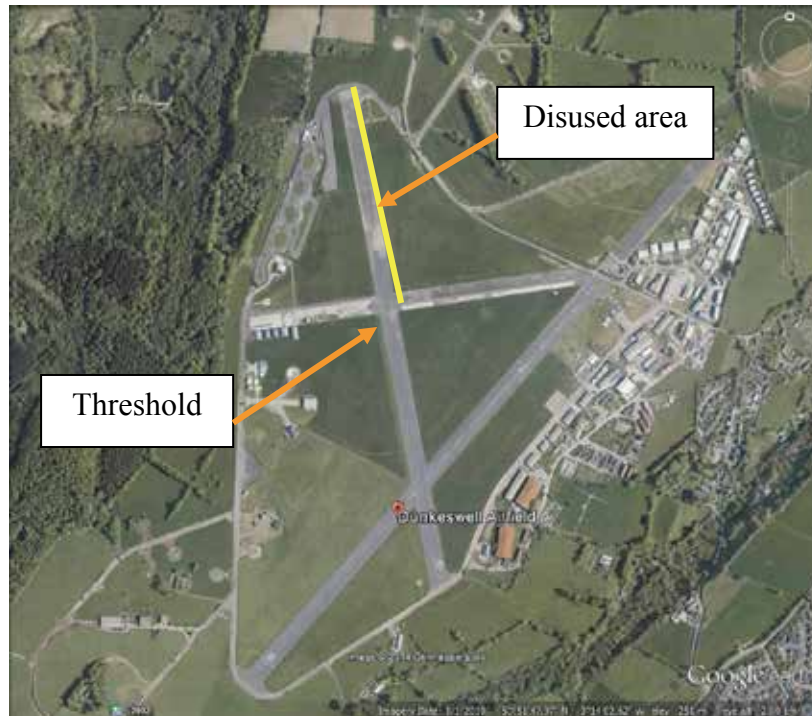
**Figure 1**

The pilot was returning to Old Sarum after a flight to Land's End. He decided to land at Dunkeswell to refuel and commenced an approach to Runway 17. During base leg and turning finals, he had been looking at the start of the tarmac surface but, on final approach, he realised that the actual runway threshold was considerably displaced (roughly the first half of the runway was disused, Figure 1). As he still had some distance to travel to the correct threshold before touchdown, he applied power to arrest the rate of descent. This had the effect of making the glidepath much shallower and the pilot believes it led him to flare too high. The aircraft stalled and he tried to recover by pushing forward on the control column to lower the nose but the aircraft struck the ground heavily and bounced back into the air. The pilot "caught the bounce" by applying power and went round for a second approach and successful landing. He suspects that the nosewheel tyre may have deflated during his first attempt and that further damage may have been caused by the second landing.

Dunkeswell Airfield showing displaced threshold of Runway 17
