CONTENTS

ACCIDENT

Aircraft Type and Registration:	Boeing 777-236ER, G-YMMM	
No & Type of Engines:	2 Rolls-Royce RB211 Trent 895-17 turbofan engines	
Year of Manufacture:	2001	
Date & Time (UTC):	17 January 2008 at 1242 hrs	
Location:	Runway 27L, London Heathrow Airport	
Type of Flight:	Commercial Air Transport (Passenger)	
Persons on Board:	Crew - 16	Passengers - 136
Injuries:	Crew - 4 (Minor)	Passengers - 1 (Serious) 8 (Minor)
Nature of Damage:	Aircraft damaged beyond economic repair	
Commander's Licence:	Airline Transport Pilot's Licence	
Commander's Age:	43 years	
Commander's Flying Experience:	12,700 hours (of which 8,500 hours were on type) Last 90 days - 85 hours Last 28 days - 52 hours	
Information Source:	Inspectors Investigation	
	All times in this report are UTC

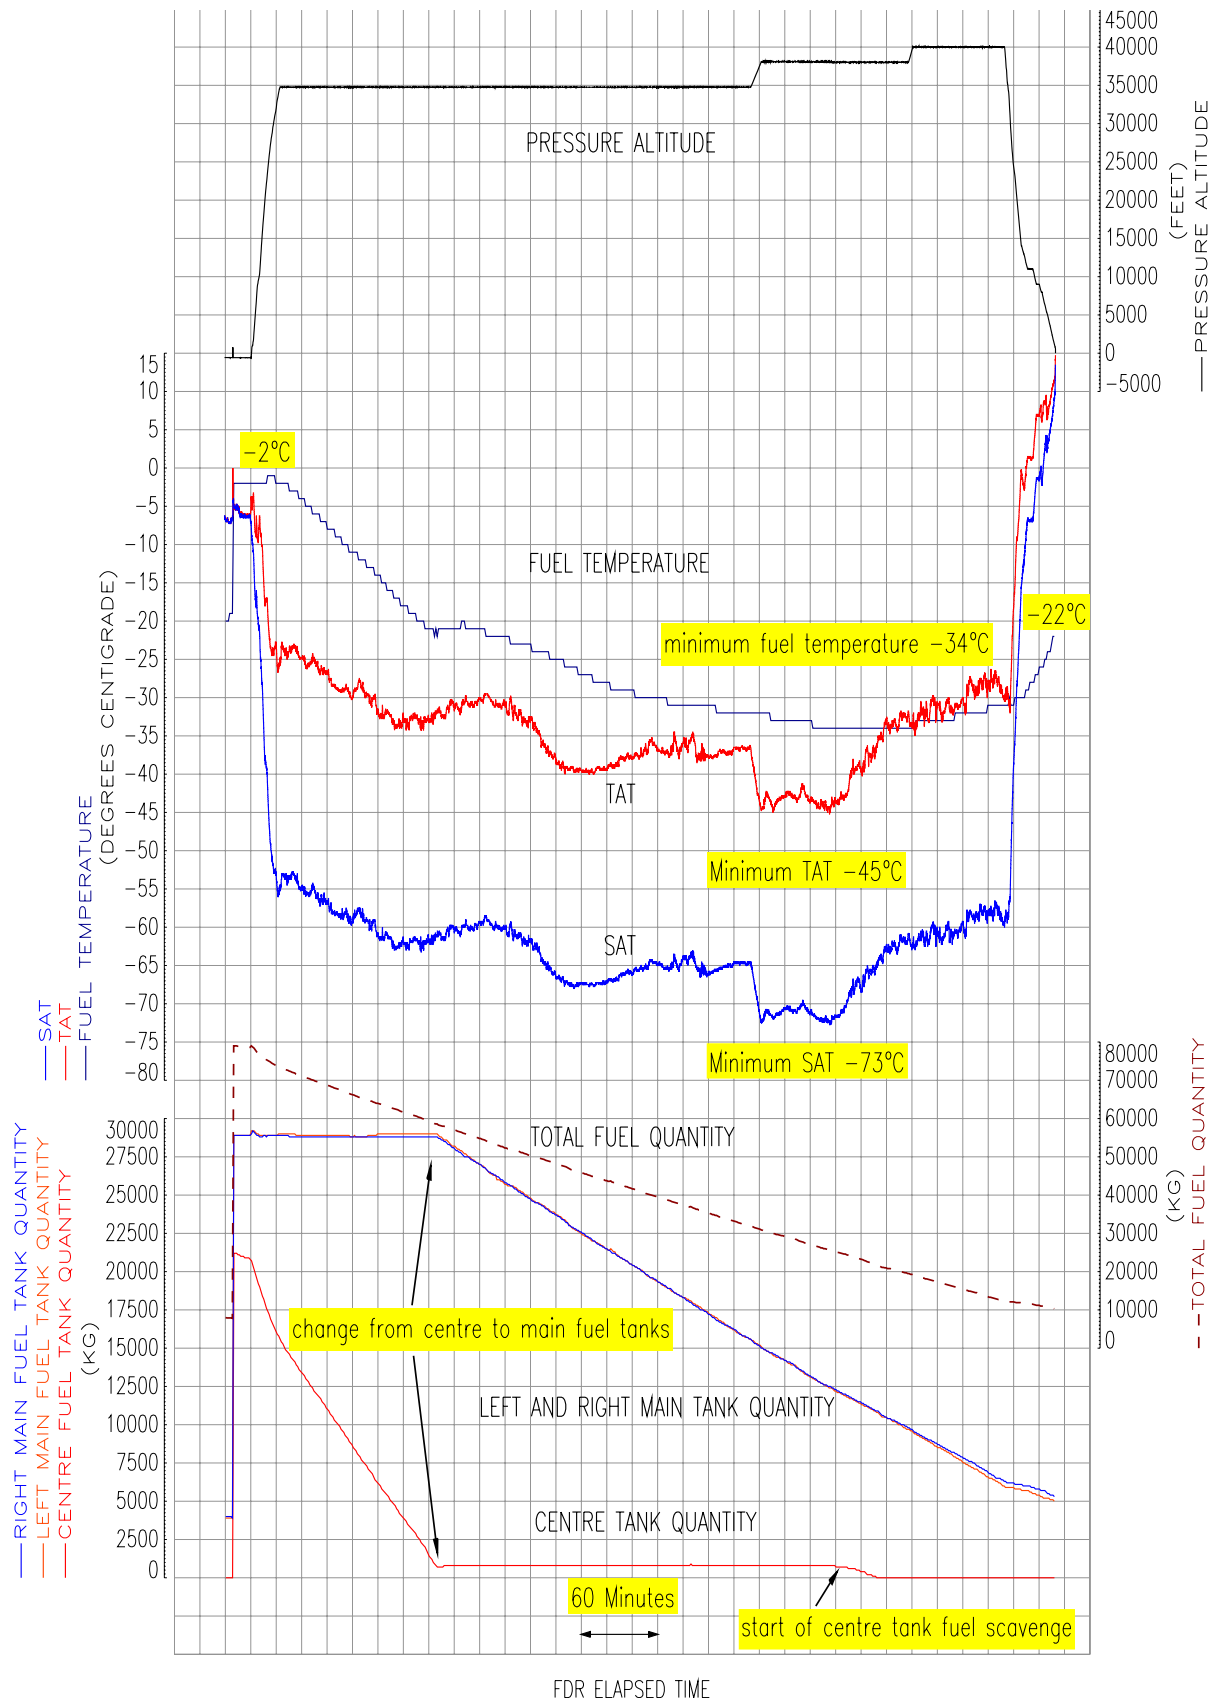
Figure 1
Temperatures

A time history of Total Air Temperature (TAT), Static Air Temperature (SAT), fuel temperature and other salient parameters during the accident flight are shown in Figure 1. Figure 2 shows a time history of the relevant parameters during the final approach and the accident sequence.

The total fuel quantity at takeoff was 78,700 kg, with 28,900 kg in both the left and right main tanks and 20,900 kg in the centre tank. The aircraft climbed to a pressure altitude of 10,590 m (34,750 ft), where, at 0232 hrs, it levelled off into the cruise portion of the flight. The TAT had reduced to -25°C (-13°F) with the fuel temperature remaining at -2°C (28°F) at this time. Engine fuel flows during the takeoff phase had peaked at 24,176 pounds per hour (pph) for the left engine and 23,334 pph for the right engine, with both engines being fed with fuel from the centre tank. This slight difference in fuel flows is not considered to be significant.

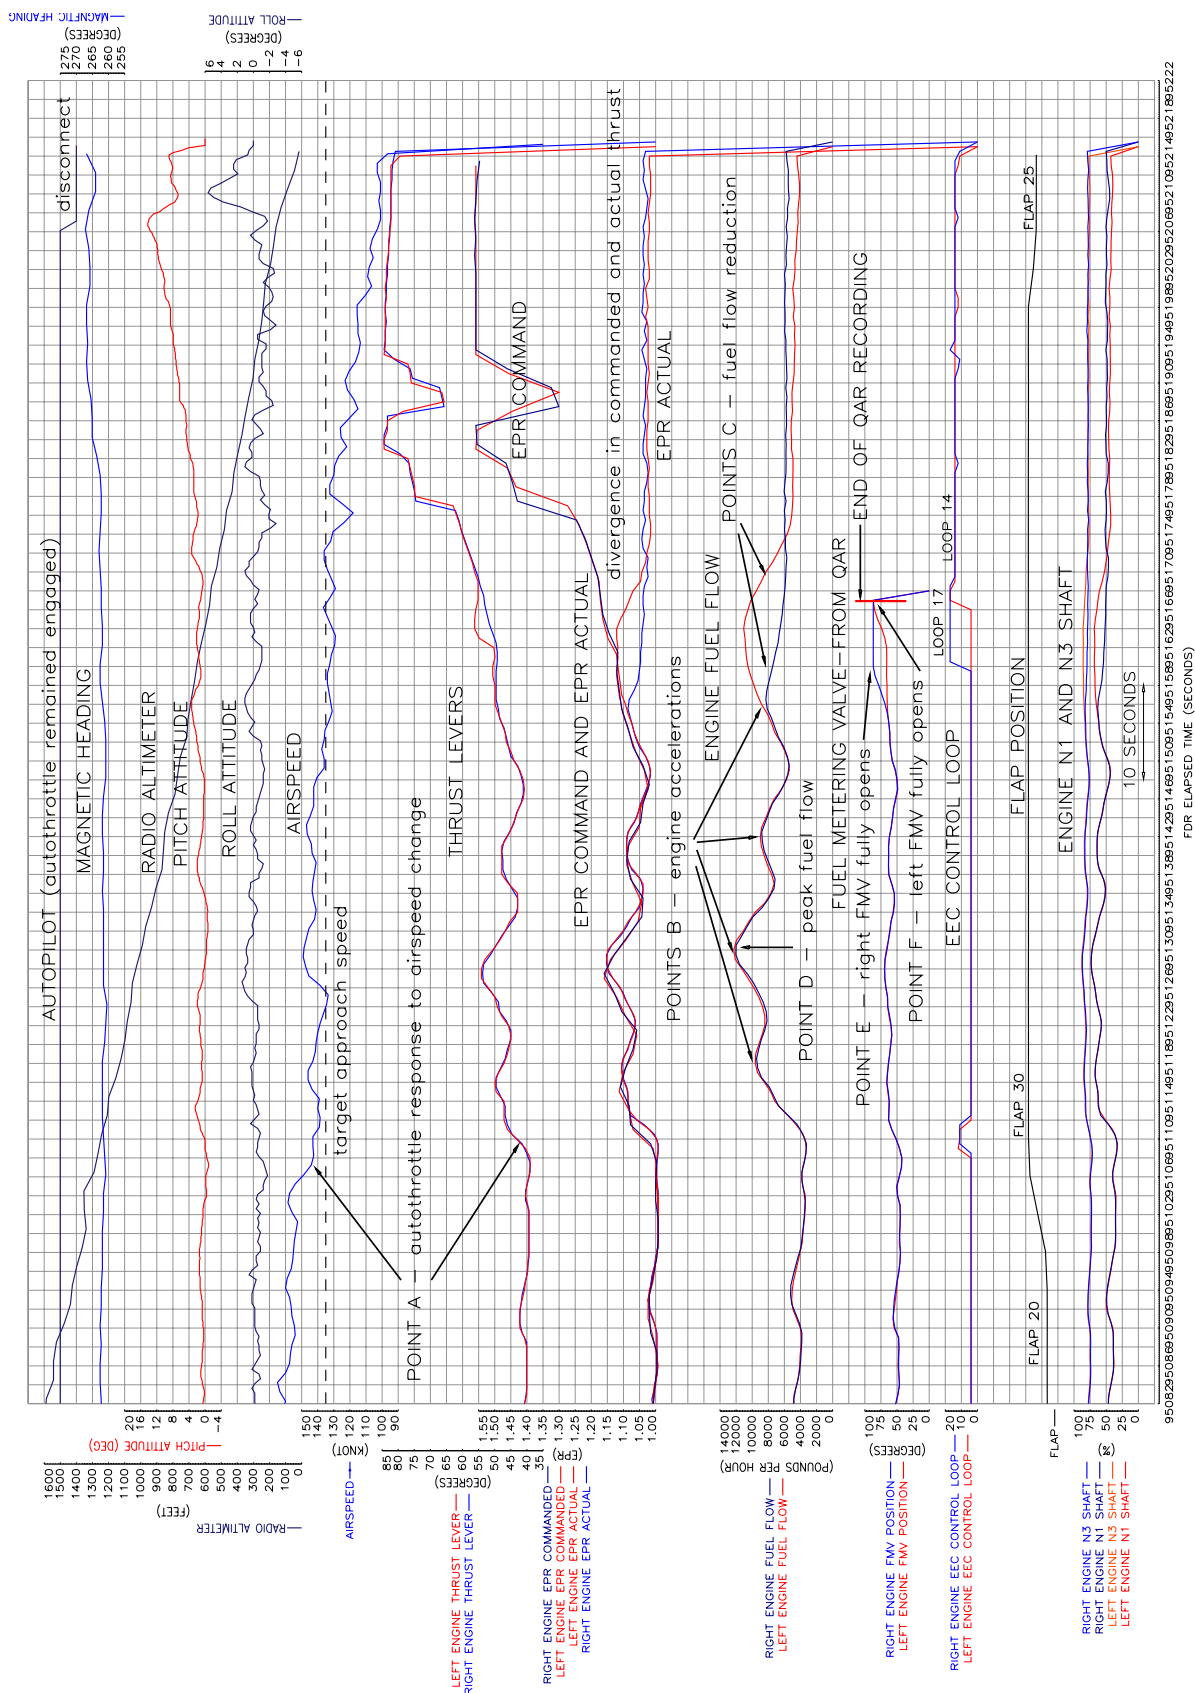
Figure 2
Final approach

airspeed (Figure 2 Point A). In response to variations in the wind velocity and associated airspeed changes, there followed a series of four, almost cyclic, thrust commands by the autothrottle (Figure 2 Points B). It was during the fourth acceleration, and as additional thrust was being commanded, that the right engine, followed some seven seconds later by the left engine, experienced a reduction in fuel flow (Figure 2 Points C). The right engine fuel flow reduction occurred at a height of about 720 ft and the left engine at about 620 ft.

Of the four thrust commands it was the second that resulted in the highest delivery of fuel flow, reaching a peak of 12,288 pph for the left engine and 12,032 pph for the right (Figure 2 Point D). These peaks occurred about 26 seconds prior to the reduction in fuel flow to the right engine. Peak fuel flows during the first and third thrust commands were lower, at about 9,500 pph and 9,000 pph respectively.

During the fourth thrust increase, the right engine fuel flow had increased to 8,300 pph before gradually reducing. The recorded EPR then started to diverge from the commanded EPR and the right engine FMV was then fully opened (Figure 2 Point E). Some seven seconds later, the left engine fuel flow, which had increased to 11,056 pph, also started to reduce and the left engine FMV was also moved to its fully open position (Figure 2 Point F). Following the reduction in fuel flow, the left engine fuel flow stabilised at about 5,000 pph and the right at about 6,000 pph. Both engines continued to produce thrust above flight idle. The autothrottle and the flight crew commanded additional thrust, with both thrust levers ultimately being placed fully forward, but there was no increased thrust available from either engine. The actual fuel flows continued to remain significantly below that being commanded.

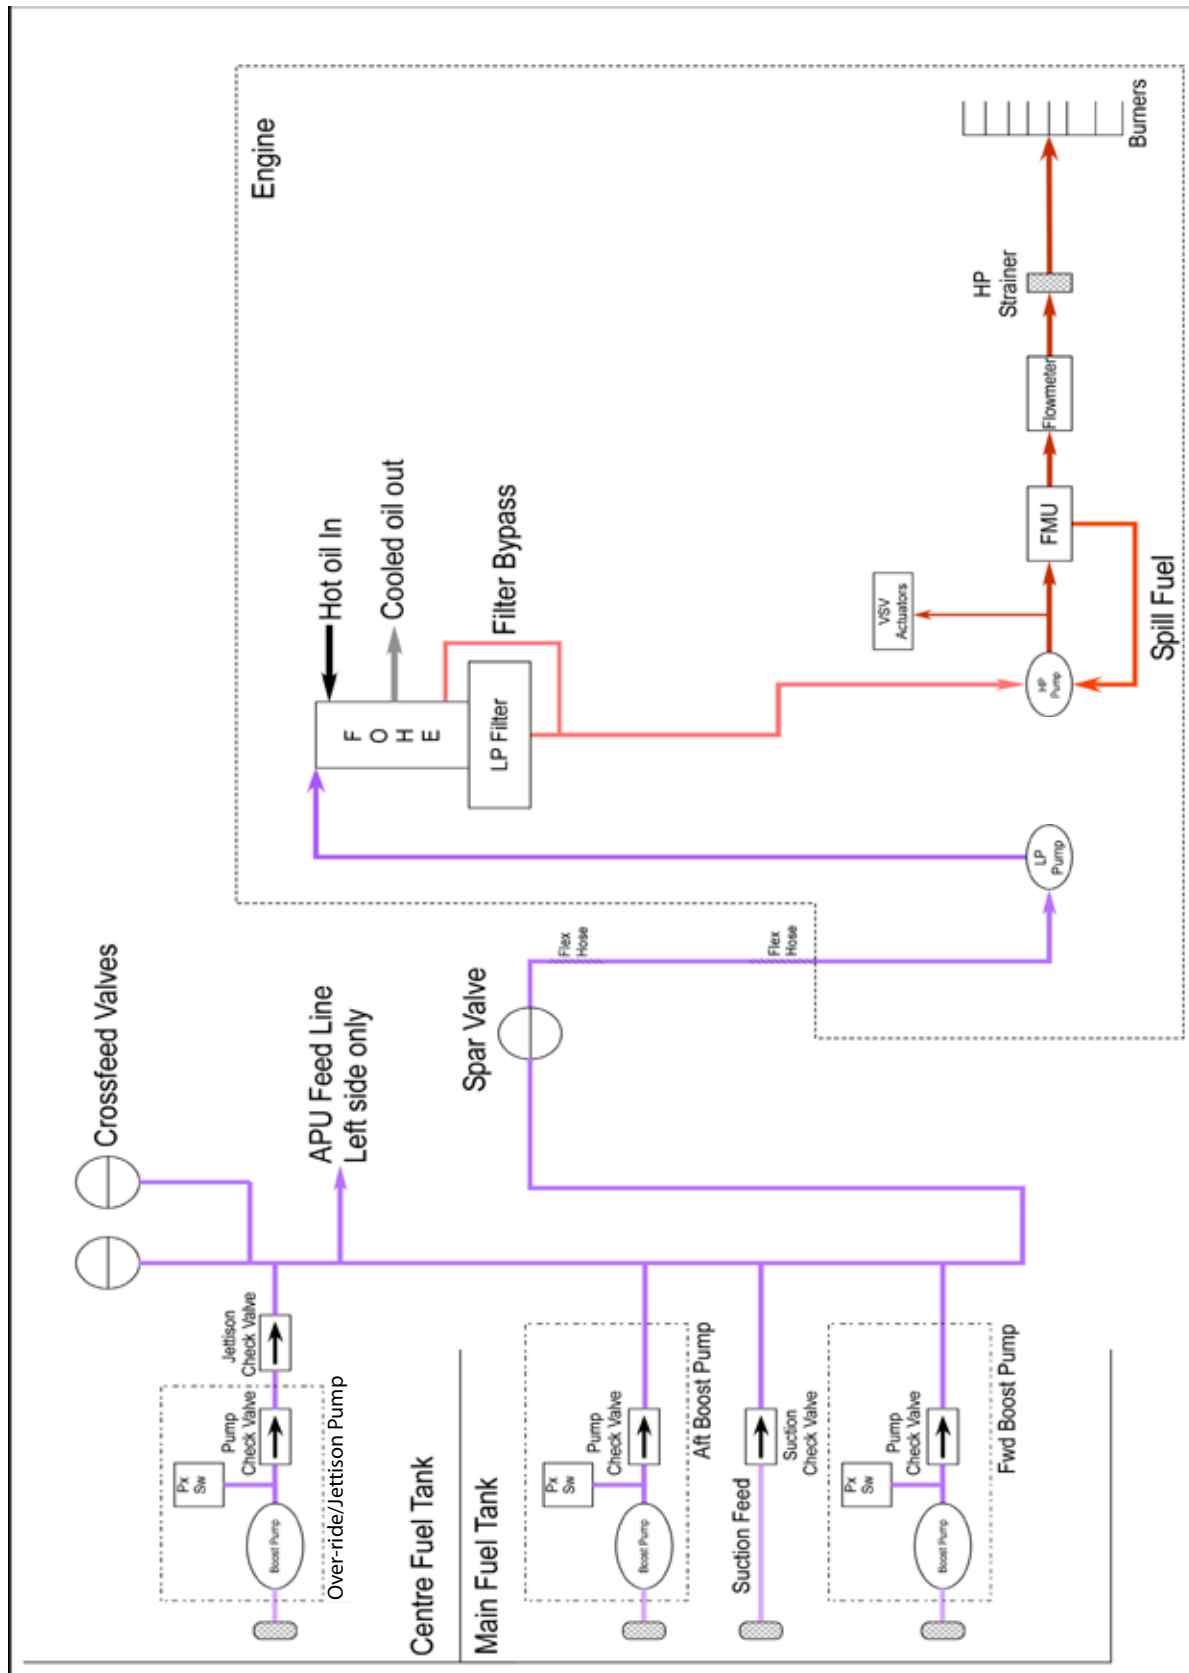
Figure 3

The fuel on the Boeing 777-200ER is stored in three fuel tanks: a centre tank, a left main tank and a right main tank; see Figure 3. The centre tank contains two override / jettison pumps (OJ) and each main fuel tank contains two boost pumps, identified as forward (fwd) and aft. Each of the pump inlets is protected by a mesh screen and the pumps are also equipped with a check valve fitted in the discharge port, to prevent fuel in the fuel feed manifold flowing back through the pump. A pressure switch, mounted between the pump's impellor and check valve, monitors the fuel pressure and triggers a warning in the flight deck if the pressure rise across the pump drops to a value between 4 and 7 psi.

Boeing 777 / Rolls-Royce Trent 800 Fuel System

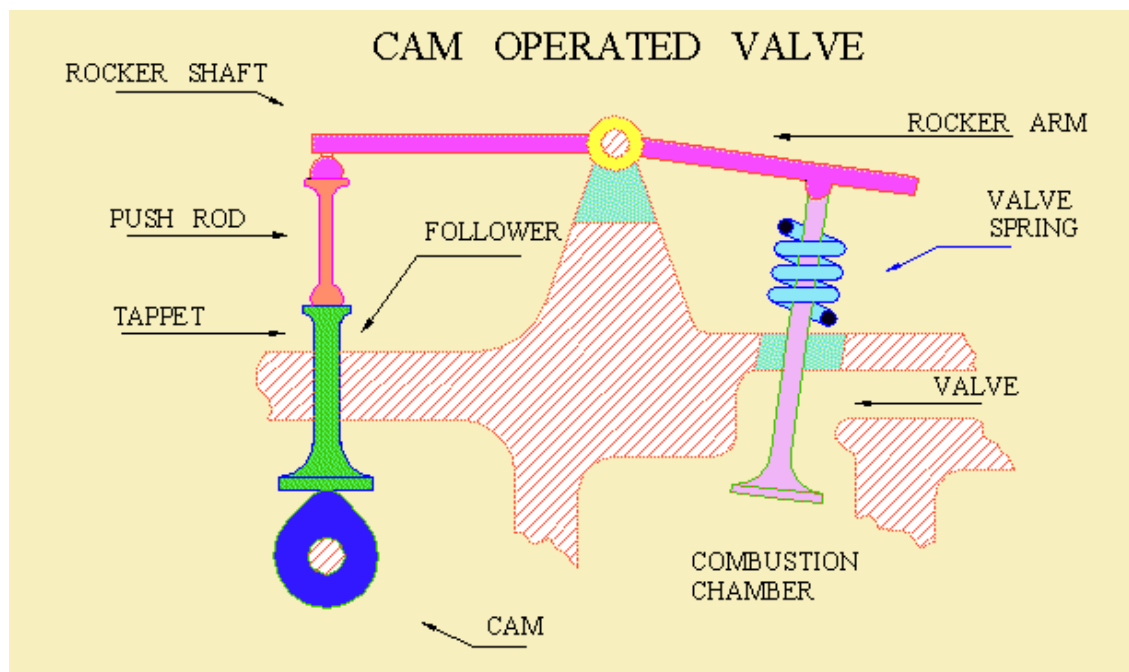
Photographs of the camshaft, the damaged lobe and the associated cam followers are shown at Figures 1 and 2. Also shown is a sketch indicating the principle of cam/valve operation, although in the subject engine, the cam followers contain hydraulic tappets, which become charged with oil when the engine is running, causing them to expand so that they take up clearances between the various components in the valve operating system. It should be noted that although there is a total of eight valves in the engine, the camshaft has only six lobes because the second and fifth lobes (counting from the front of the engine) each operate the inlet valves of opposing cylinders, Nos 1/2 and 3/4 respectively. Each exhaust valve is operated by a dedicated cam lobe. The effect of the wear was to remove approximately 0.138 in from the cylinder Nos 1/2 inlet valves cam 'peak', which would have resulted in a corresponding loss of inlet valve lift for both cylinders.

Sketch showing principle of valve operation

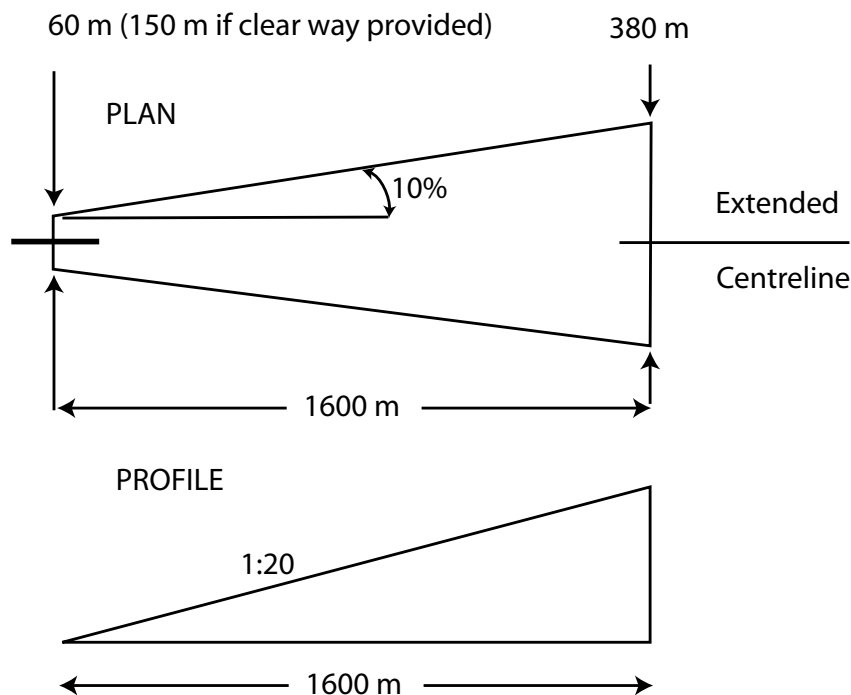
Figure 3

Runway 23 is designated as a code 1 runway for the purpose of determining the freedom from obstacles when landing and taking off. As such, its takeoff obstacle limitation climb surface has a slope of 5%, originating 30 metres beyond the end of the takeoff run and extending out to a distance of 1,600 metres, orientated on the extended centreline. The inner edge of this surface is 60 metres in width and the outer edge is 380 metres wide, with a linear increase in width of the surface between the two edges. See Figure 3.

Takeoff climb surface associated with a runway where the code number is 1

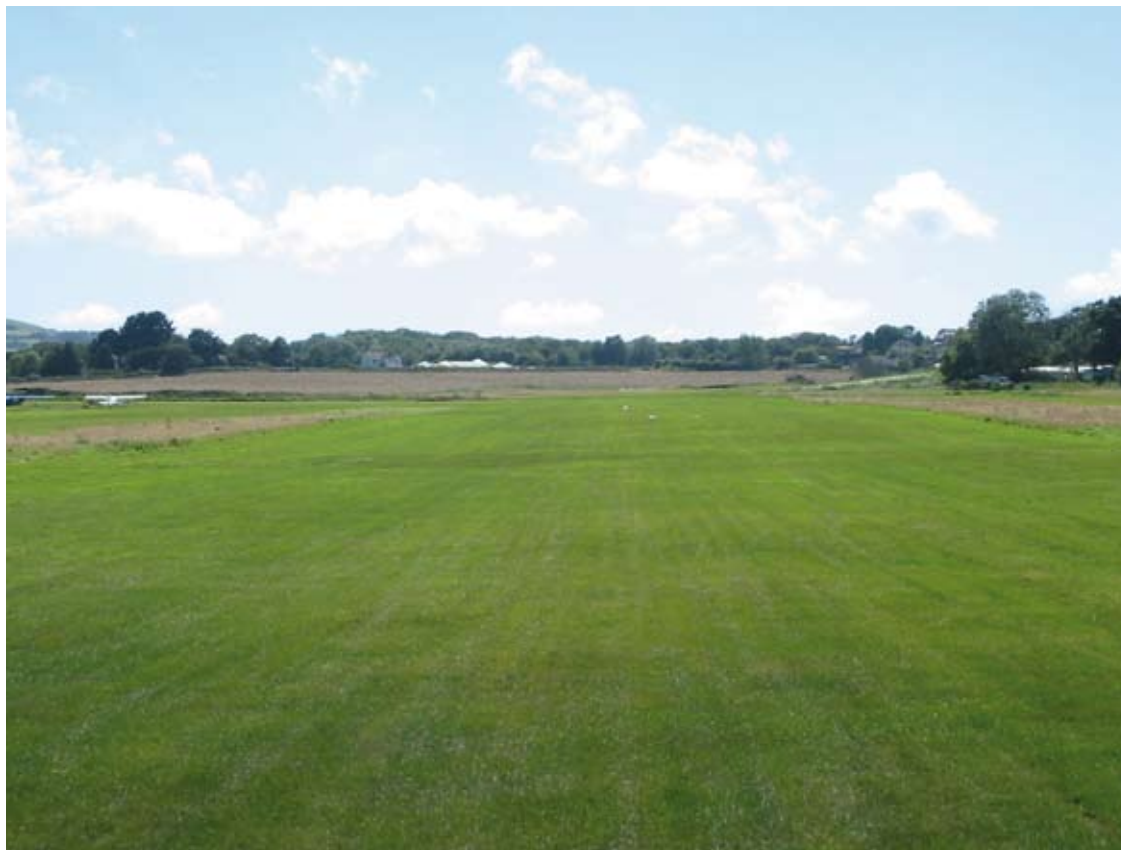
Figure 4 shows a photograph taken from half way down the runway, looking south-west.

Photographs of Runway 23 looking south-west

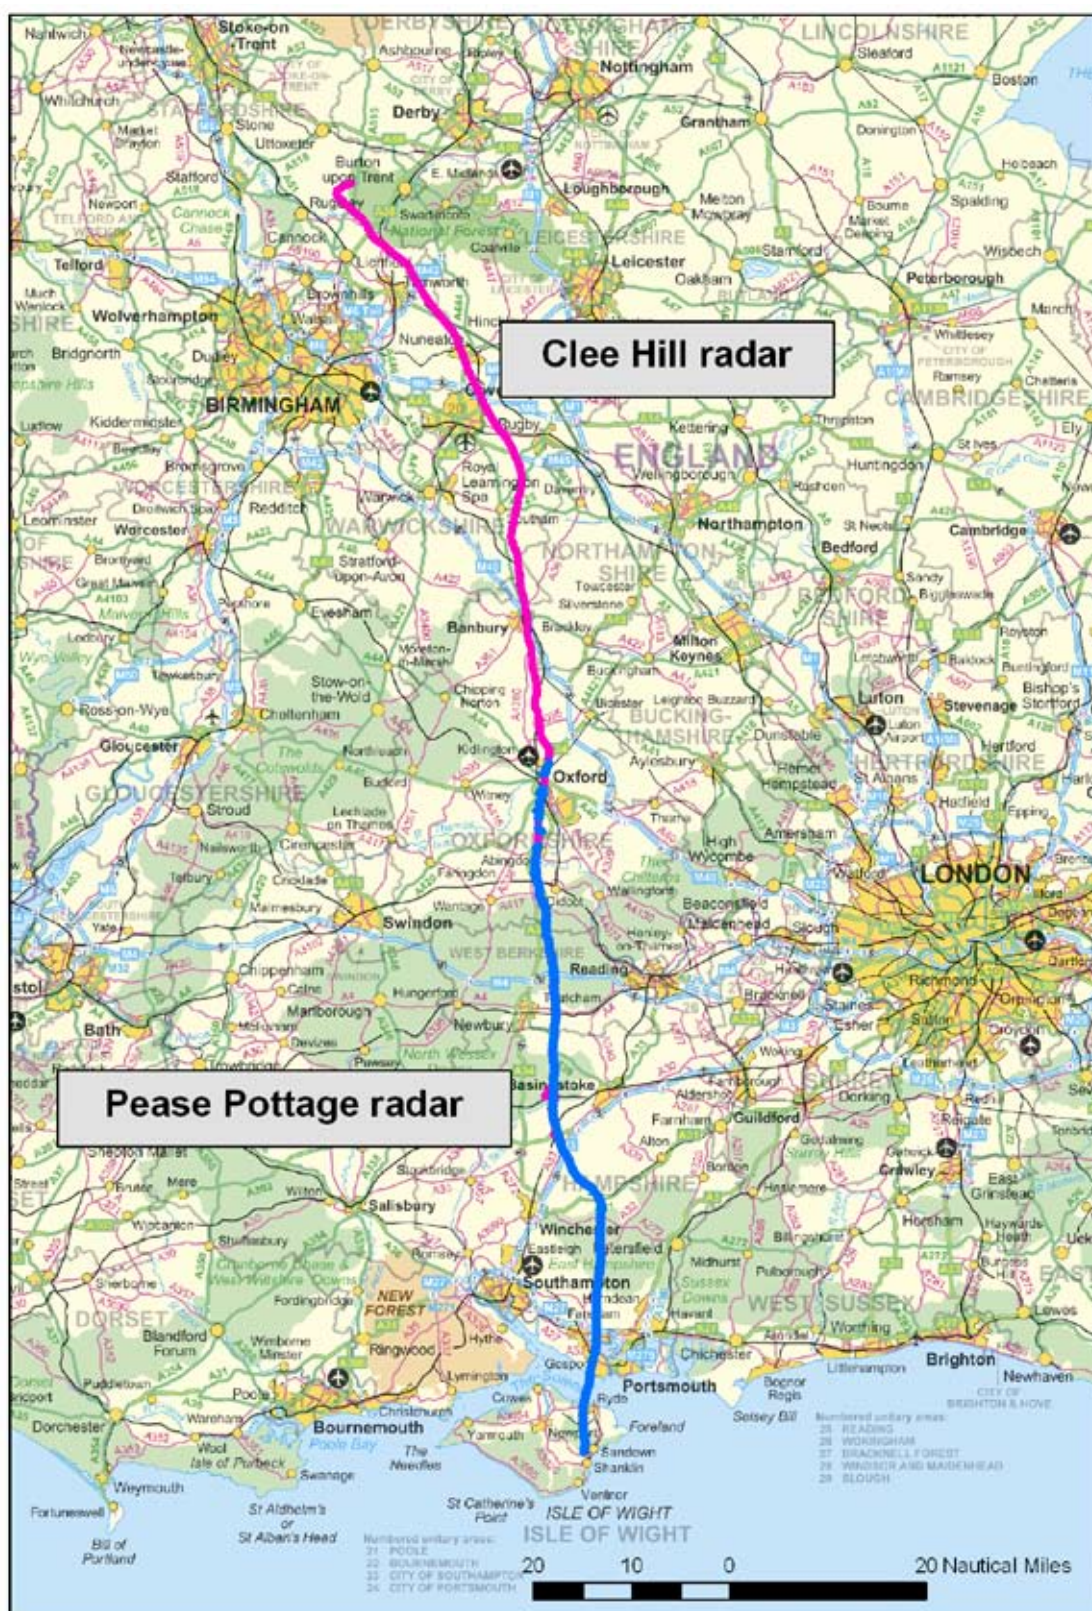
Primary and secondary surveillance radar information from the radar heads located at Clee Hill and Pease Pottage was available for the aircraft’s flight prior to the accident flight. Figure 5 shows this track, starting at 0748:23 hrs as G-AVRP climbed away from Tatenhill airfield, to the west, ending at 0939:40 hrs with the aircraft approaching Sandown Airport. No more radar data of G-AVRP was available.

G-AVRP's flight track from Tatenhill to Sandown Airport

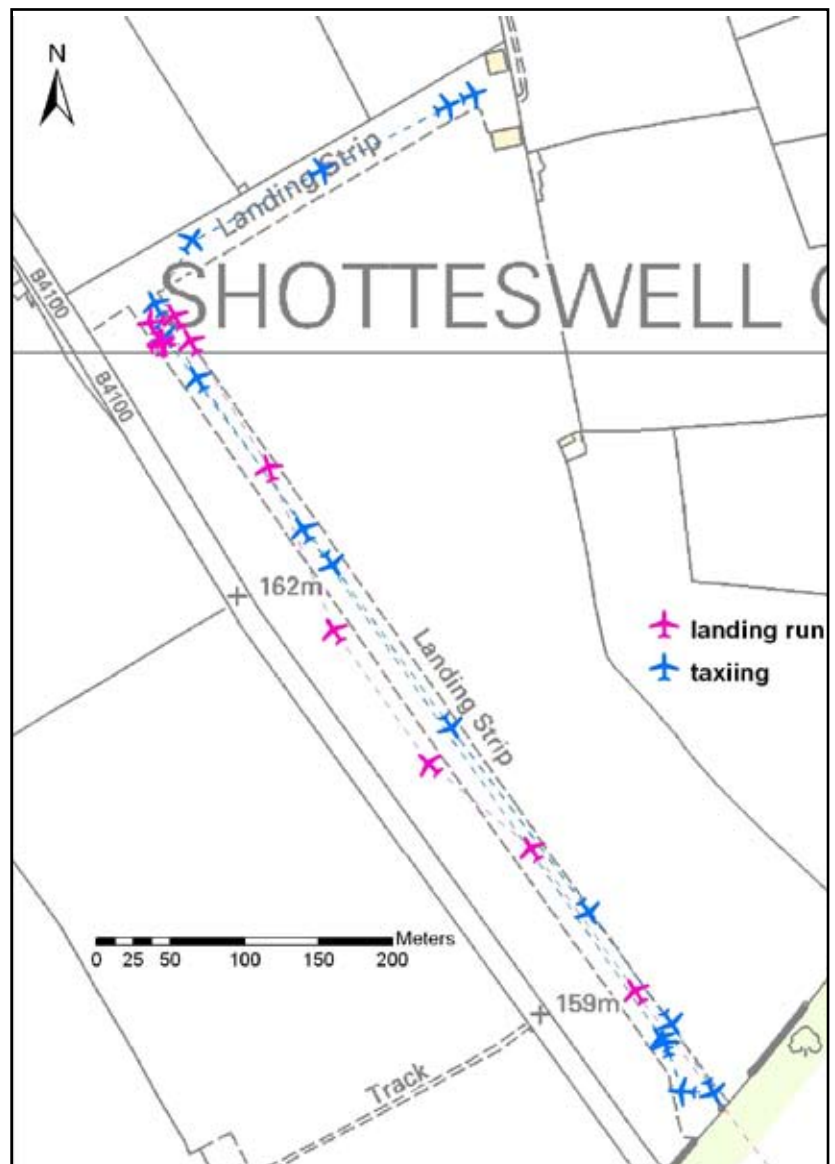
Figure 1

was apparent to observers on the ground that the pilot had to contend with a crosswind from the left. The GPS data indicated that during the touchdown the aircraft veered to the left, possibly off the runway, before returning to the prepared runway surface (see Figure 1). After landing, G-BMDC remained at the end and to the left of Runway 33 for two and a half minutes before backtracking along Runway 33 to the threshold, where

Landing and subsequent taxiing at Shotteswell airstrip prior to accident flight

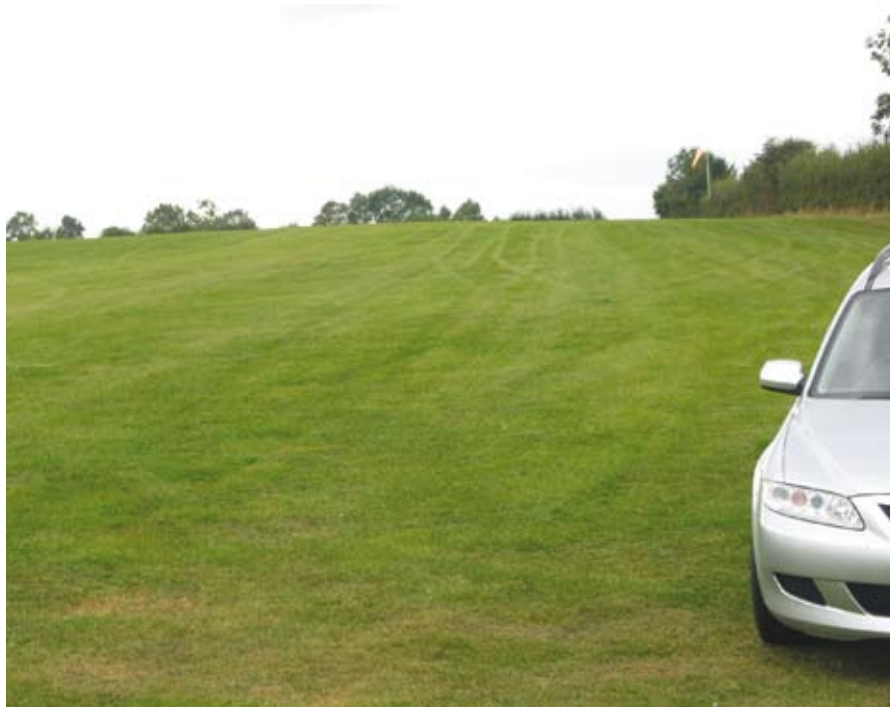
A survey of the airfield immediately after the accident indicated that the useable length of Runway 25 was 302 metres, with a 1.6% upslope; this distance did not include the grass area in front of the hangar which was not considered useable by an aircraft of the size of G-BMDC. Including the grass area in front of the hangar resulted in an approximate 'hedge-to-hedge' distance of 330 metres. At the western end of the runway was a hedge which was approximately 18 to 22 ft tall. Immediately on the other side of that was a single carriageway road, the B4100, on the far side of which stood trees that were approximately 30 to 40 ft in height. See Figures 2 and 3.

Figure 2
Runway 25 from the threshold

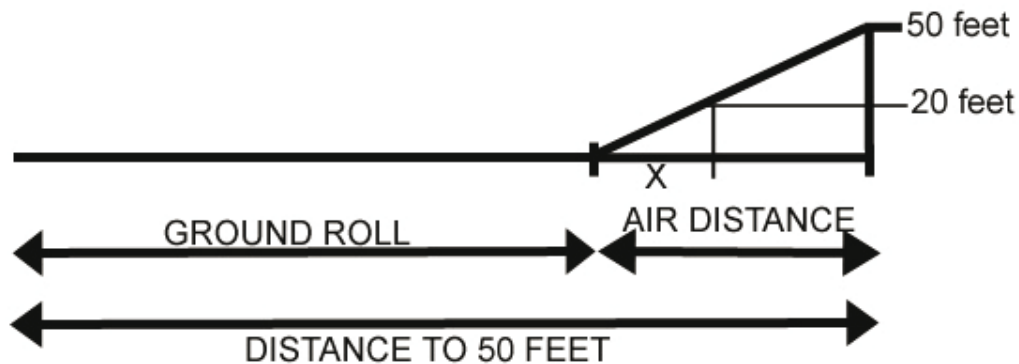
The POH did not provide a method for calculating takeoff distance required to a height of 20 feet, so the geometric method depicted in Figure 5 was used.

Method used to estimate the takeoff distance to a height of 20 feet³
