AAIB Bulletin

2/2018

Published 8 February 2018

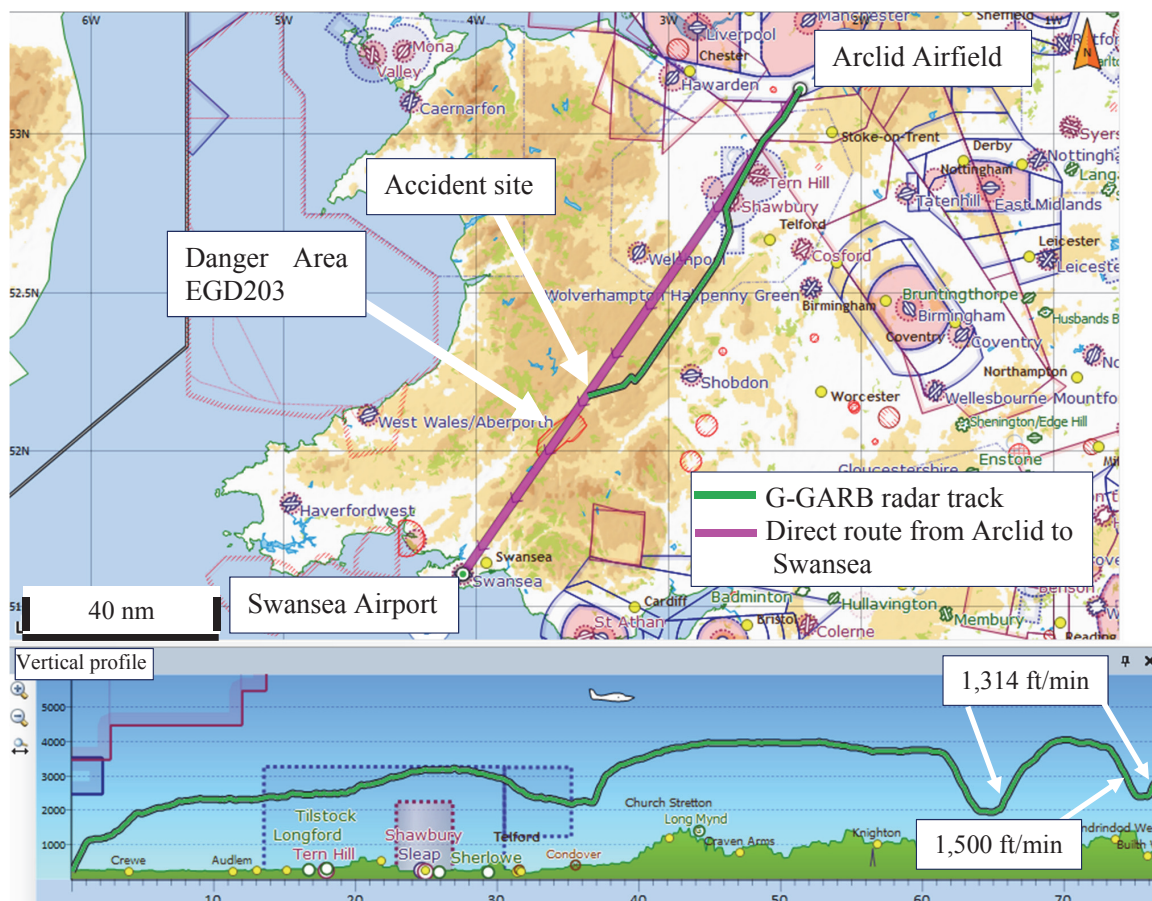
Figure 1

At about 0946 hrs G-GARB took off from Arclid Runway 20 and departed on a south-westerly course towards Swansea. Radar data later showed that the aircraft climbed gradually to an altitude of 3,300 ft amsl; the altitude during the flight varied but remained above 2,000 ft amsl up to the point of the accident. A plot of the vertical profile of the flight is shown in Figure 1.

G-GARB recorded radar track with derived vertical speeds
(Chart produced by SkyDemon and used with permission)

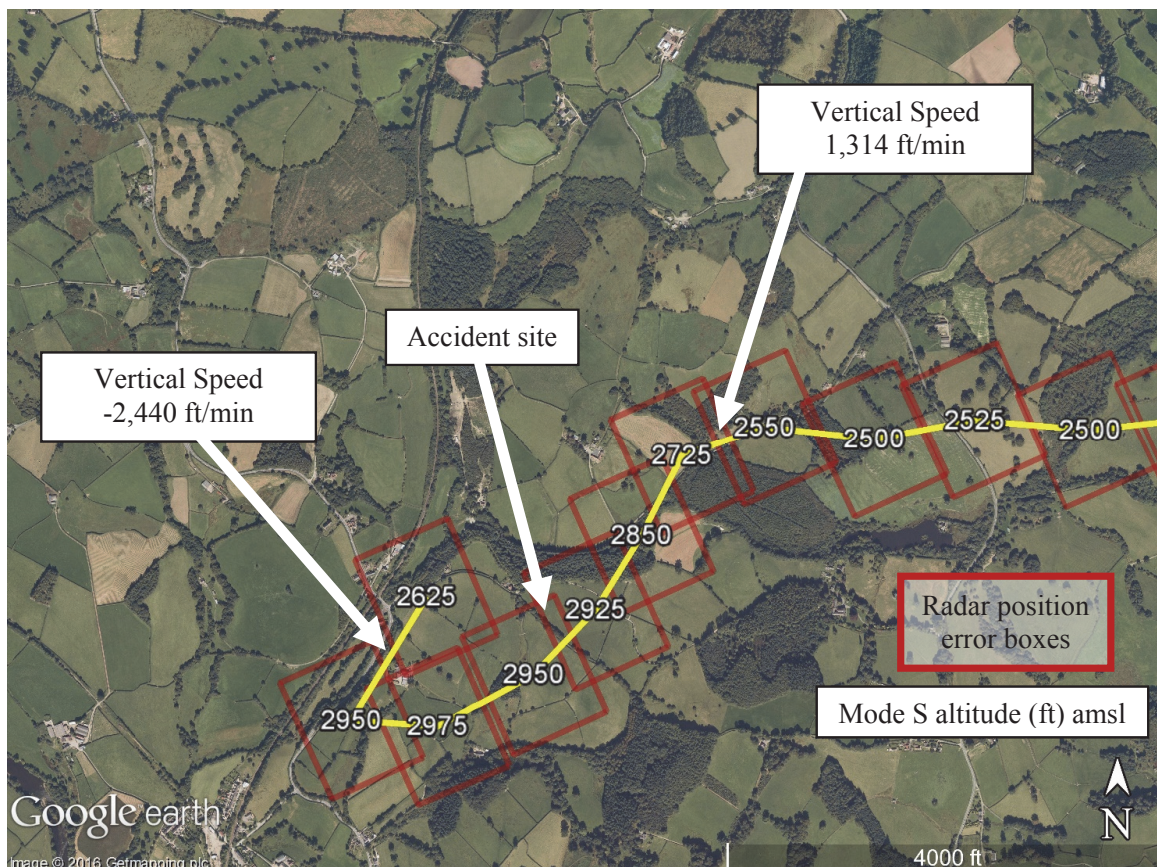
Figure 4

The final stage of the flight is illustrated in Figure 4, which includes 'error boxes', in red, denoting the limited accuracy of the radar position data. A minute and a half prior to the end of the radar recording, the aircraft started to fly at approximately level altitude and constant heading for 40 seconds. Calculated groundspeed for this period was 87 mph \pm 18 mph (depending on radar error). Considering the aircraft's approximate heading and a reported wind of 240°/ 10 kt, this equates to an airspeed of 97 mph \pm 18 mph. At 1055:27 hrs, the aircraft commenced a climb from 2,550 ft to 2,975 ft over 40 seconds. The maximum derived vertical speed during this climb was 1,314 ft/min with an average of 638 ft/min. Between the penultimate and final recorded radar returns, the aircraft descended 325 ft over 8 seconds; a descent rate of 2,440 ft/min. The final recorded radar return was at 1056:23 hrs with the aircraft at 2,625 ft (2,100 ft agl), almost overhead the accident site.

G-GARB recorded radar data showing altitude amsl and position error boxes in red

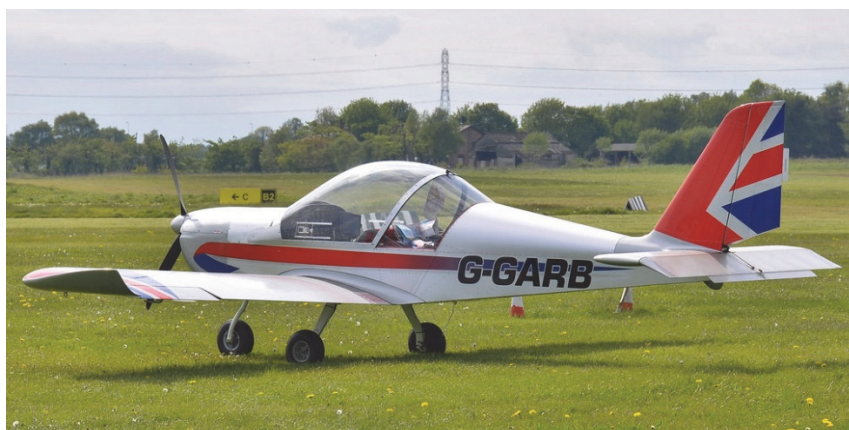
Figure 5

The accident aircraft, G-GARB (Figure 5), was built in 2013 and had accumulated 249 hours at the time of the accident, with its last annual inspection completed in January 2016. After the pilot’s purchase of G-GARB in 2015, it was initially kept outside at Arclid but was later moved to a hangar at Blackpool Airport during the winter of 2015/16. In April 2016 the pilot-owner brought it back to Arclid where it was parked outside.

The accident aircraft, EV-97 Teameurostar UK, G-GARB
(photo courtesy of and copyright Craig Duffy)

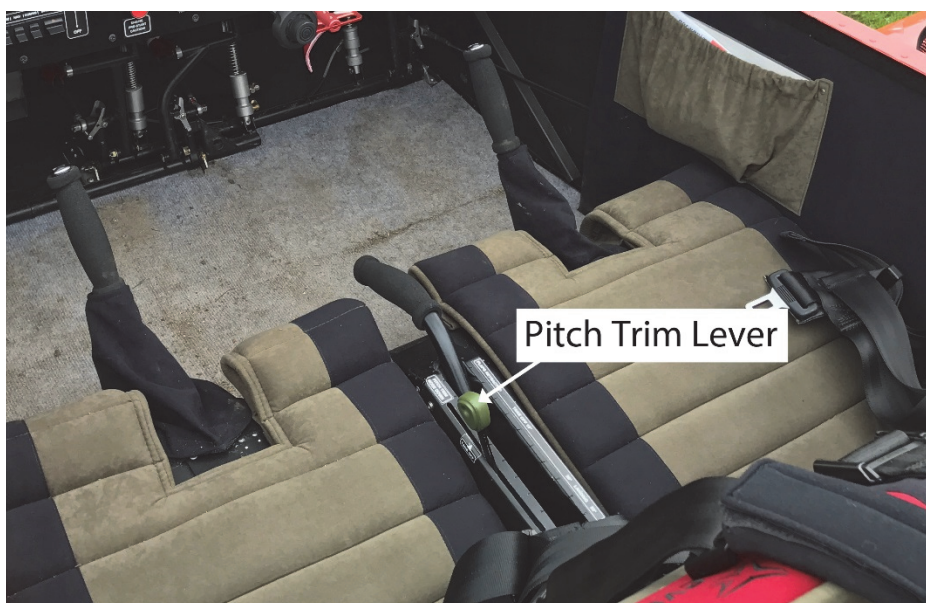
Figure 6

The elevator had a trim tab which was operated via a 'Bowden-type' cable and a lever mounted between the seats (Figure 6). This trim lever was pushed forward to generate nose-down trim and pulled aft to generate nose-up trim.

Pitch trim lever on another EV-97 aircraft

An EV-97 flight instructor informed the AAIB that he had experienced "a couple" of occasions when a student pilot or passenger had inadvertently pressed down on the trim lever causing a 'bunt type' manoeuvre. He said this could happen when someone was trying to shift their weight in the seat by pushing down with their left hand (Figure 6). The flight evaluation used an incremental approach to determine the effect of sudden changes in trim lever position from straight and level cruise flight. During trim changes the control stick was held loosely and allowed to move until recovery action was taken.

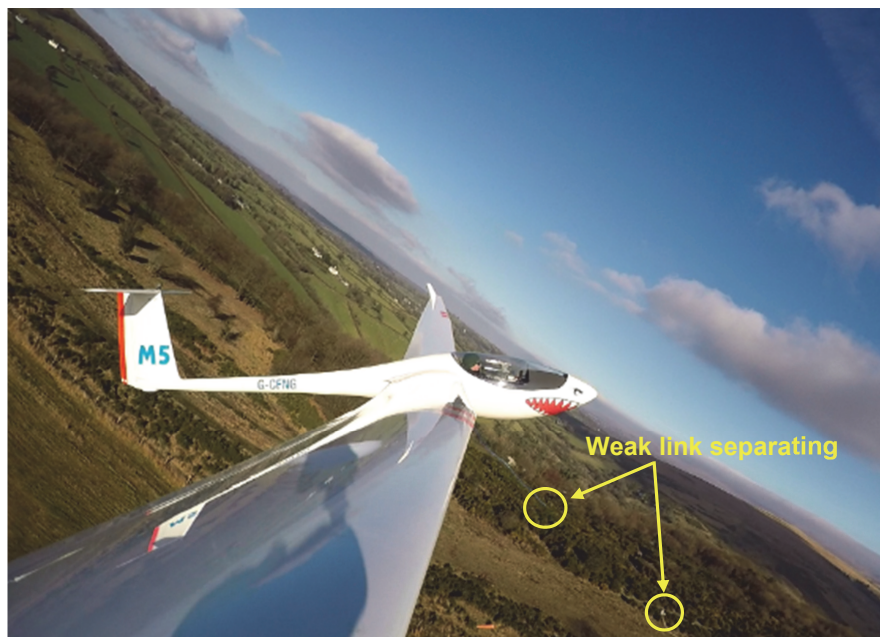
Figure 2

The initial launch appeared normal with the glider becoming airborne at about 53 KIAS, five seconds after the launch started. Three seconds after the glider became airborne it was at 78 KIAS, and about 100 ft aal, when the weak link parted (Figure 2). The pilot immediately looked left and looked left repeatedly from this point on. At no time did the pilot look to the right.

Glider at the moment of launch failure

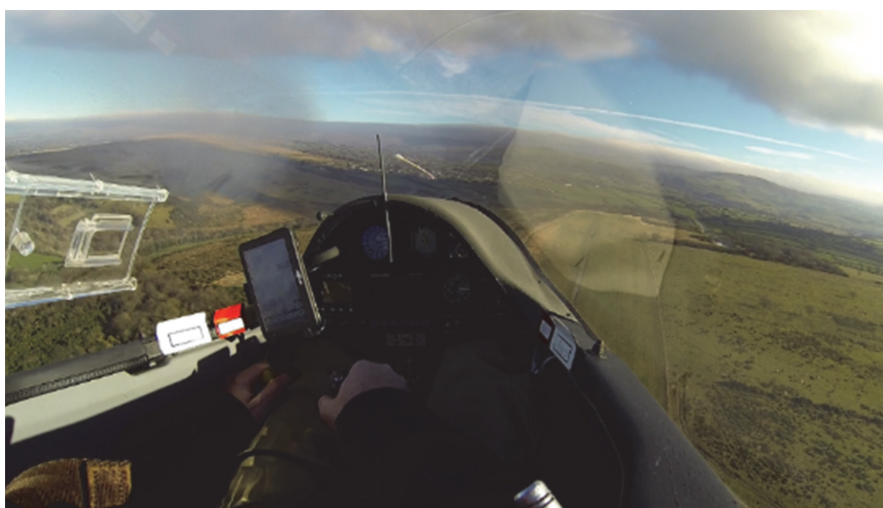
Figure 3

Over the next four seconds the glider pitched gently nose down, gaining height while slowing to 60 KIAS⁸. This pitch-down manoeuvre brought the nose of the glider to approximately level with the horizon. The pilot then made an approximately half-to-two-thirds left roll input on the control stick, while sustaining a neutral to slightly forward pitch input. The glider rolled left, the nose dropped below the horizon and began to turn to the north during which the speed reduced to 51 KIAS (Figure 3).

Cockpit view as left roll input is being made

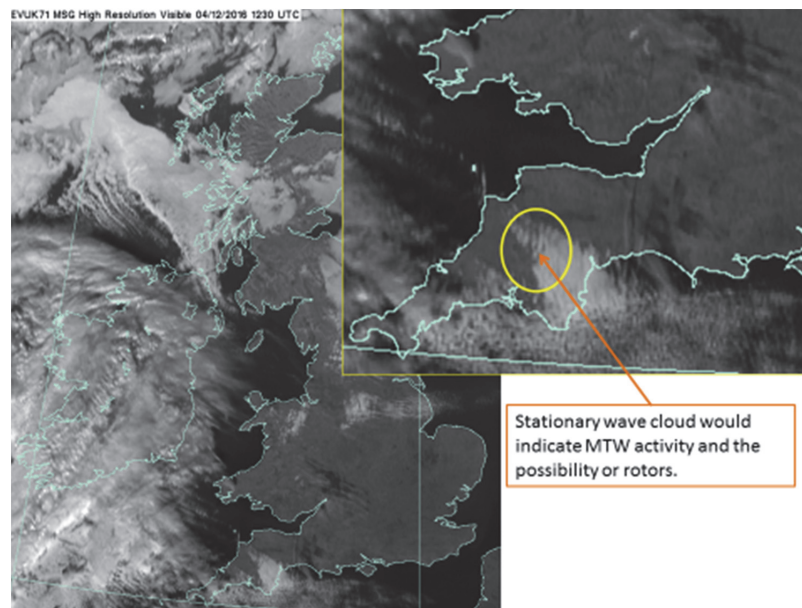
Figure 6
Satellite image

Satellite imagery of the area at the time of the incident confirms the presence of mountain wave activity in the Dartmoor area and therefore a high probability of significant turbulence at low levels (Figure 6).

'Mountain wave' activity from high ground

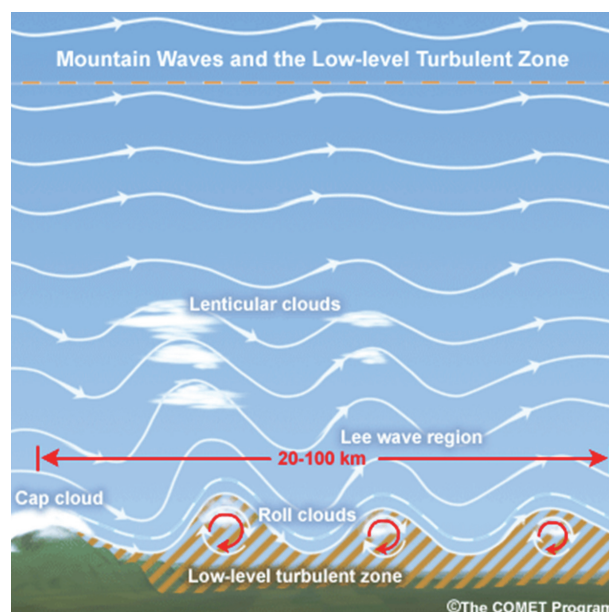
Figure 7
'Mountain Wave' diagram

In areas of mountain wave activity a low-level turbulent zone can extend many kilometres downwind from the high ground inducing the phenomena. Brentor Airfield would have been within this zone on the day of the accident (Figure 7).

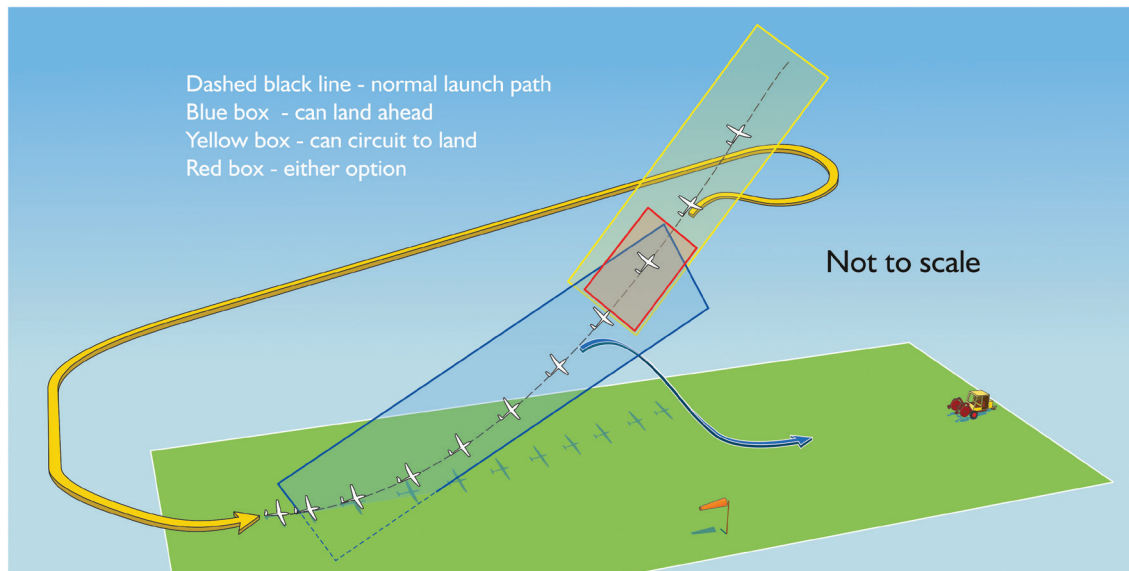
Figure 8
 Launch options picture

The failure handling can be broken down into phases depending on when it occurs. In the event of a failure during the initial stages of a winch launch the glider should be able to land ahead, on the gliding site (Figure 8). After a short period the glider will reach a height from which it is possible to return to the launch site via some form of abbreviated circuit. The glider site and conditions should be such that one option is always possible and to ensure this happens there will also be a period during which both options will be possible. This overlap is normally in the order of 200 to 300 ft deep and as the headwind or field length increases the depth of this overlap will also increase.

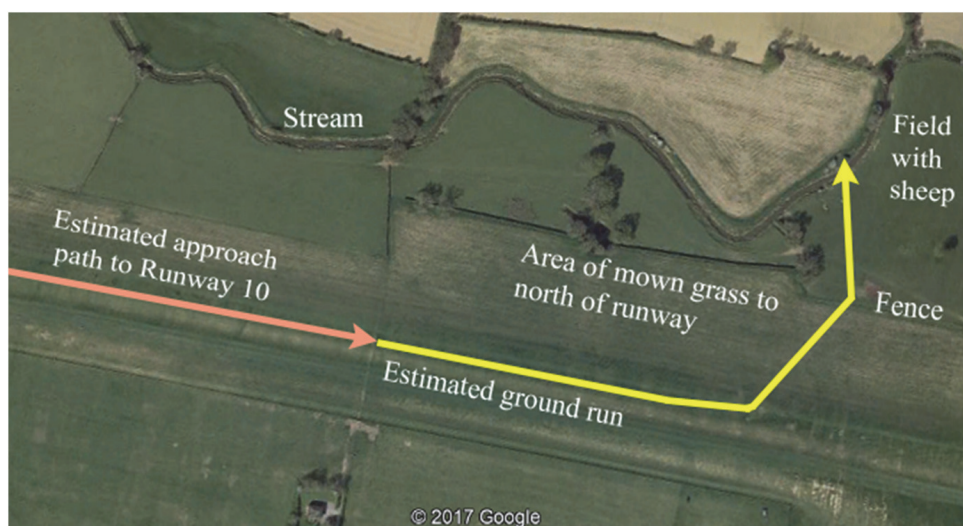
Figure 1

rudder pedal to try and overcome the aircraft's tendency to turn further left as the power increased. Despite his efforts the aircraft continued to turn left, departed the runway and accelerated over an adjacent area of mown grass.

The pilot saw a wire fence and trees ahead but managed to lift off, heading for a clear area between the trees. As the aircraft approached the fence he thought he had gained sufficient airspeed and pulled the nose back to climb over the fence. Although the mainwheels did not appear to make contact, he heard the underside of the fuselage rub the wire and the tailwheel was snagged momentarily, turning the aircraft further left and causing the nose to drop. The aircraft then touched down again on the far side of the fence and traversed an adjacent field, at high power, striking three sheep in its path. It then crossed a stream and came to rest in an overgrown hedgerow on the northern bank (Figure 1). The pilot undid his lapstrap and diagonal shoulder strap, made a radio call, and turned off the fuel and electrics before climbing out un-injured. Two of the sheep suffered fatal injuries.

Aerial view of the eastern portion of Lashenden airfield with G-JODL's estimated track
©2017Google, Image © DigitalGlobe
