CONTENTS

ACCIDENT

Aircraft Type and Registration:	BAe.ATP, G-MANH
No & Type of Engines:	2 Pratt & Whitney Canada PW126 turboprop engines
Year of Manufacture:	1989
Date & Time (UTC):	9 April 2011 at 0147 hrs
Location:	Cardiff Airport
Type of Flight:	Commercial Air Transport (Cargo)
Persons on Board:	Crew - 2 Passengers - None
Injuries:	Crew - None Passengers - N/A
Nature of Damage:	Both right main landing gear tyres, gear leg components, hydraulic pipes and flap/nacelle fairings damaged
Commander's Licence:	Airline Transport Pilot's Licence
Commander's Age:	56
Commander's Flying Experience:	10,138 hours (of which 1,379 were on type) Last 90 days - 85 hours Last 28 days - 28 hours
Information Source:	AAIB Field Investigation

Synopsis

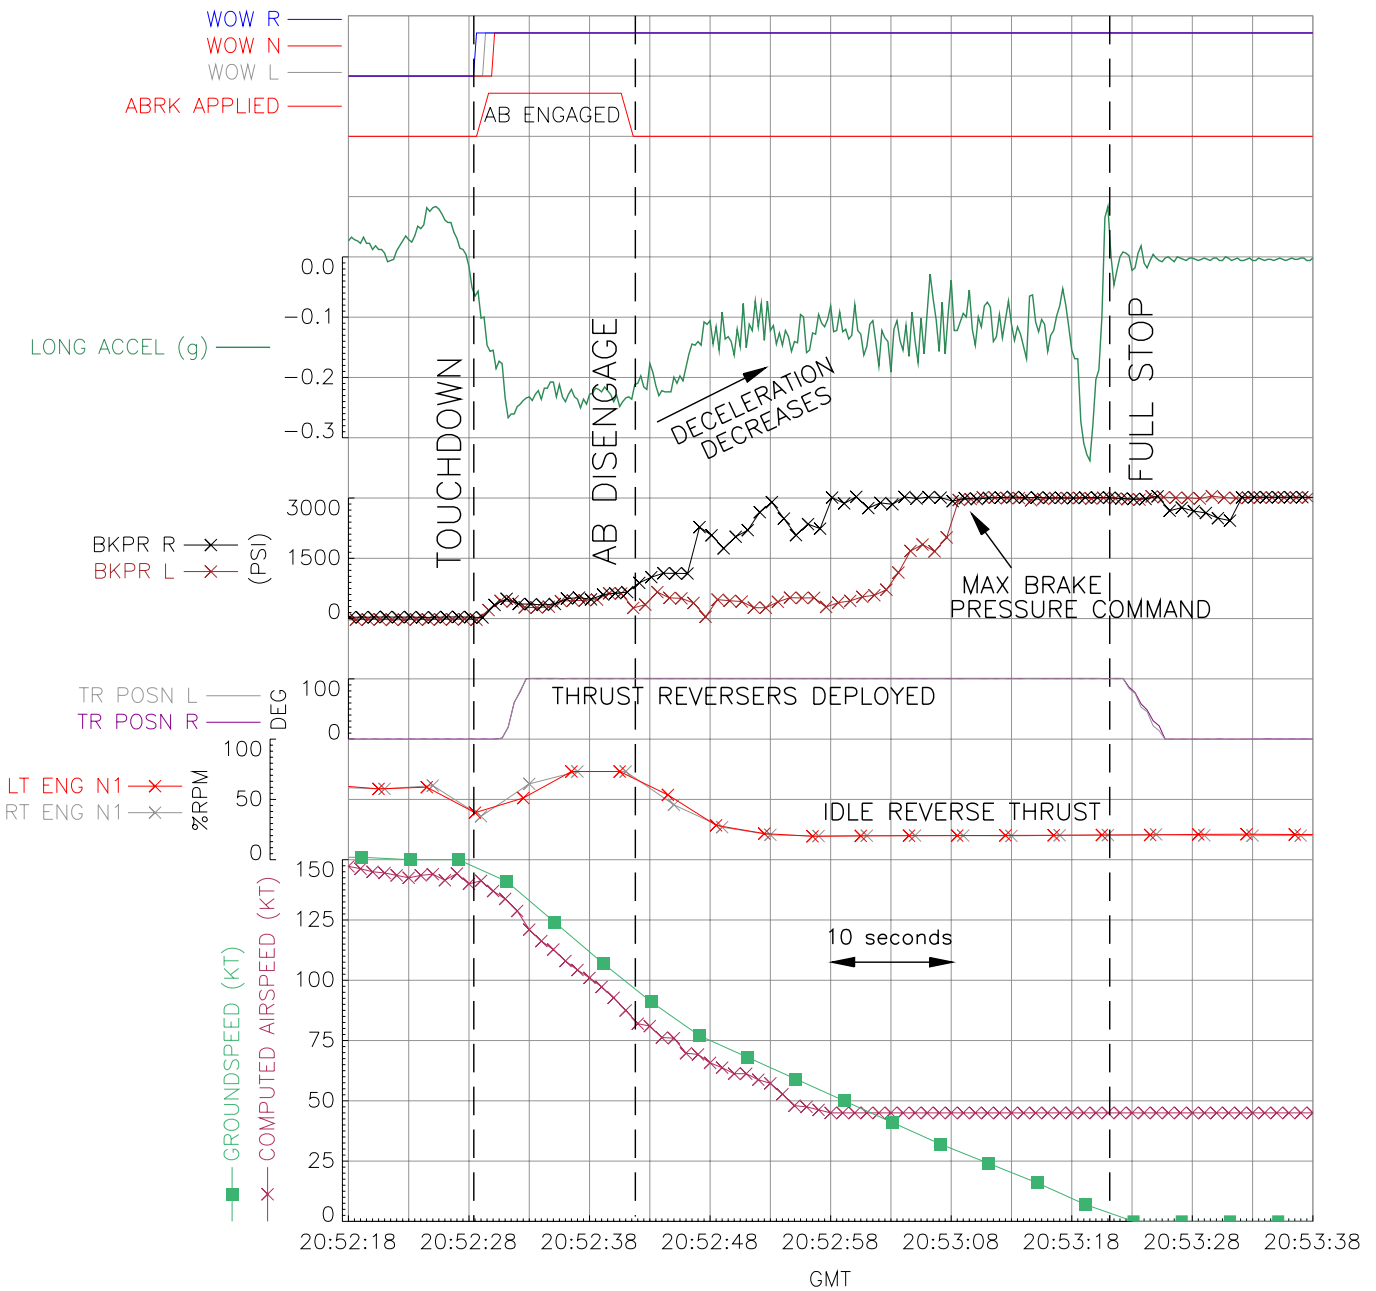
Figure 2
G-FDZR FDR parameters

Upon autobrake disengagement, manual braking was applied, initially significantly more on the right pedal than the left. At a recorded groundspeed of approximately 30 kt, maximum brake pressure was commanded to both sets of MLG brakes. Pressure applied to each brake could not be determined because commanded brake pressure was recorded upstream of antiskid regulation.

After the reduction in reverse thrust, there was a notable decrease in the aircraft deceleration to an average of 0.12g over the final 30 seconds of the landing. Application of full manual braking appeared not to change the deceleration except in the final two seconds, when deceleration peaked at 0.34g.

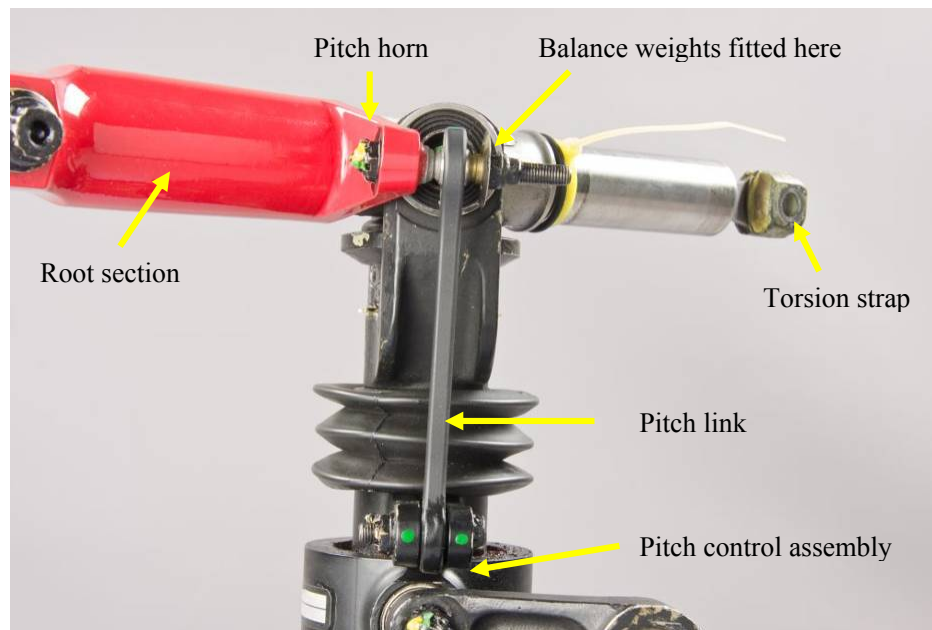
Figure 6

root section that incorporates a pitch horn. A pitch link connects the pitch horn to the pitch control assembly which, in turn, is connected through the control system to the pedals in the cockpit. In the event of a disconnect in the tail rotor control system, the torsion strap will rotate the blade to a preset pitch. The rotor assembly is balanced by weights which can be attached to either the tip of the aerofoil section of the blade or the bolt which secures the pitch link to the pitch horn. (See Figure 6.)

Significant features on the tail rotor assembly

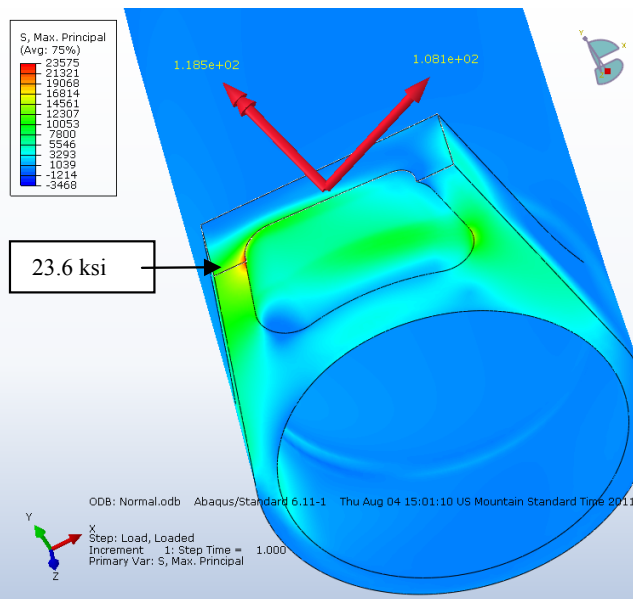
For the normal maximum loading condition, Figure 16a shows that the maximum stress occurs in the outboard upper corner of the pocket. As the pitch link loads are reversible, the maximum stress would be mirrored. In Figure 16b it can be seen that, for the failed pitch link condition, the maximum stress occurs at all four corners of the pocket with the highest stress at the inboard corners.

Maximum stress - normal loading

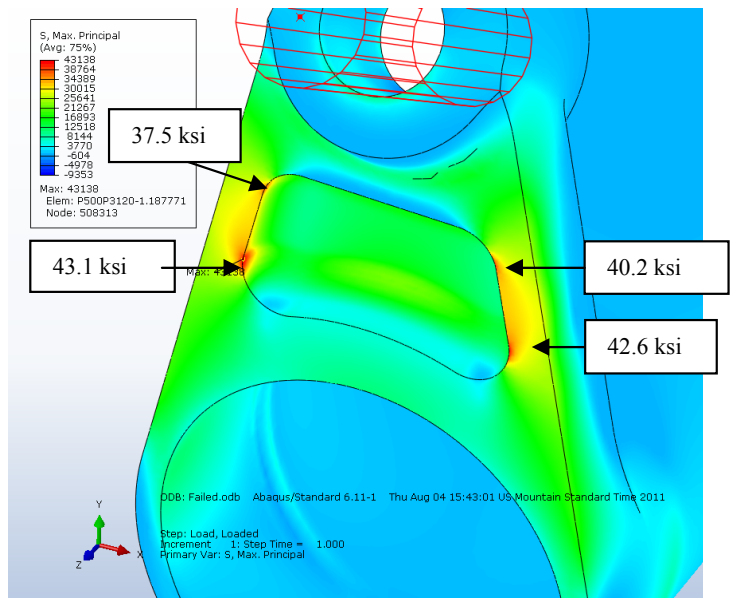
Figure 16b

Maximum stress - failed pitch link

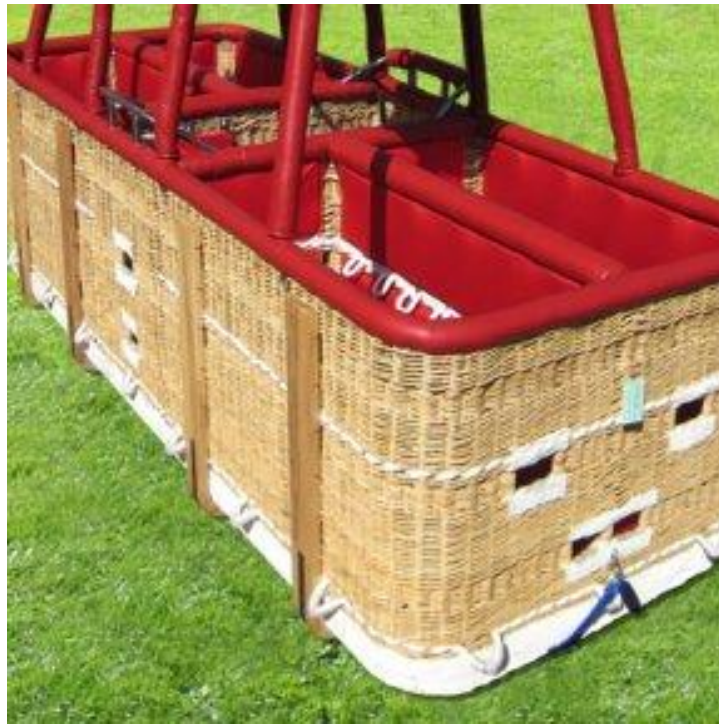
As the passengers were boarding the balloon basket one passenger fell to the ground and sustained a fracture to his upper arm. The ground support crew escorted him clear of the balloon and the flight continued. The passenger stated that the balloon basket tipped as he was boarding causing him to fall to the ground. Two witnesses stated that the basket moved because of a gust of wind. The pilot stated that the basket remained on the ground throughout the passenger embarkation and that he believed the cause of the accident was that the passenger missed his footing on the basket. The mean surface wind strength at the time of the incident, obtained from the Met Office, was below the maximum stated by the manufacturer for takeoff.

Figure 1
Balloon basket with foot holes
