**SECTION 1.4.6 – OTHER**

1.4.6.1 The accident involved two aircraft from different formations. Together, the formations numbered four aircraft and eight crewmembers. The actions of the eight crewmembers, interwoven with the maintenance and Flypro of the four aircraft, create a complex picture. Further complication was added by personnel performing multiple supervisory duties due to half of the Sqn having deployed to Cyprus on exercise. The similarity of the formation call signs, ASTON and ABBOT, can also create confusion.

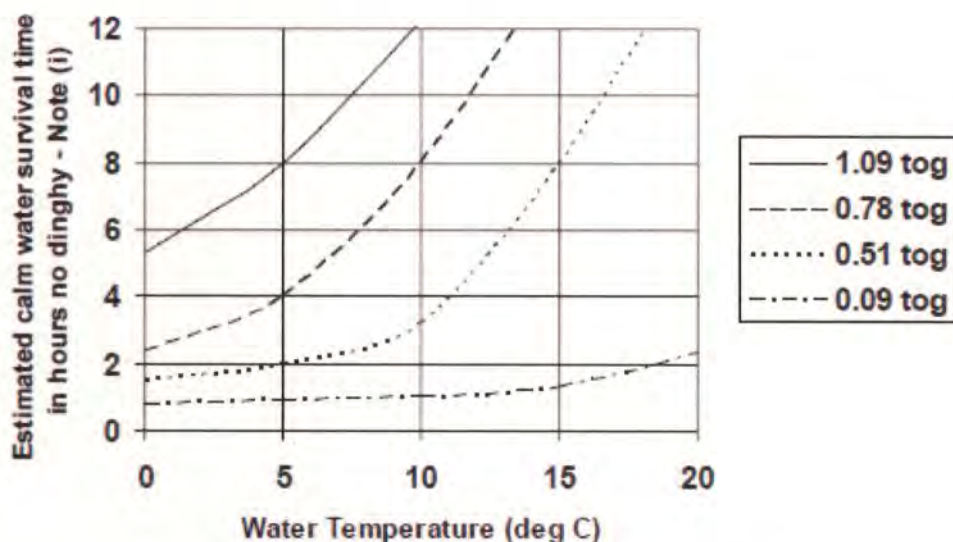
Figure 65. MRP RA 2130 Survival Graph

1.4.6.82 Annex B provides estimated survival times for various aircrew clothing assemblies for a given water temperature (Figure 65).

The accompanying notes state that “At these temperatures individuals without immersion coveralls may die rapidly from cold shock before the onset of life-threatening hypothermia” and that “As these estimates are to be used for safety purposes, they are based on the shortest likely survival times for relatively thin individuals (approx 10th percentile mean skinfold thickness)”.

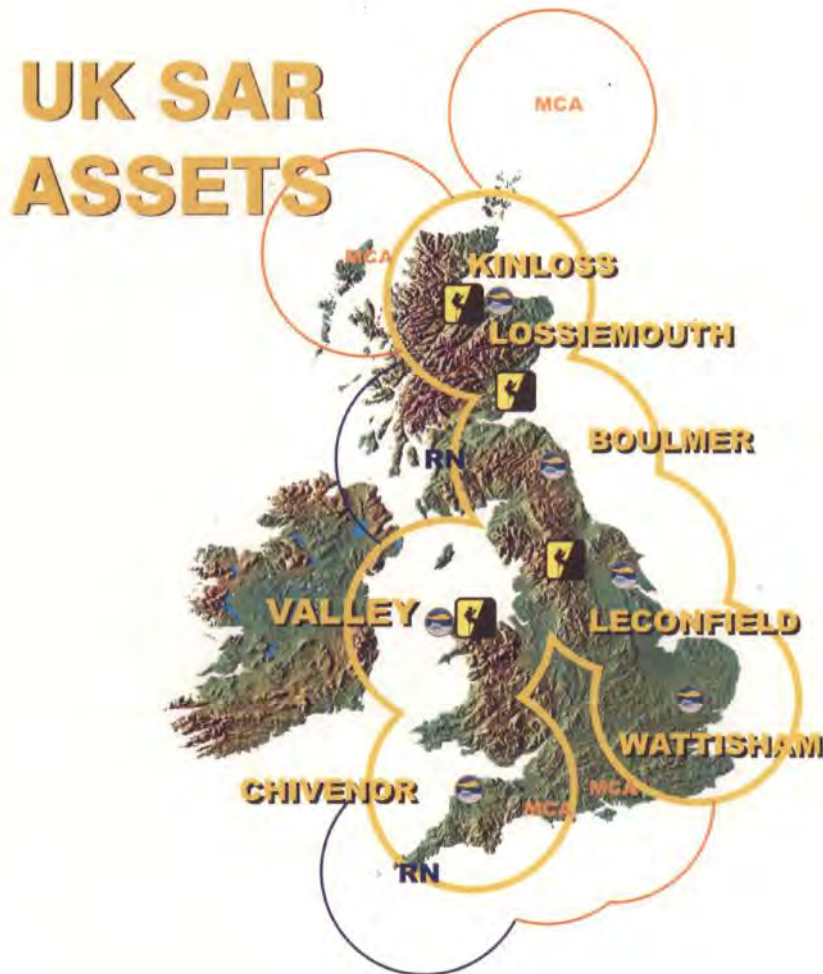
Figure 66. SAR Network.

1.4.6.89 **SAR Helicopter Network.** The UK SAR helicopter network consists of 12 units comprising RN, RAF and Maritime and Coastguard Agency (MCA) assets. Figure 66 displays one hour flight time radius circles from each operating airfield. Capabilities of RN, RAF and MCA assets differ, particularly during night operations. For example, MCA do not have a Night Vision Device capability and therefore would not be able to respond to overland operations in remote areas in all but the best weather conditions. It is this publicised picture (Figure 66) that gives the impression that there is total coverage of UK coastal waters within a one hour response time in daylight hours. In reality the SAR assets could be in a different location (away from the centre of the ring) and could be unserviceable/manning shortfalls which could mean an asset from another location covering a larger area resulting in significantly increased recovery times.

1.4.6.90 Necessary tasks sometimes prevent the provision of an aircraft at 15 mins readiness. These include aircraft already "on task", training and maintenance test flights. There are also unanticipated occurrences such as aircraft unserviceabilities, poor weather and crew unavailability. On these occasions, cover is maintained over the network by ensuring that the next nearest stations can provide cover. Measures to ensure that such cover is maintained can involve moving aircraft and crews between stns. Therefore, response times may differ significantly and it is not unusual for a helicopter to be tasked from adjoining units.

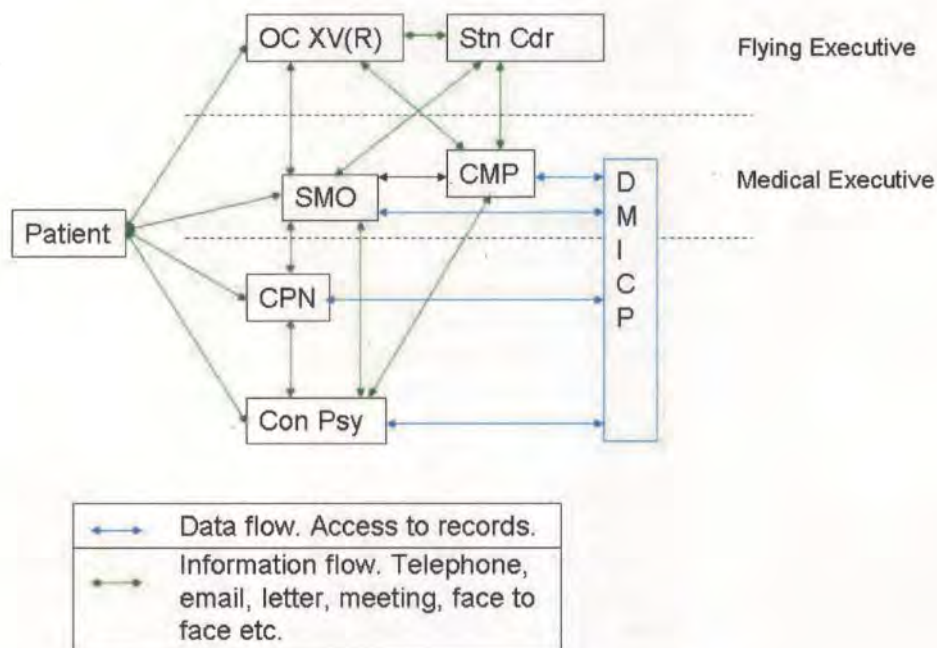
Figure 71. Diagram to show information flow.

1.4.6.186 The feedback from external clinical care/treatment to the Flying Executive is via the stn MOs, as they are the occupational physicians with the greatest knowledge of the specialisation (in the absence of RAF aviation specialist psychiatrists). Stn MOs can have different levels of occupational experience depending on how much aviation medicine (AvMed) training they have received.
