CONTENTS

ACCIDENT

Aircraft Type and Registration:	Boeing 737-8AS, EI-DLR	
No & Type of Engines:	2 CFM56-7B turbofan engines	
Year of Manufacture:	2006	
Date & Time (UTC):	13 November 2008 at 1920 hrs	
Location:	Stand D 61, London Stansted Airport, Essex	
Type of Flight:	Commercial Air Transport (Passenger)	
Persons on Board:	Crew - 4	Passengers - 164
Injuries:	Crew - None	Passengers - None
Nature of Damage:	No 1 engine cowling damaged, tow bar attachment broken	
Commander's Licence:	Airline Transport Pilot's Licence	
Commander's Age:	53 years	
Commander's Flying Experience:	14,000 hours (of which 2,500 were on type) Last 90 days - 270 hours Last 28 days - 23 hours	
Information Source:	AAIB Field Investigation

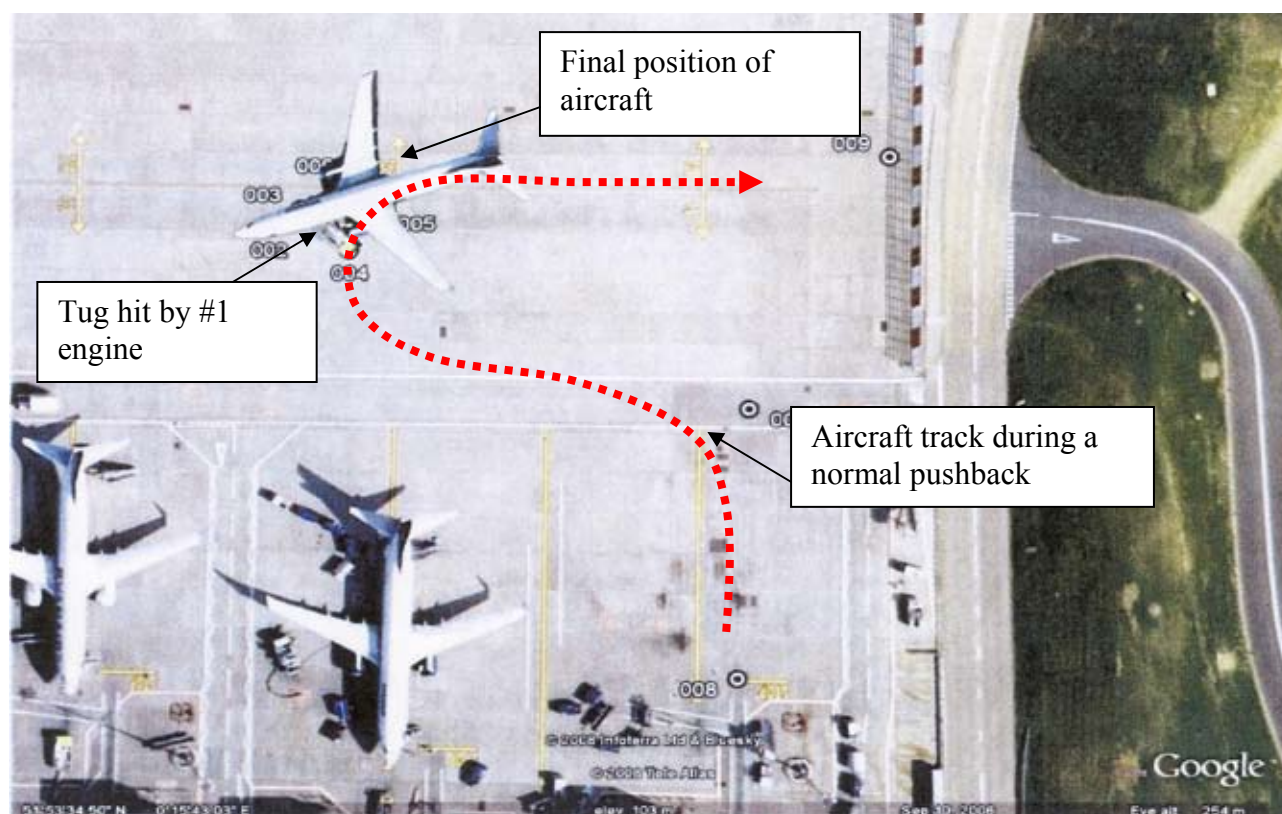
Figure 1

'Dogleg' pushback manoeuvre from Stand D 61 at London Stansted Airport

Plotting of the ground markers identified that, in its final position, the aircraft was pointing approximately 30° to the left of the taxiway centreline, Figure 1. Although the pushback procedure used on this stand is known as a 'dogleg' pushback, the aircraft actually transcribes a path closer in shape to a letter 'S'. In order to achieve this, the tug faces almost at right angles to the centreline of the aircraft prior to the manoeuvre being completed, Figure 4. Given the angle of the towbar relative to the aircraft as a consequence of this manoeuvre, the tug would have been able to exert relatively little resistive force to the forward movement of the aircraft. The aircraft's nosewheels would also have been pushed to a high angle of turn at this point so, as the aircraft moved forward, the tyres skidded rather than rolled, leaving the ground marks observed. The tug driver vacated his cab, given its increasing proximity to the aircraft's operating engine, leaving the tug in the path of the oncoming aircraft. The left engine then contacted the side of the tug, rotating it and pushing it sideways. At this point, the pilot applied the brakes and stopped the aircraft.

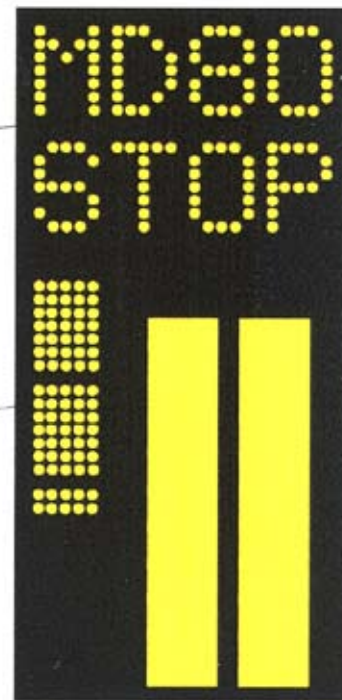
A dot progress matrix that will decrease in length by one row at a time. When aircraft is in the correct stop position the progress strip will be extinguished. One row is approx. 0.6m.

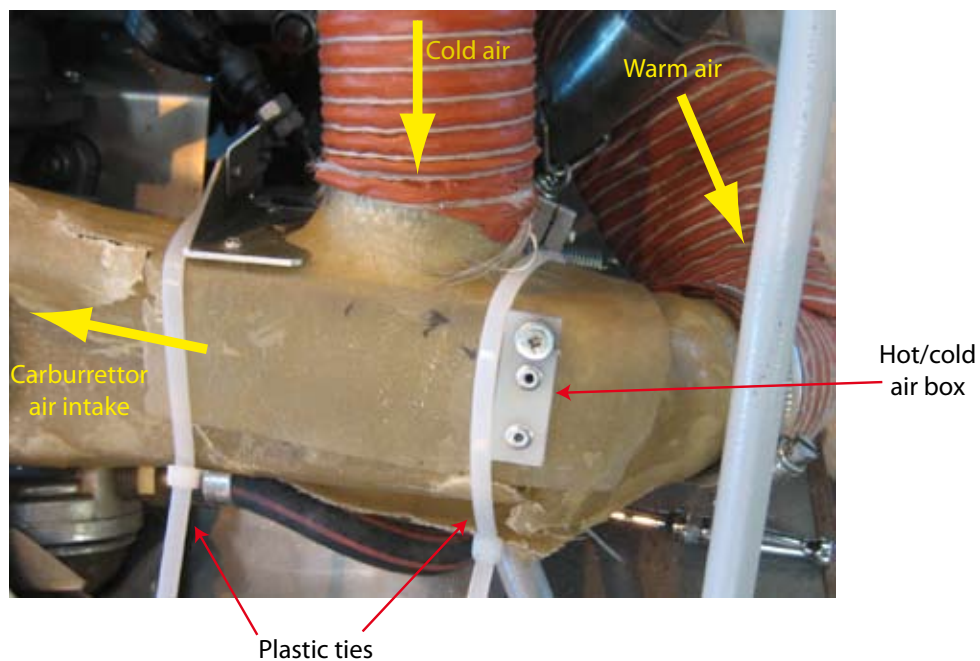
Figure 1
Carburettor hot/cold air system

The carburettor hot/cold air box on this aircraft was constructed from two 'U' shaped rectangular lightweight composite channels, mounted one over the other to form a rectangular box, and held together using two plastic ties, Figure 1.

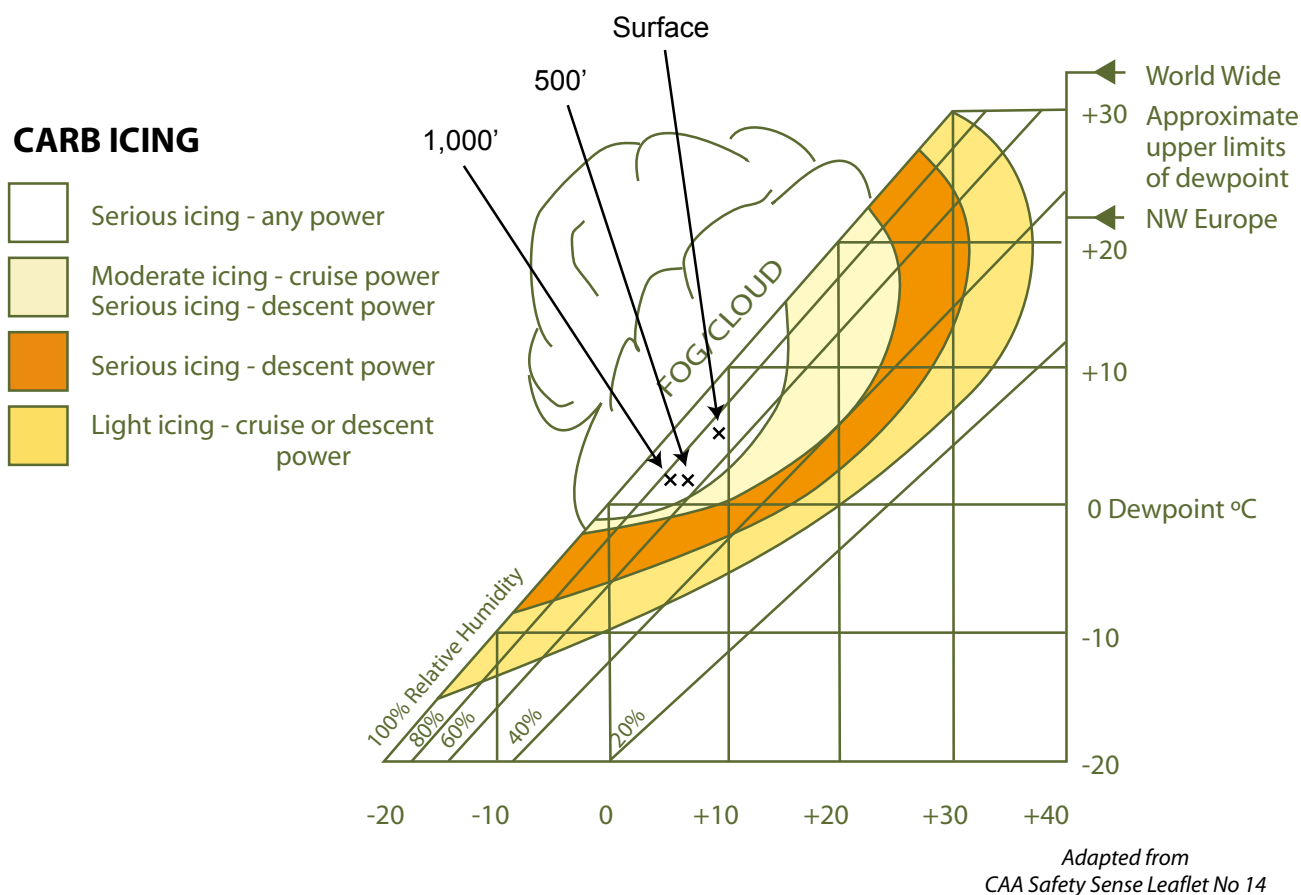
Figure 4

aircraft levelled off and entered a steep turn to the left shortly after takeoff. This turn, and the pilot's statement in his MAYDAY call that he intended to return to land on Runway 36, indicated that some problem had arisen which required urgent action on his part. The witness reports that the aircraft flew level or continued to climb indicated the unlikelihood of a complete loss of power at this stage. It seems likely that there was a partial loss of power, probably associated with the carburettor heat malfunction identified by the engineering investigation, and brought about by meteorological conditions conducive to serious carburettor icing at any power

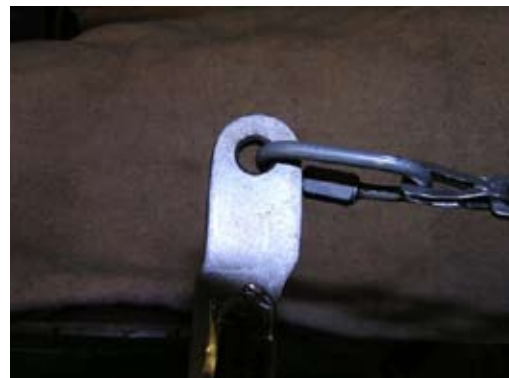
Figure 2

Subsequent discussion of the issue at his local LAA Strut meeting produced a consensus opinion that the tailwheel offset most probably had something to do with the springs in the tailwheel operating linkage. After some experimentation at home, the pilot found that it was possible for the disconnect links in the tailwheel operating horn to become displaced and shorten the effective length of the associated tailwheel control, producing an offset tailwheel with the rudder in the neutral position. Figures 2 and 3 respectively illustrate the implicated link in its normal and displaced positions.

Normal position

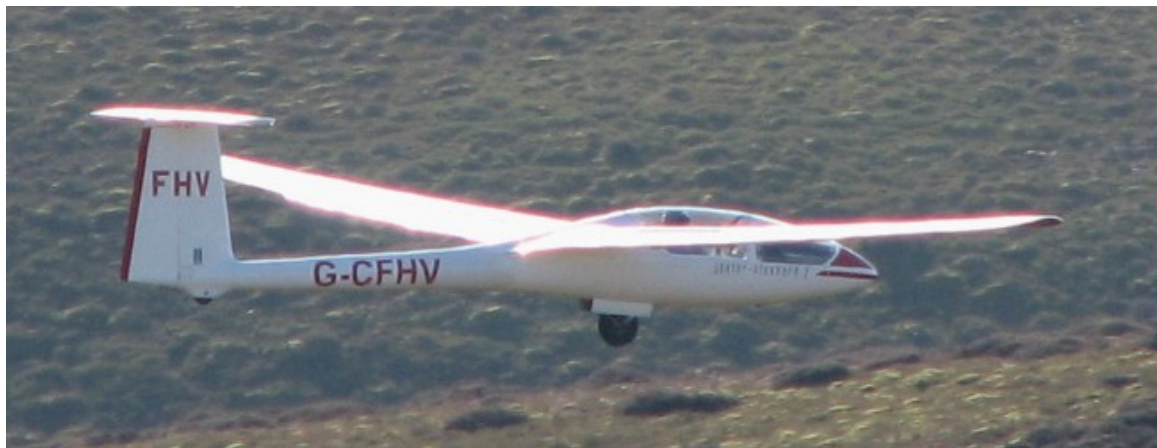
**Figure 1**

The Jantar Standard 2 is a high performance sailplane of Standard Class, see Figure 1. The cantilever shoulder wings have single glass fibre main spars, no ribs and are covered with foam core moulded skins. The wings have simple ailerons and airbrakes in the upper and lower surfaces of each wing. There is provision for water ballast, but this facility was not used on the accident aircraft. The glass fibre fuselage has a steel tube central frame, and the rear portion is stiffened by half-frames and ribs. The seat back is adjustable to accommodate pilots of varying sizes. The cantilever T-tail is of similar construction to the wings and has a spring trim in the elevator. There is a retractable monowheel with disc brake and a semi-recessed tail wheel.

Jantar Standard 2 G-CFHV

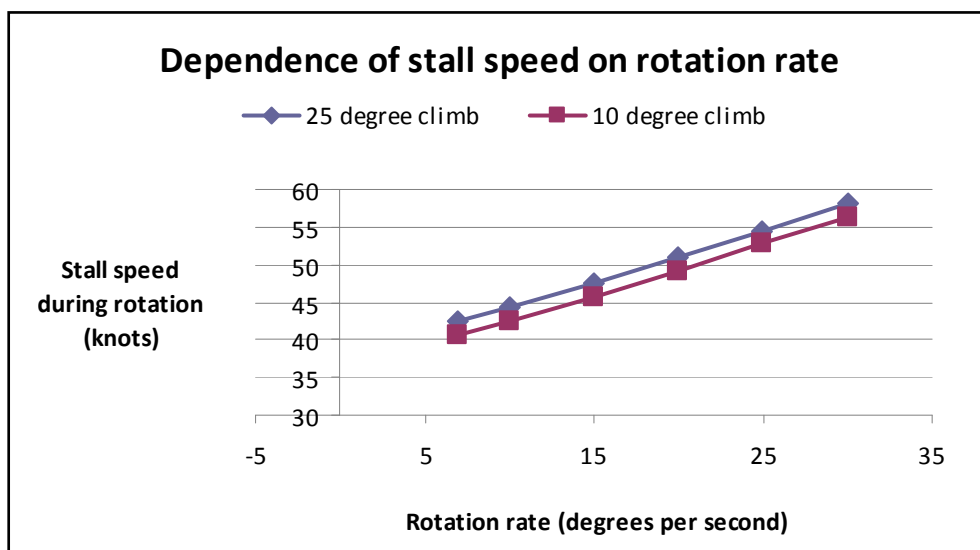
**Figure 2**

The dependence of stall speed on rate of rotation for a Jantar Standard 2 (with an unaccelerated stalling speed of 34.5 kt and maximum lift to drag ratio of 39), at climb angles of 10° and 25°, with a cable pull of 80% of the weight of the glider, is indicated in Figure 2.

Relationship of stall speed with rate of rotation
