CONTENTS

(ALL TIMES IN THIS BULLETIN ARE UTC)

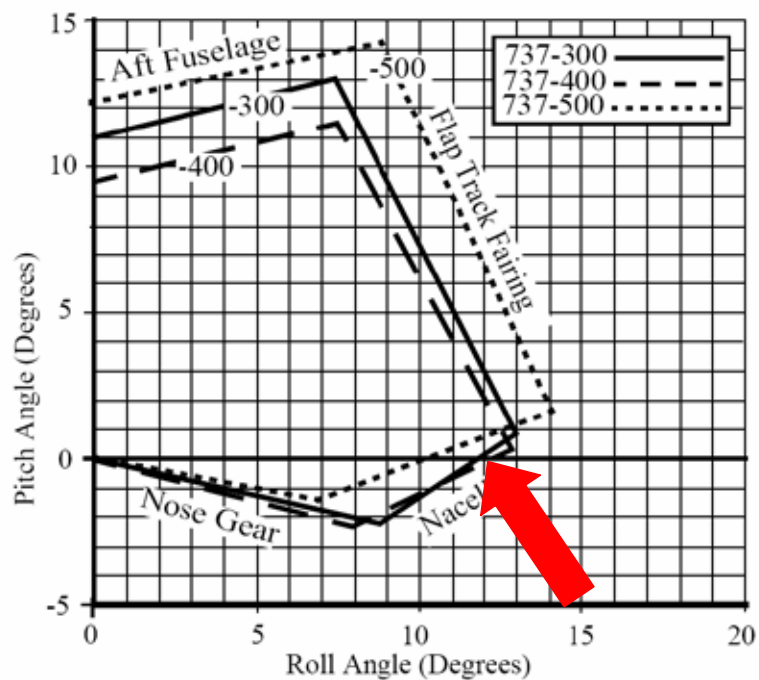
Figure1

of salient parameters for the landing, some of which are presented at Figure 1, were analysed. However, rudder pedal angle and rudder deflection parameters were not recorded. Rudder pedal was originally recorded on the FDR but subsequently removed during a modification to make space for right-flap position. This modification was deemed acceptable by the CAA as the regulations applicable to this aircraft only required primary flight controls to be recorded “when sufficient capacity is available” on the flight recorder system. The CAA is now recommending to the operator to re-instate the rudder position input as they believe this to be a more important parameter to record than right-flap position given the documented history of Boeing 737 rudder system problems, and the fact that left-flap position is recorded.

Figure 1 starts with the aircraft established slightly low on the ILS to Runway 32 and with the autopilot disconnected. The aircraft continued on or below the glideslope, wings level and decelerating, until 50 ft agl, when it started to roll left wing down (see Point A), reaching 12° three seconds later as the aircraft passed through 20 ft agl. The airspeed reached 124 kt as opposite control wheel was applied (Point B) and thrust was applied (point C). The thrust levels increased from a nominal 55% N_1 to 80% N_1 causing the aircraft to pitch up (Point D) and accelerate. However, as the aircraft responded in roll it also started to yaw to the right (Point E).

Salient FDR Parameters for Incident Landing to G-CELD
