## CONTENTS

## ACCIDENT

<b>Aircraft Type and Registration:</b>	Airbus A320-232, G-EUUF
<b>No &amp; Type of Engines:</b>	2 International Aero Engine V2527-A5 turbofan engines
<b>Year of Manufacture:</b>	2002
<b>Date &amp; Time (UTC):</b>	26 June 2006 at 1645 hrs
<b>Location:</b>	Taxiway Kilo, London Heathrow Airport
<b>Type of Flight:</b>	Commercial Air Transport (Passenger)
<b>Persons on Board:</b>	Crew - 7                      Passengers - 83
<b>Injuries:</b>	Crew - None                      Passengers - None
<b>Nature of Damage:</b>	Damage to right engine and to tractor
<b>Commander's Licence:</b>	Airline Transport Pilot's Licence
<b>Commander's Age:</b>	51 years
<b>Commander's Flying Experience:</b>	16,022 hours (of which 4,122 were on type) Last 90 days - 186 hours Last 28 days - 37 hours
<b>Information Source:</b>	AAIB Field Investigation

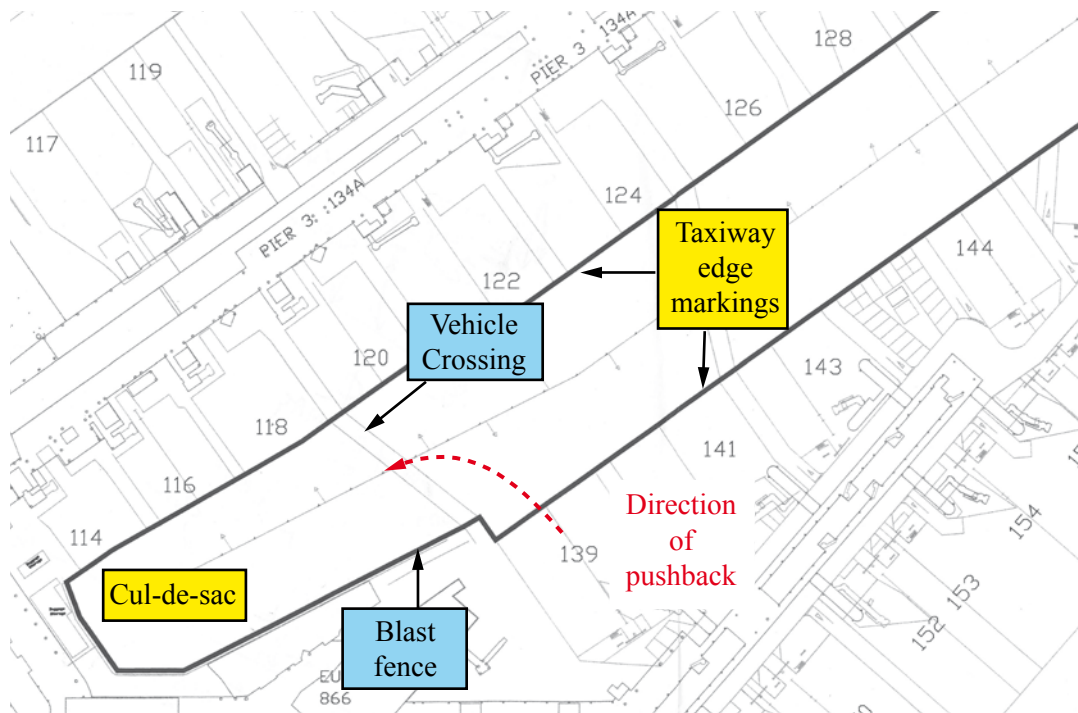
**Figure 1**

The aircraft was prepared for a routine departure from London Heathrow Airport to Munich, Germany. There was no significant weather and good visibility. Due to ATC delays the pushback was delayed for ten minutes. Once ATC clearance was received the aircraft was pushed back from Stand 139 onto Taxiway Kilo. ATC requested a long pushback to allow another aircraft onto Stand 139. This meant that the aircraft would need to be pushed back into the narrower part of Taxiway Kilo, abeam Stand 118 and adjacent to a blast wall on the right side (Figure 1 - Airport diagram).

Plan of cul-de-sac, showing pushback details

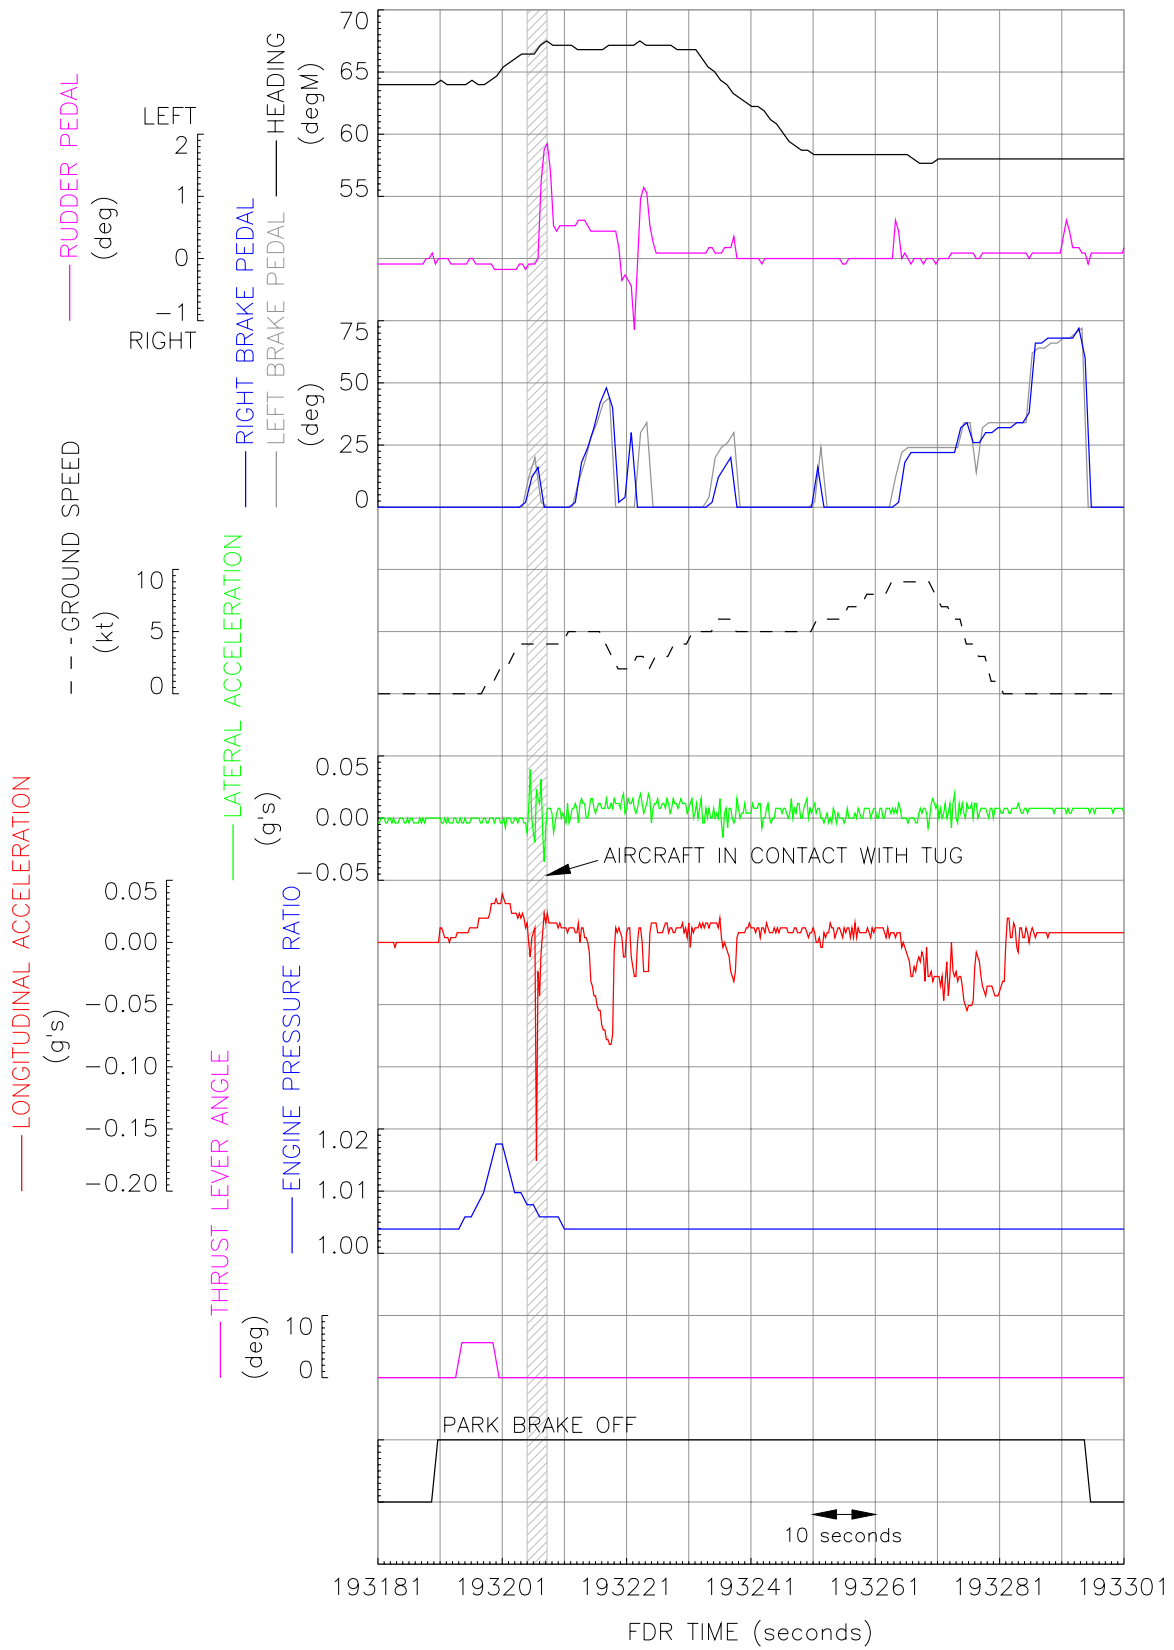
**Figure 3**  
Salient FDR Parameters

A 'time history' plot of the relevant parameters is given at Figure 3. The data presented at Figure 3 starts after pushback, with the park brake set and starting checks complete, just over 10 seconds before G-EUUF started moving forward under its own power.

momentarily as the commander performed a brake check. During this check G-EUUF struck the tug - indicated by spikes in both lateral and longitudinal acceleration over a three second period (highlighted). This jolt was also noted by the crew. A small amount of left pedal was applied immediately after the collision, lining the aircraft up on a heading of 067°M, followed by braking which decelerated the aircraft to about two knots. The distance travelled before the collision was calculated to be 13 m.

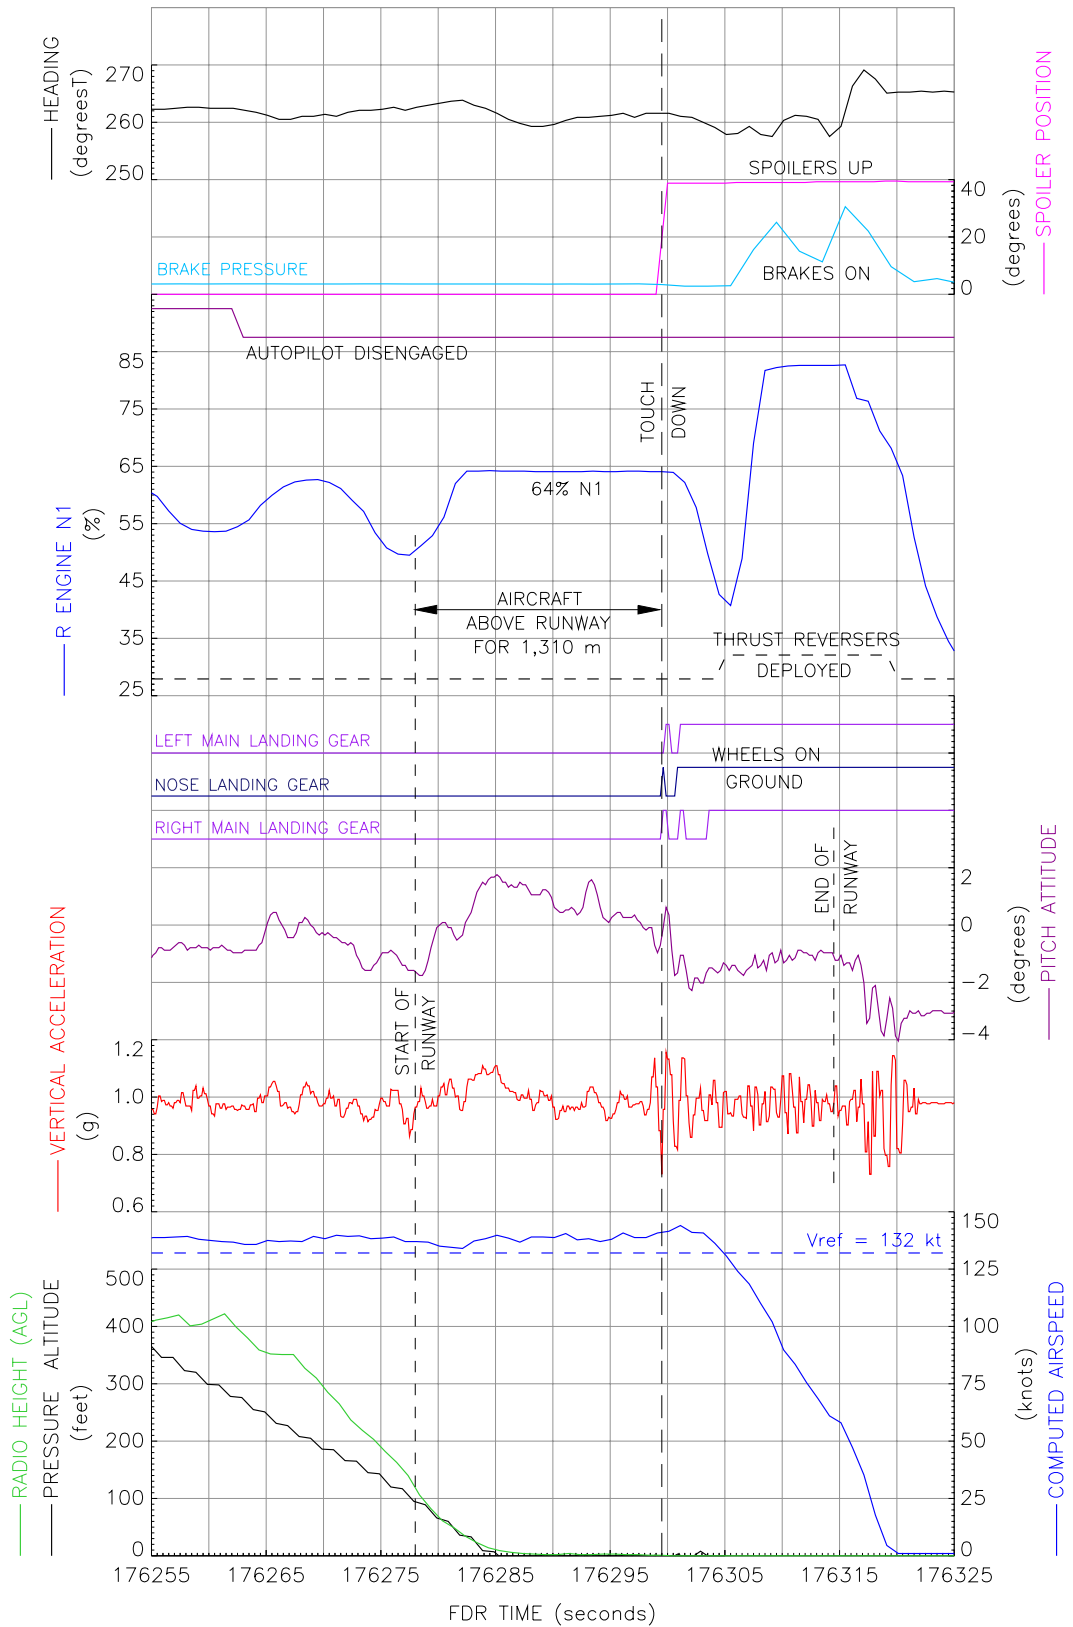
**Figure 1**  
 Salient FDR Parameters  
 (Accident to D-ABCD on 5 February 2006)

A time-history of the relevant parameters during the accident is shown at Figure 1. The data presented at Figure 1 starts 45 seconds before touchdown, with the aircraft on the extended centreline to Runway 26, 0.8 nm from the threshold. The aircraft's height was 370 ft aal and airspeed was 138 kt ( $V_{REF} + 6$ ), descending at about 720 feet/minute, with the trailing edge flaps at 45° and the landing gear down. The autopilot was ON before being disengaged seven seconds later as D-ABCD passed through 300 feet aal<sup>4</sup>.

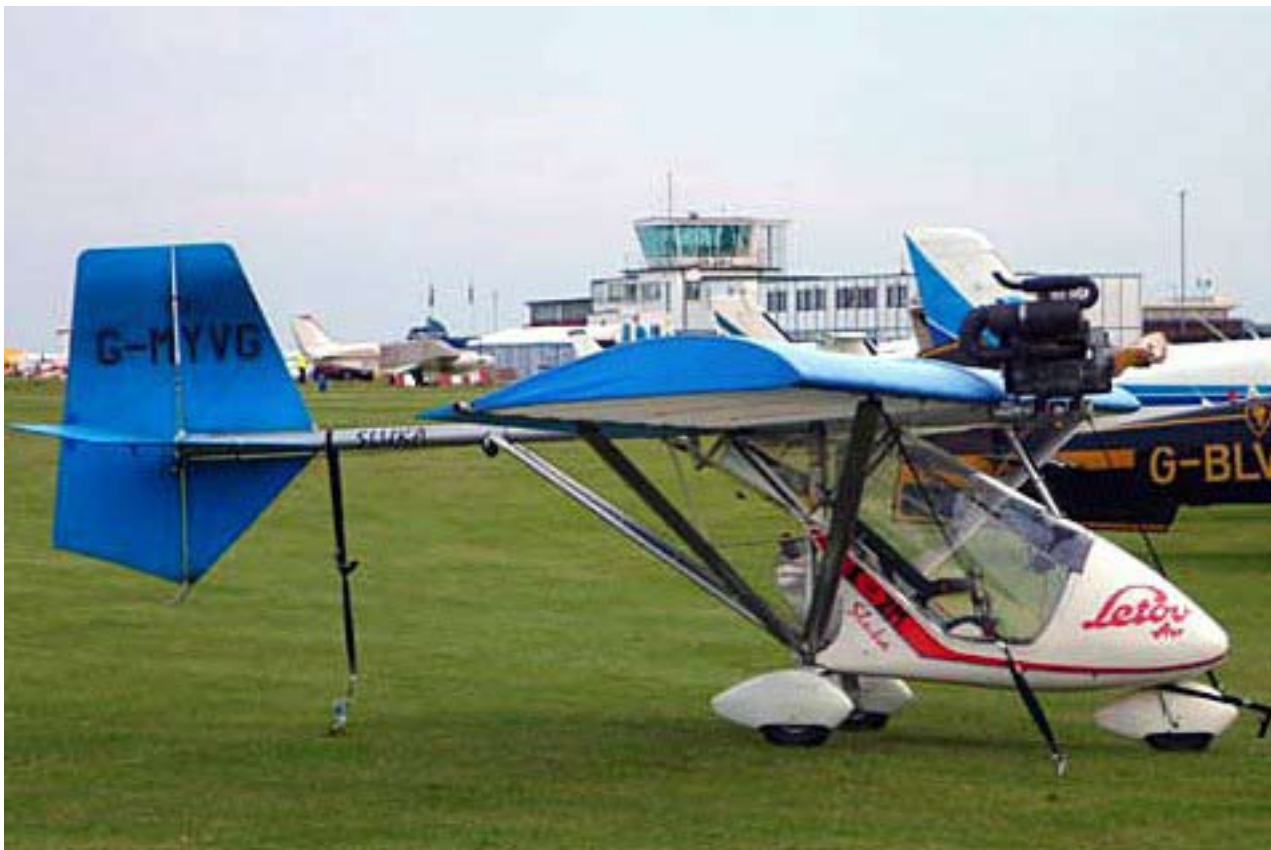
**Figure 1**

The Sluka is a high-wing, single-seat aircraft in the Microlight Category; a photograph of an intact example is presented at Figure 1. The tail surfaces are of fabric-covered, tubular construction, with upper and lower vertical fins rigidly attached to the rear of the aluminium alloy fuselage boom. The horizontal stabiliser comprises left and right tailplanes that are pin-jointed to the boom, with structural rigidity being provided by upper and lower bracing wires attached respectively to the upper and lower fins. A bolt and stiff nut are used to secure the upper wires, although a castellated nut and a split pin are used for the lower wires. This is to allow the lower wires to be readily detached so that the two tailplane halves can be folded up against the fin for storage.

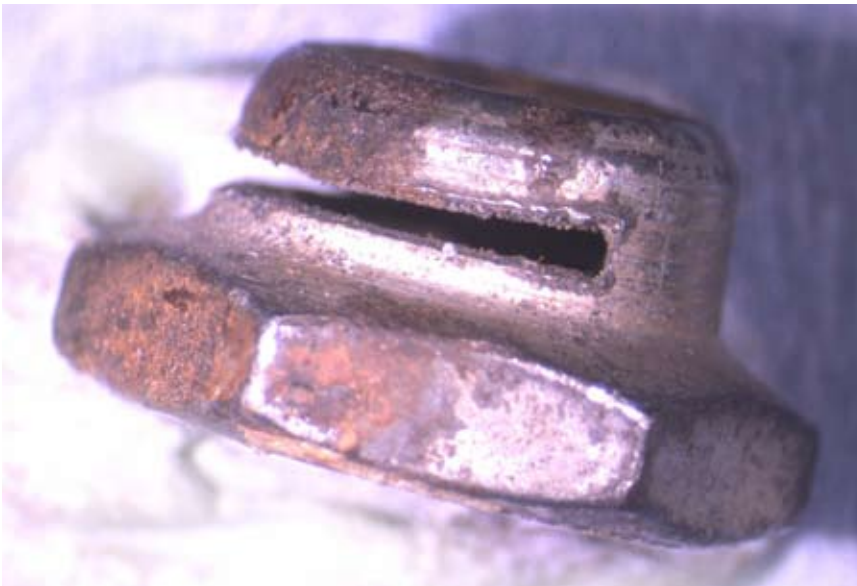
**Figure 3**

Whilst examining the intact aircraft it was noted that the tailplane wire attachments to the upper fin were approximately at eye level and thus easy to check on a walk-round inspection. In the event that the nut should back off a significant amount, the tangs would no longer lie flush with the surface of the fin, a feature that would be readily visible. The PFA Inspector commented that he had visually checked the attachment prior to the Permit renewal check flight in April.

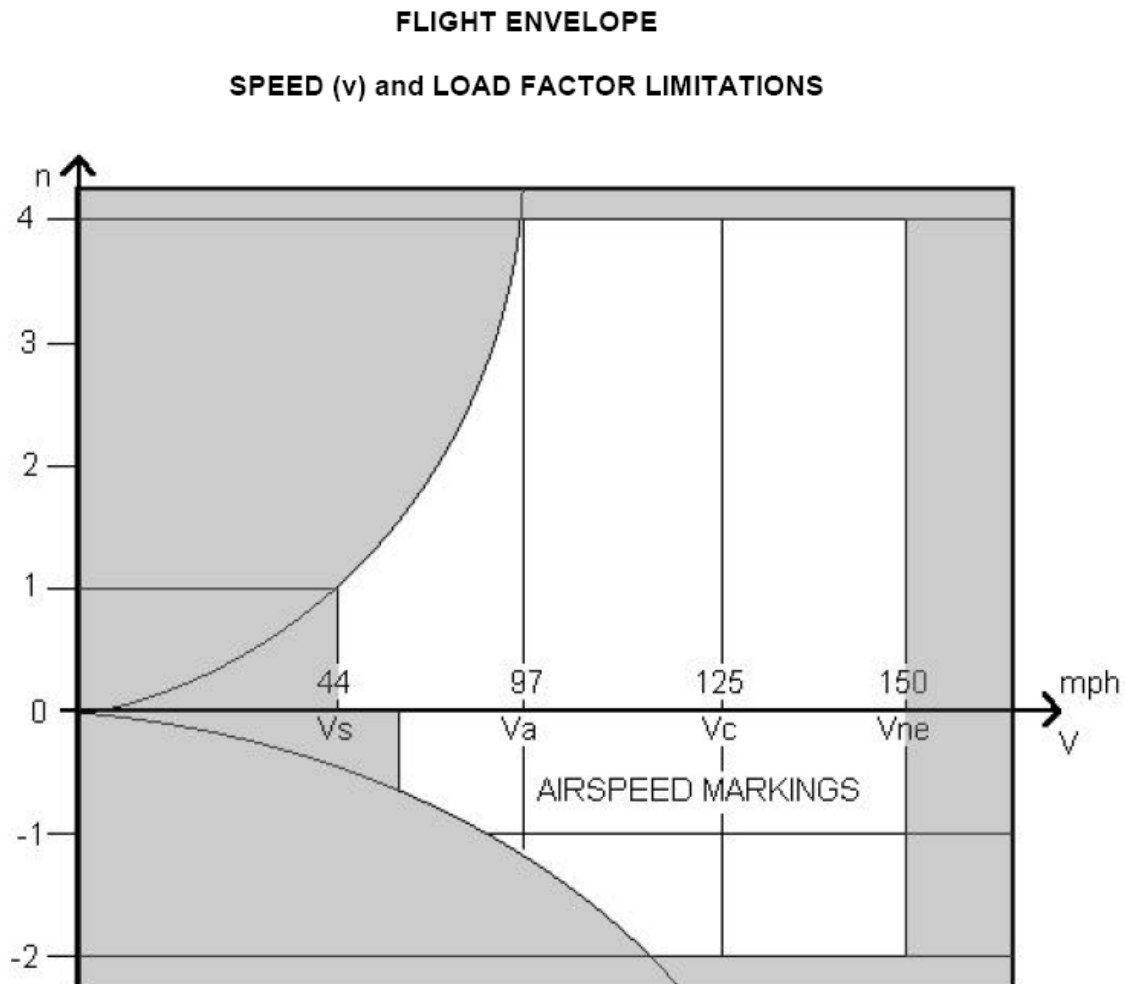
**Figure 1**

with two fuel tanks, one in each wing, and the fuel used was motor gasoline. The aircraft structural limitations were +4g and -2g. See Figure 1.

Load factor graph

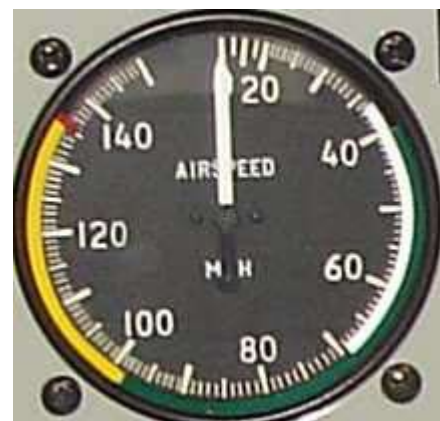
Figure 2 shows a picture of an Airspeed Indicator (ASI) similar to that fitted to G-YOXI. The instrument is marked with colour banded airspeed ranges indicating the safe operating ranges and operating limits. The upper limit of the green band shows the maximum cruising speed for normal operation ( $V_{NO}$ ), which in this case was the same as the manoeuvring speed ( $V_A$ ) of 97 mph (see Figure 1). The  $V_A$  is the maximum speed at which the flight controls can be fully deflected without

**Figure 2**  
Airspeed indicator

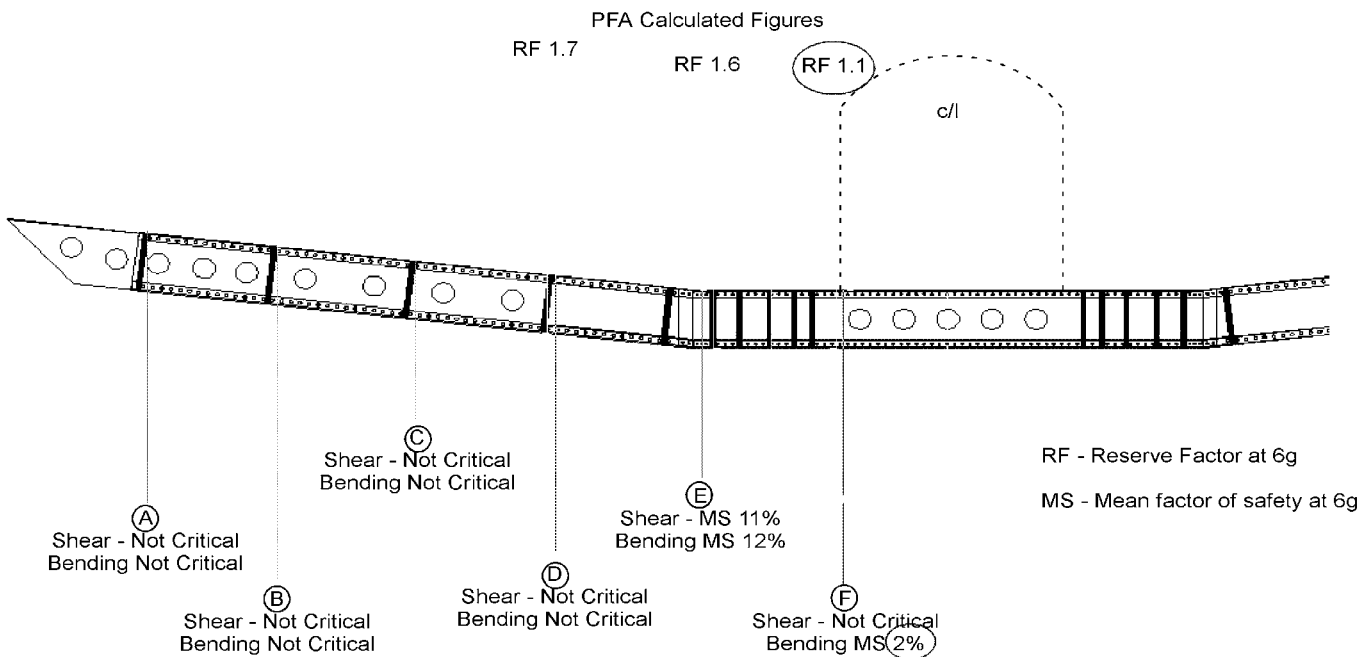
**Figure 6**

critical or declared a margin of safety as a percentage at the ultimate load and at a higher MAUW of 480 kg. The PFA calculations were similar but declared a reserve factor, but these were for the CH600 rather than the CH601. The sections and the respective conclusions are shown in Figure 6 and Table 1.

Aircraft manufacturer calculated figures
