AAIB Bulletin

7/2014

Published 10 July 2014

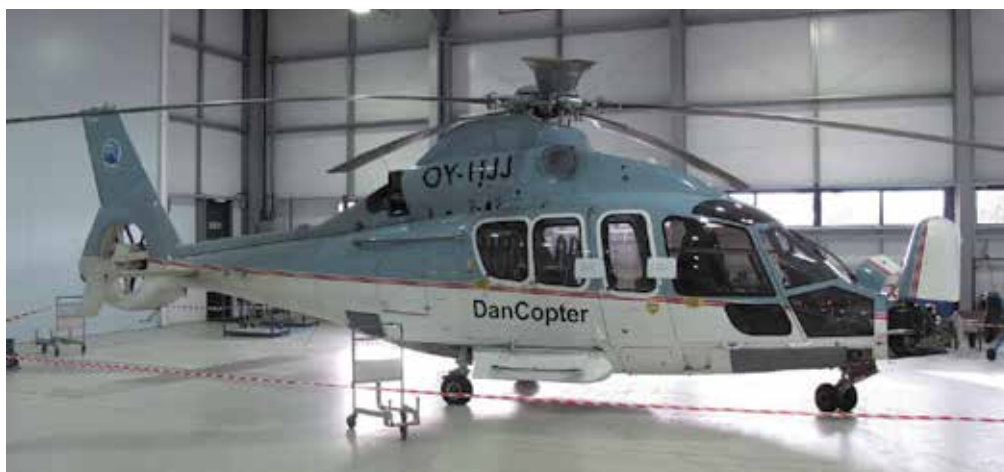
Figure 1

Eurocopter EC155B1 OY-HJJ
