## CONTENTS

<b>Summary of:</b>	<b>Aircraft Accident Report No: 1/2010</b>	123
	Report on the accident to Boeing 777-236ER, G-YMMM at London Heathrow Airport on 17 January 2008

**(ALL TIMES IN THIS BULLETIN ARE UTC)**

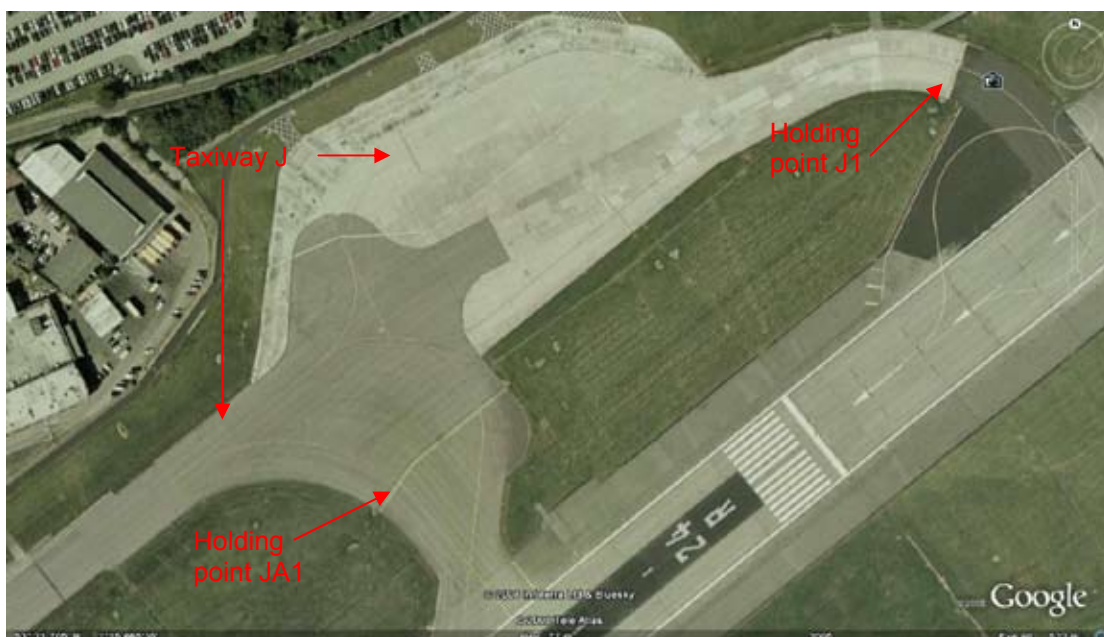
**Figure 1**

(since this photograph was taken, the runway has been redesignated as Runway 23R)

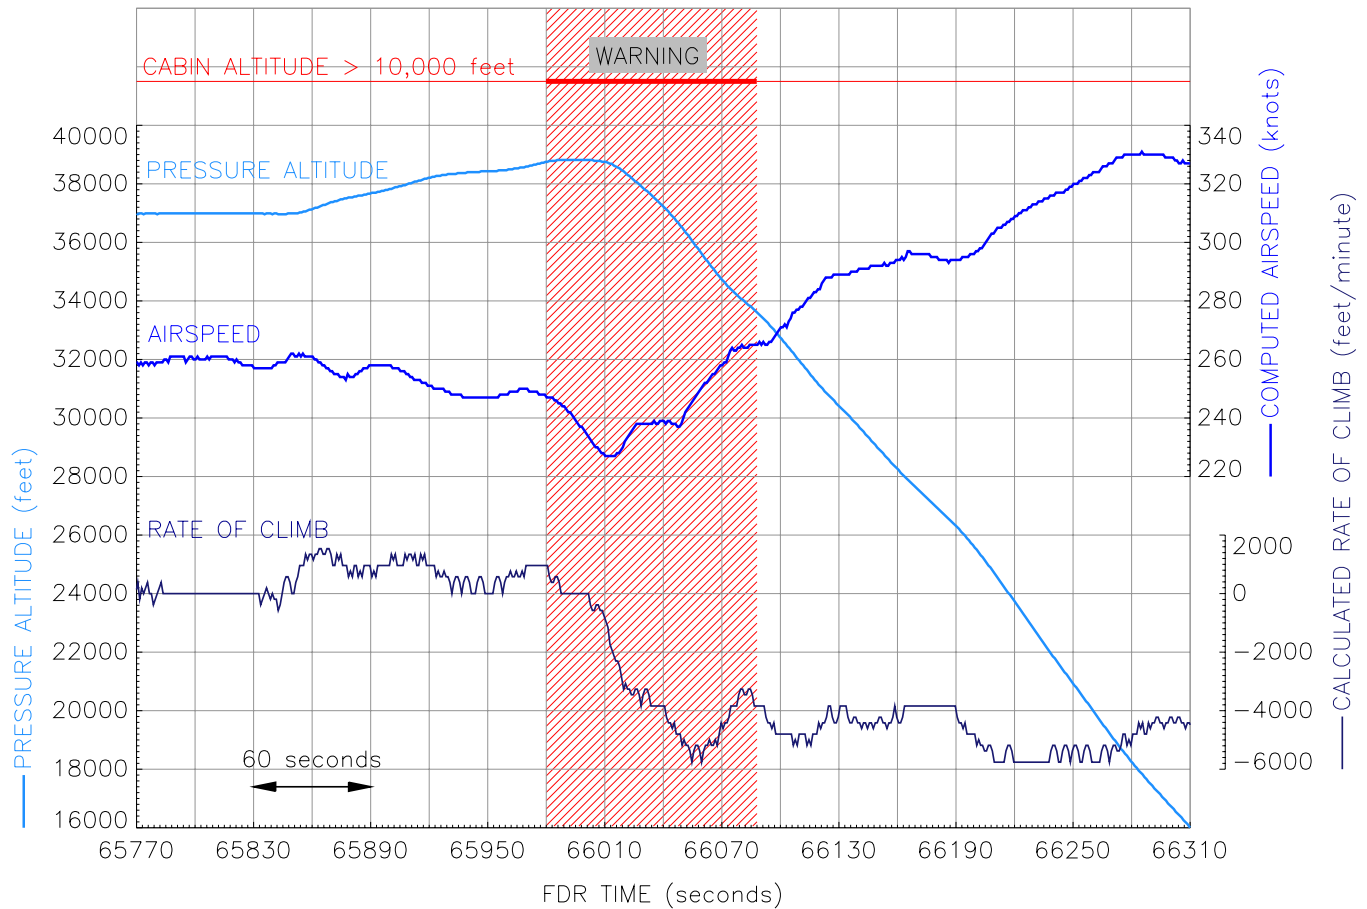
**Figure 1**

**Salient FDR parameters**

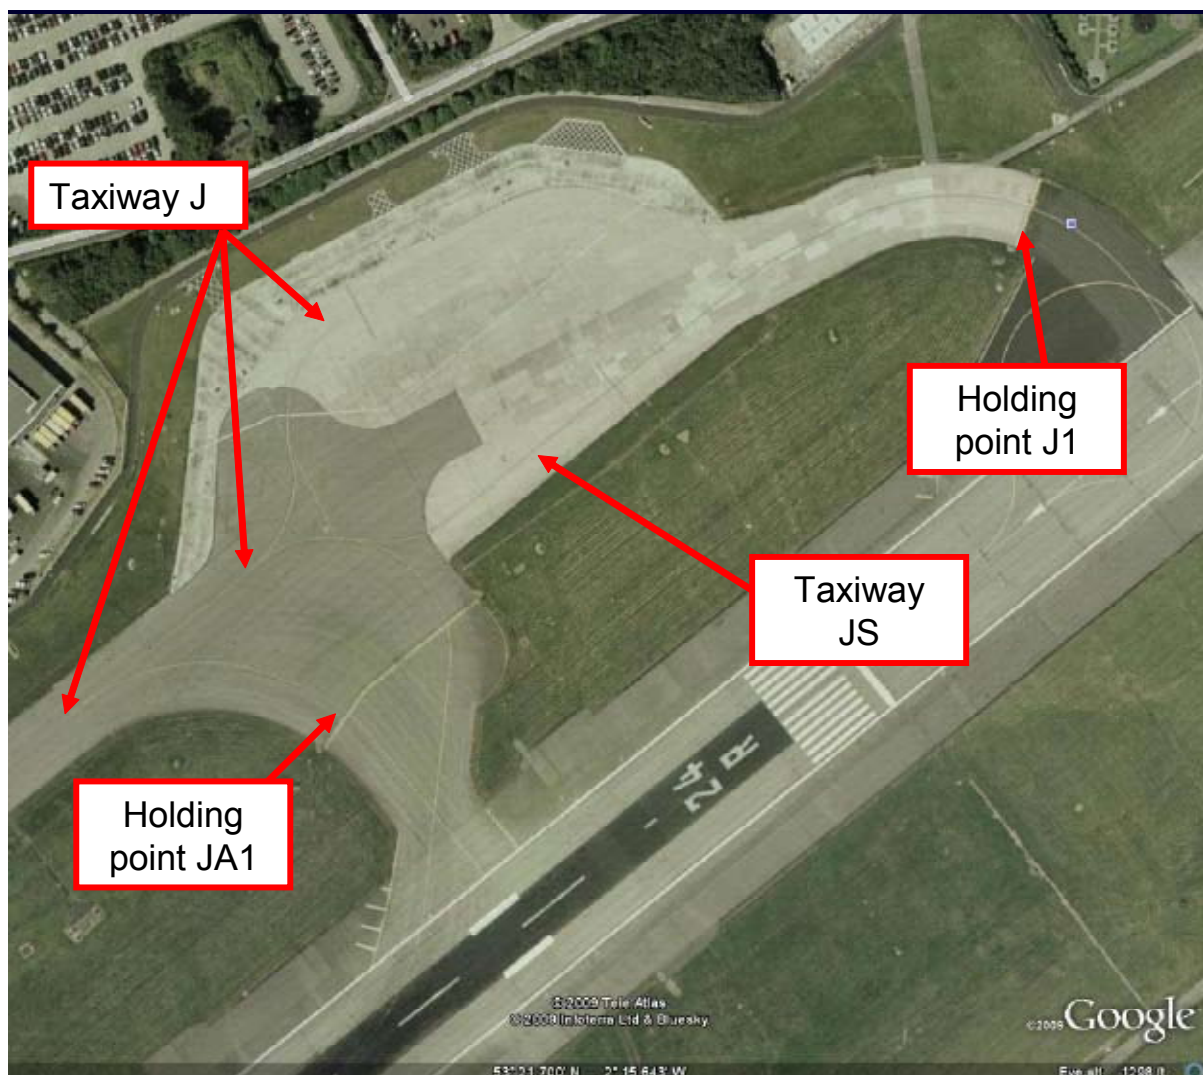
Figure 1

Complying with an instruction from the Ground Movement Control (GMC) controller, the commander of G-JEDR taxied his aircraft to Holding Position JA1 (see Figure 1) and stopped the aircraft “on the line” at about 1216 hrs. The flight crew prepared for an immediate departure and waited for clearance to enter the runway. They were aware that the Boeing 777, AP-BGY, was taxiing along Taxiway Juliet and would pass behind them.

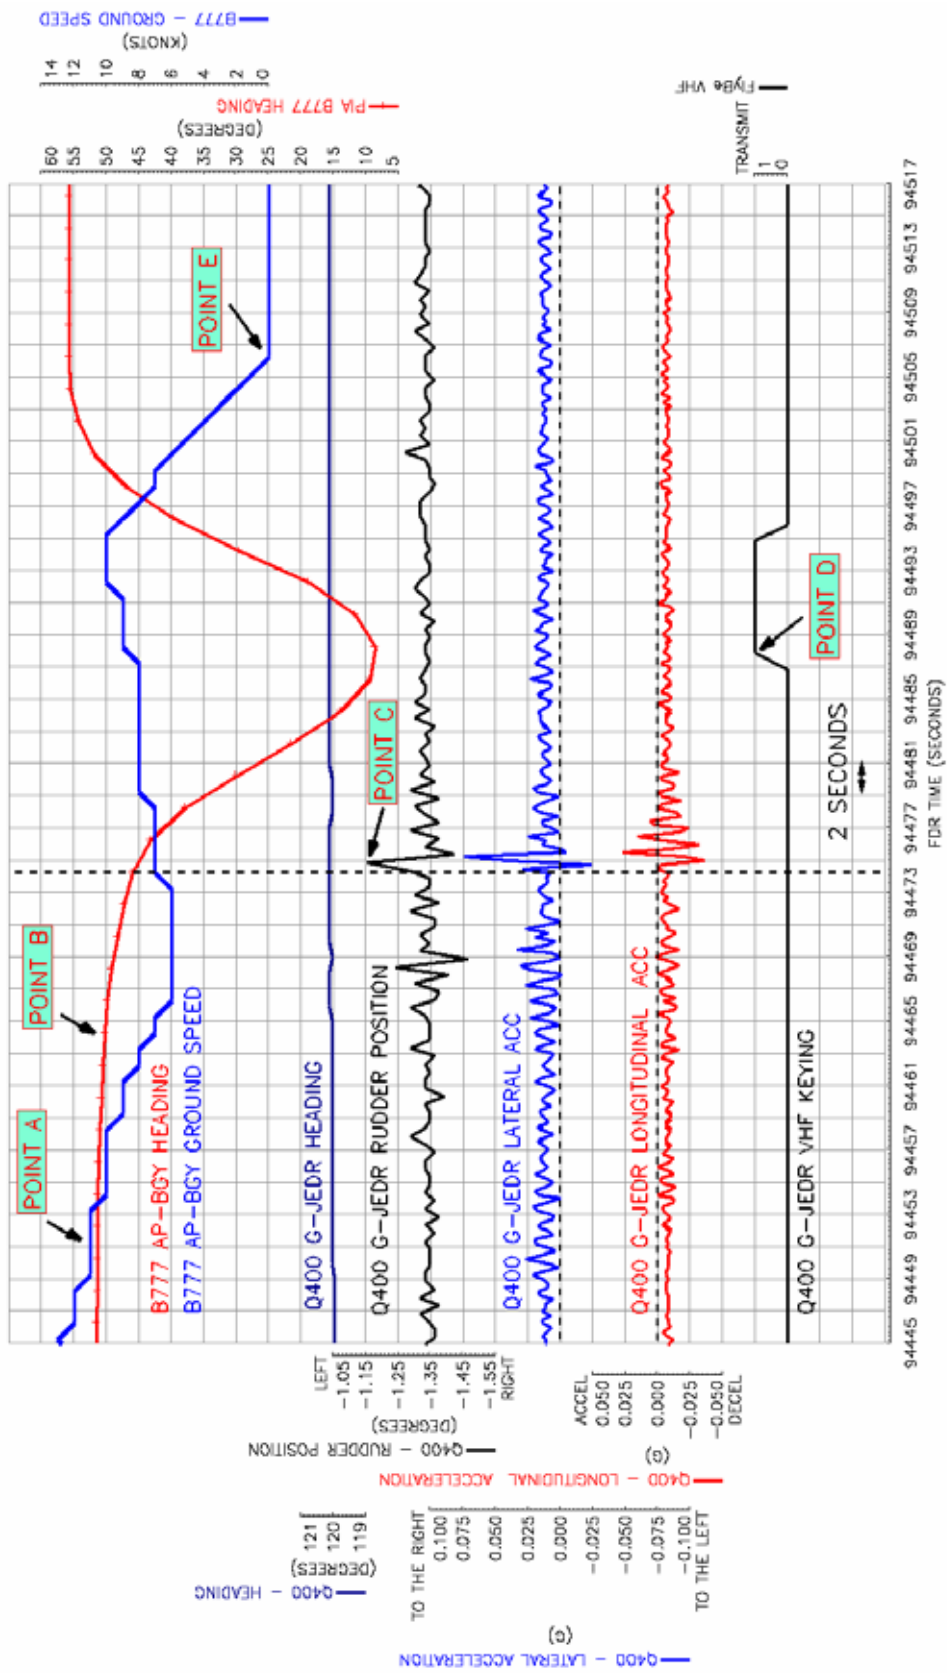
Figure 3

When AP-BGY was about 100 metres from G-JEDR, it gradually decelerated (Figure 3, POINT A). There was some conversation between its flight crew about the position of G-JEDR, reflecting a concern that there would be little separation between the aircraft as they passed. As it closed to about 60 metres from G-JEDR, AP-BGY started to make a gradual turn to the left, with its ground speed reducing to about 6 kt (Figure 3, POINT B). As the turn continued, the collision occurred. There was a small oscillation of G-JEDR's rudder during the impact (Figure 3, POINT C), with associated lateral

and longitudinal accelerations being recorded. There was no associated recording of an impact on AP-BGY and its flight crew made no mention of one. The flight crew in G-JEDR briefly discussed whether they had been struck, before they contacted ATC to advise "[CALLSIGN] I THINK THE AIRCRAFT BEHIND US HAS JUST CAUGHT THE BACK OF OUR WING...OUR TAIL RATHER" (Figure 3, POINT D). ATC responded by advising that they had noticed it as well and advised AP-BGY to hold position, which it did (Figure 3, POINT E).

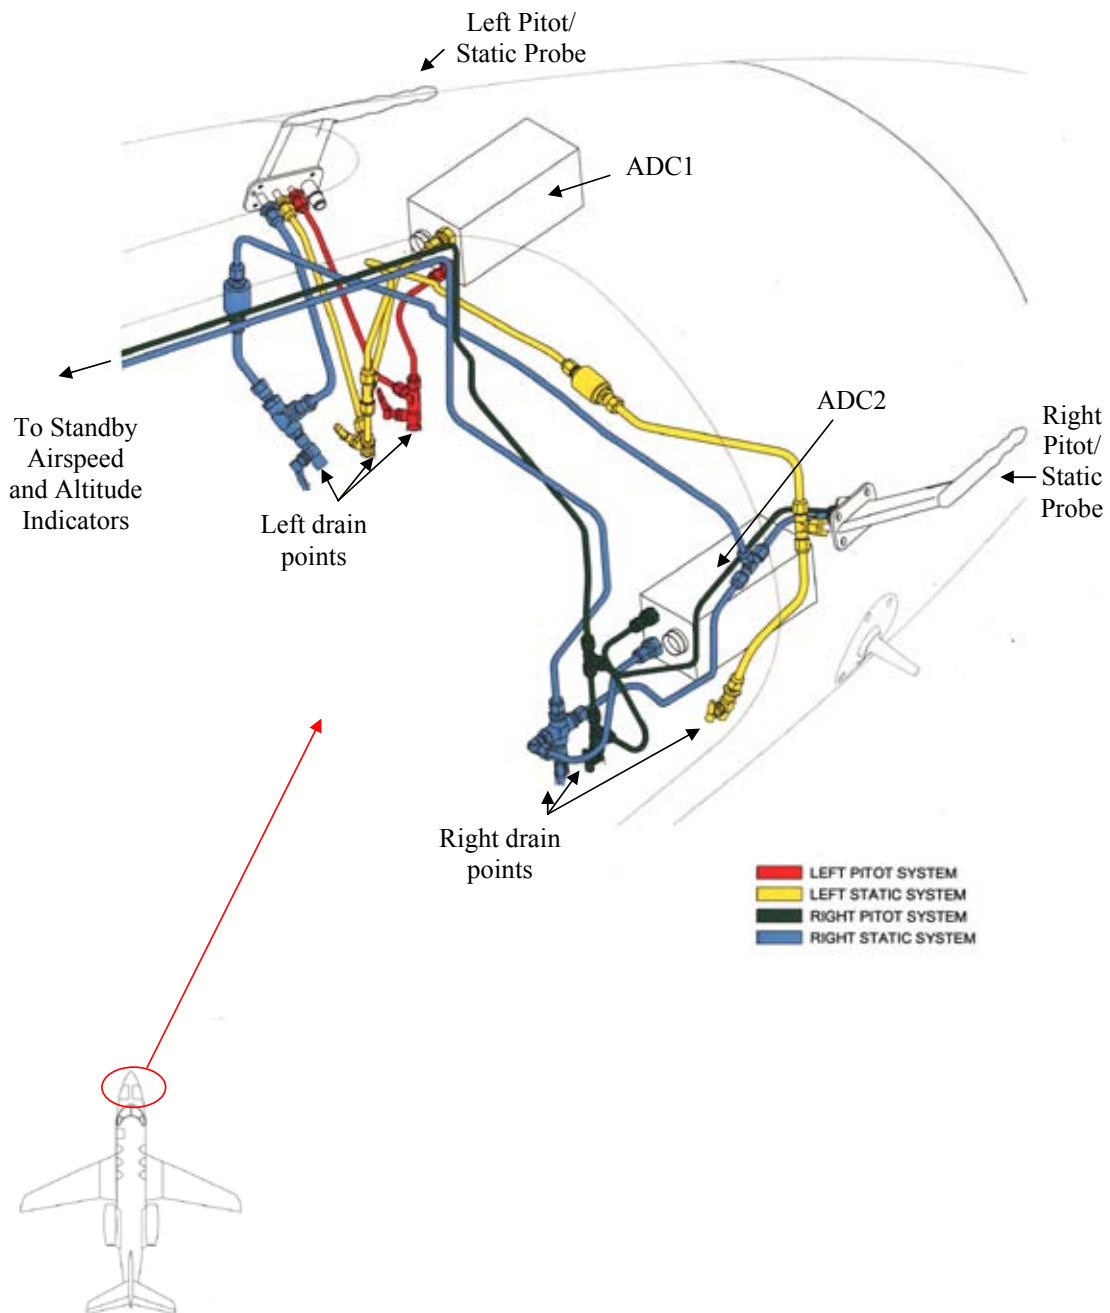
**Figure 2**  
Pitot/static connections

The ADS includes two identical ADCs which output processed air data from pneumatic and temperature sensor inputs. The pitot/static system has two probes, one each side of the front fuselage, which connect via various tubes, connections and unions to the two ADCs and to the standby instruments. (See Figure 2). The left

probe pitot connection supplies the left (No 1) ADC only and the right probe pitot connection feeds the right (No 2) ADC and the standby ASI. The left and right probe static lines are cross-connected and supply static pressure to the ADCs. The standby ASI and altimeter use the same static feed as ADC2.

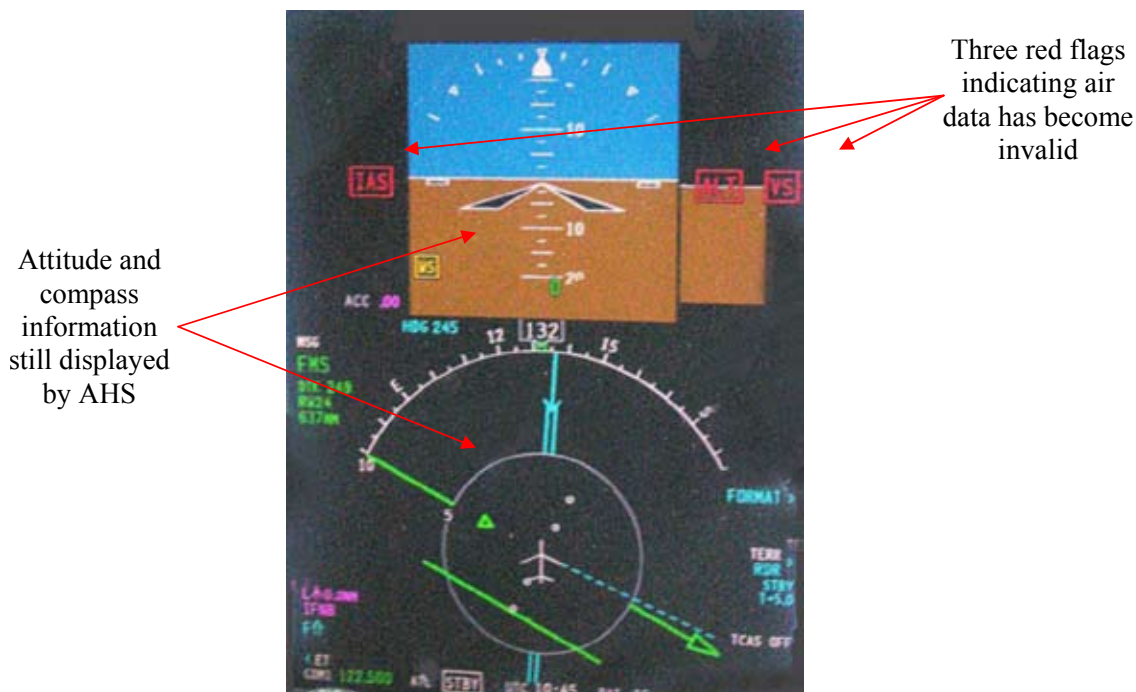
**Figure 3**

If the air data information becomes invalid, red boxed IAS, ALT and VS captions appear instead of the airspeed, altitude or vertical speed tape on the PFD of the side affected. With these flags in view, all air data information is removed (see Figure 3),

PFD display with air data information invalid

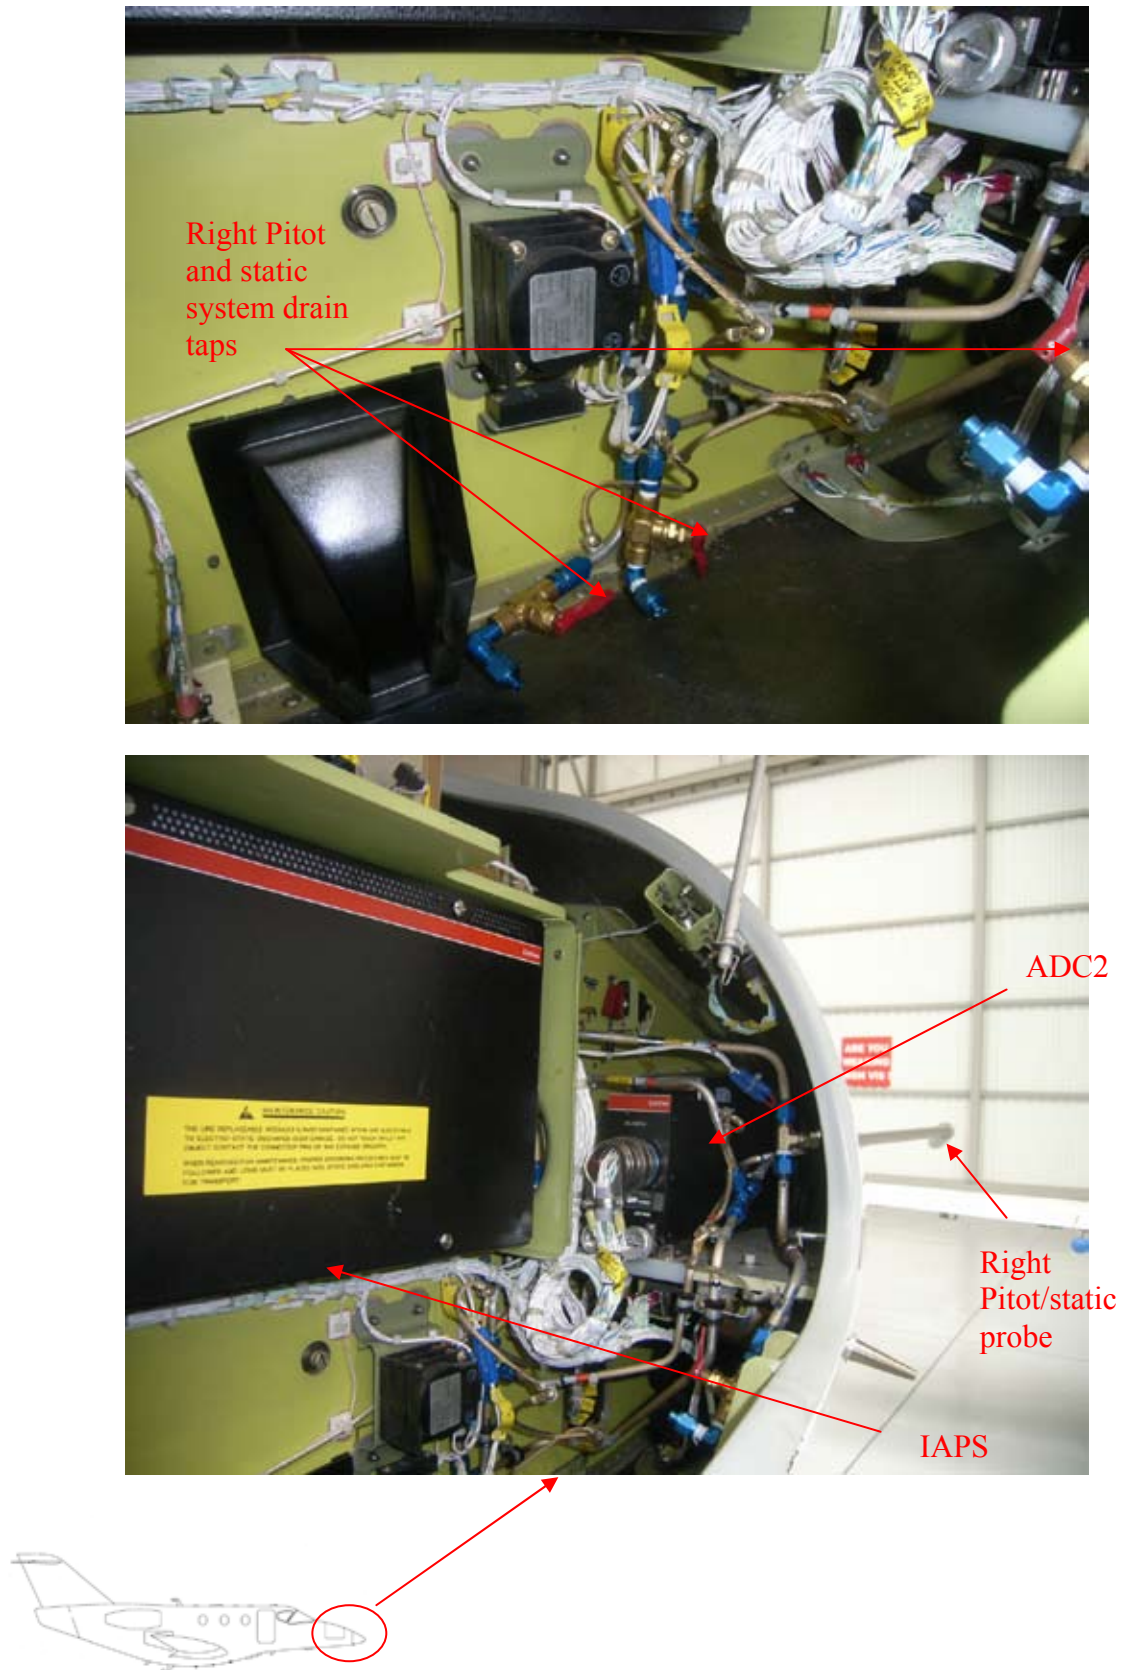
**Figure 4**  
Right Avionics Bay

The Aircraft Maintenance Manual (AMM) requires the operation of the pitot and static drains every 200 hours in order to remove moisture which may have entered the system. The process requires the removal of the blanking caps on the bottom of the drains and the turning of a red spring-loaded lever on each of the drain traps for the two independent (left and right) static and pitot systems (see Figure 2). This should allow any moisture to drain. The system must be leak-checked following the procedure. Figure 4 shows the location for the right system drains in the right avionics bay.

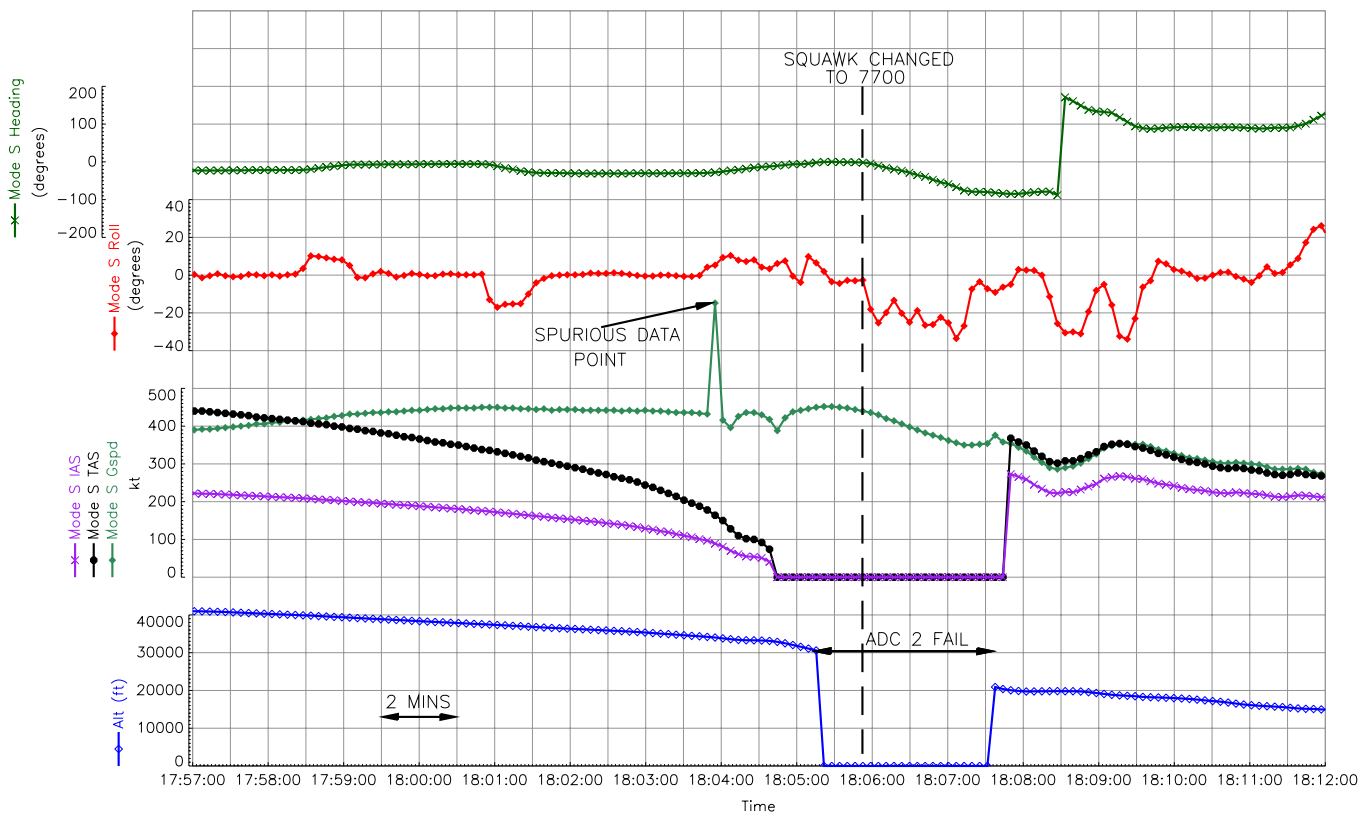
**Figure 5**

The Mode S radar recording data from Debden covered most of the flight from Copenhagen and included airspeed and altitude data in addition to positional information (see Figure 5).

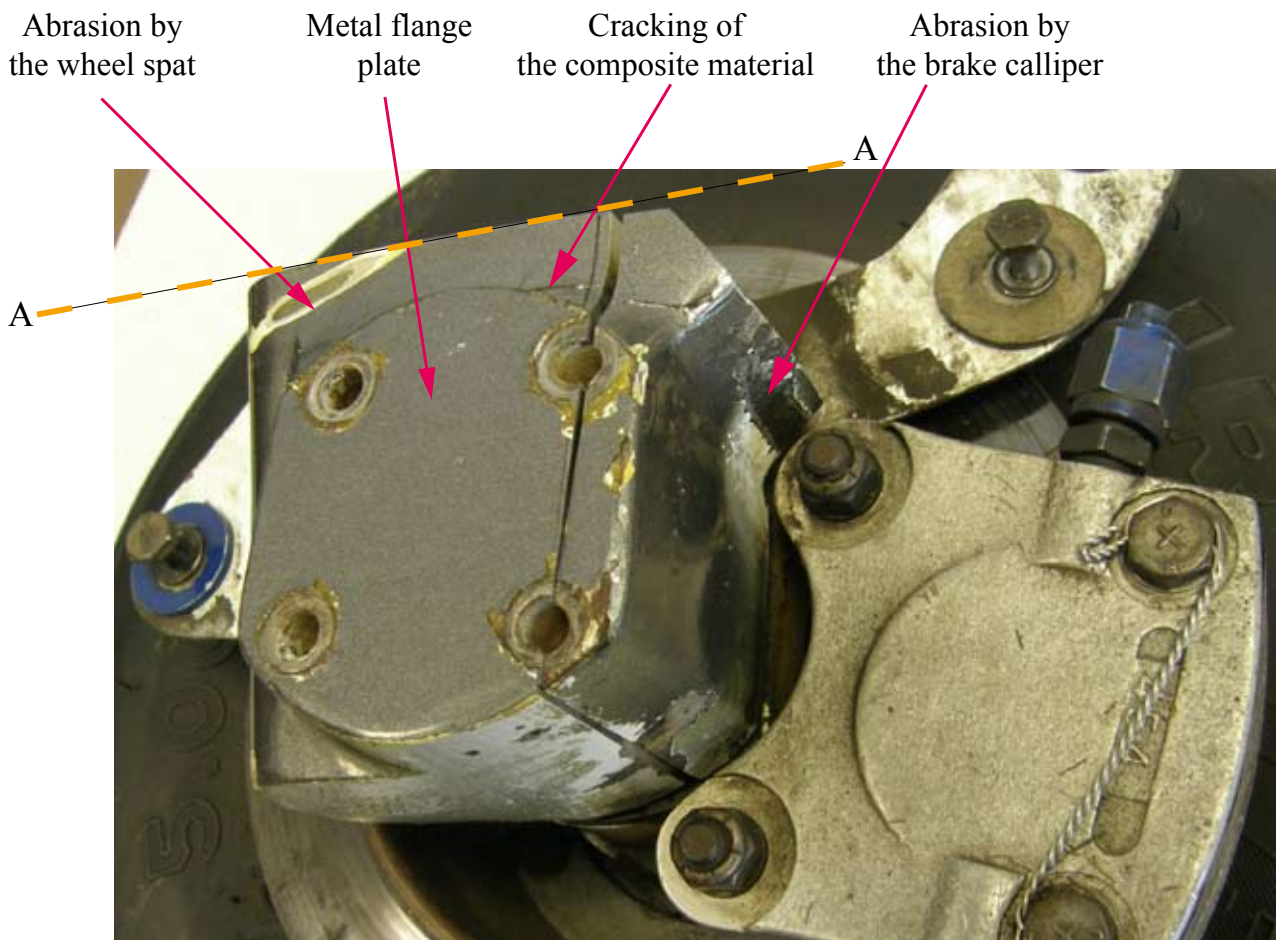
**Figure 1**

The manufacturers’ Service Manual calls for a visual inspection at 1,000 hrs of the main landing gear spring for dents, cracks and delaminations, especially at the wheel axle attachment and the centre bushing, for wear and looseness. There are no specific requirements to inspect for abrasion of the outer layer of the glass fabric reinforced composite material. The aircraft had achieved 1,201 hrs since manufacture.

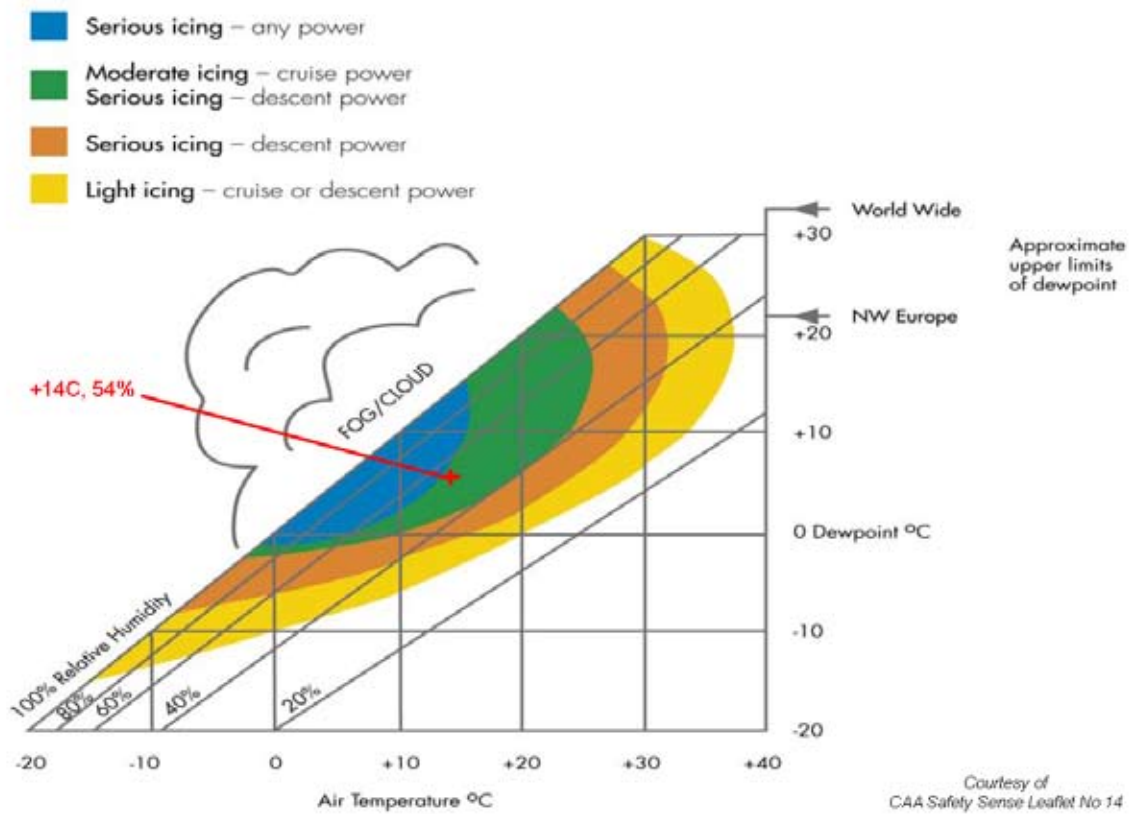
**Figure 2**  
Carburettor icing probability chart from CAA Safety Sense Leaflet 14

slightly sooted but otherwise in satisfactory condition. The engine had not suffered from any mechanical failure, so the pilot concluded that the engine may have suffered from carburettor icing. The temperature and humidity at the time were 14°C and 54%, which placed the risk of carburettor icing on the borderline between '*Serious icing – any power*' and '*Moderate icing – cruise power*' based on the CAA's carburettor icing probability chart (see Figure 2).

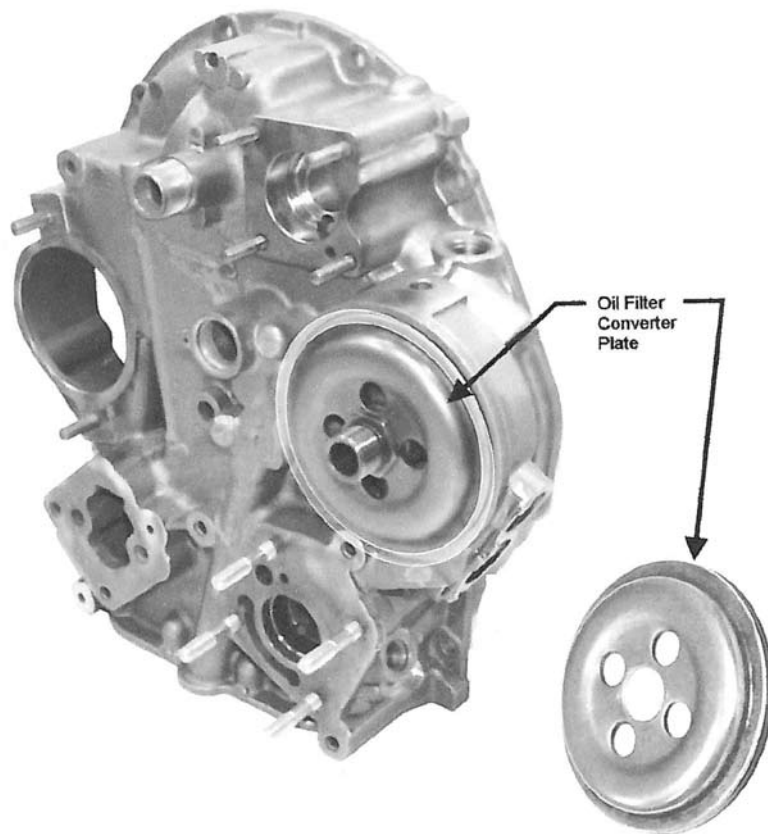
**Figure 1**

Oil filter converter plate location on the accessory drive housing

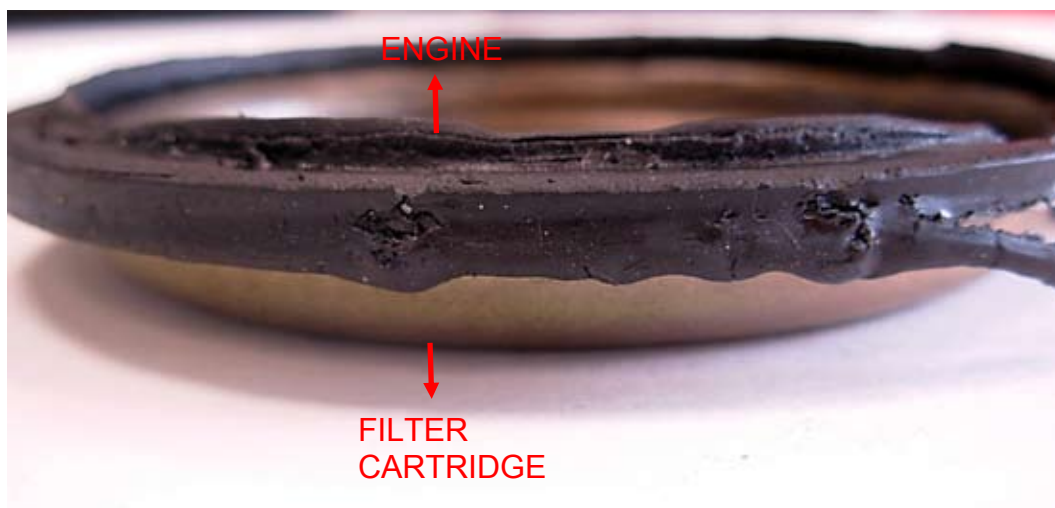
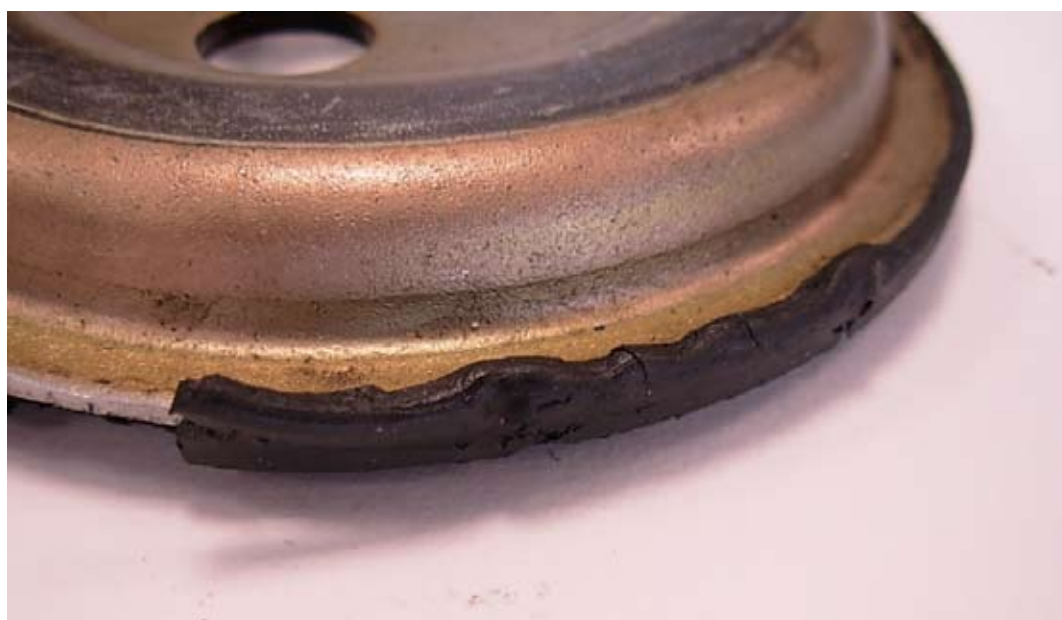
**Figure 3**

The failed gasket had sustained considerable damage, as shown in the photographs at Figure 3a and 3b. It was concluded that this was partly the result of high temperatures generated within the engine following the loss of lubrication.

The available evidence strongly indicated that the engine failed as a result of a complete loss of oil following the failure of the gasket on the oil filter converter plate. Loss of oil was consistent with the reported symptom
