AAIB
Air Accidents Investigation Branch

AAIB Bulletin

12/2014

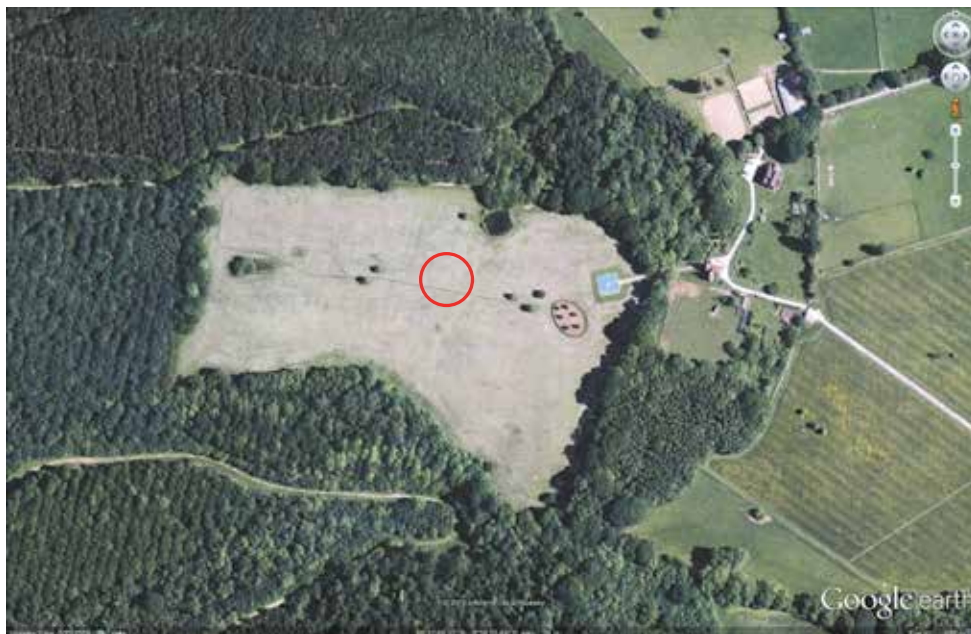
Figure 1

The field containing the landing site near Peasmarsh;
the red circle indicates the position of the triangle of lights

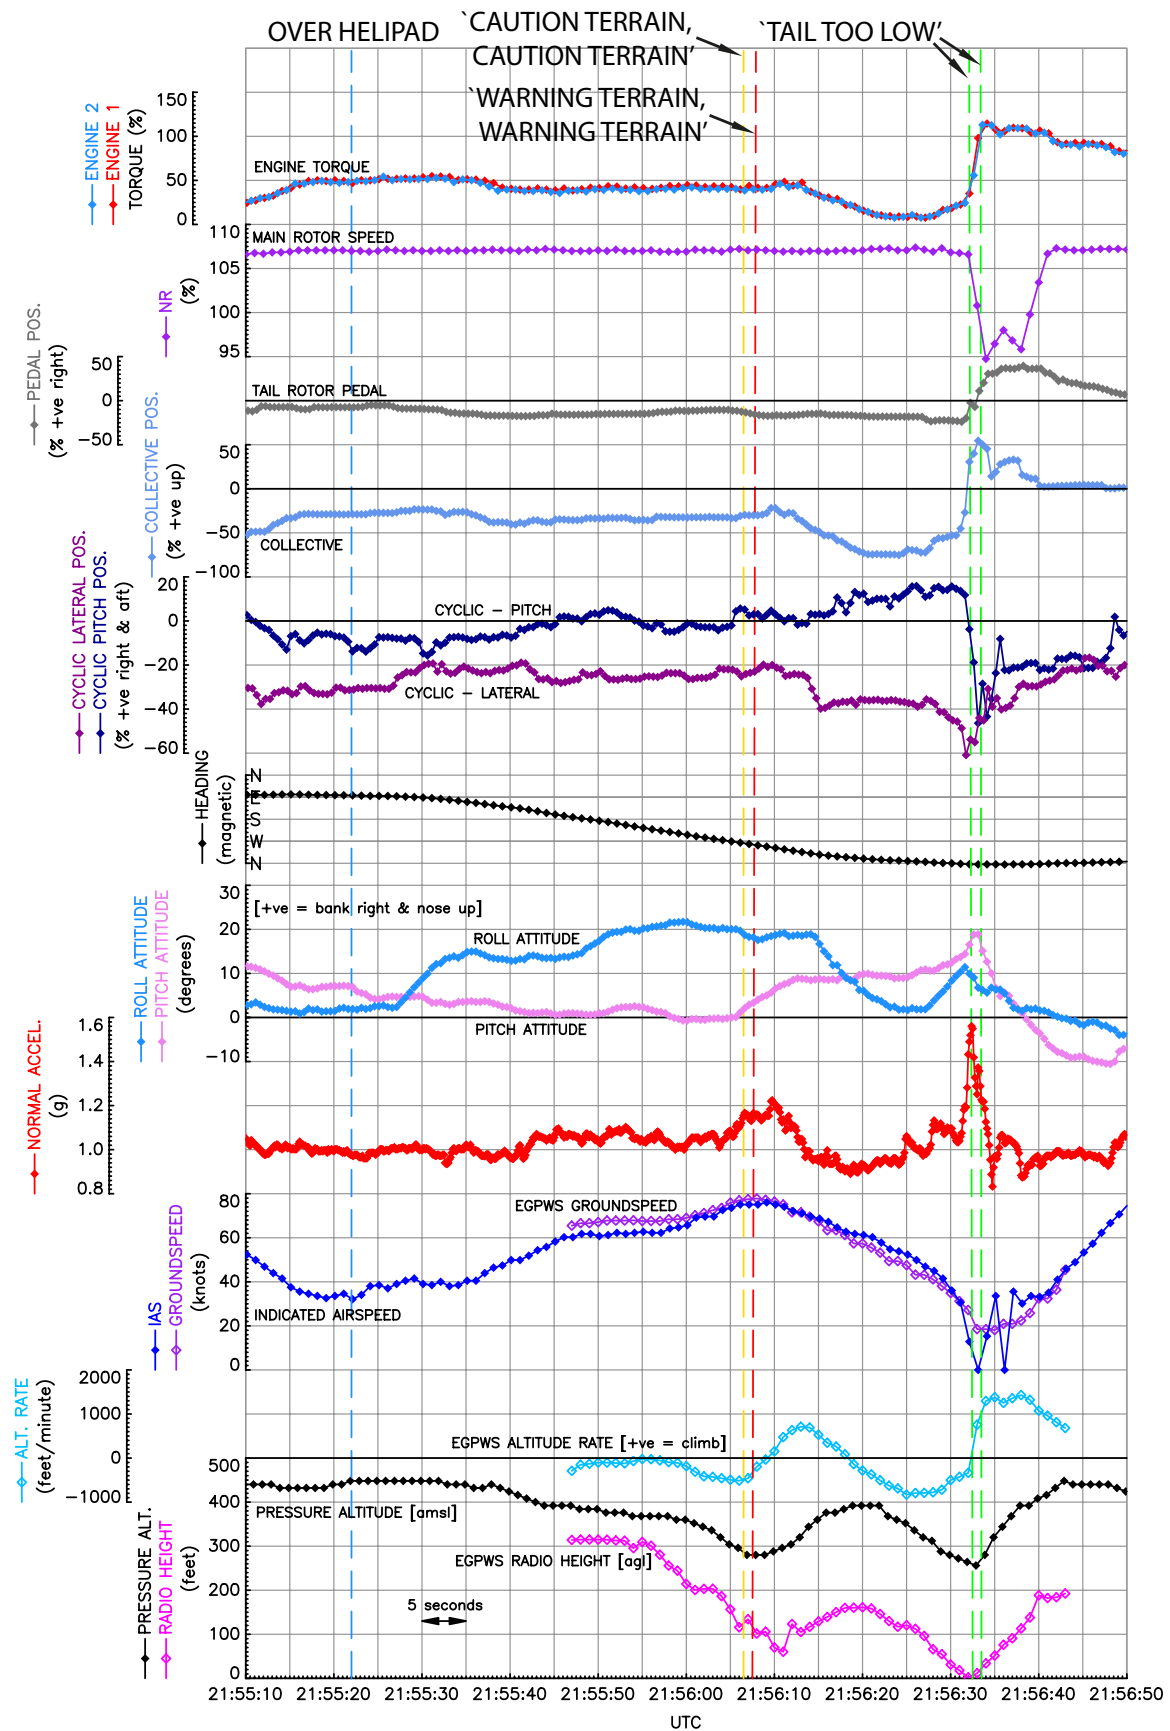
Figure 2 starts with the helicopter decelerating though 52 KIAS at 324 ft amsl¹⁰ (about 204 ft aal) on the approach to the helipad from the west. It passed over the helipad 12 seconds later (time 21:55:22 hrs) at 32 KIAS, at about the same altitude.

G-WIWI salient flight data from flight recorder and EGPWS

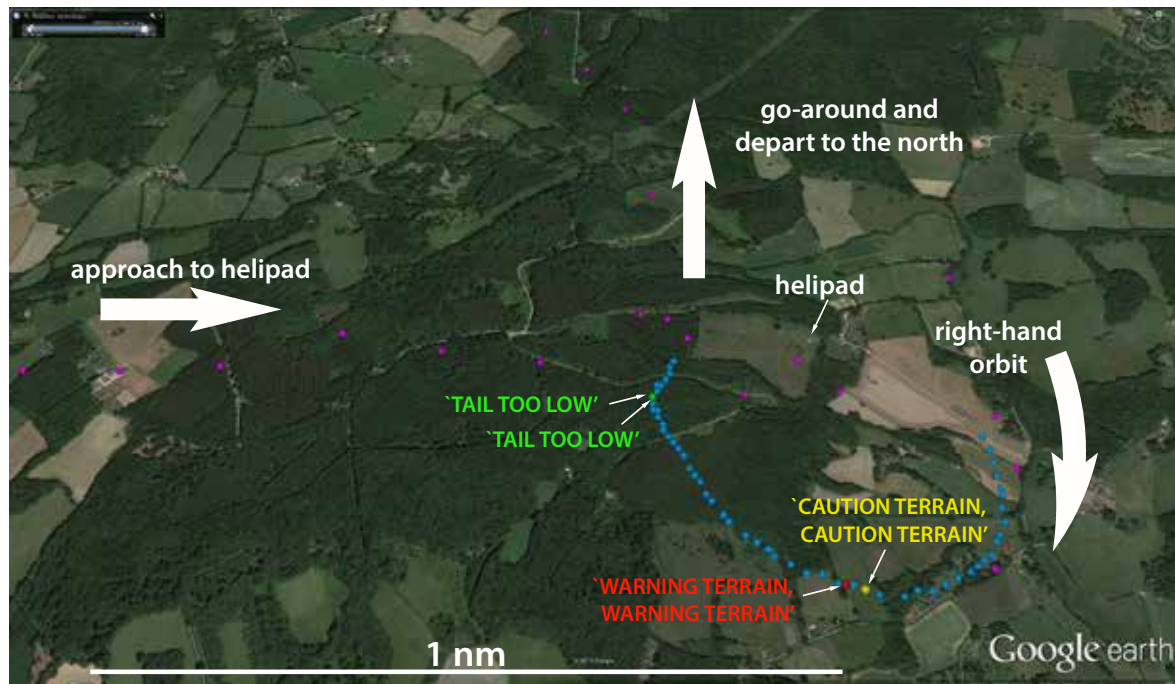
Salient parameters from the flight data and EGPWS recordings are presented in Figure 2. Figure 3 shows the ground track detected and recorded by the radar head at Pease Pottage, 40 miles to the west and north, and the GPS track recorded by the EGPWS. (The helicopter's altitude was near the radar's lower limit at that range and acquiring a fix in azimuth and recording a track was imprecise.) Also indicated on the ground track are the positions at which EGPWS caution and warning alerts were made.

Radar ground track (dark pink) and EGPWS GPS ground track (light blue)

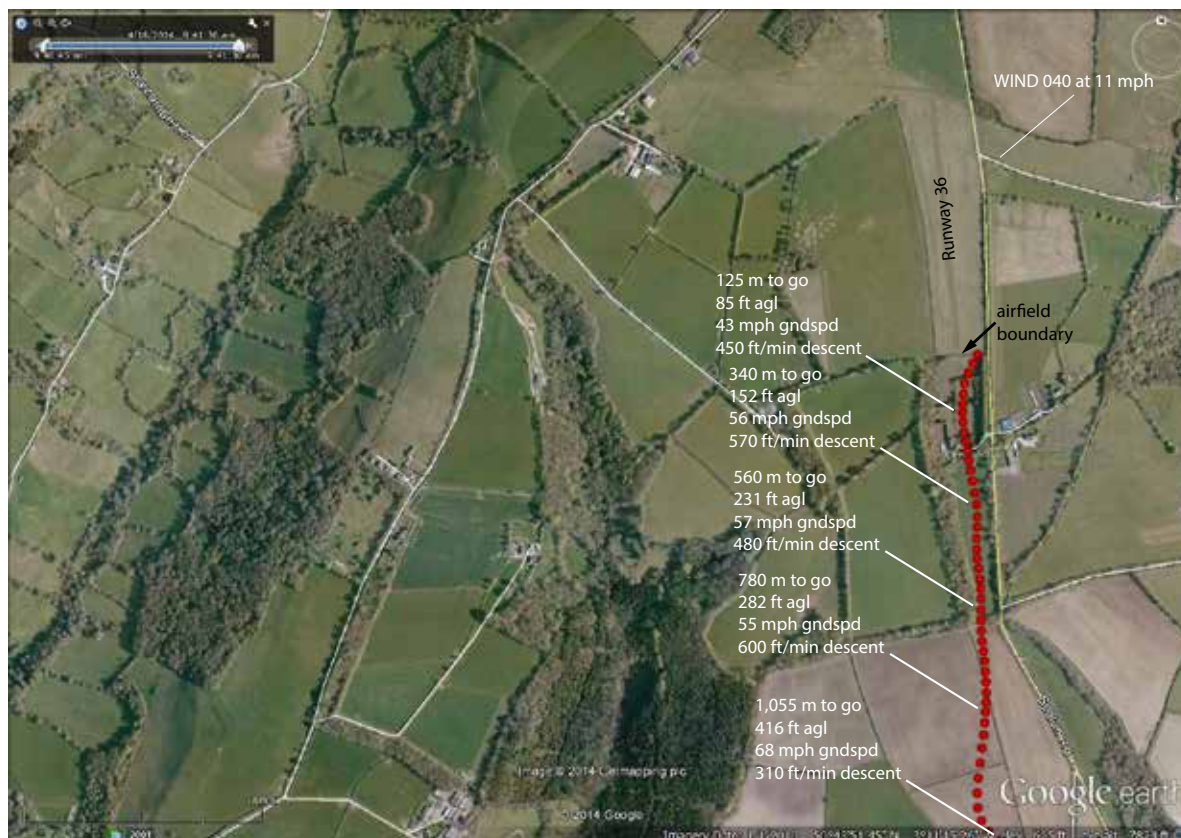
The data indicated that G-CCWR approached Farway Common from the east and turned directly toward the airfield on a north westerly track with about 2 nm to go. The aircraft overflowed the numbers of Runway 36 at about 550 ft aal, turned downwind at about 500 ft aal, and turned final at about 400 ft aal and 70 mph groundspeed. The ground track of the aircraft on final approach is illustrated at Figure 2 with the associated GPS data at Figure 3.

Ground track of G-CCWR on finals to Runway 36
(distance-to-go and height figures are relative to the airfield boundary for Runway 36)

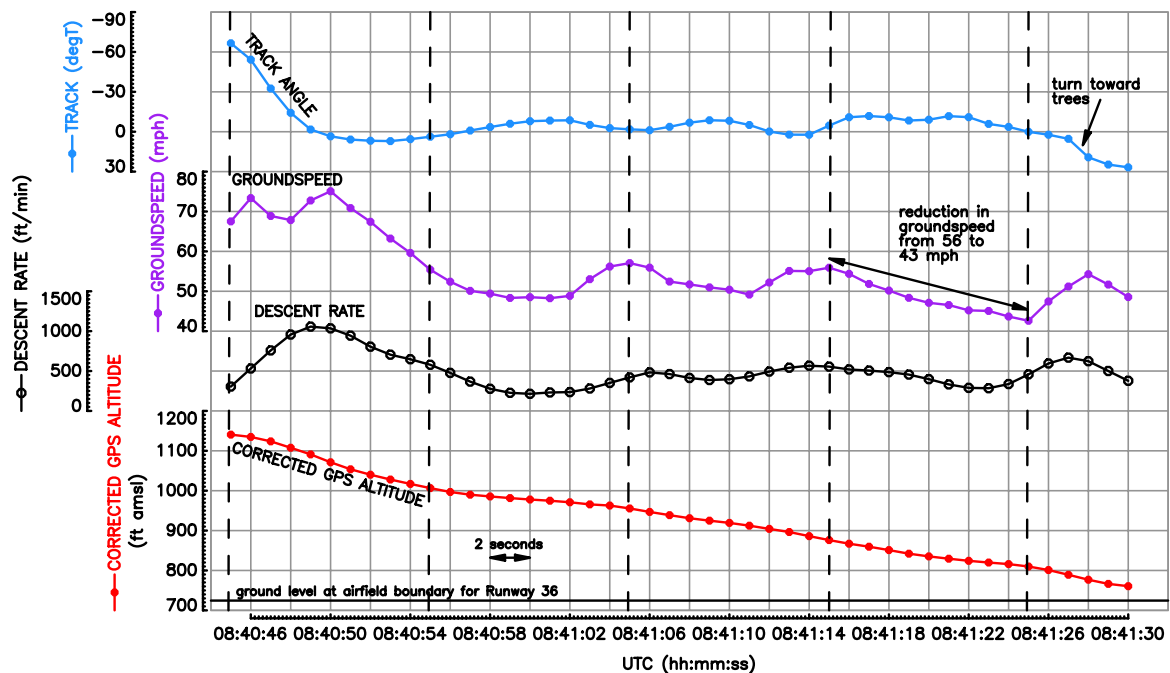
Figure 3 shows that during the latter part of the approach the groundspeed reduced steadily over a 10-second period until it reached a minimum of 43 mph about 3 seconds before the aircraft struck the trees. The wind speed was about 11 mph from 040° with gusts up to 16 mph suggesting that the airspeed at this point could have been between 51 mph and 55 mph. However, in the shadow of the trees the wind speed could have been lower and consequently the airspeed could have been lower than 51 mph. The groundspeed then increased briefly to 54 mph as the aircraft turned and descended into the trees.

GPS derived data of G-CCWR on final approach to Runway 36
(with points highlighted in Figure 2 identified by dashed lines)

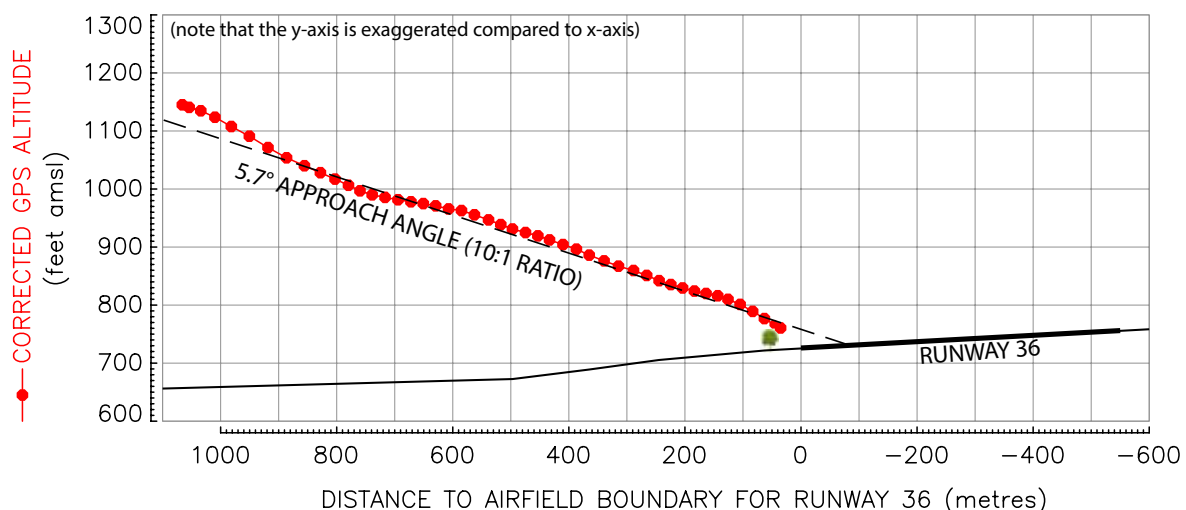
The altitude data of G-CCWR on final approach to Runway 36 is also presented in Figure 4 against distance to go to the airfield boundary to Runway 36. This indicates that G-CCWR was being flown with an approach angle of close to 6° after turning onto final approach (note that a 5.7° approach angle equates to a 10:1 slope ratio). It was calculated that an

Vertical profile of G-CCWR on final approach to Runway 36 and a dashed line for reference depicting a 5.7° approach angle (10:1 ratio) to clear the 33 ft high trees (50 m before the airfield boundary) by 10 ft

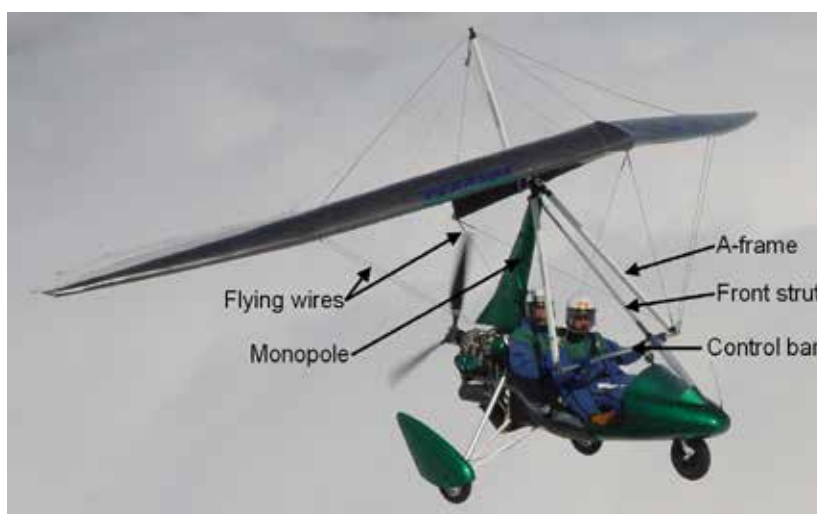
Figure 5

The Pegasus Quik is a two-seat, flex-wing (weight-shift control) microlight aircraft, comprising a trike unit and wing connected by an upright monopole (Figure 5). The trike incorporates a tricycle undercarriage and G-CCWR was powered by a 100 hp Rotax 912ULS engine fitted with a 3-bladed Warp Drive propeller. Maximum engine speed

Pegasus Quik (photograph courtesy Bill Brooks)

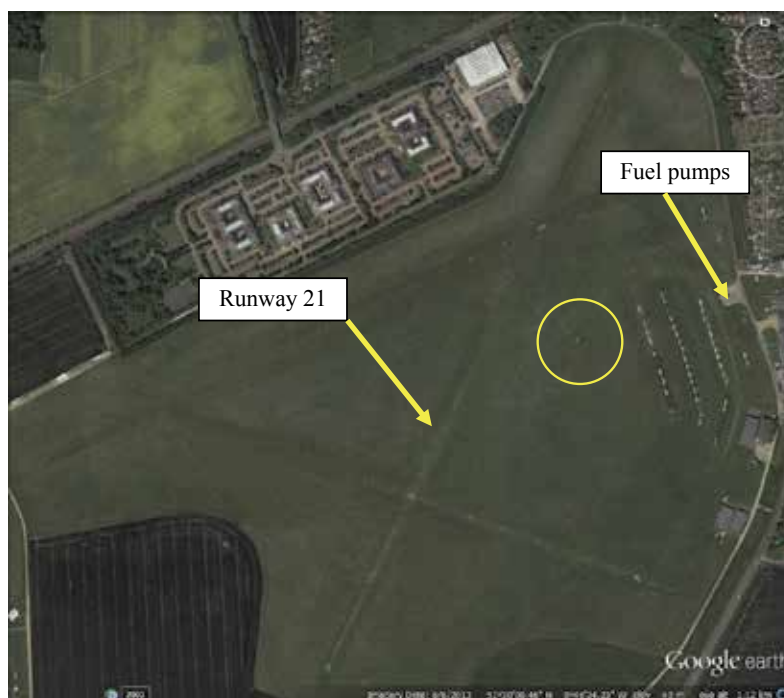
Figure 1

The pilot, who is a long-standing member of the flying club at White Waltham, had landed on Runway 21 and intended to taxi to the fuel pumps to refuel (Figure 1). Because forward visibility when taxiing is limited on the Extra 300, the pilot adopted a weaving path to clear himself from other aircraft and to follow some existing tyre tracks. Unfortunately, he did not see a small, low bowser containing Jet A1 fuel which the aircraft struck nose-first, causing damage to both. The pilot admitted that he had known perfectly well that the bowser, which

Aerial view of White Waltham Airfield, showing location of bowser containing Jet A1 fuel (circled)
