Aircraft Type and Registration:	Airbus A320-231, G-JOEM	
No & Type of Engines:	2 IAE V2500-A1 turbofan engines	
Year of Manufacture:	1993	
Date & Time (UTC):	17 March 2004 at 1540 hrs	
Location:	Birmingham Airport, West Midlands	
Type of Flight:	Public Transport (Passenger)	
Persons on Board:	Crew - 6	Passengers - 168
Injuries:	Crew - None	Passengers - None
Nature of Damage:	Damage to forward left cabin door	
Commander's Licence:	Airline Transport Pilot's Licence	
Commander's Age:	36 years	
Commander's Flying Experience:	7,000 hours (of which 4,400 were on type) Last 90 days - 155 hours Last 28 days - 50 hours	
Information Source:	Aircraft Accident Report Form submitted by the pilot and further enquiries by the AAIB

Aircraft Type and Registration:	Falcon 50, CS-DFI
No & Type of Engines:	3 TFE-731 turbofan engines
Year of Manufacture:	1982
Date & Time (UTC):	16 September 2004 at 1035 hrs
Location:	London City Airport, London
Type of Flight:	Commercial
Persons on Board:	Crew - 2 Passengers - 4
Injuries:	Crew - None Passengers - None
Nature of Damage:	Nil
Commander's Licence:	Airline Transport Pilot's Licence
Commander's Age:	40 years
Commander's Flying Experience:	6,465 hours (of wh

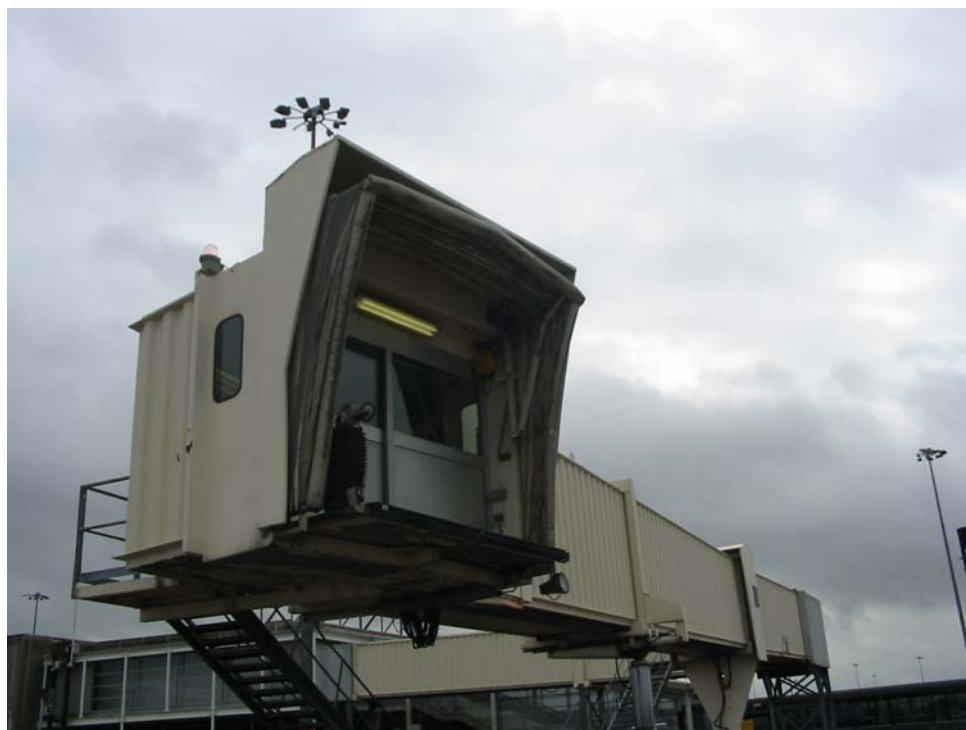
Figure 1

Passengers were boarding the aircraft through the forward left cabin door, via an airbridge (see Figure 1). When approximately two-thirds of the passengers had embarked, the cabin crew noticed that the bottom of the door, which opens outwards and forwards, was in contact with the floor of the airbridge. The crew contacted their handling agent and one of their staff attended the aircraft.

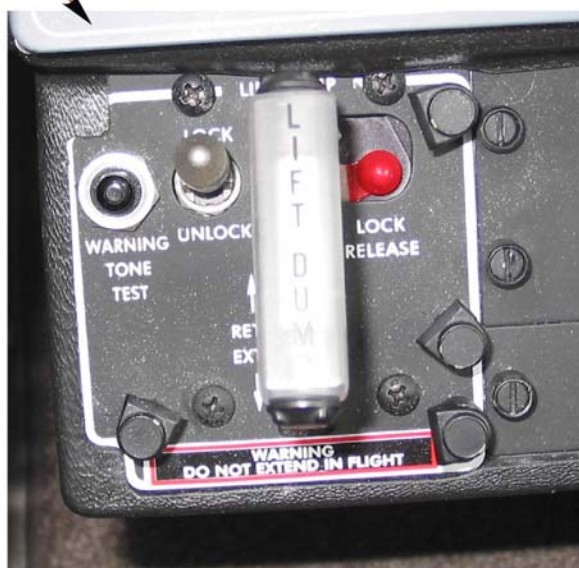
Figure 3 - Lift Dump and Speedbrake components

Post Modification Lift Dump Handle as fitted to N200PR

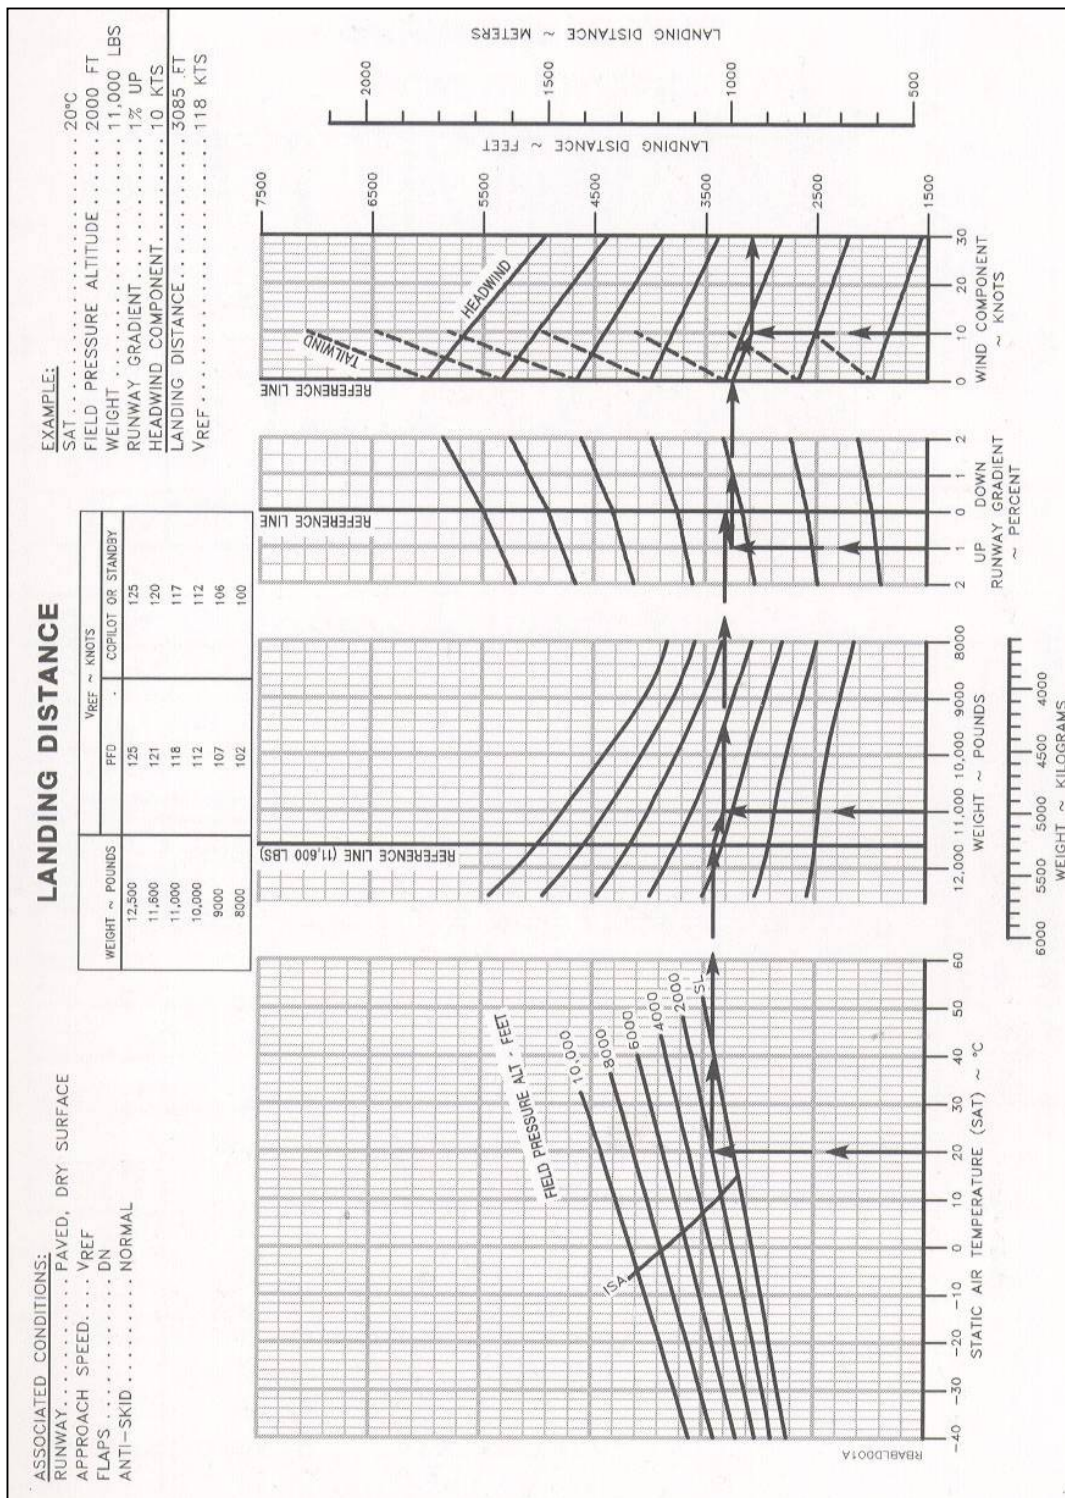
Figure 5 - Normal Landing Performance Charts

An example of the AFM landing performance chart is shown at Figure 5. The data are presented in a commonly used format, but they are of small scale and minor plotting errors can lead incrementally to significant miscalculations. The manufacturer recognised the limitations of the published charts, especially when used in the air during single-pilot operations, which is why abnormal and emergency checklists included percentage increases to normal landing distances on the presumption that pilots would have calculated their normal landing distance on the ground before departure. At the top left corner of the chart the conditions associated with the data published on the chart were listed, but the charts did not reflect all the landing performance criteria listed above. In particular the braking technique was omitted. Additionally, the pilot stated that his initial type training did not include all of the information on the actions necessary to achieve the published landing performance.

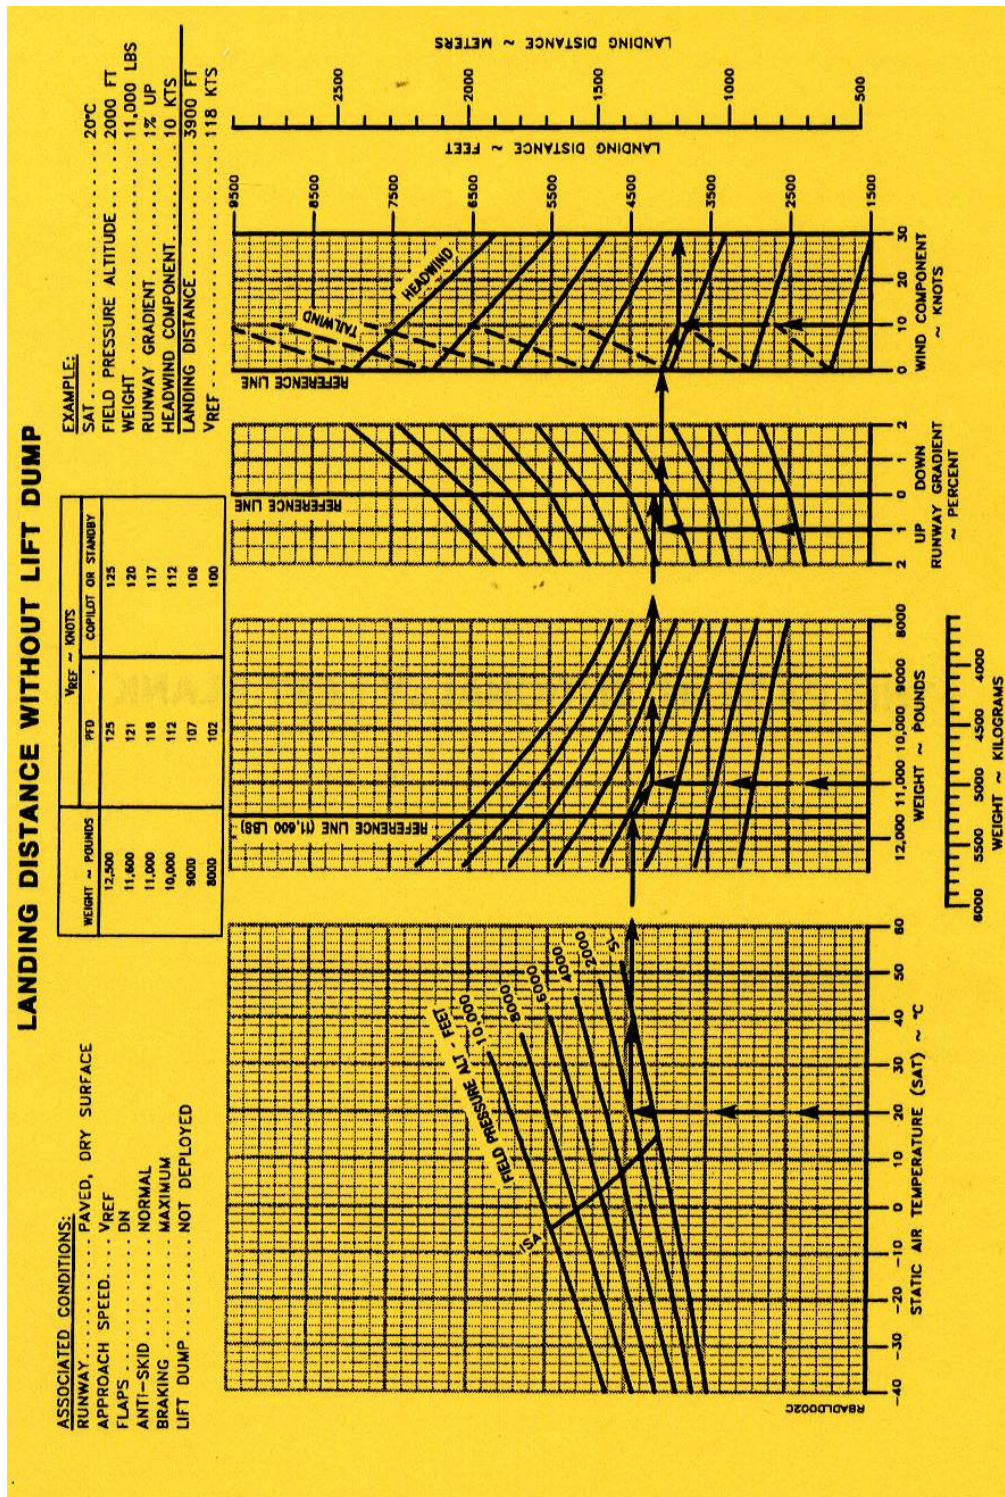
Figure 6 - FAA AD imposed Landing Performance Chart without Lift Dump

Following a series of runway overrun accidents involving non-deployment of the lift dump spoilers, the manufacturer designed a modification to the lift dump system. Pending installation of this modification the FAA issued AD2003-07-09 and AD2003-10-05; these required that no credit be taken for the improved landing performance provided by the lift dump system and all landings should be planned on the basis that the lift dump system was inoperative. Thus in March 2003 the manufacturer issued aircraft operators with a temporary change to AFMs which provided performance charts for a landing with the lift dump system inoperative (Figure 6): once the lift dump system had been modified this chart should then have been removed from the AFM. This temporary landing performance chart included lift dump spoiler status and braking technique in the list of associated conditions. The landing distances provided by this chart were significantly less than increasing the normal landing performance by 53%, which was used to represent the most conservative condition.

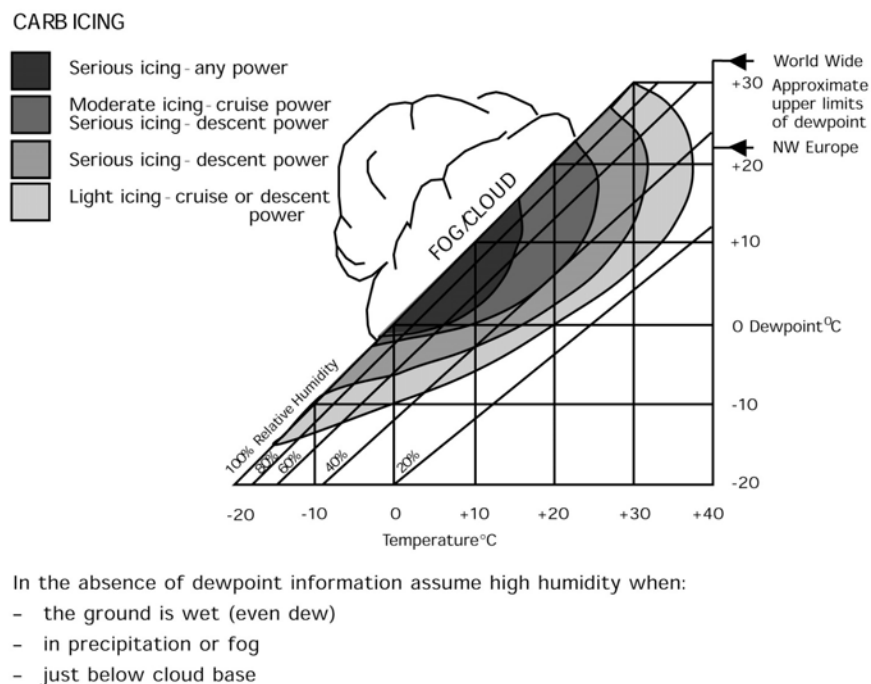
Figure 1

A graph to illustrate the probability of carburettor icing is reproduced below at Figure 1.

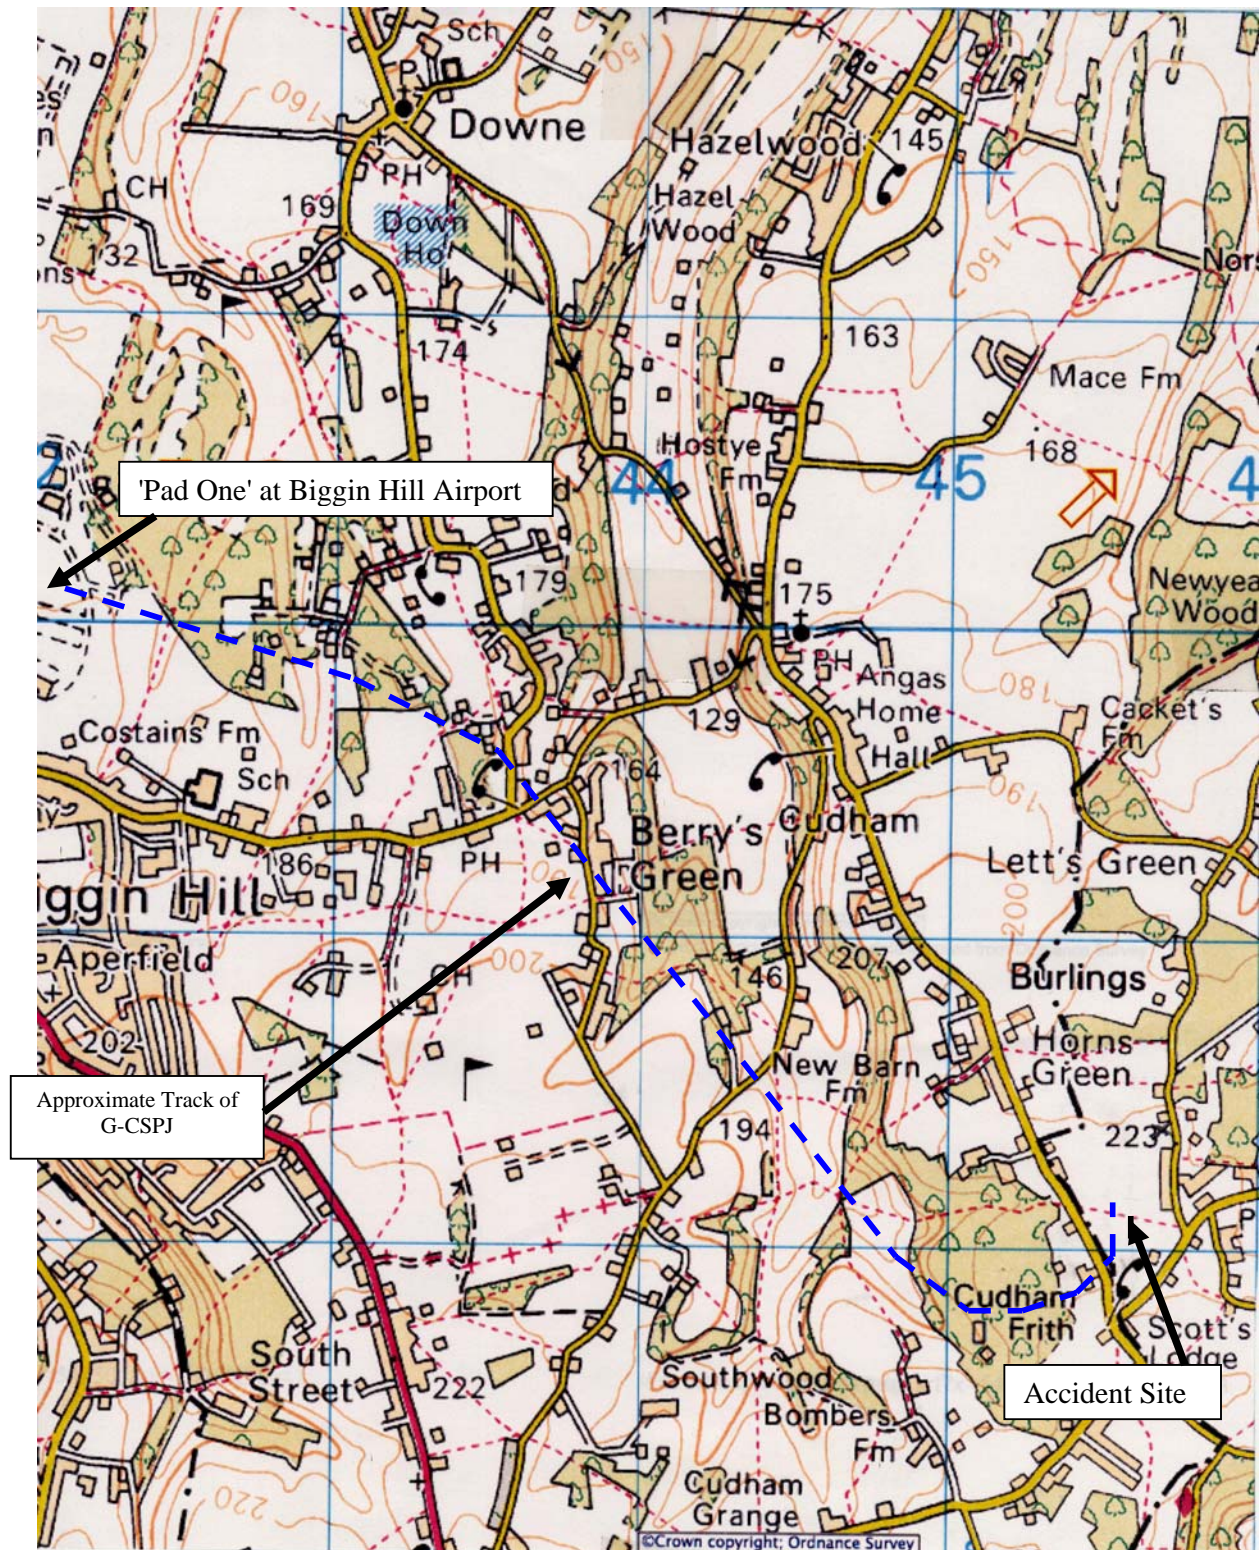
Figure 2

made at 0848:30 hrs on the Biggin Hill Approach frequency has been identified as coming from the Hughes 369. The voice is considered to be that of the pilot and the two words heard are a distressed utterance rather than recognised RTF language. This transmission coincided with the time that the helicopter is believed to have struck the ground in a field on the east side of Cudham Lane South (see Figure 2).

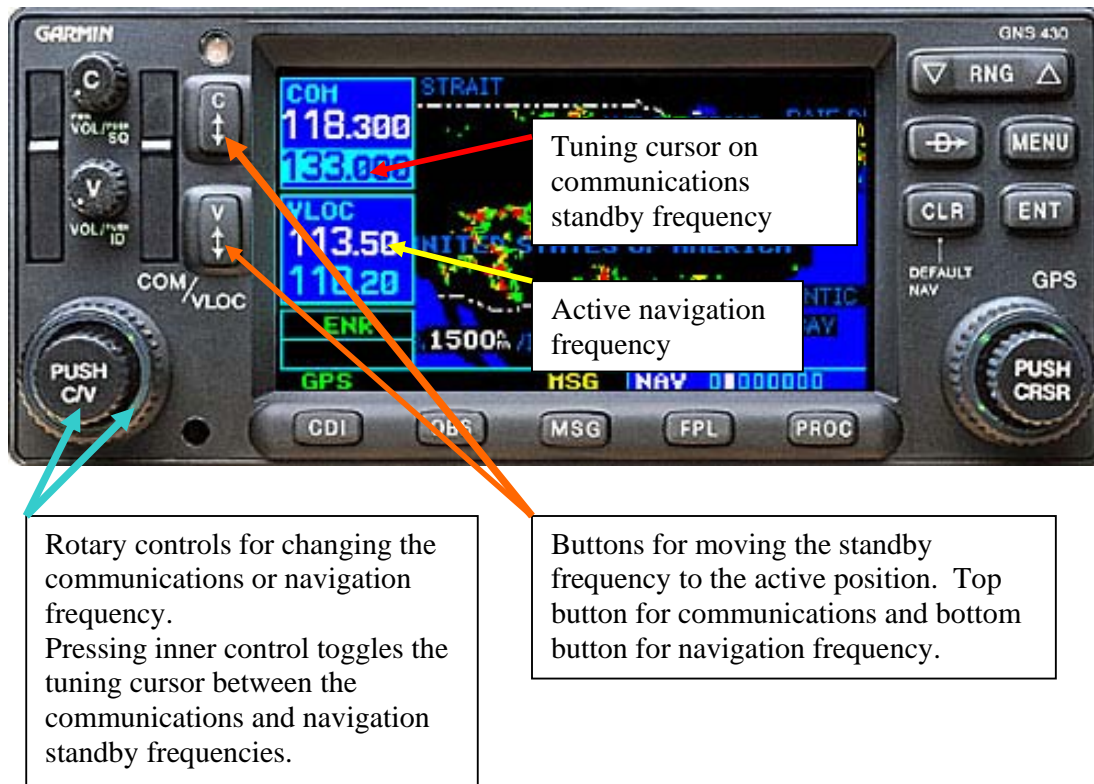
Figure 3
(Garmin GNS 430)

The aircraft was fitted with the Garmin GNS 430, which combines VHF communications, navigation functions and moving map graphics on a single colour display (see Figure 3). The communications and navigation frequencies are both altered by means of the same co-located rotary knobs (one inner and one outer) situated on the bottom left hand corner of the combined control panel and display. Rotating the outer knob changes the MHz frequencies and the inner knob similarly changes the kHz frequencies. Momentarily pressing the inner knob toggles the tuning cursor between the communications and navigation standby frequency displays. It is possible to do this accidentally while changing the kHz part of the communications or navigation standby frequency. Both the communications and navigation displays show their respective active and standby frequencies. Pressing separate buttons for each facility moves the standby frequency to the active position.

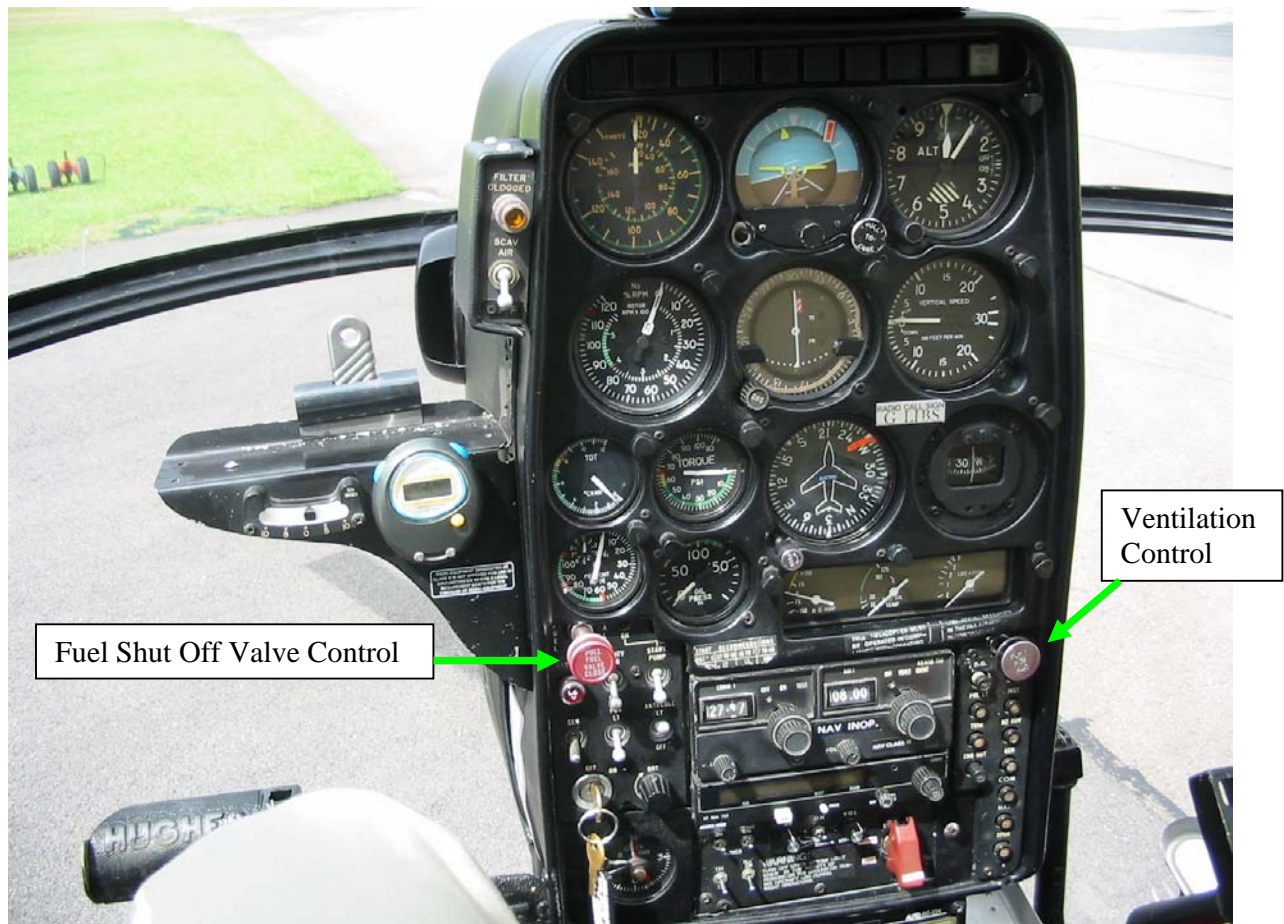
Figure 4
(Instrument console – Hughes 369HS)

The fuel shut off valve is operated by a push-pull control on the left side of the instrument panel. The control, which is pulled out to close the valve, is in a similar but opposite position to the ventilation control on the right side of the panel (see Figure 4). In the Jet Ranger there are two ventilation controls and they are situated in comparable positions to the fuel shut off valve and the ventilation control in the Hughes (see Figure 5). Further, the shapes of the fuel shut off valve and the ventilation control in the Hughes are similar although the fuel shut off control is red in colour whereas the air vent control is black.
